**GROUND APPRAISAL REPORT**

**MILL LANE, HITCHIN,  
HERTFORDSHIRE, SG4 7NN.**

**MARTIN GRANT HOMES**

| Reference: | GE23305-GAR-JAN26 |

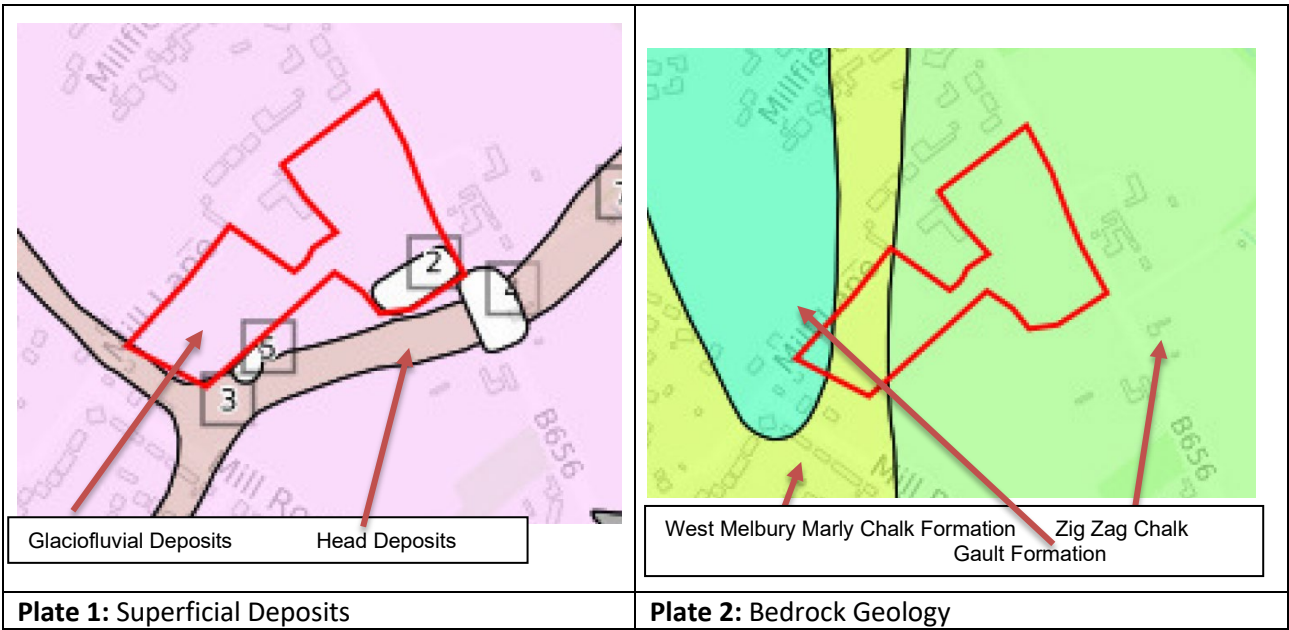
British Geological Survey geological mapping indicated the geology of the site was likely to comprise superficial Glaciofluvial deposits, with Head Deposits mapped nearby over the West Melbury Marly Chalk Formation in the east, Zig Zag Chalk Formation in the west and Gault Clay in the very west.

For further details of the distribution of geological units, reference should be made to Plate 1 – Superficial deposits and Plate 2 – Bedrock geology.

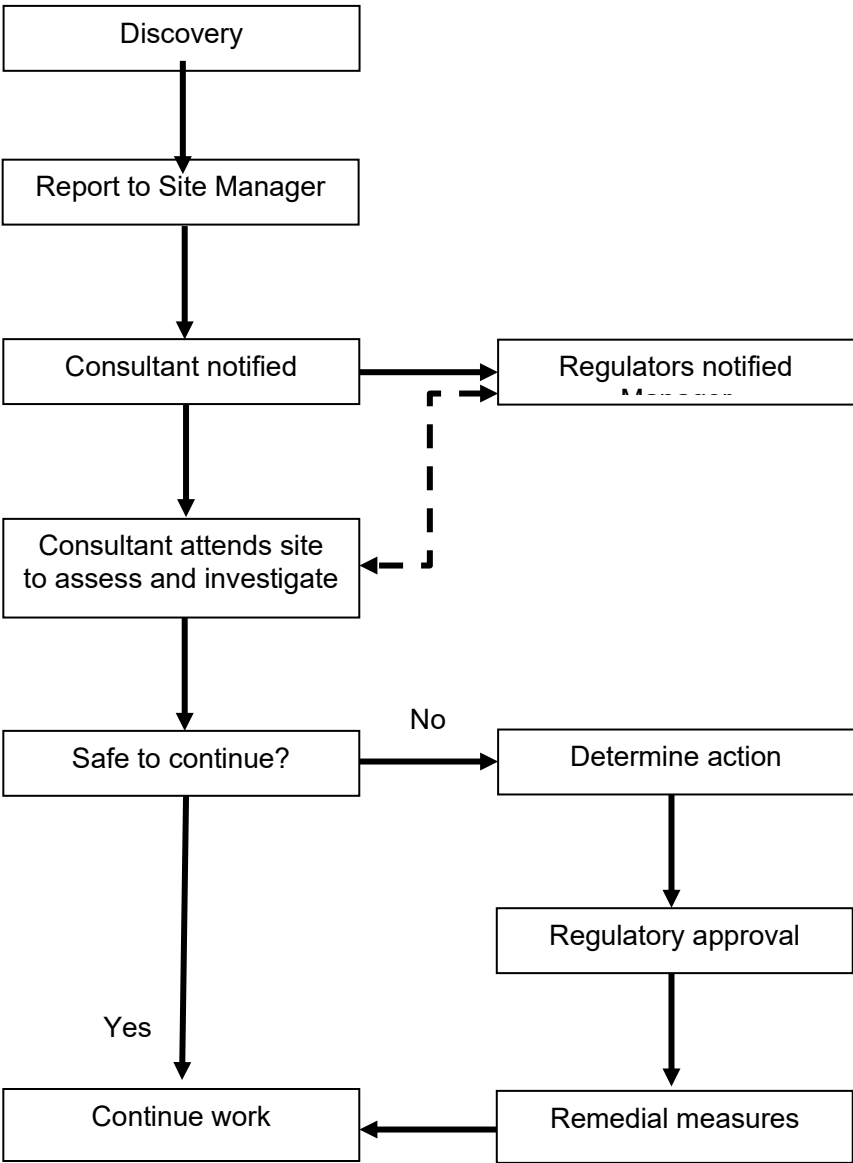
Chart 1: Discovery Strategy Process

- Where remedial action is required, regulatory consultation and approval will be sought;
- A record will be produced by the Consultant and held on site (with copies held by the Consultant, Client and Local Authority/other relevant organisation), detailing the discovery, assessment works undertaken, findings thereof, confirmation either of no action required or detailing the remedial action taken and validation thereof.

The process is shown overleaf:

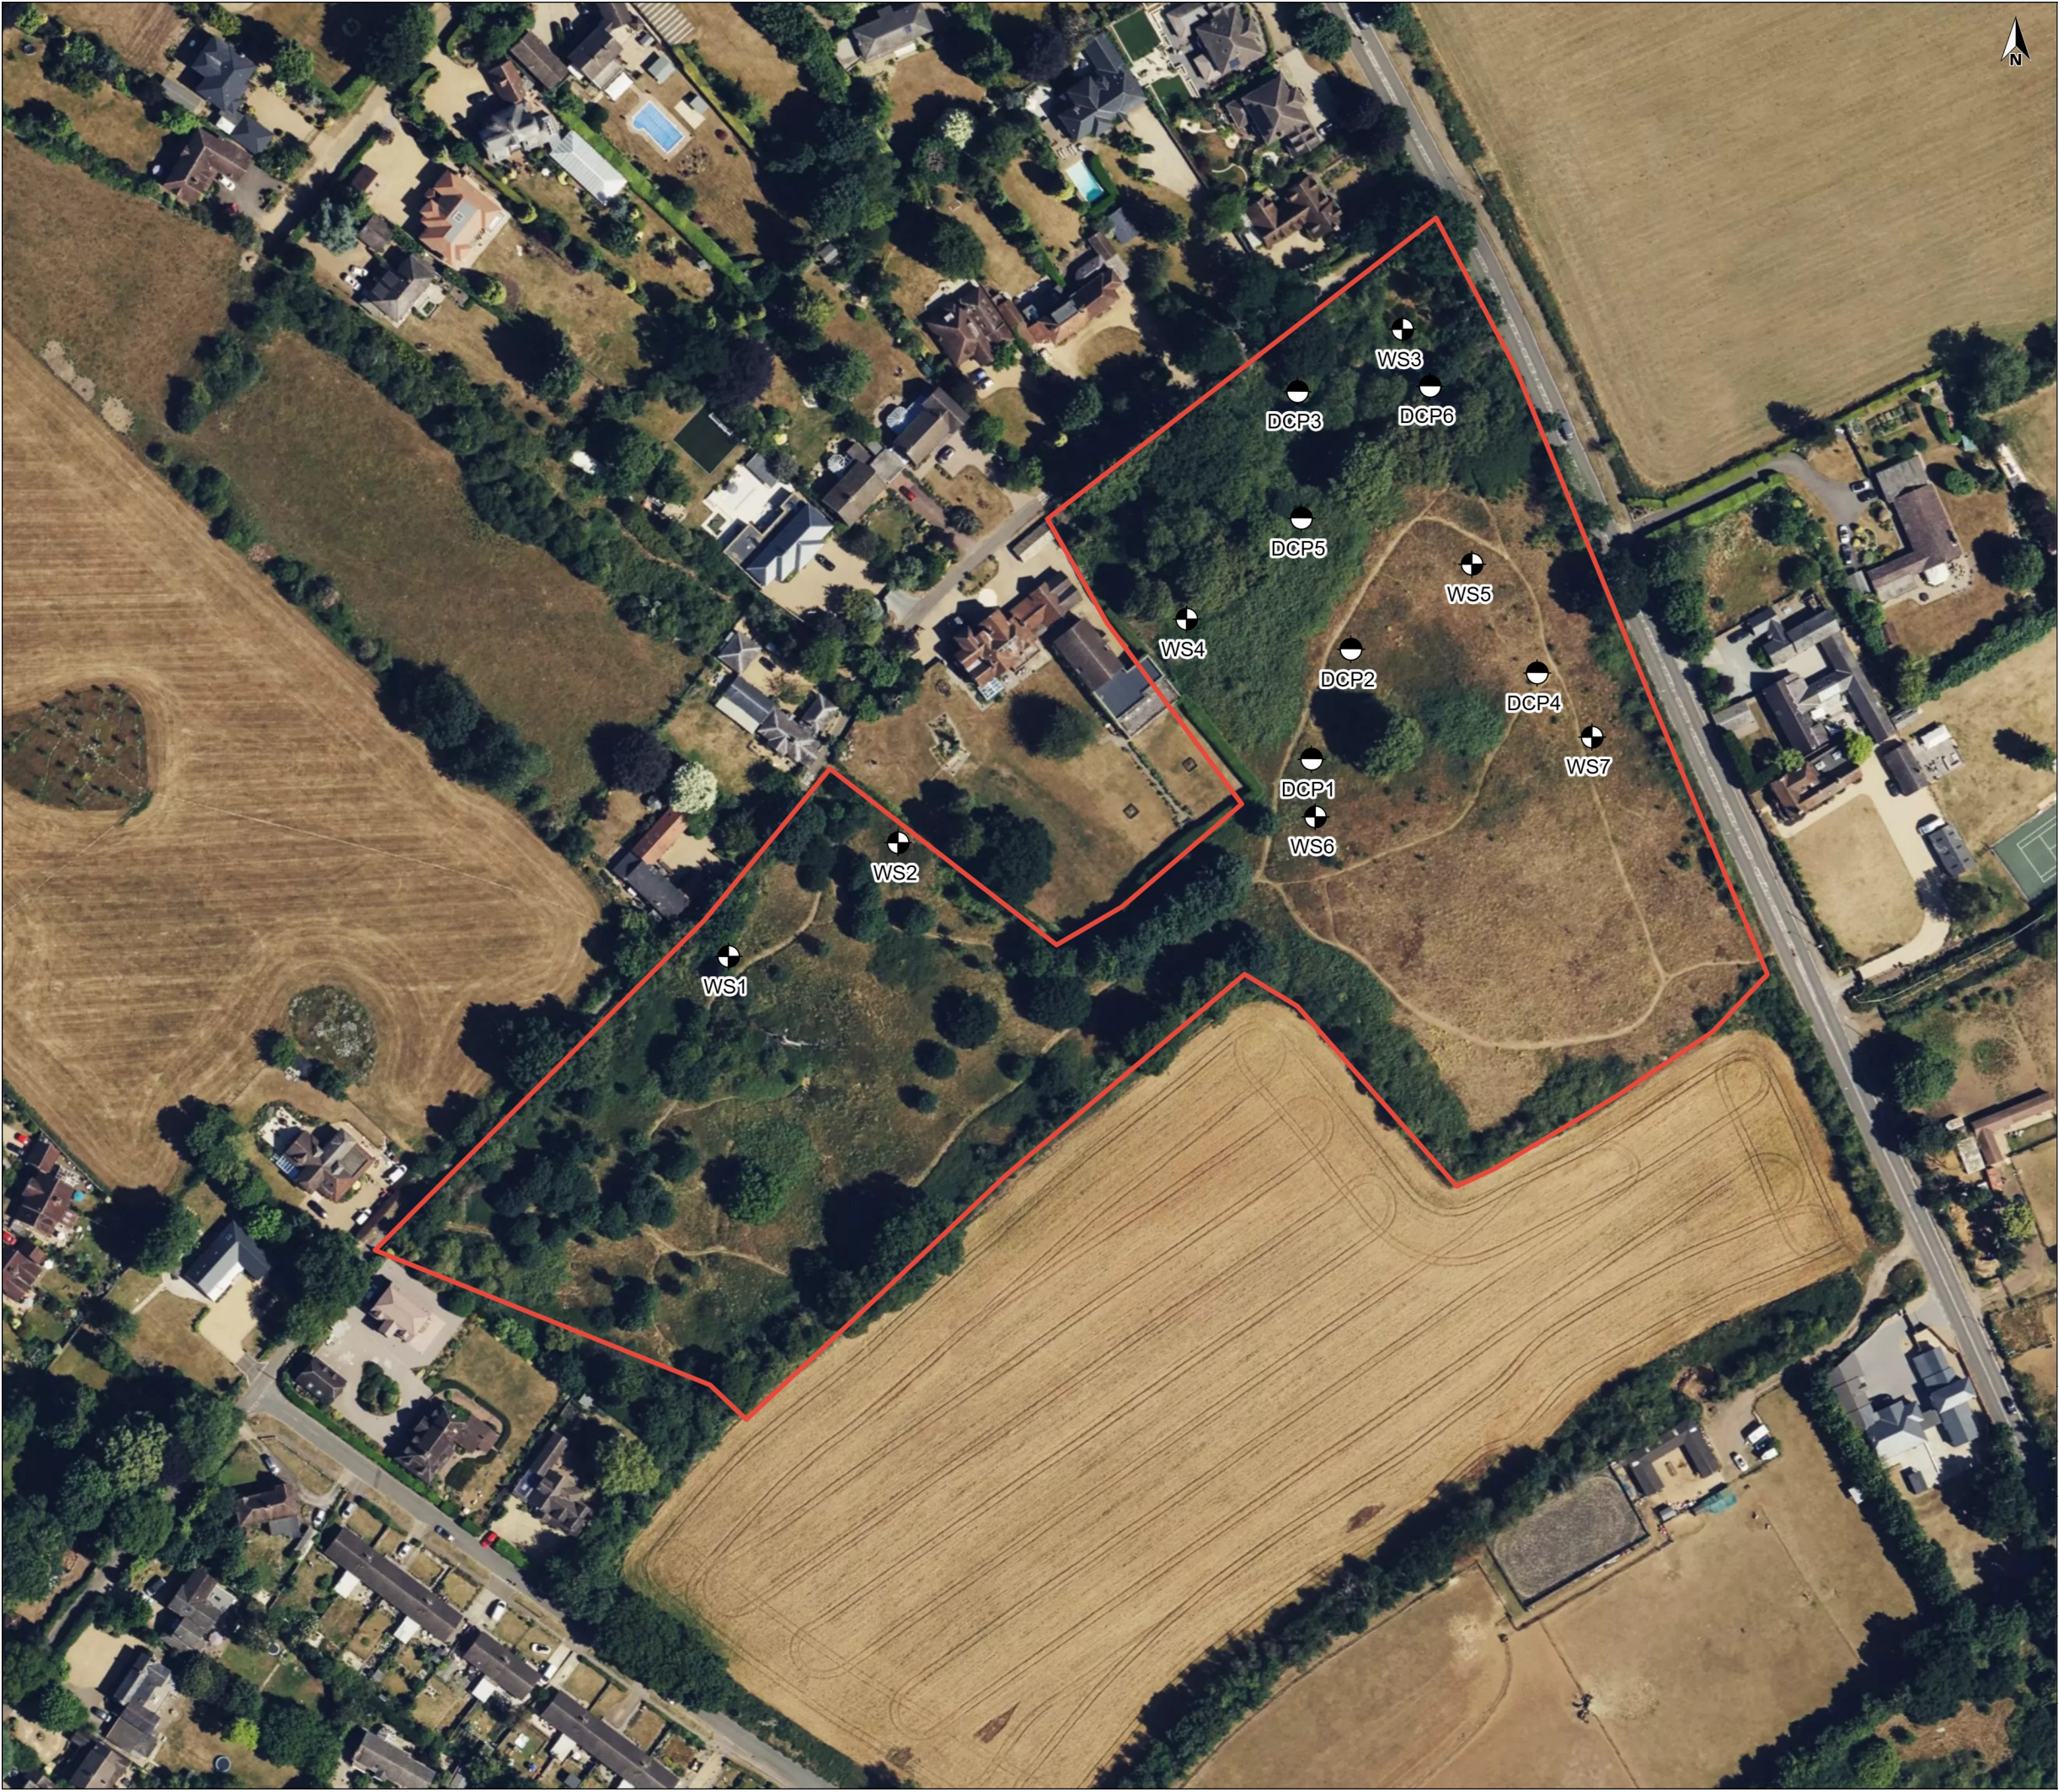
- DCPs
- Window Sample Locations
- Site Boundary

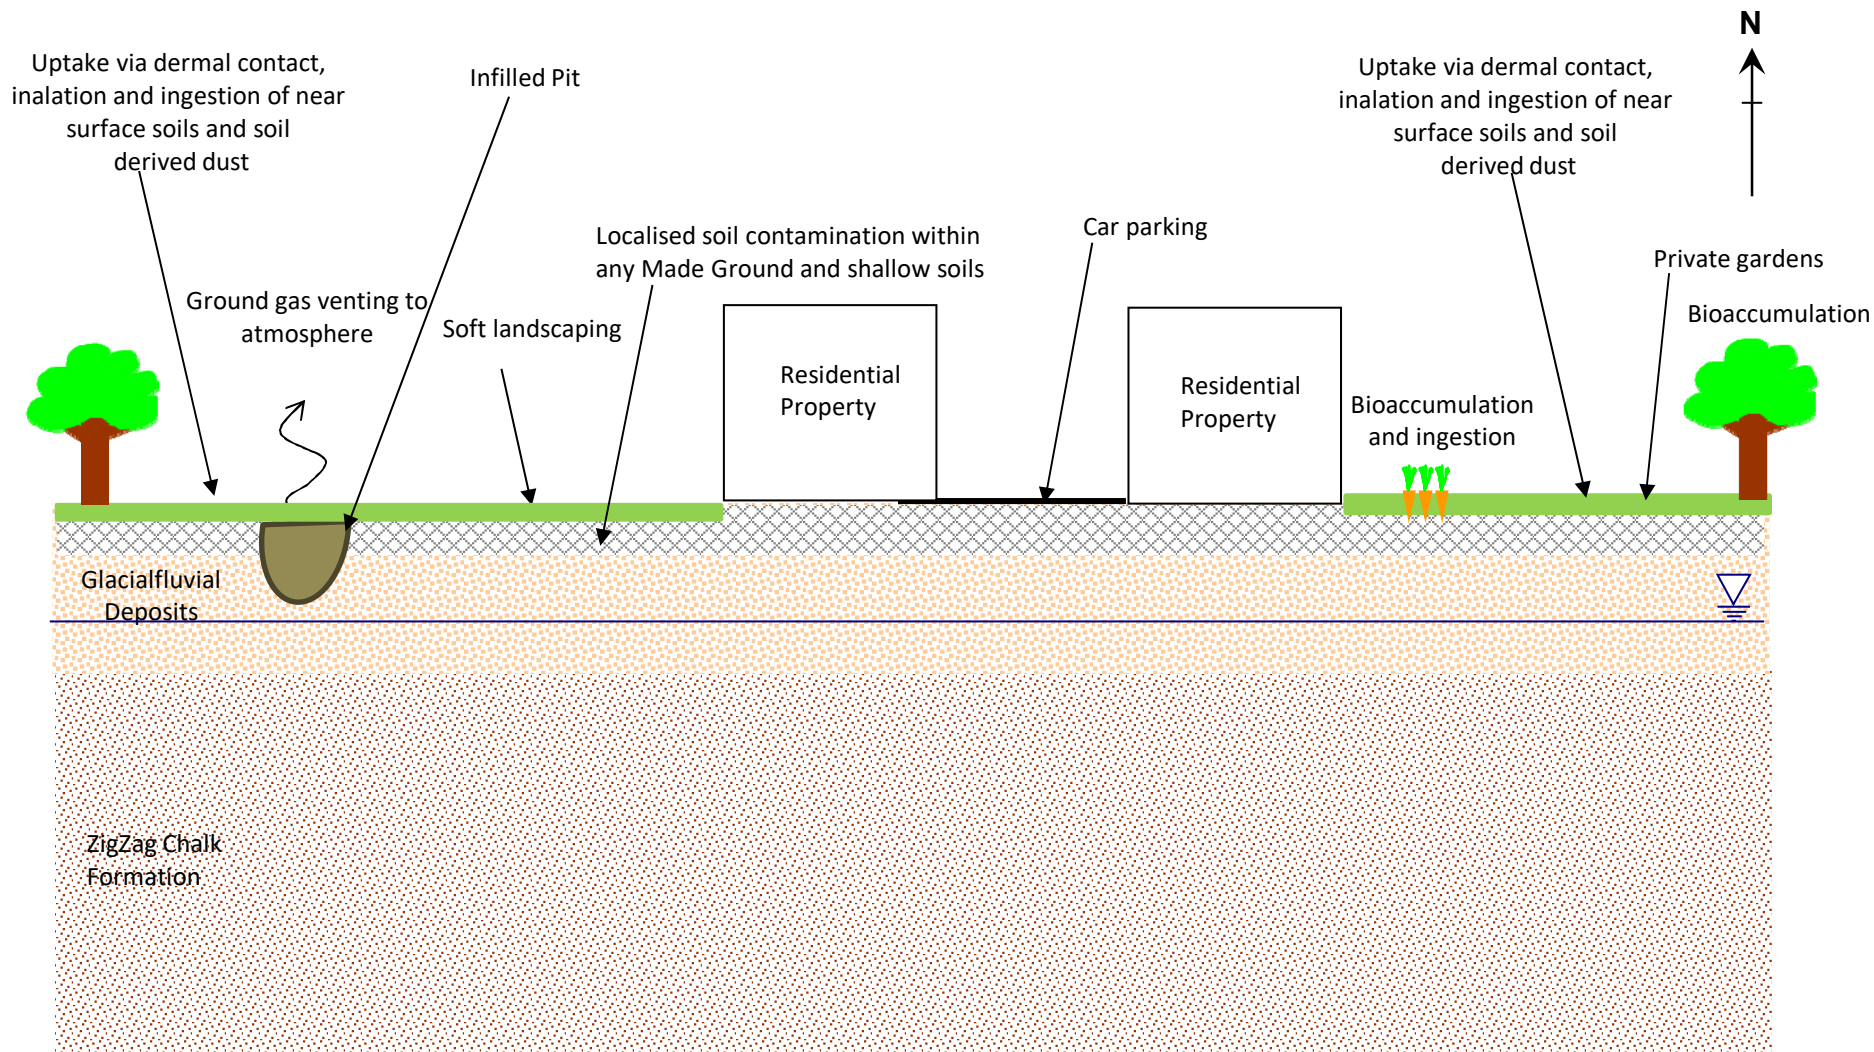
| <b>Project:</b> | Mill Lane, Hitchen | | | <b>Title</b> | Conceptual Site Model (Future Land Use) | | |

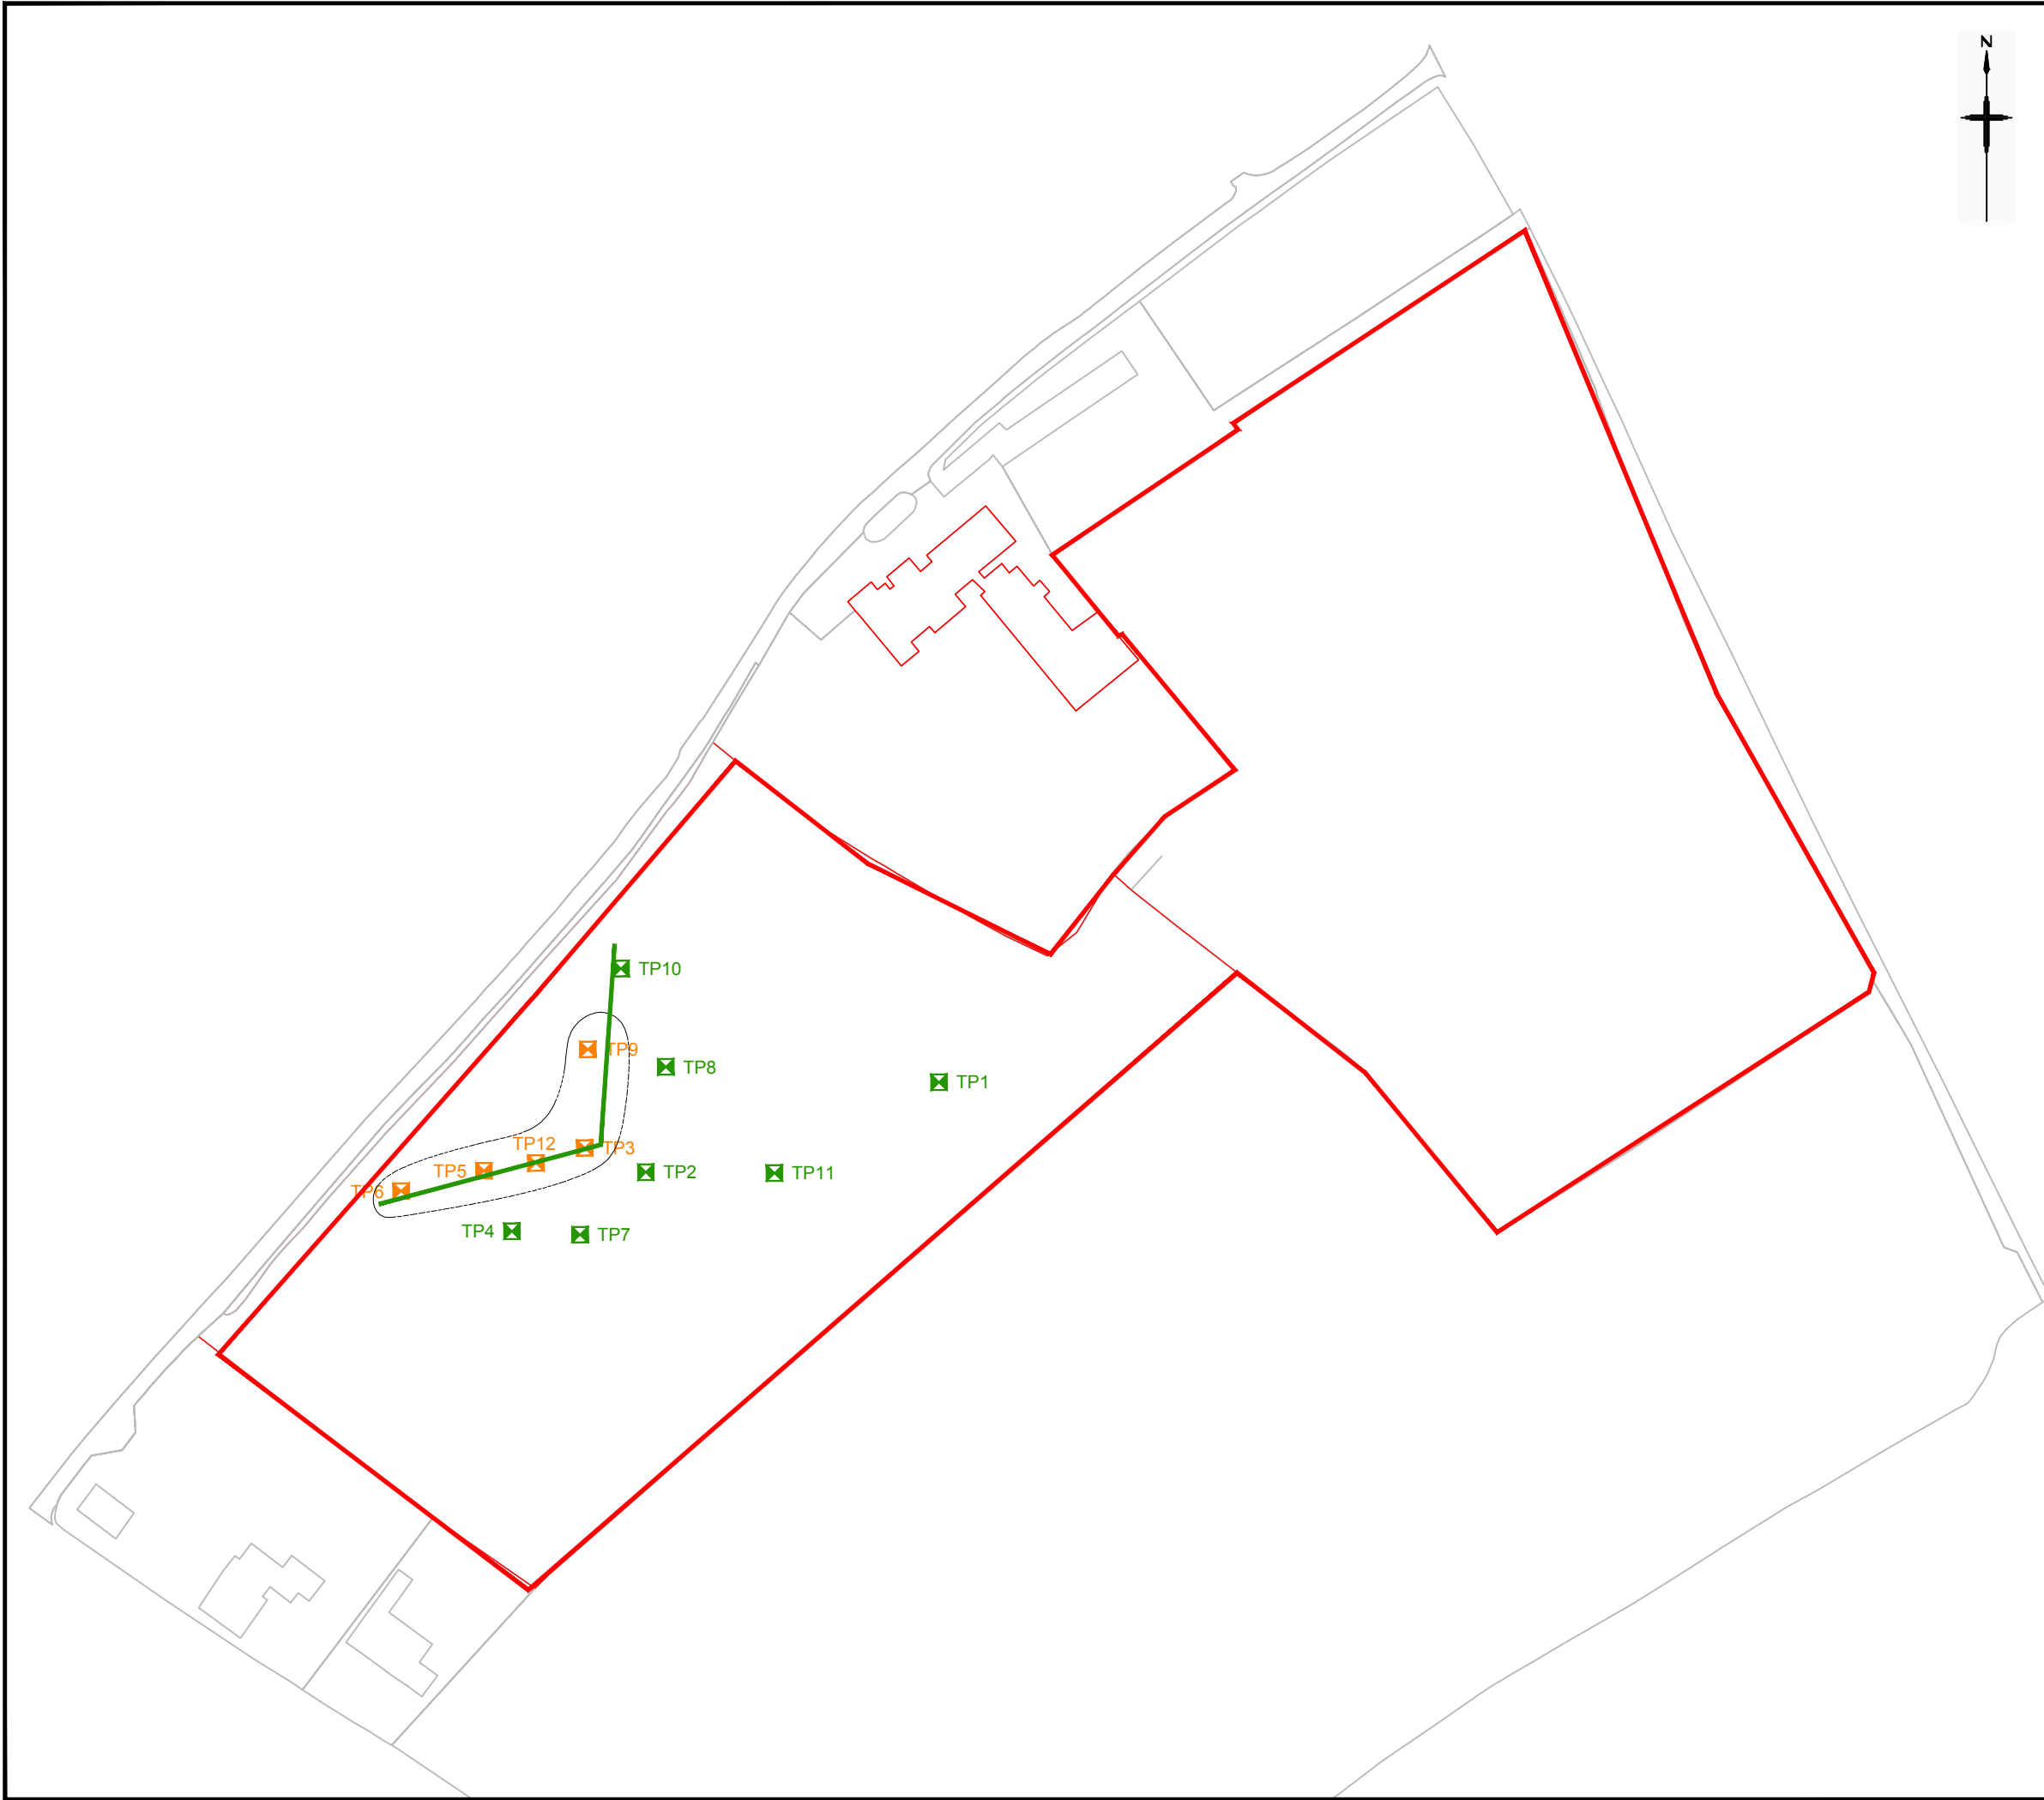
| FIGURE 2 | P1 |

- Site Boundary
- Section Line (See Figure 3)
- Area of Infilled Material Encountered
- Trial Pit Location
- Trial Pit Location with Suspected Infilled Material Encountered

It should be noted that due to access and time restrictions, the extent and depth of the infilled pit (as identified by the Desk Study) could not be fully investigated and should be considered as a further phase of investigation, once access can be gained.

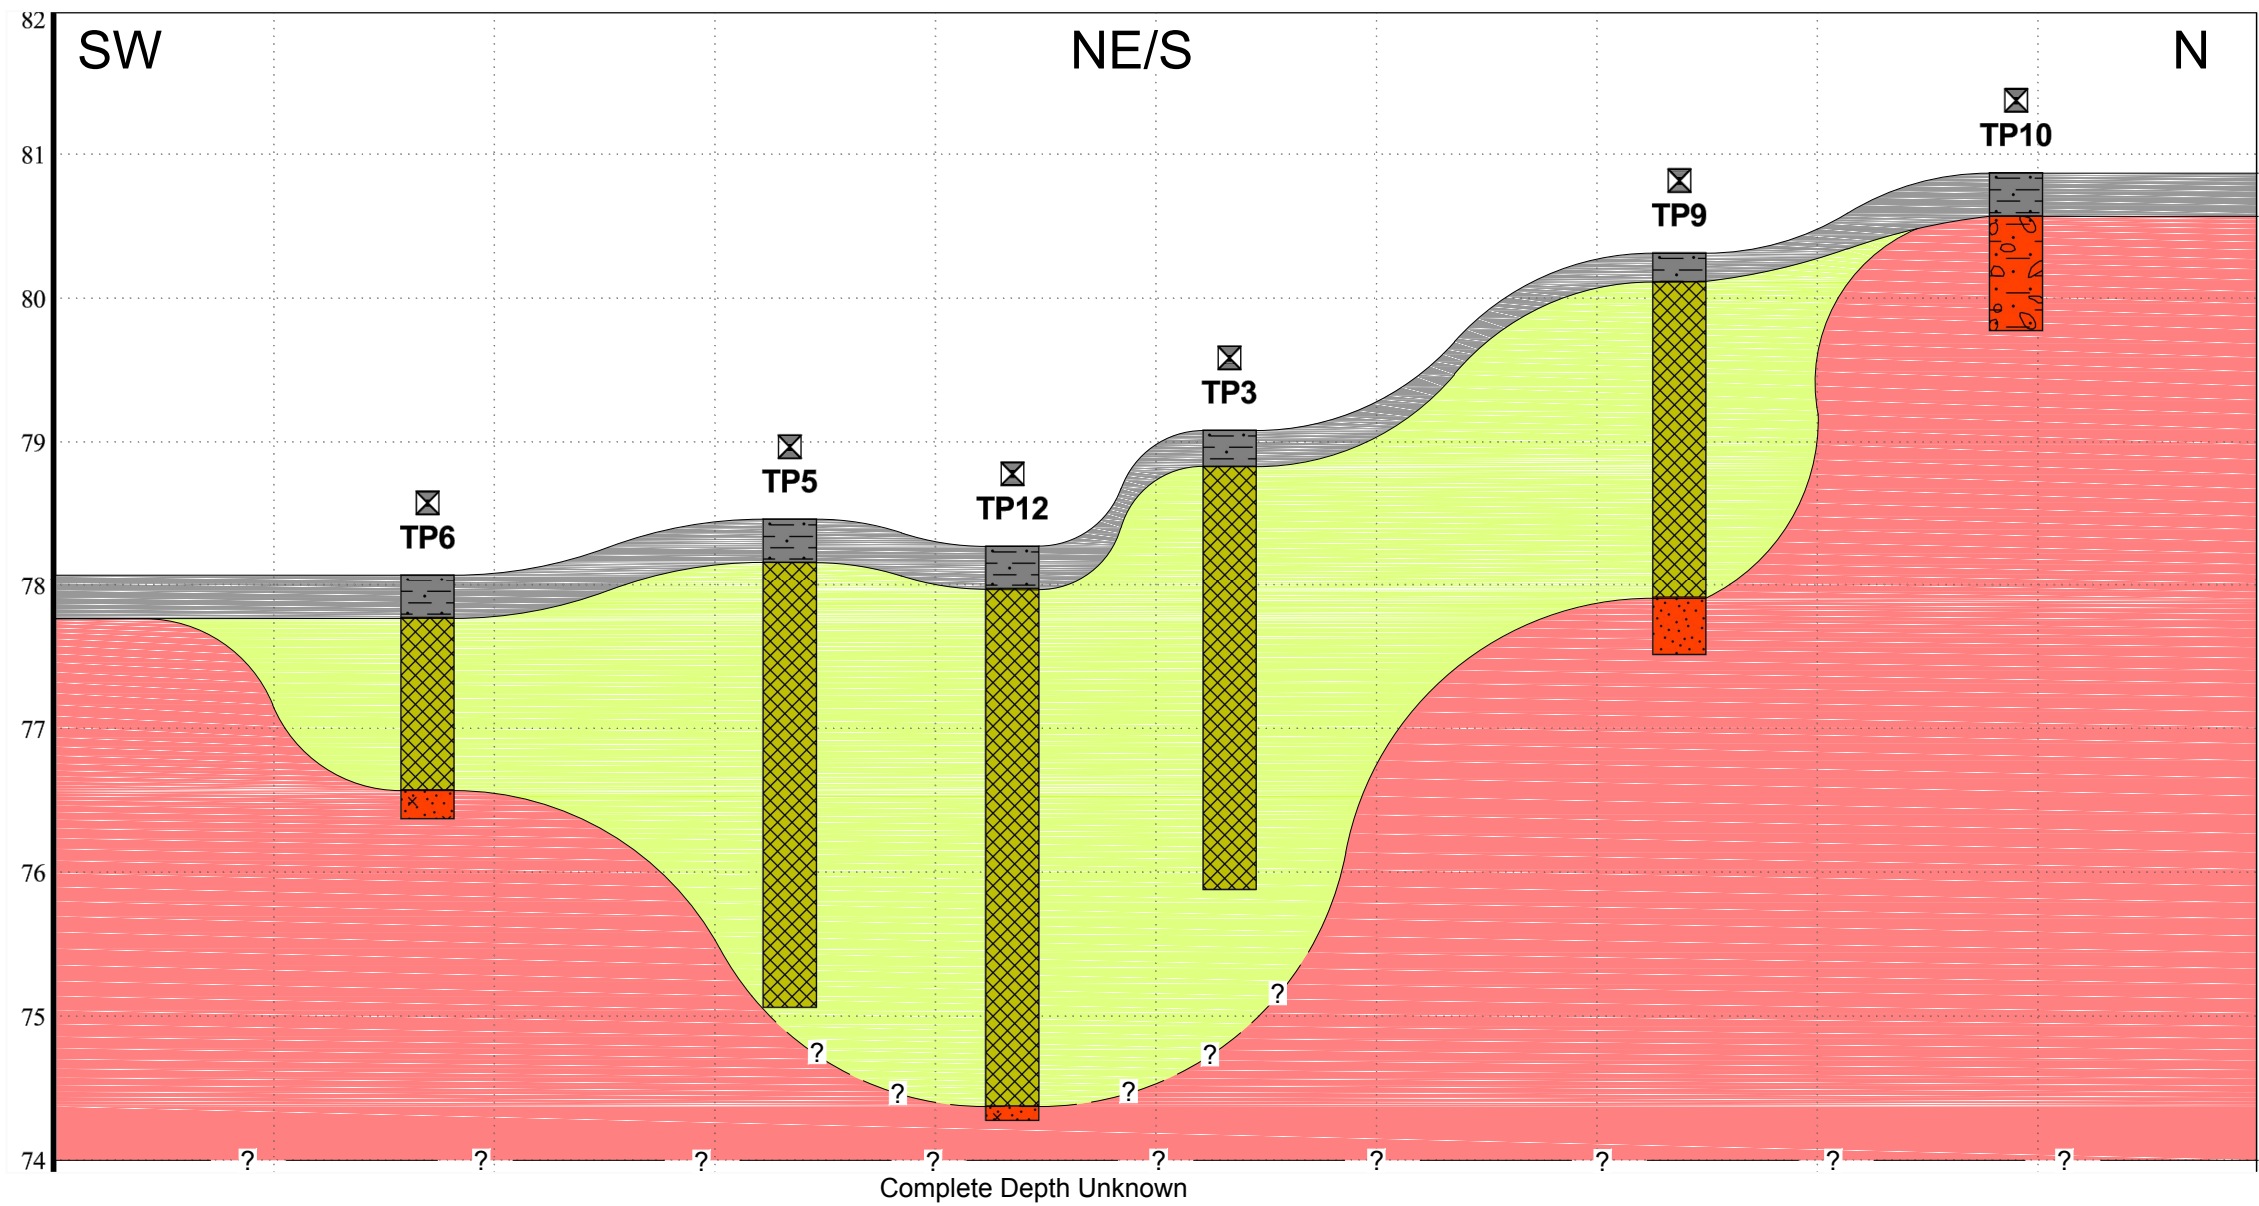
- Topsoil
- Made Ground (Suspected Infilled Sand Pit)
- Glaciofluvial Deposits
