**REPORT ON A SITE INVESTIGATION**

**SLIP END FARM**

**Report Reference 142400**

*April 2026*

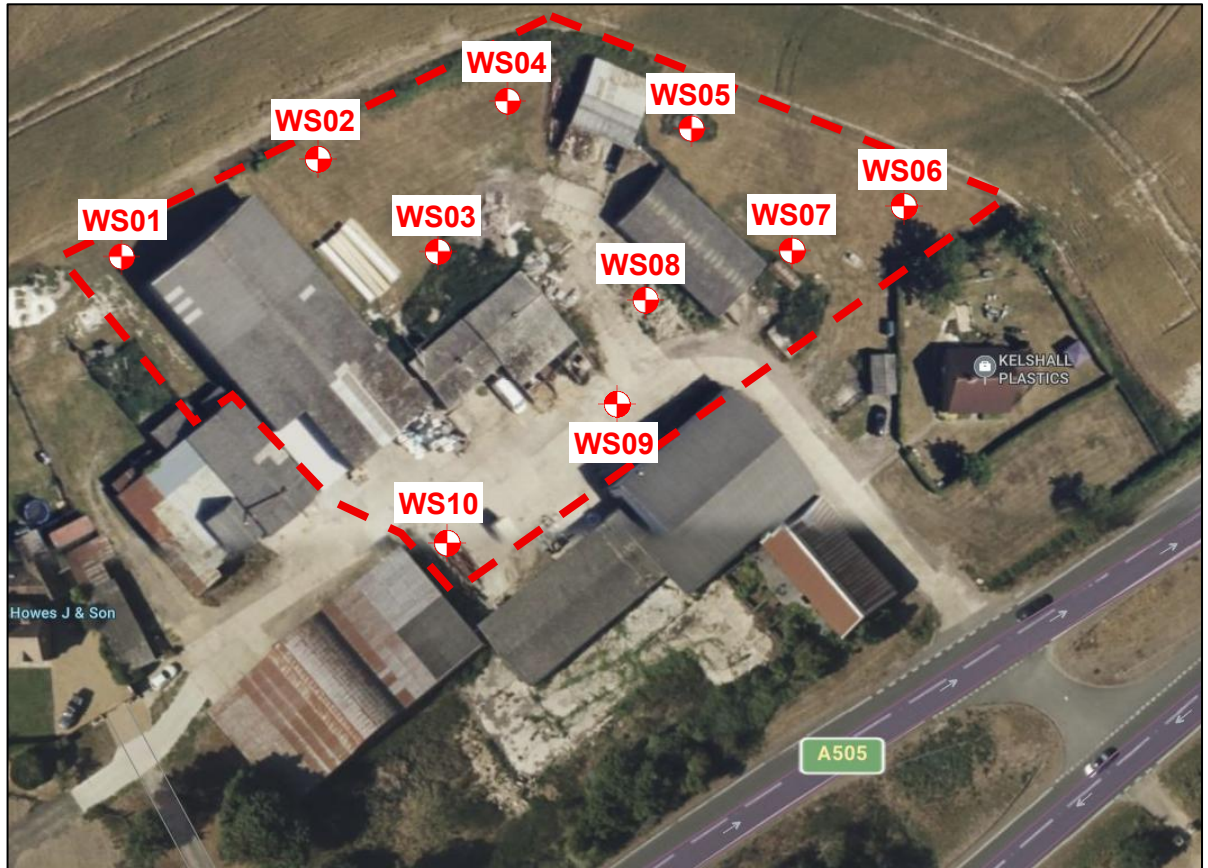
Figure 2

# Borehole Location Plan

The site comprises a 70m wide by 100m long plot with a collection of about six barns/farm buildings divided by grass and bare earth within the north-eastern half and a concrete hard standing yard areas along the south-eastern side of the site as shown in Figure 2.

The site work was carried out on 18 and 19 February 2026 using a dynamic sampling rig. The works comprised ten window sample boreholes (WS01 to WS10), whose locations are shown in Figure 2. Service plans were consulted, and a cable avoidance tool (CAT) was used to check for the absence of buried services prior to boring.
