**PLANNING AND HERITAGE STATEMENT**

**RE: HOUSEHOLDER AND LISTED BUILDING CONSENT, FOR CREATION OF LINK  
BETWEEN LISTED BARN AND NON LISTED OUTBUILDING.**

**Bibbsworth Hall Farm, Bibbs Hall Lane, Ayot St Lawrence, Hitchin, Herts, SG4 8EN**

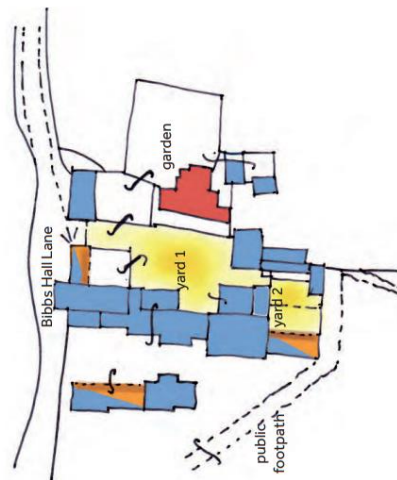
Bibbsworth Hall Farmstead in 1892

The earliest available map of Bibbsworth Hall Farm shows the farmstead already well established with the farmhouse set to the side next to a historic orchard.

The building arrangement was very linear forming two distinct yards inter connected through buildings and smaller yards serving open fronted structures.

The buildings to the north formed a strong frontage to Bibbs Hall Lane with one building protruding into the street scape.

The buildings to the west stood separate but close enough to be considered part of the building cluster.

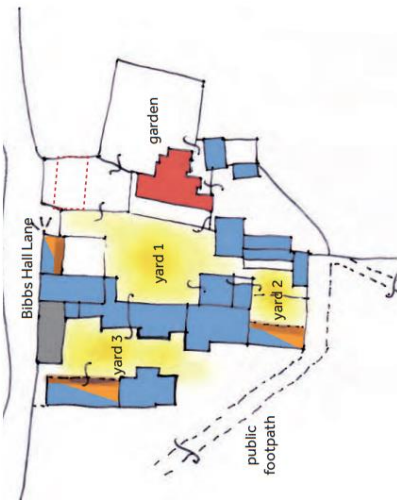
Bibbsworth Hall Farmstead in 1923

The 1923 OS map shows the farmstead changed little. The addition of a new building to the north strengthened the street front, forming a third yard linked to the main yard through one of the existing structures.

A building in the farmhouse's street facing garden was removed along with the small structure which had been projecting into the street scape, opening up the orchard and garden more clearly to the farmyard

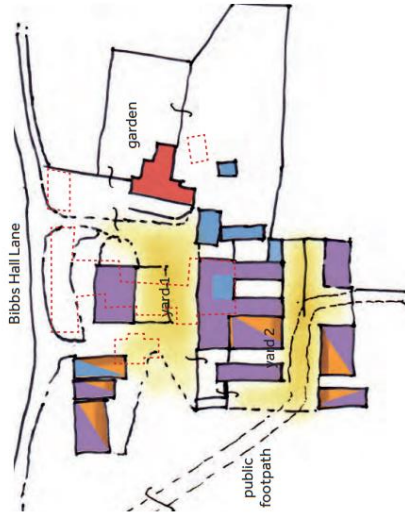
Bibbsworth Hall Farmstead in 1958

By 1958 the farmstead had changed dramatically with most of the linear line of buildings removed and new structures added. Some of the new structures had open frontages and are larger in scale compared to some of the older structures.

The historic, ergonomic piecemeal style of development has been distorted by the adoption of a more structured rectilinear plan. Wider, flowing access is gained to all buildings with the yards having a more open ended relationship with the wider landscape rather than tighter access points.

A rear extension was added to the farmhouse around this period and one of the small structures within its curtilage removed.

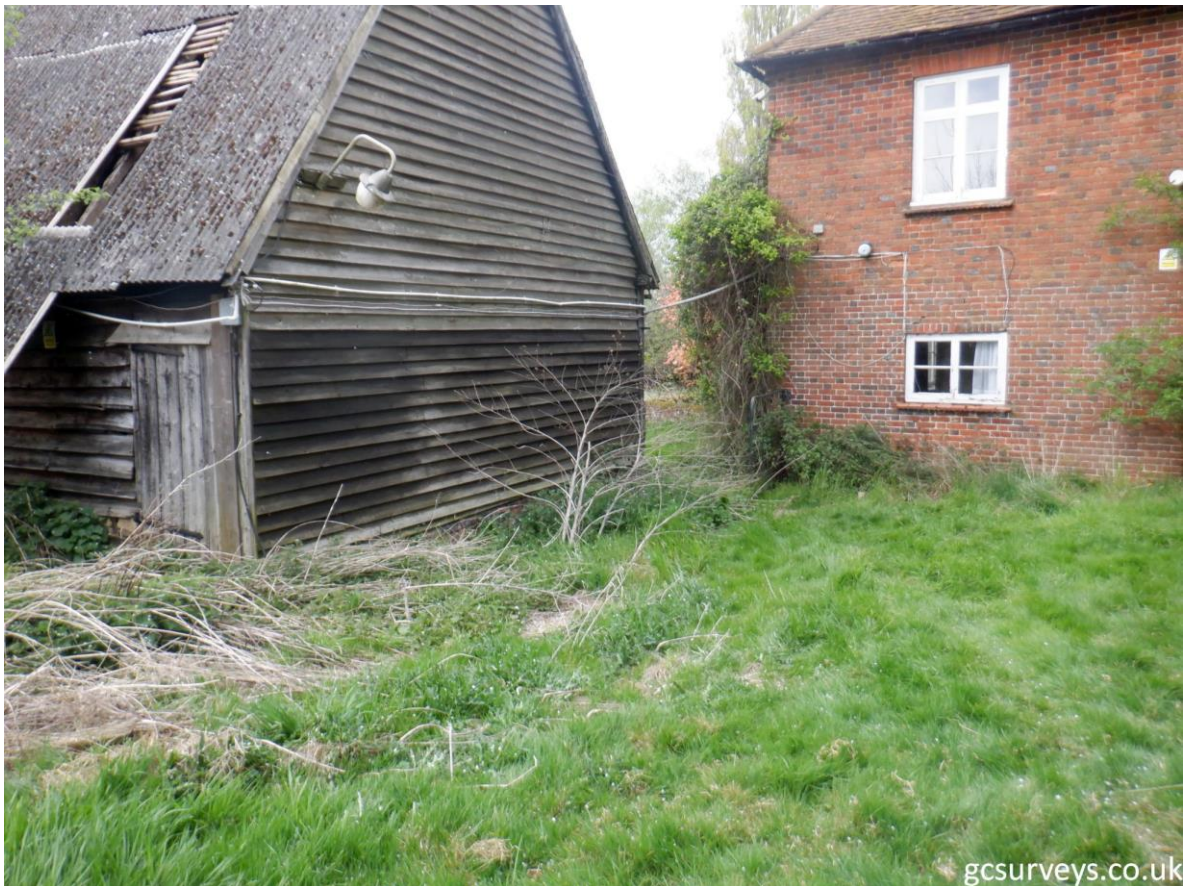
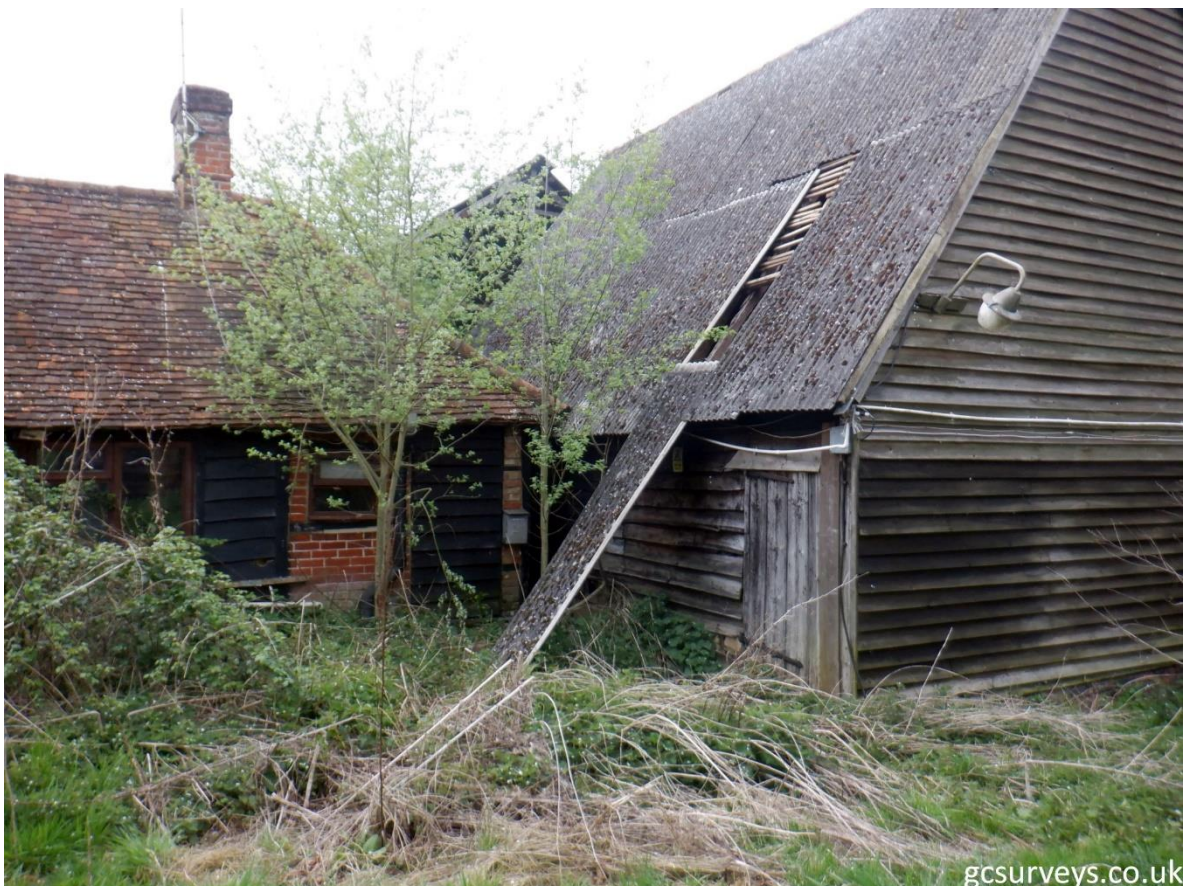
Condition of Brickwork plinth below sole plate prior to implementation of permission  
23/01999/LBC

The structures are linked by a short wall and virtually touch. It is proposed to create a link between the existing timber framework of the barn to the studio, in an area where the sole plate was in poor condition and was sat on a concrete wall (previous intervention).

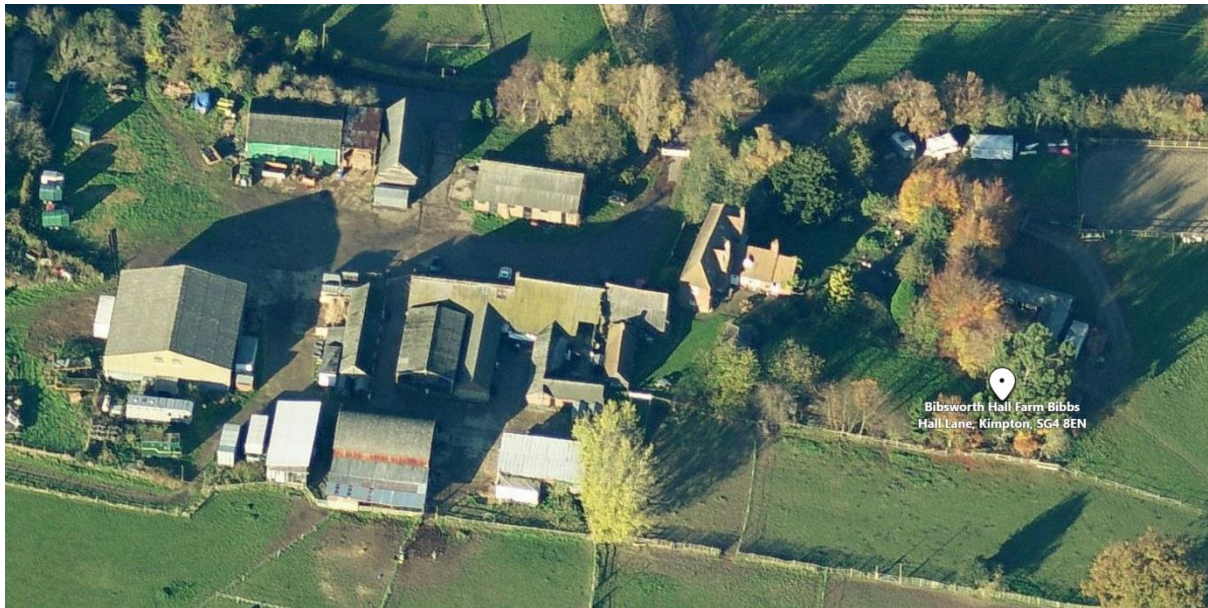
Relationship between studio and barn after commencement of permission 23/01999/LBC

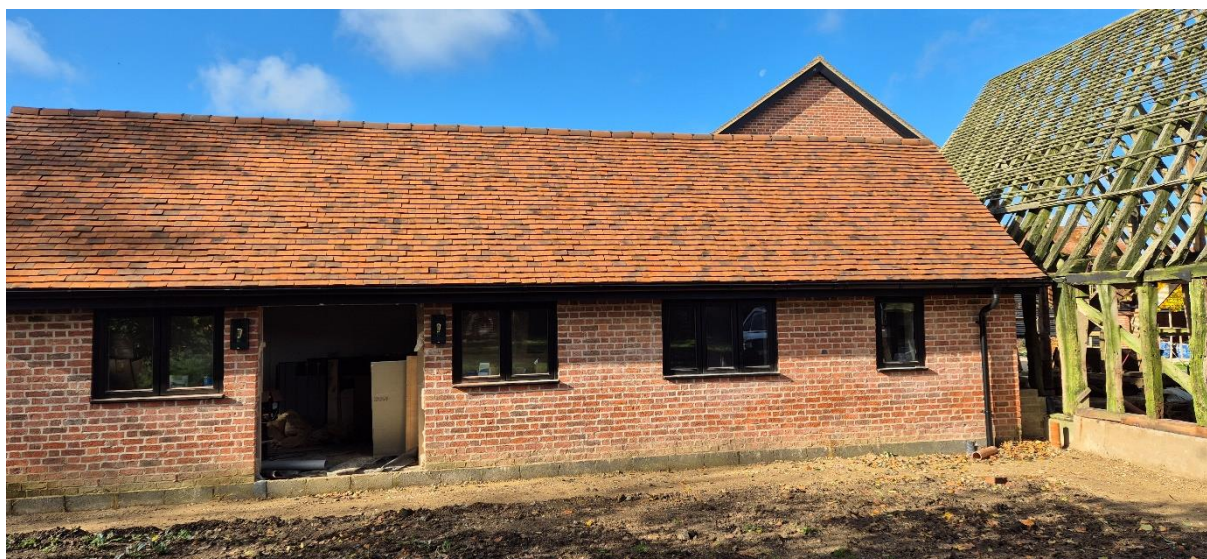
Gap between existing barn timbers where opening can be created after commencement of permission 23/01999/LBC.

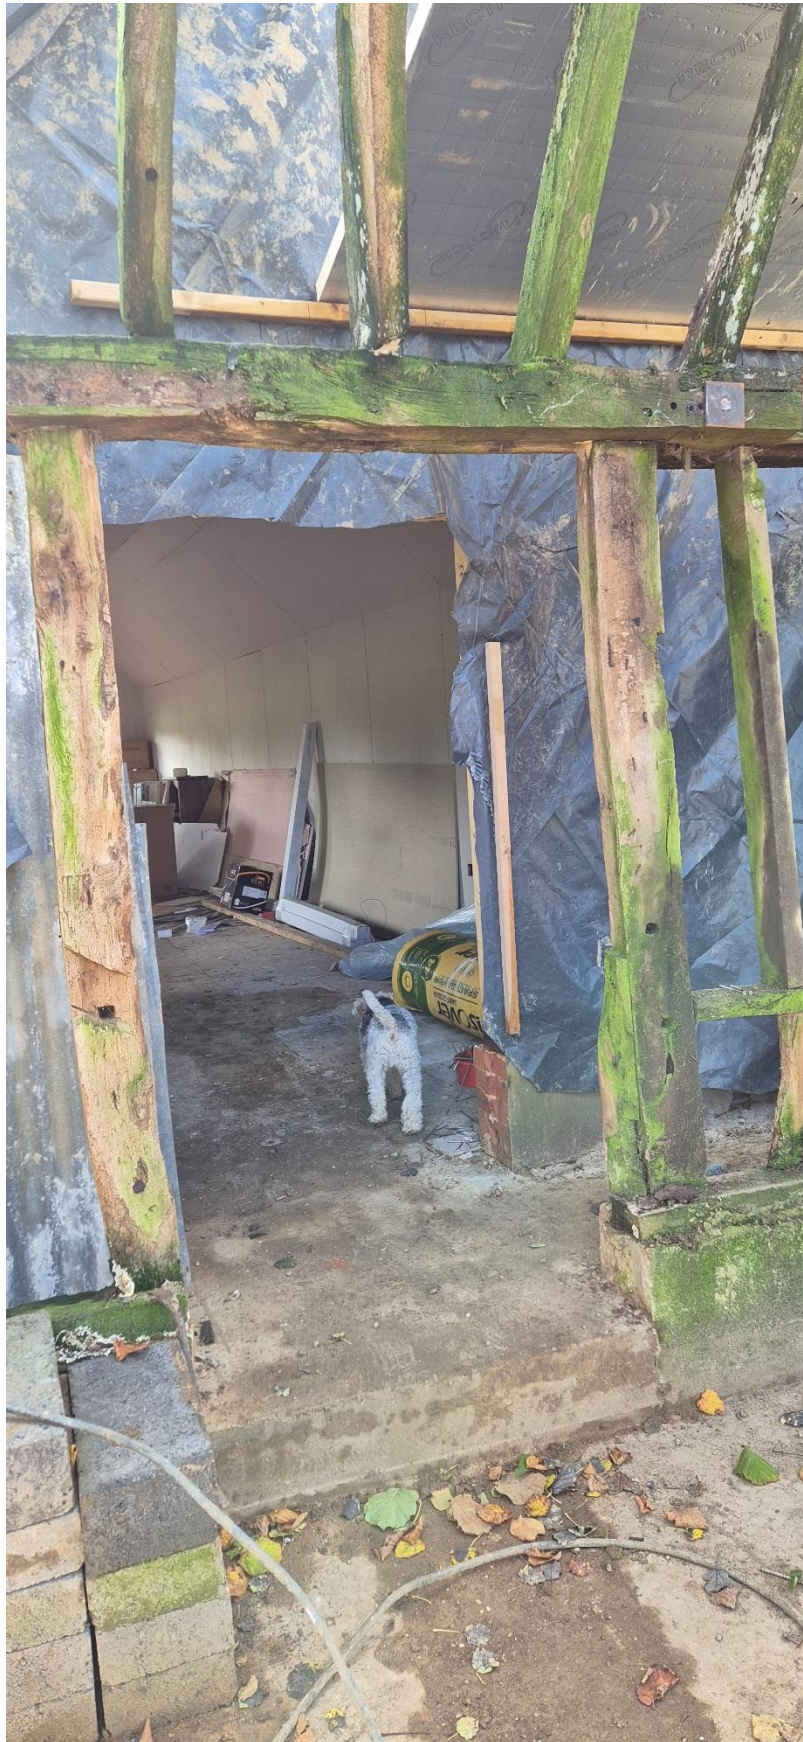
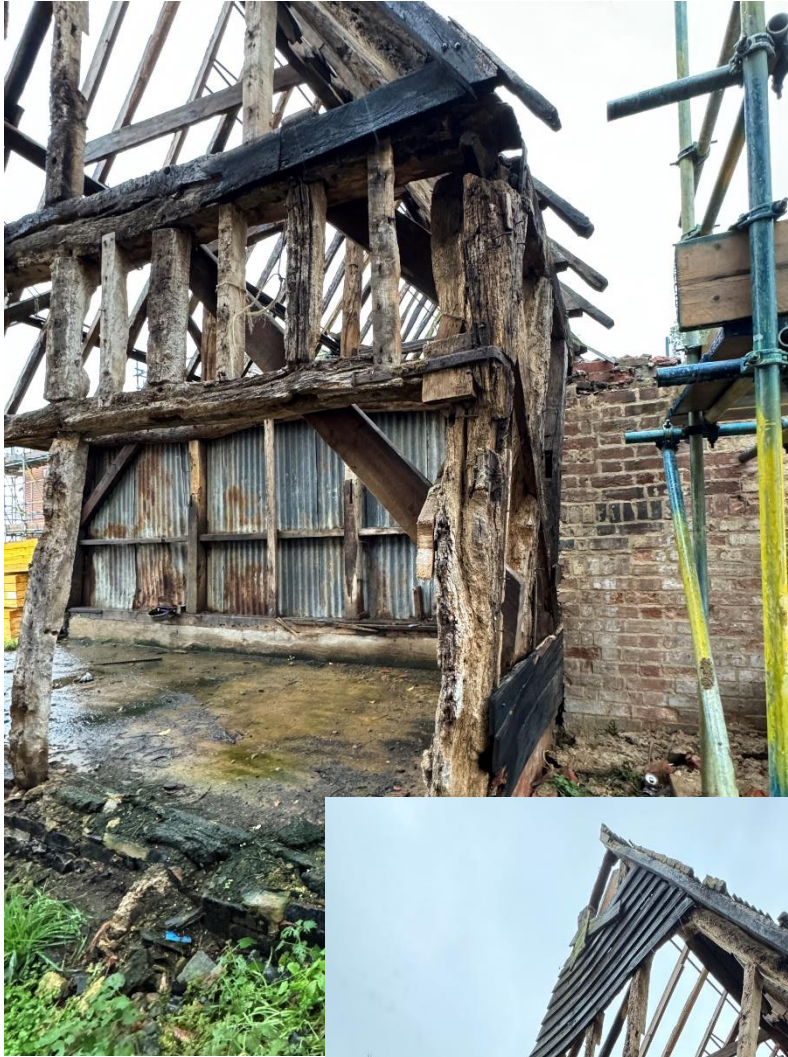
Photographs of linking wall on western elevation after commencement of permission 23/01999/LBC.
