# The Old Granary, Barley

Design + Access Statement  
with Heritage Assessment and Heritage Statement

Submitted for Planning and Listed Building Approval

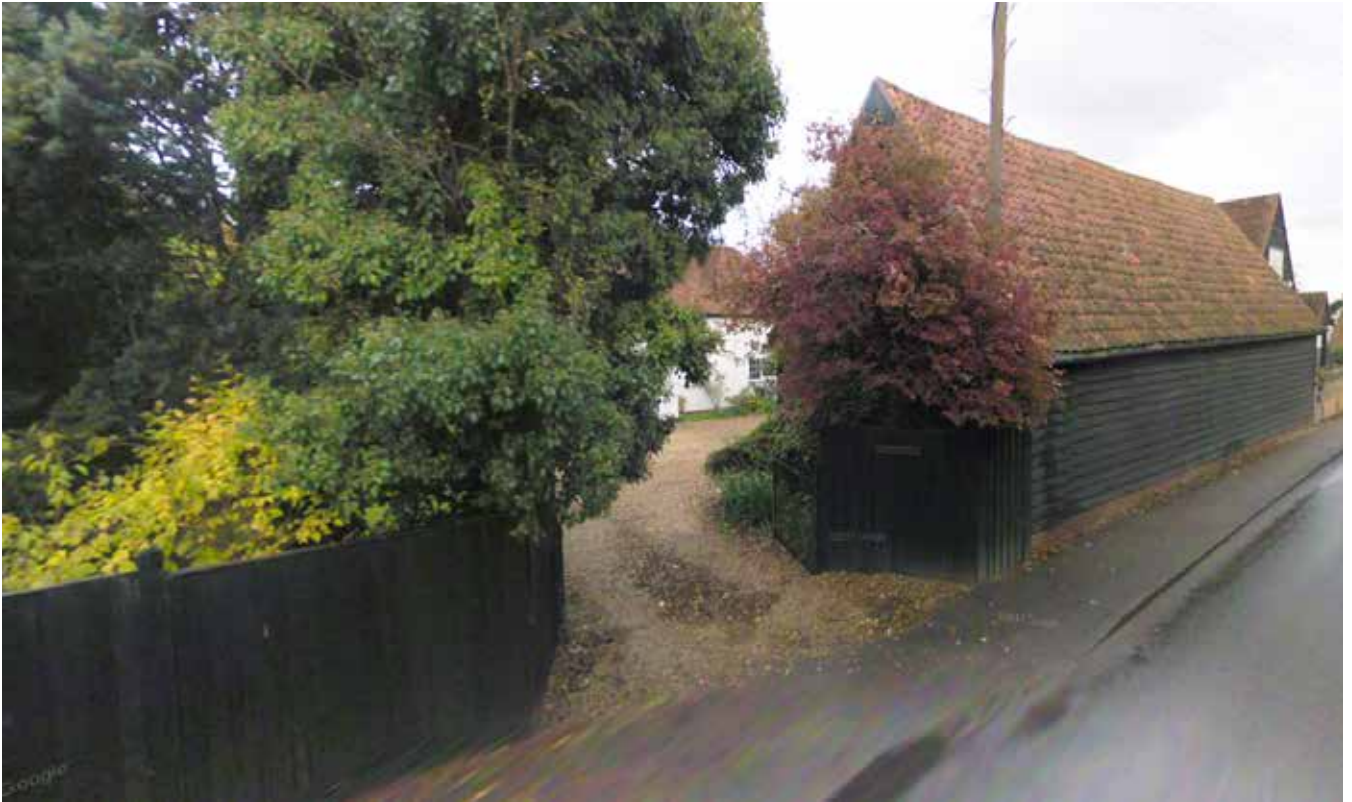
above: entrance to the site from Church End with the Old Granary barely visible beyond the boundary planting and the barn abutting the street, solid gates have been added to the drive opening since this photograph was taken

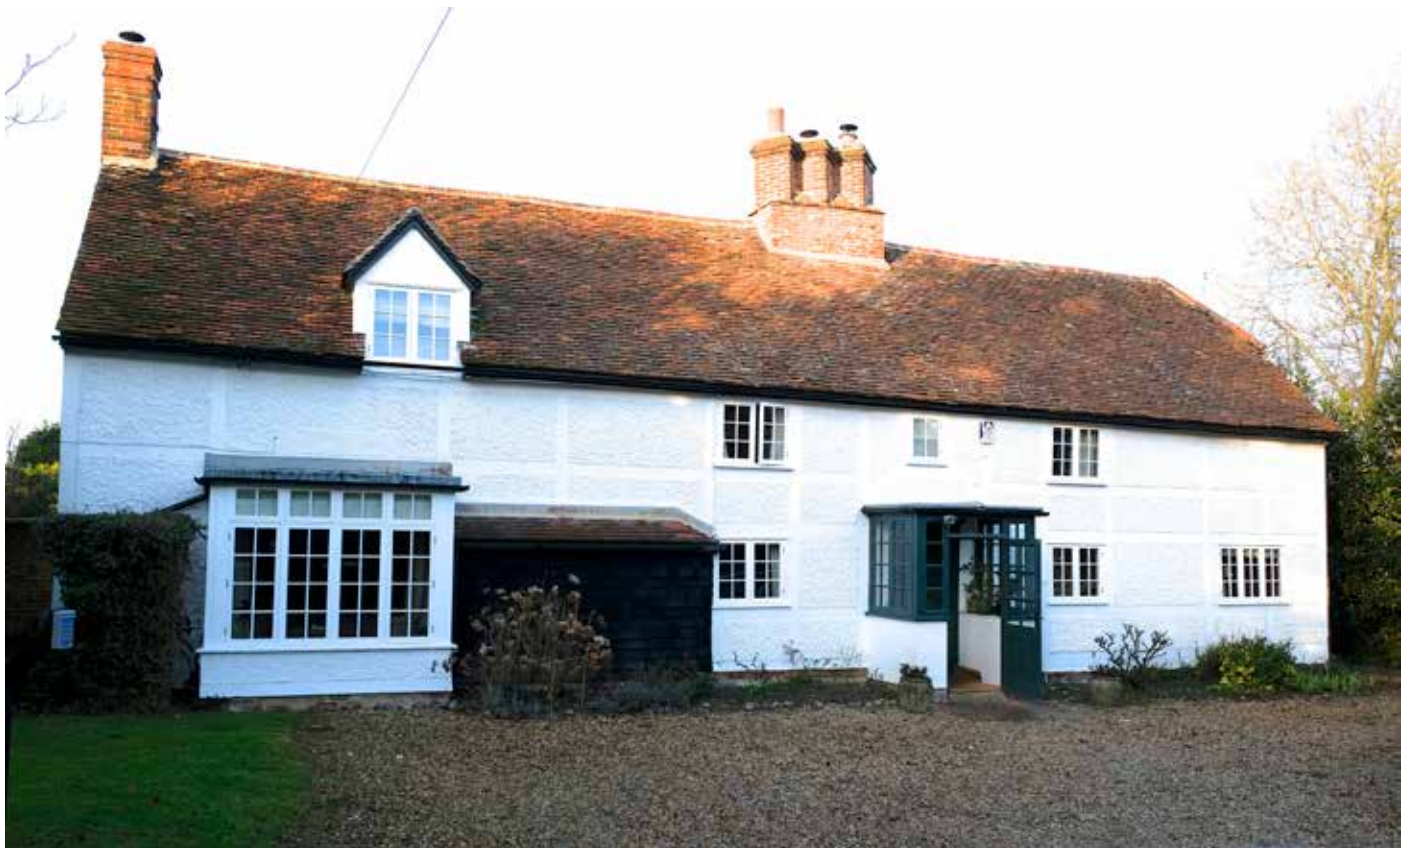
above: the south front of the house, the bay window and porch were added in the twentieth century

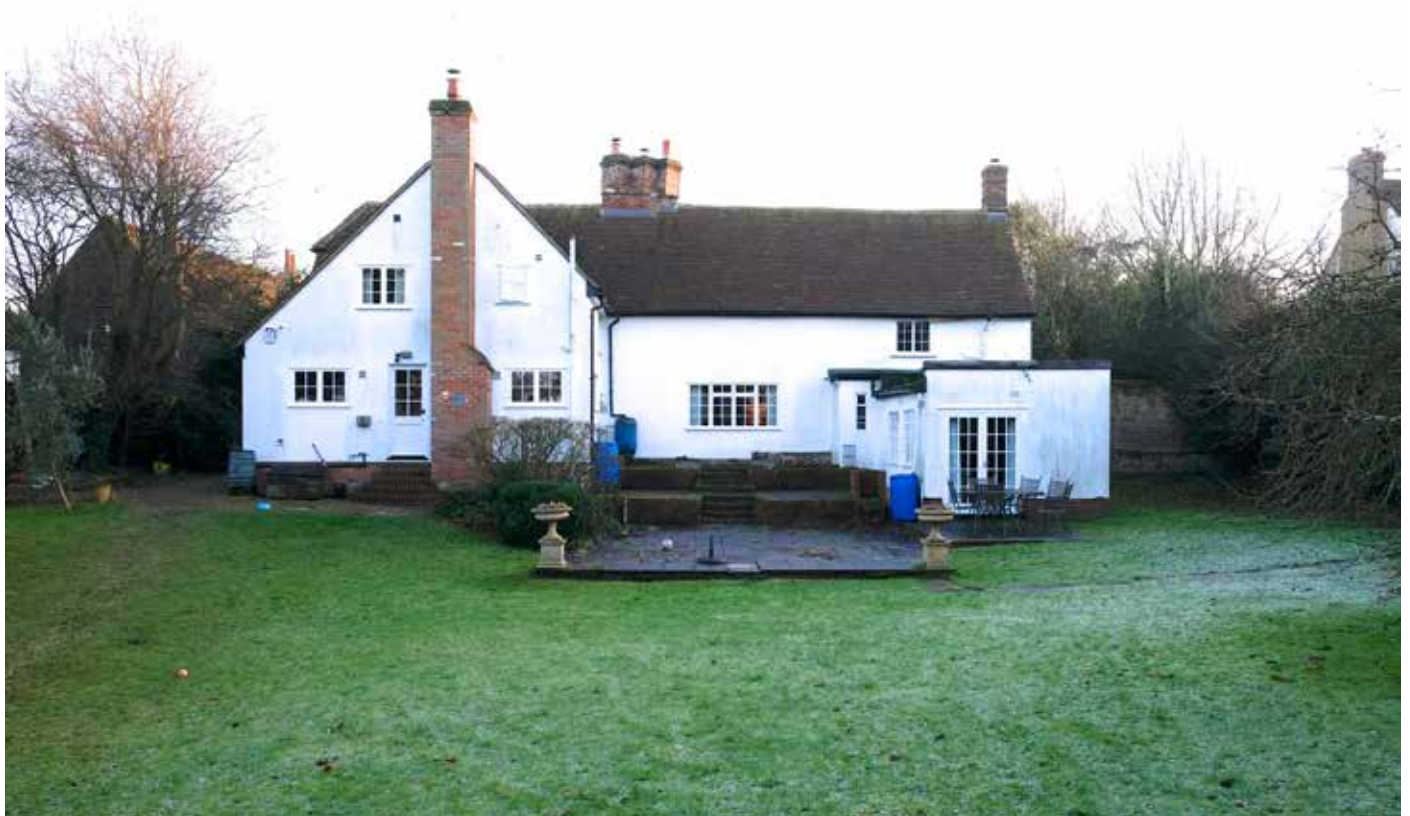
below: the rear of the house from the garden with 1953 extension on the right and 1988 extension on the left

The 1953/54 extension to the north is a single-storey rectangular block with a flat asphalt roof. This is set behind a parapet to the north and west but is visible from the east. Its fenestration is irregular and the profusion of rainwater goods along the east elevation that deal with the various steps in the roof is particularly unattractive.

The 1988 extension has a roof that matches the pitch of the main block, though the ridge is set asymmetrically to give a continuous eaves line to the west and a lower eaves line to the east. Its northern gable has a chimney on the external wall providing a route for the boiler flue.

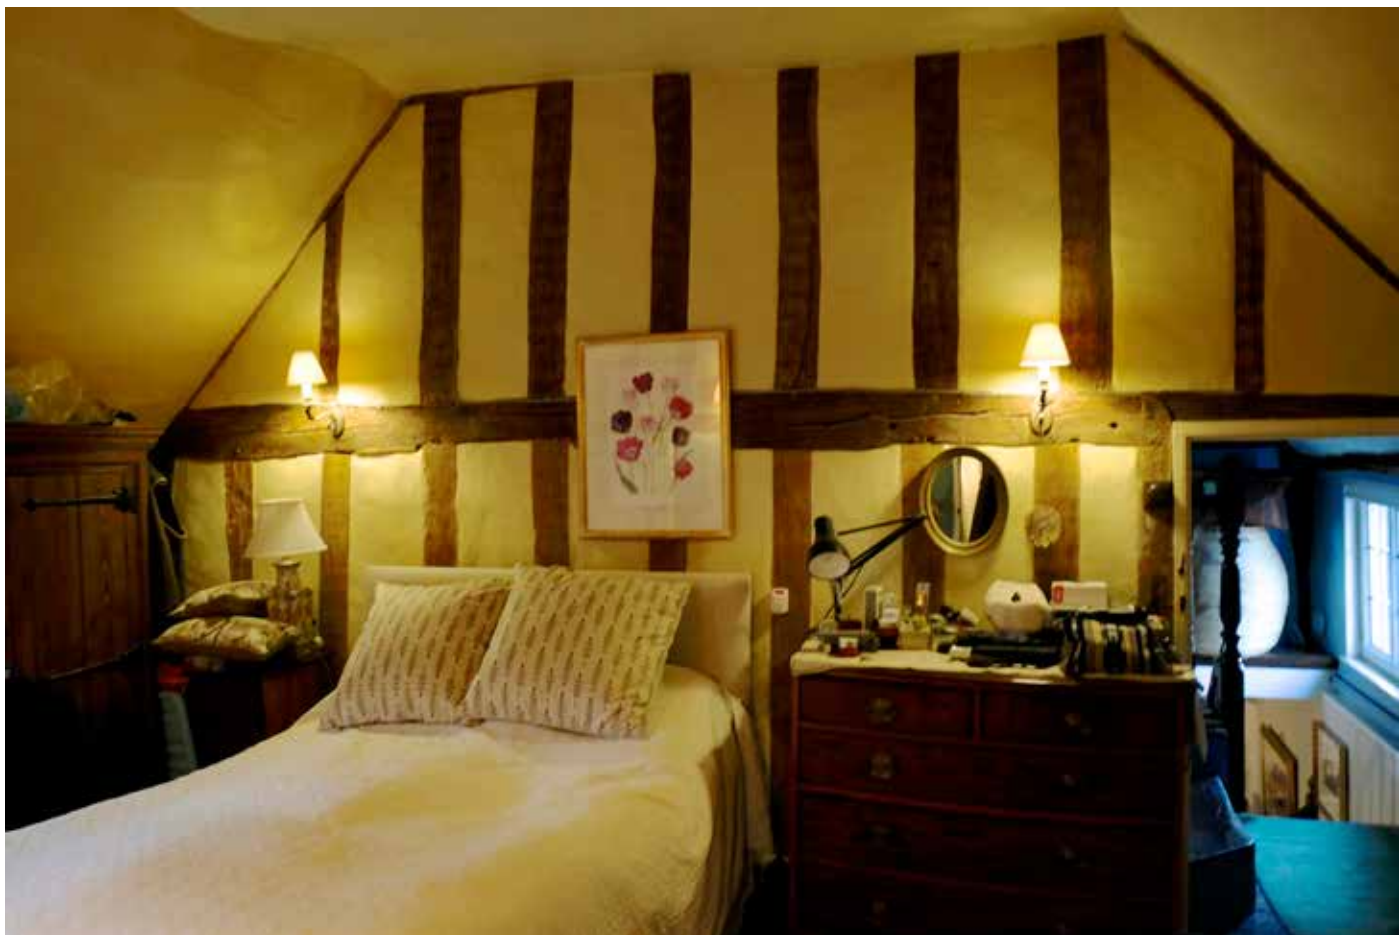
above: wall on the first floor marking the original western extent of the house with door cut through to nineteenth-century extension

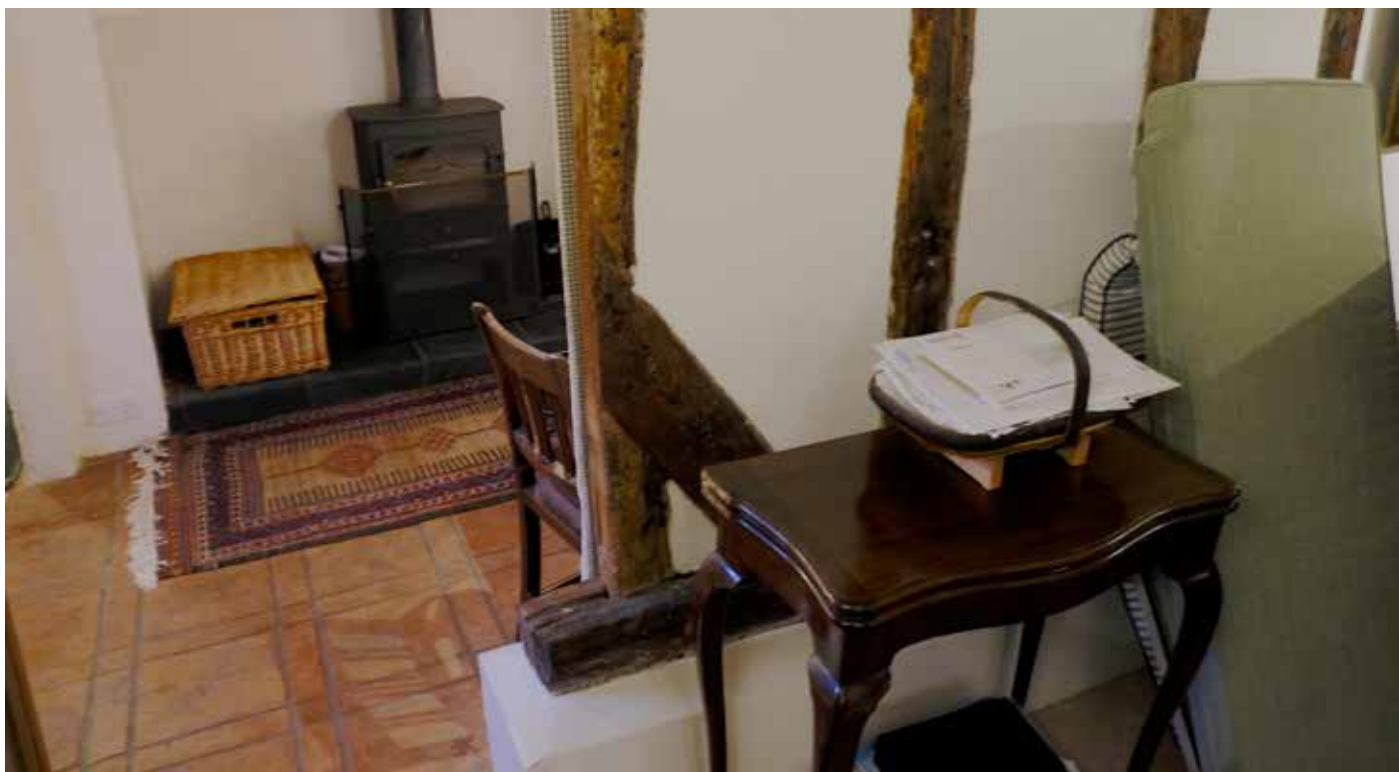
below: stub of the diagonal tie at the base of the wall between the present Kitchen and Dining Room suggesting that this wall was part of the original house and that the present opening was cut through the wall

The eastern extent of the original house is less clear, there being two lines of structure on the ground floor that could represent the original wall. The existing solid wall does include a diagonal tie that has been cut through to create the current opening next to the door to the cellar steps. This suggests that the wall was an original part of the house and was later adapted.

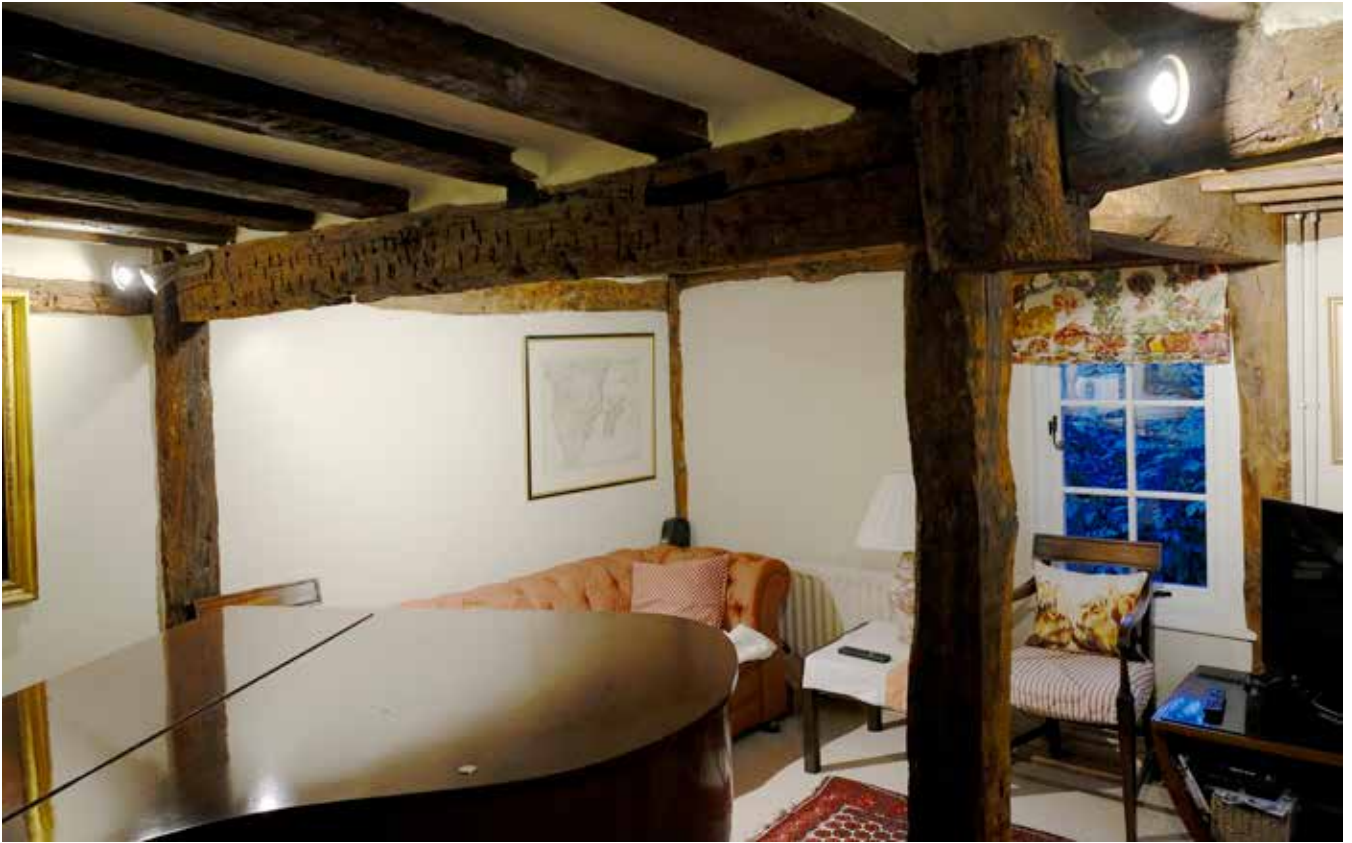
above: interior of the eastern extension, possibly dating from the seventeenth century

below: interior of the western extension, likely dating from the nineteenth century. The door leads through to the 1953 extension, the stair is modern and replaced an earlier stair

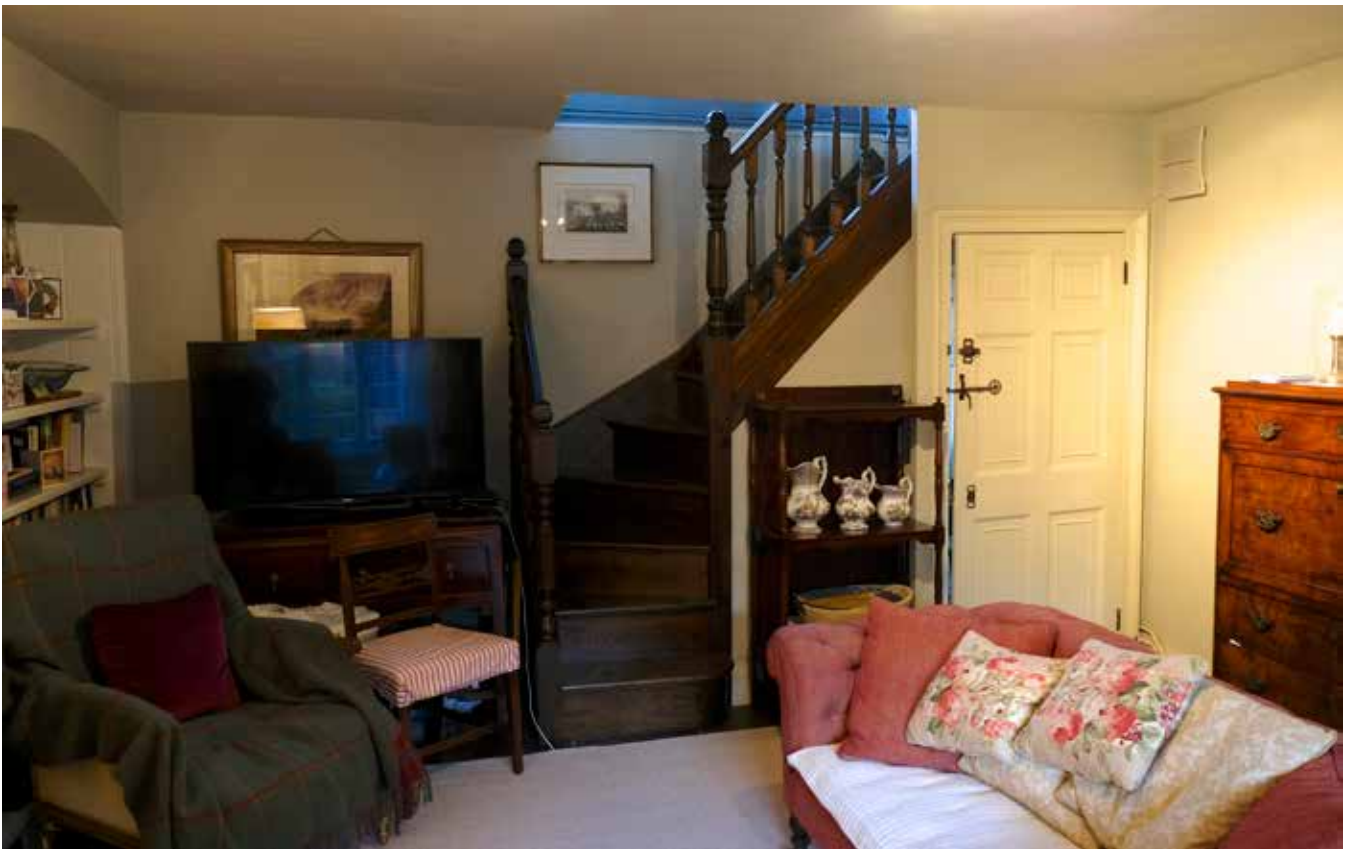
The nineteenth-century Drawing Room looking north showing the secondary stair to the first floor and the door through to the 1953/54 extension

At the west end of the house in the nineteenth-century drawing room the straight stair behind a wall shown in the 1953 plan has been replaced with an open stair with winders that turns into the room.

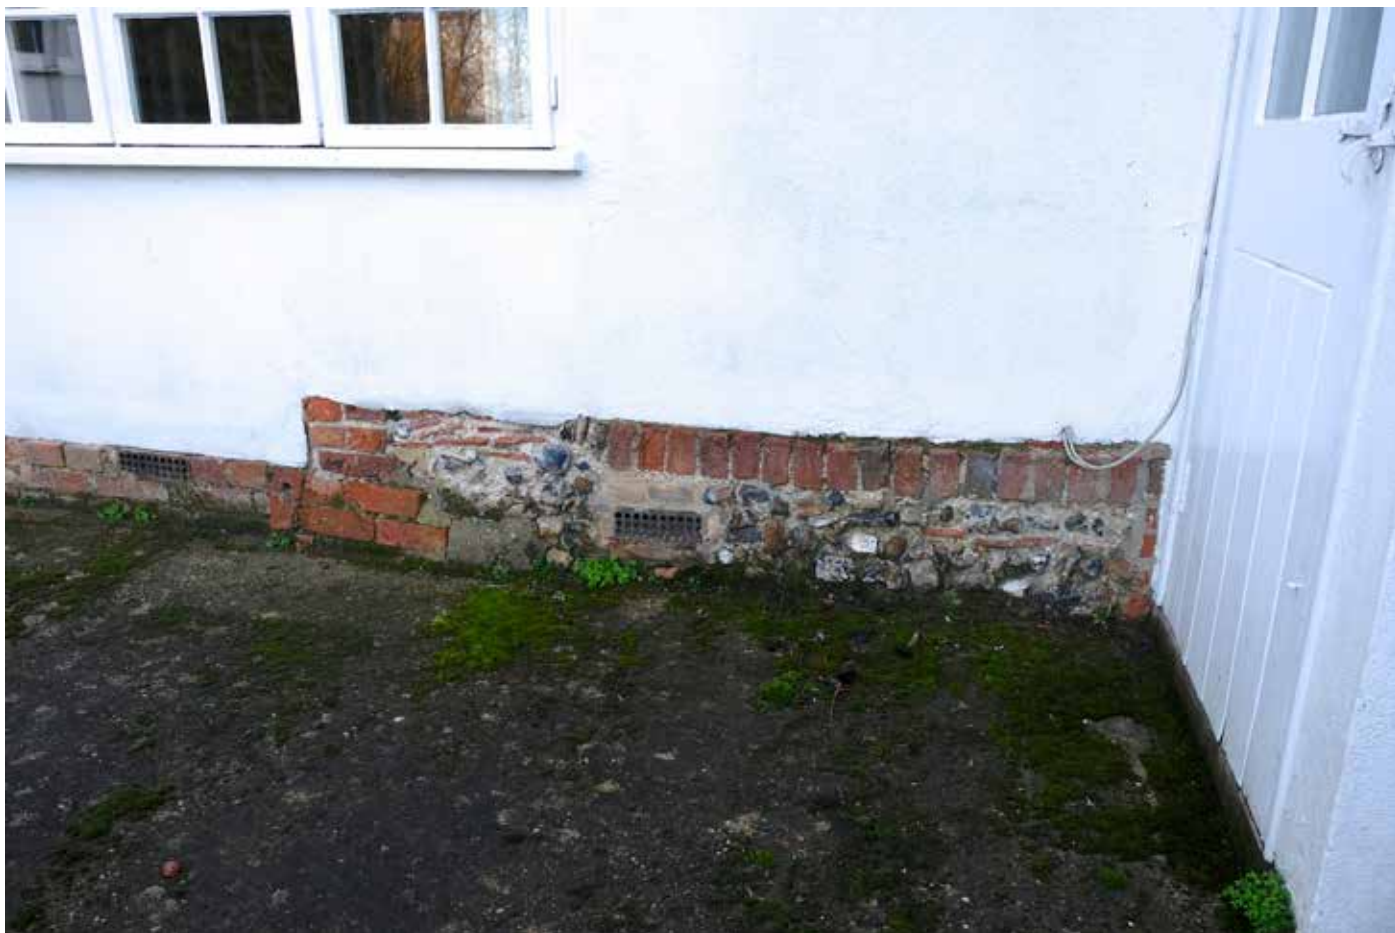
The masonry plinth to the north wall of the original house at the top of the terrace showing a mixture of flint, tile, old brick and modern brick

On the north elevation between the 1953/54 and the 1988 additions there is a section of the masonry plinth on which the timber frame sits that is formed from flint and tile with a capping of brick. This is very irregularly built and may be later infill rather than original walling.

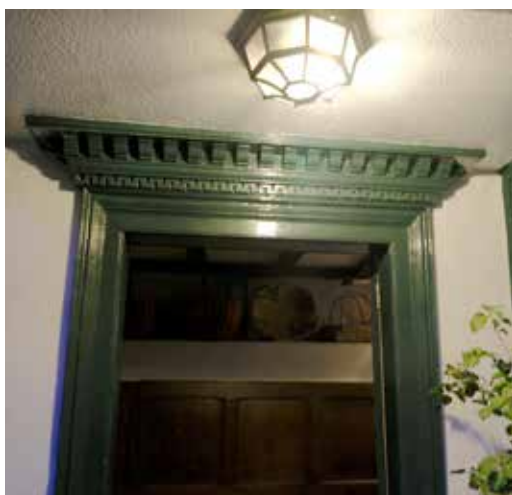
Nineteenth-century door surround within the porch

The entrance door beyond the twentieth-century porch dates from the early nineteenth century and is an attractive if somewhat incongruous, insertion from this period. The cornice above the architrave has a band of deeply-cut 'greek' key patterning, likely cut from stock lengths, and simple closely-spaced modillions above.

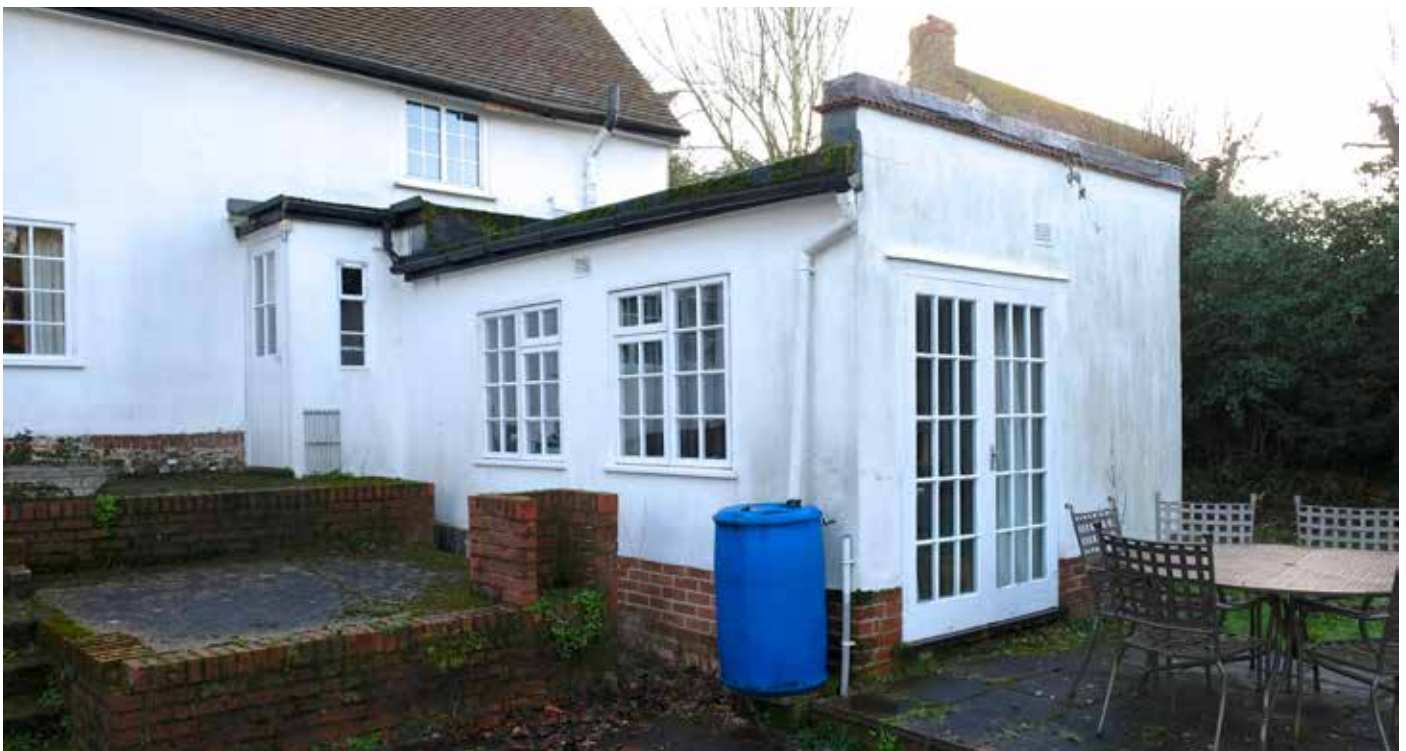
The 1953/54 addition from the north east with the concrete terracing leading up to the back of the house

The 1953/54 extension and the concrete terracing are considered to be of no significance because both elements positively detract from the architectural and artistic qualities of the building and the garden onto which they front. The listing text describes the extension as being of “no special interest”. The concrete terrace is retained by modern red engineering brick and the roof of the extension is visibly covered in asphalt with a metallic sheet material applied over the parapet that partially surrounds the roof. The poor material quality is echoed by the poor condition of both elements and the form of the extension, which is a utilitarian agglomeration of boxes.

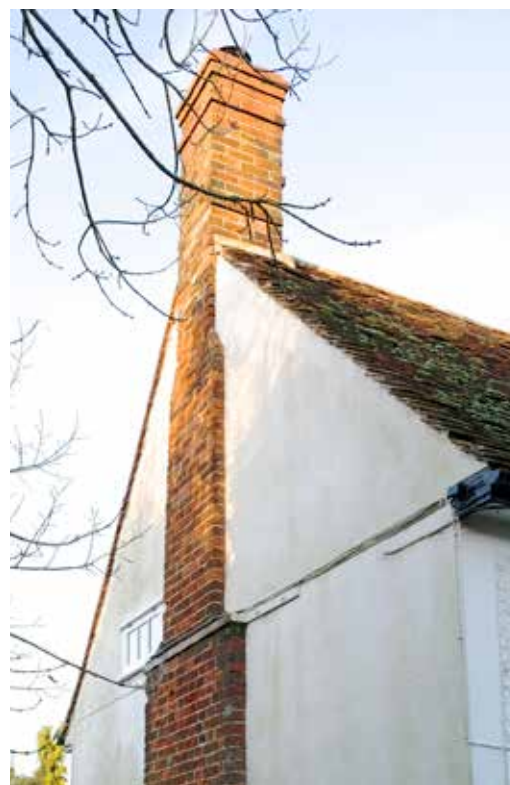
The nineteenth-century chimney on the west end of the house, the stack at the top has been rebuilt

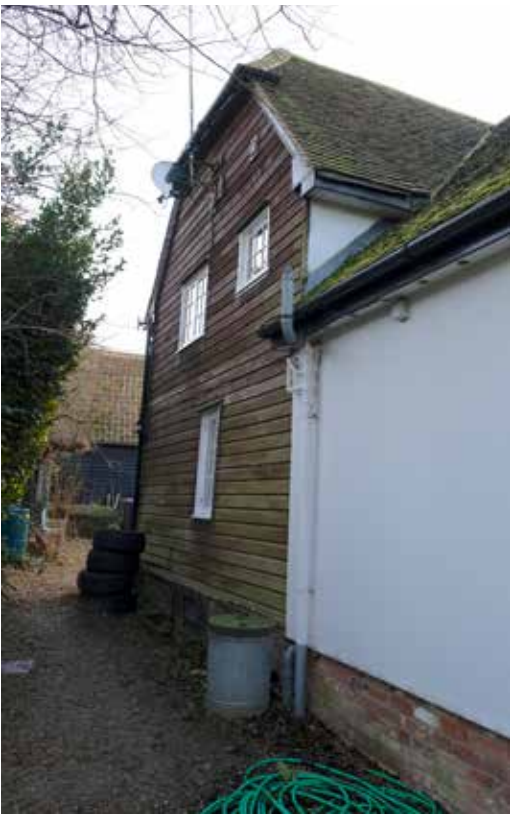
The east end of the house, which was clad with timber boarding in the early twentieth century
