# **Blakeney Homes Limited**

## **Ground Investigation Report**

**Land South of Hambridge Way  
Pirton  
Hitchin  
SG5 3QY**

**Report Ref: 24.09.008 – f01  
December 2024**

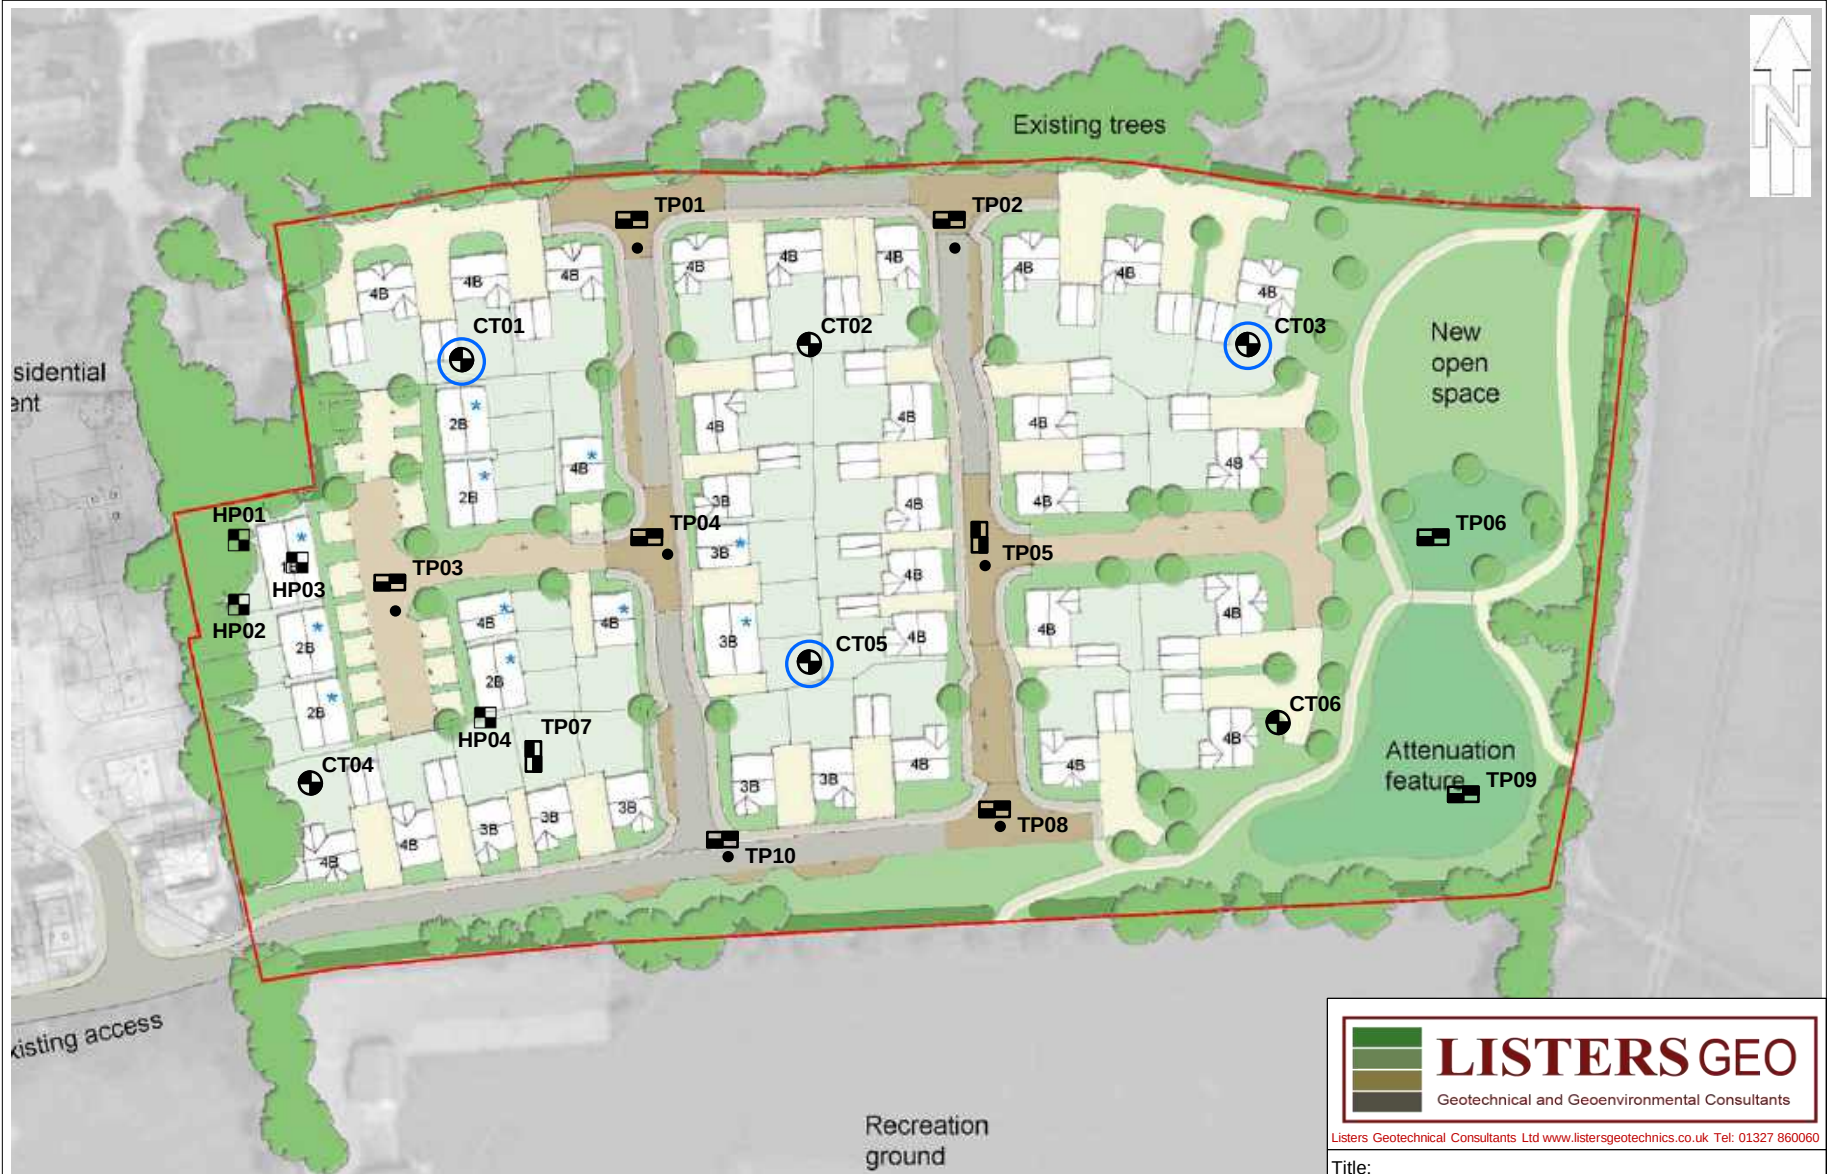
| <p>Key:</p> <p> Continuous Tube Sampler Borehole </p> | | <p> Monitoring Well Installation </p> | <p> Dynamic Plate Test </p> |

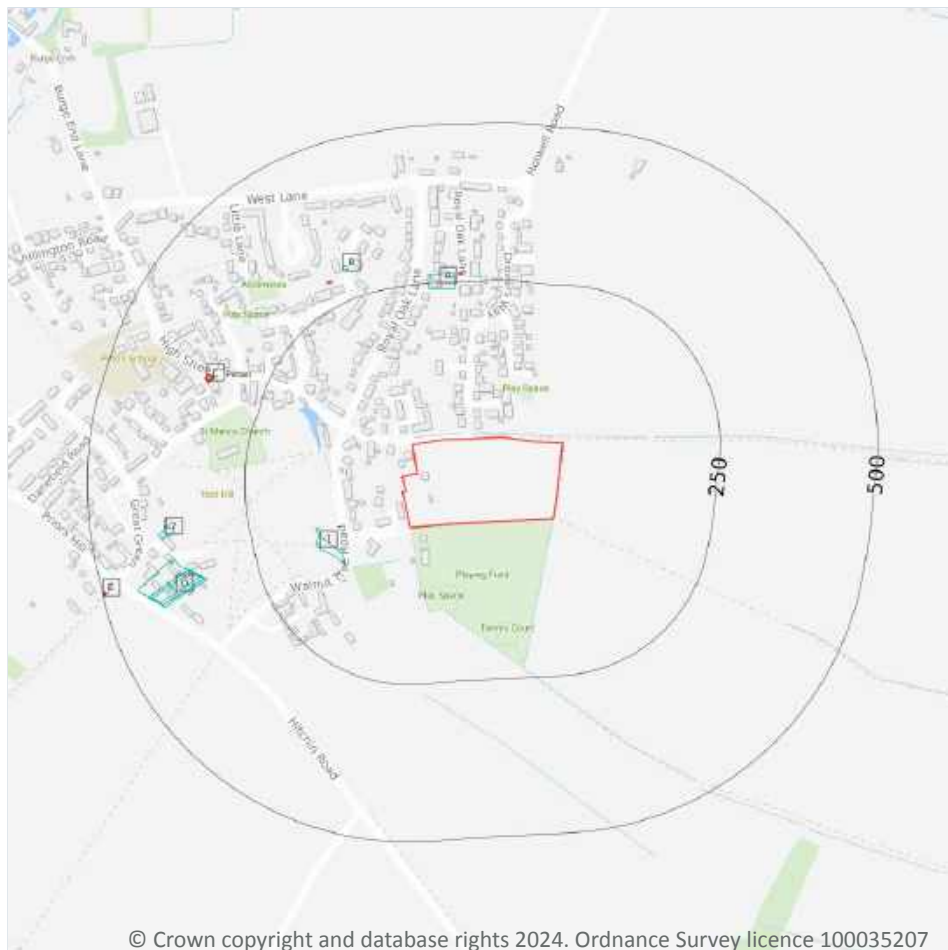
## 1 Past land use

- Site Outline
- Search buffers in metres (m)
- Historical industrial land uses
- Historical energy features

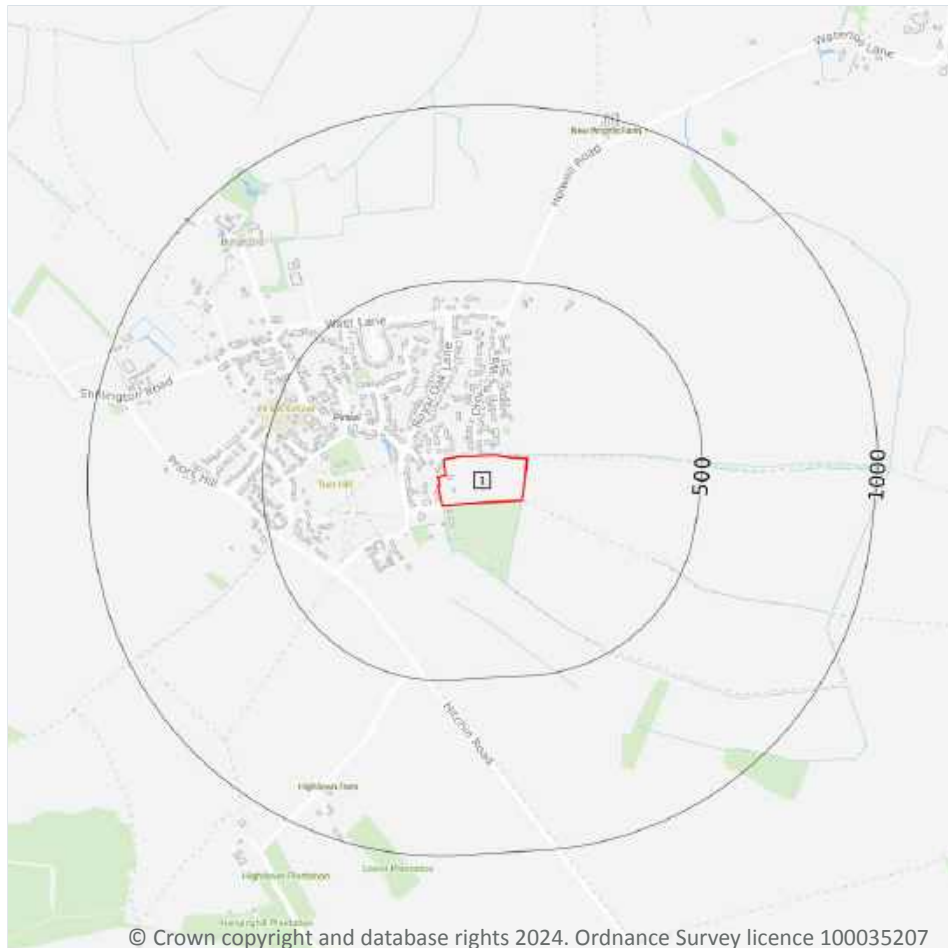
## 14 Geology 1:10,000 scale - Availability

- Site Outline
- Search buffers in metres (m)
- Full coverage
  - Partial coverage
  - No coverage

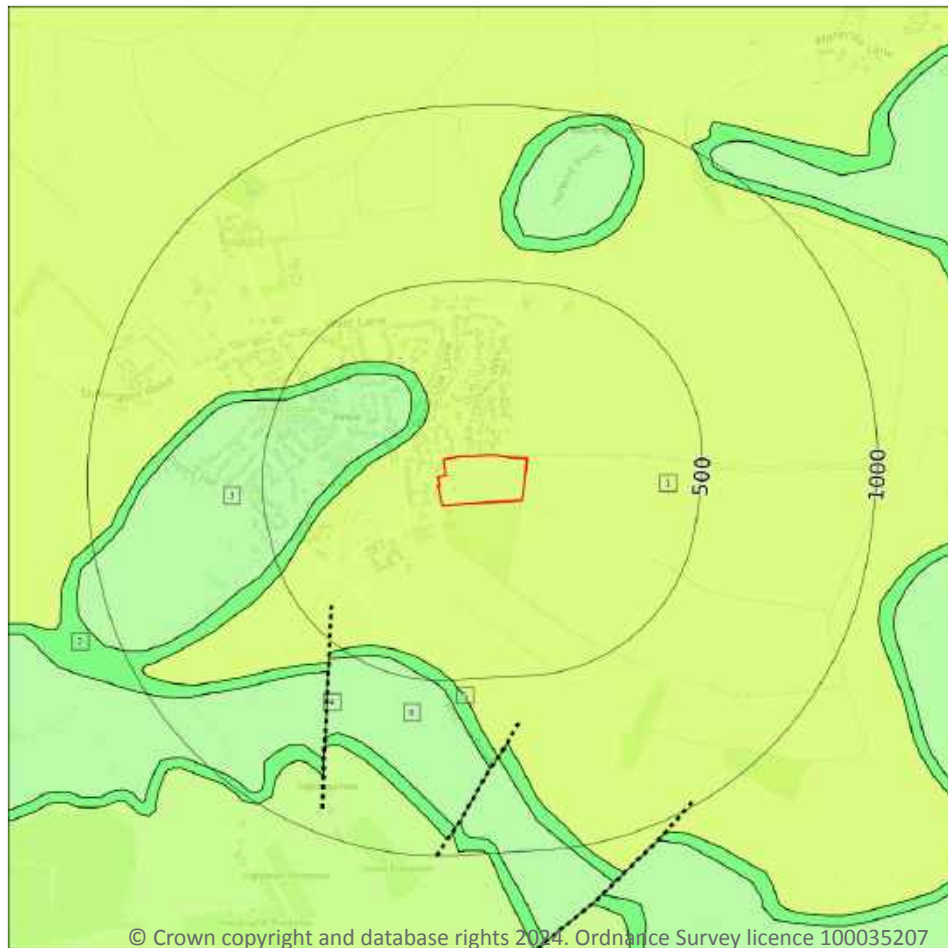
## Geology 1:50,000 scale - Bedrock

— Site Outline
