**PHASE 2 ENVIRONMENTAL INVESTIGATION**  
**of a site at**  
**ASHWELL ROAD, BYGRAVE, BALDOCK,**  
**HERTFORDSHIRE**  
**for**  
**RICHARD YOUNG**

**Project No 3236**  
**Report ref: 3236-P2E-1**  
**Issued: 05 May 2026**  
**Revision:**

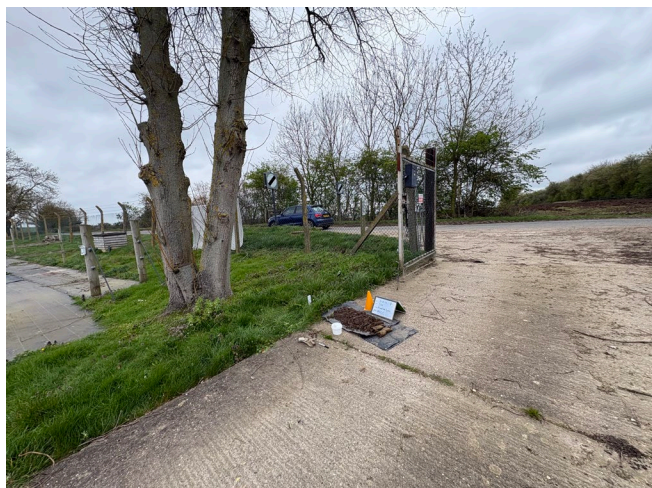
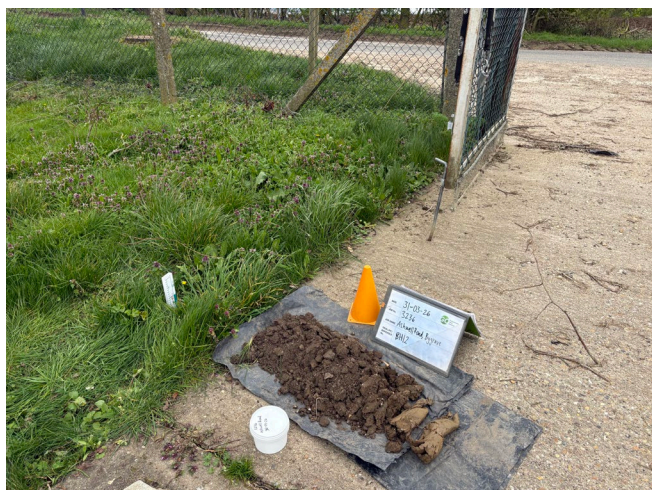
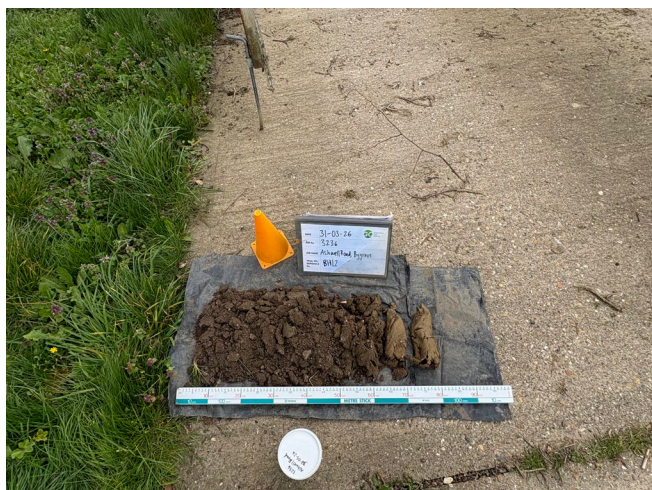
## BH 12

No evidence of sewage sludge was noted during the site investigation. The highest level of SOM was 7.95% in BH12 with an average value across the site of 4.39%. The maximum depth of made ground encountered was 0.5m below ground level with an average across the site of 0.3675m below ground level. Given the depth of made ground across the site and the level of SOM it is not considered that there is a significant potential for ground gas generation.
