**REMEDIATION STRATEGY & VERIFICATION PLAN**  
**of a site at**  
**ASHWELL ROAD, BYGRAVE, BALDOCK,**  
**HERTFORDSHIRE**  
**for**  
**RICHARD YOUNG**

**Project No 3236**  
**Report ref: 3236-P3E-1**  
**Issued: 06 May 2026**  
**Revision:**

Mr Richard Young requested GO Contaminated Land Solutions to develop a remediation strategy for a site at Ashwell Road, Bygrave, Baldock.

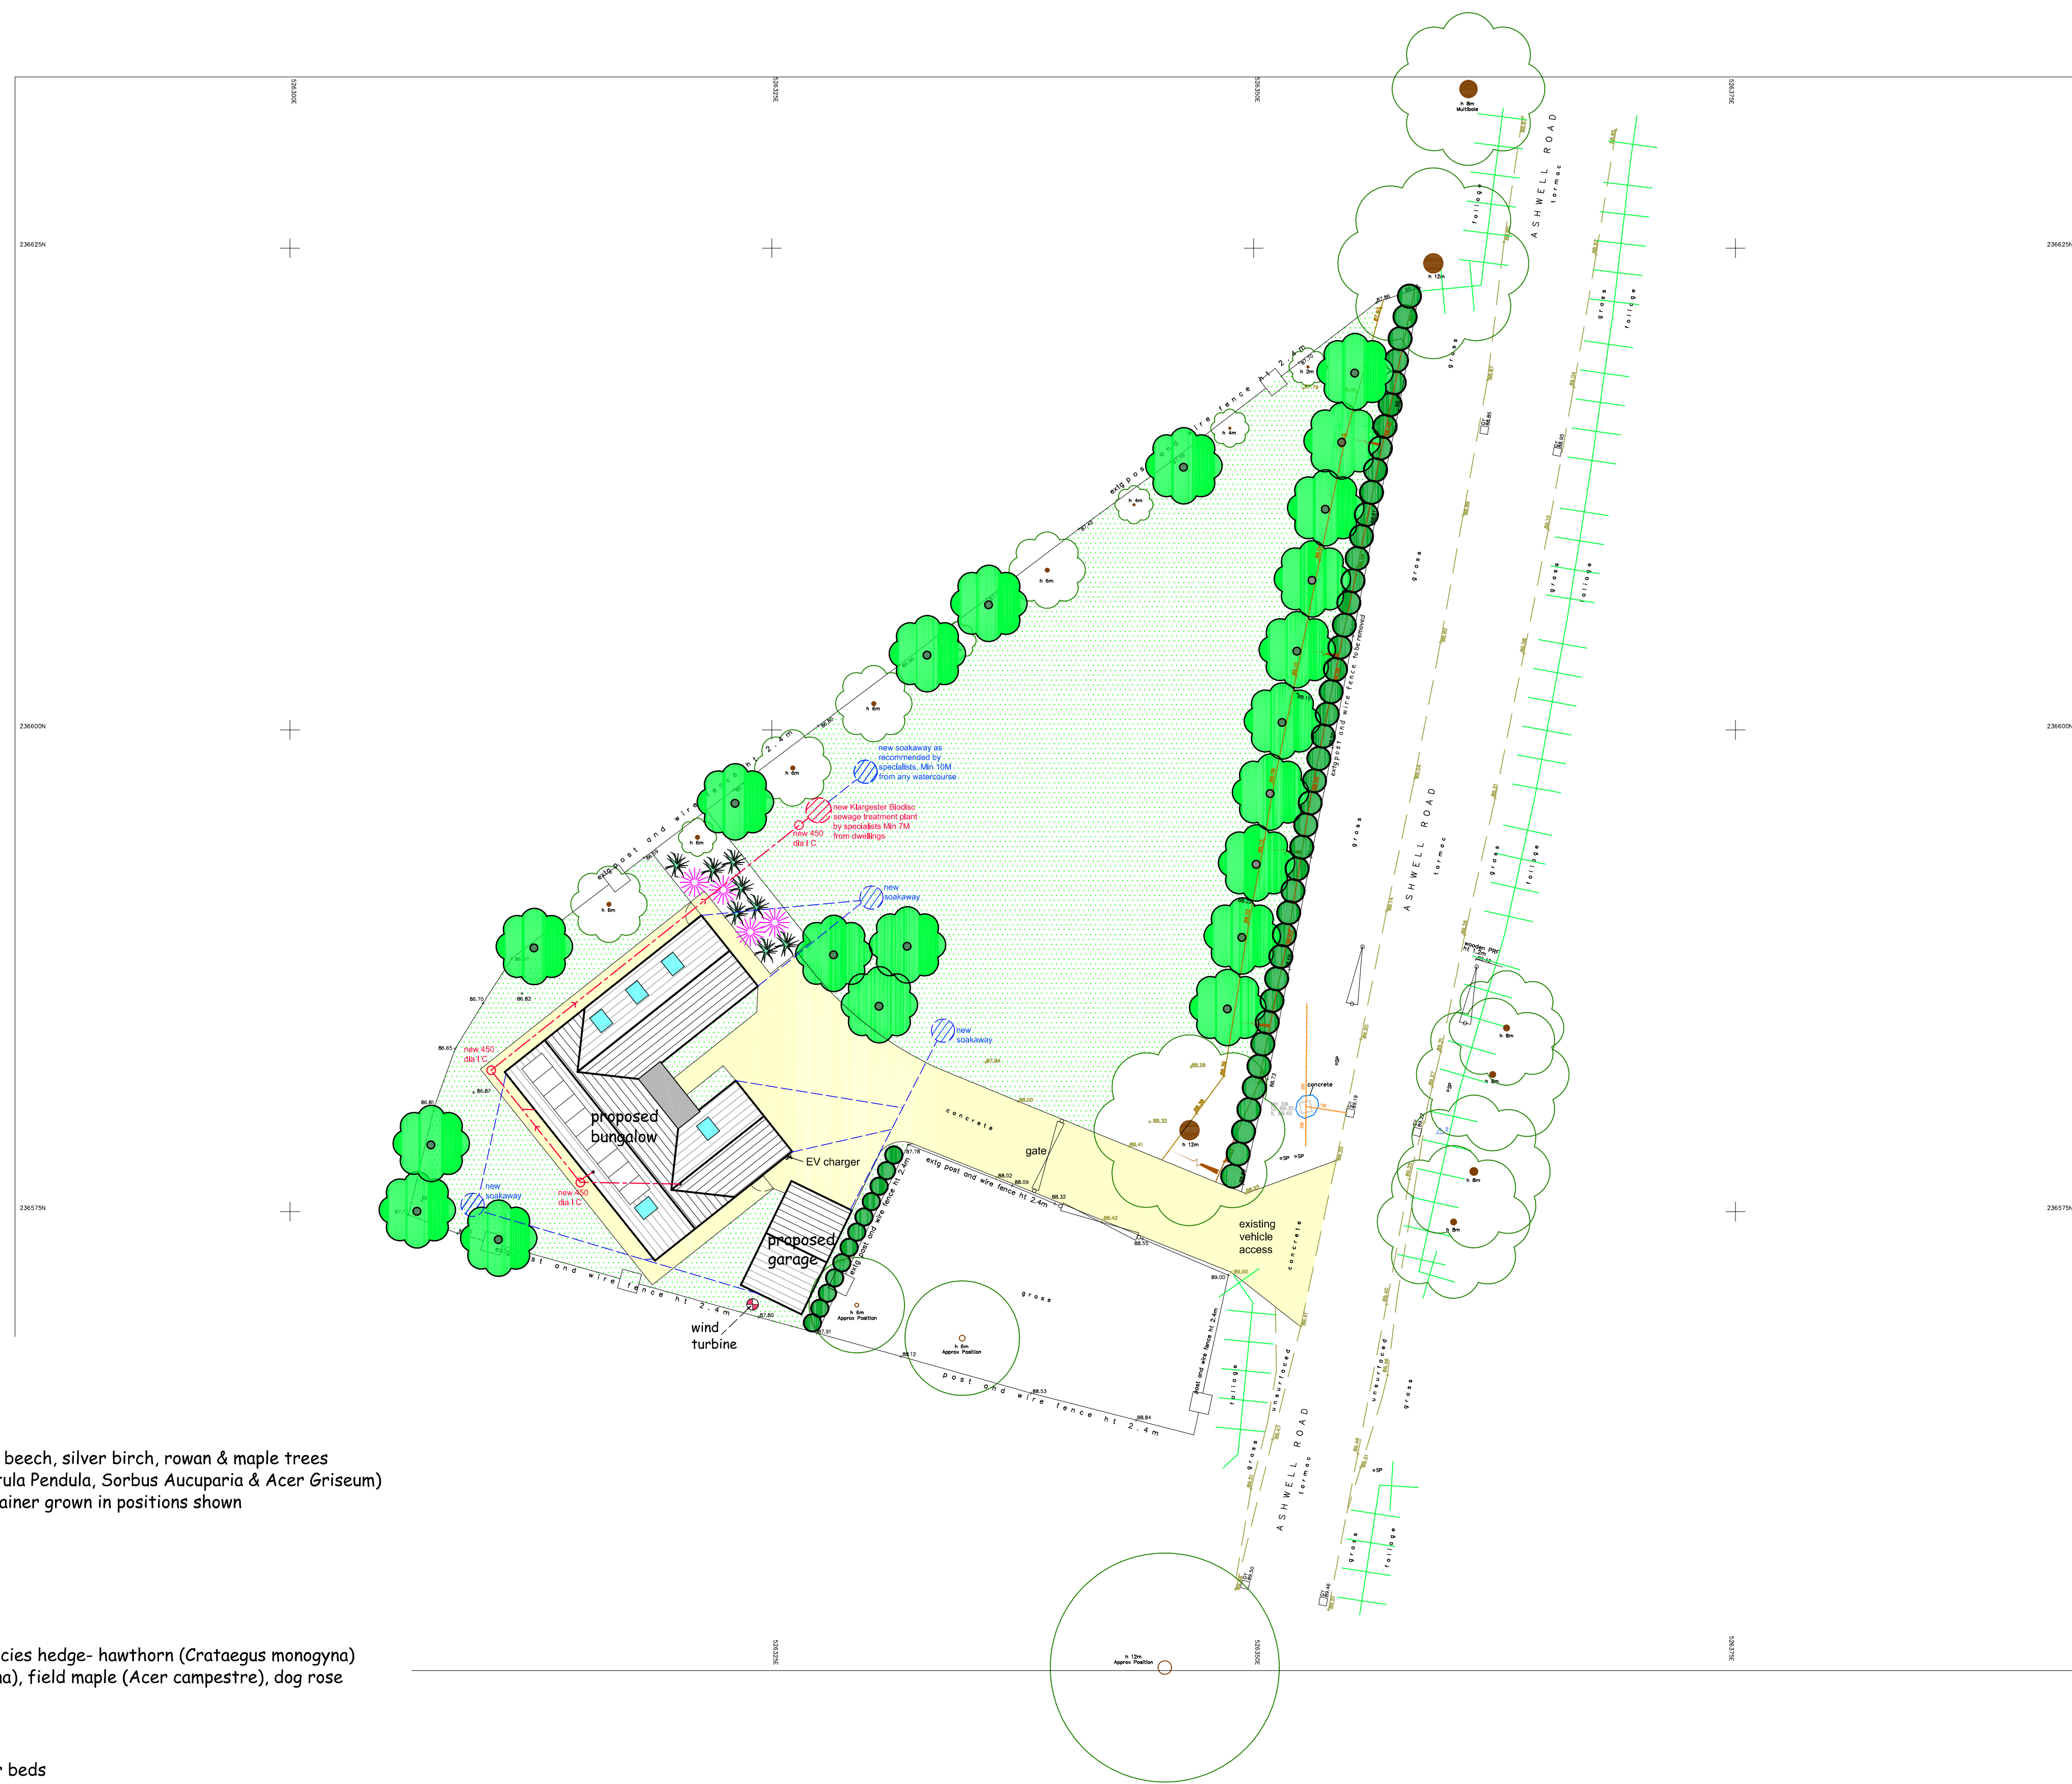
SITE PLAN 1:200

The drawing shows a single storey house including parking facilities, EV charging station, and private gardens. Access to the property is gained via a dedicated entrance from Ashwell Road.

new trees mixture of beech, silver birch, rowan & maple trees  
(Fagus Sylvatica , Betula Pendula, Sorbus Aucuparia & Acer Griseum)  
3 - 4M high, 10L container grown in positions shown

mixed shrub & flower beds

Plan details for the proposed redevelopment of the site are shown on the drawing contained in appendix A.
