# Maydencroft Manor Loft Conversion

Gosmore,  
Hertfordshire,  
SG4 7QA

## Design & Access Statement Incorporating Heritage Statement

October 2025

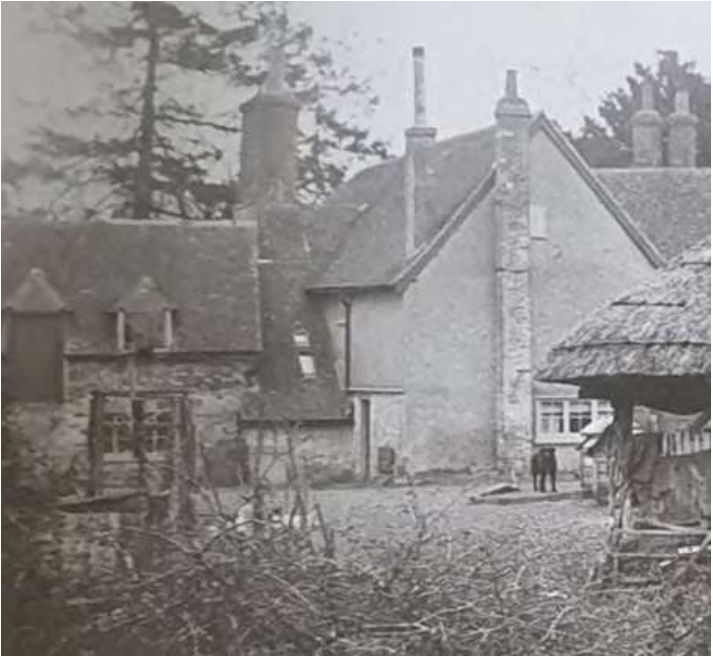
Photo 1908 facing the west end of the east-west gable range, chimney on the face of the gable no longer exists, GF window is now bigger and central. The render/brick exposed has changed over time.

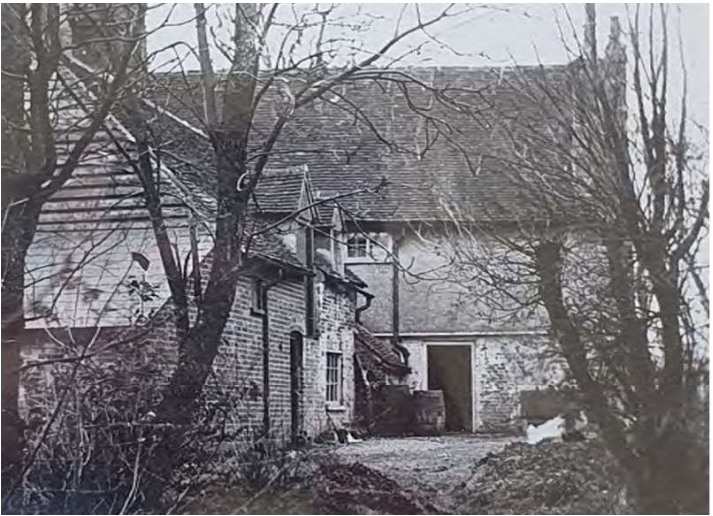
Photo 1908 facing the north side of the east-west gable range, door has since been bricked up

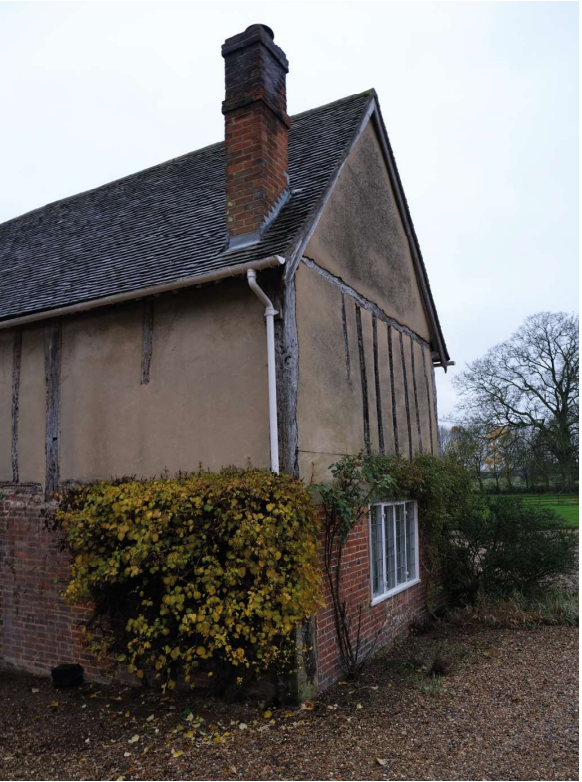
Photo 2020 north-west end of the east-west gable range (prior to conservation repairs of external fabric) showing changes since the 1908 photos.

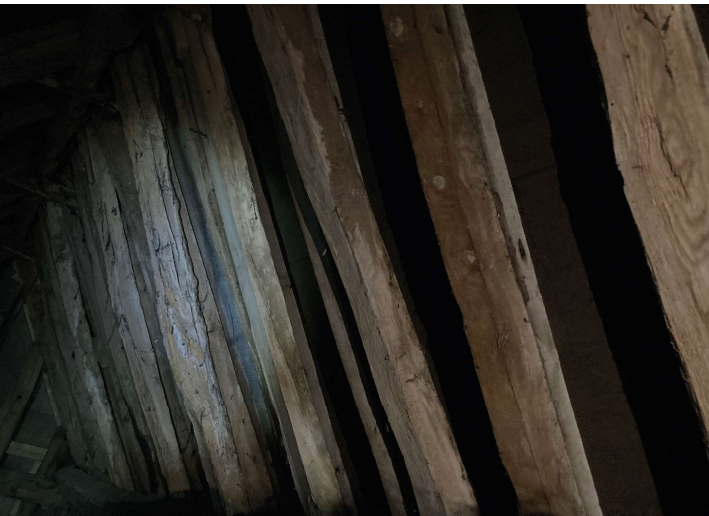
Photo 2025 showing historic rafters with modern rafters overlaid, likely done when the house was re-roofed in the 1980's. (Loft space of east west range of house).

The original timber rafters throughout the loft space predominantly have been preserved, during the 1980’s re-roofing instead of replacing them they were overlaid with new rafters so the originals with their deflection are very visible within the loft space.

8. New breathable insulation to underside of roof with historic rafters left visible. As detailed above, its likely that the historic rafters will be predominantly visible due to the overlaying of new rafters at the time of the re-roofing in the 1980's therefore the insulation layer will sit between the new rafters at the upper level. It is considered that this will therefore have no impact on the heritage.

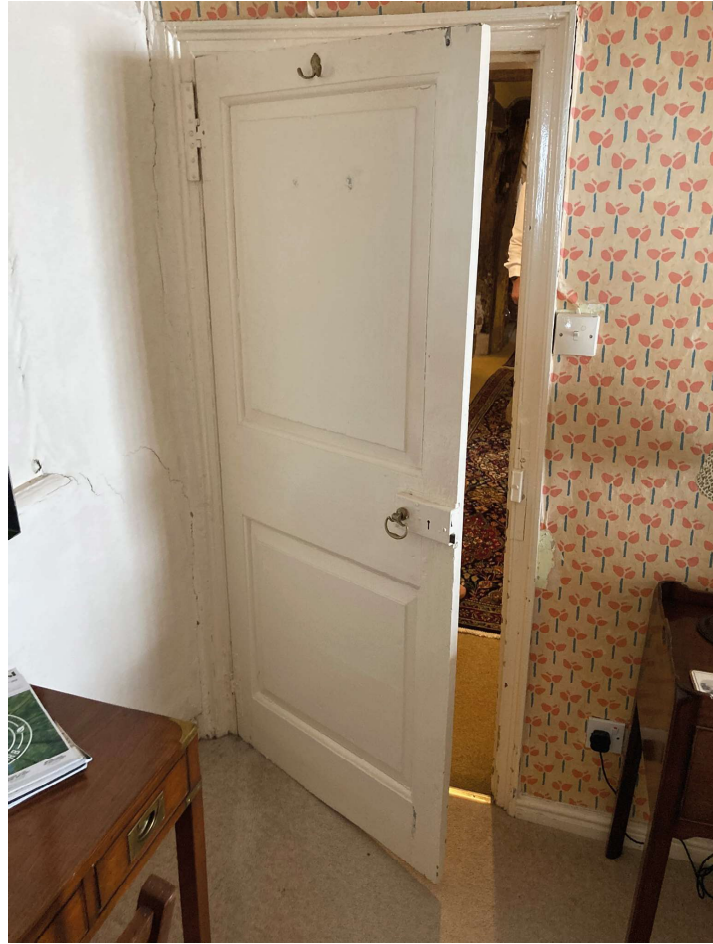
Photo of existing door, view from inside Bedroom 6

3. Move existing door into bedroom 6 to the new partition wall, essentially retaining the existing entrance door to the bedroom but in a new location. There is no loss here and the door will retain character in the same area of the house. This is considered to have no impact on the heritage.

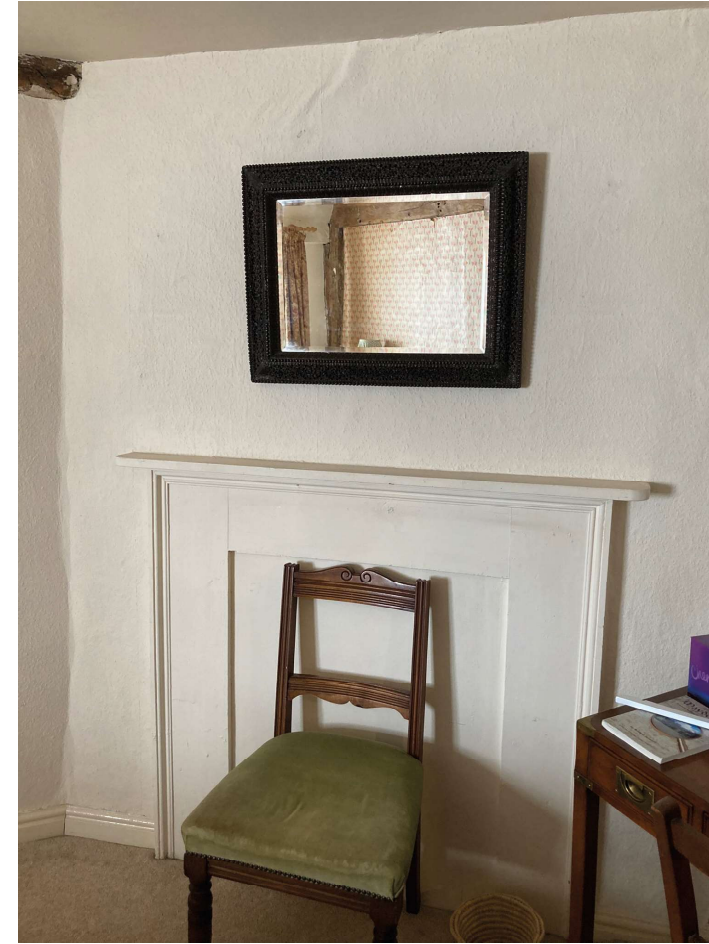
Photo of the 20th C chimney breast diagonally across the corner of Bedroom 6 with modern surround and blocked up opening. (North east corner of the gabled range).

The chimney in the far north east corner of the north wing is a 20th Century insertion, seen above roof level and then internally with a chimney breast diagonally across the corner of the room at both ground and first floor level. At first floor a modern fireplace surround is fixed to the surface of the wall with the opening blocked up, this may have always been a ‘dummy’ fireplace at first floor level as it is directly above the wood burning stove installed at ground floor level or it was installed for use at first floor level only and later altered to serve the ground floor when the adjacent external chimney on the end of the gable was removed to widen the ground floor window, later in the 20th Century. Its significance is relatively low in the heritage of the house but does hold some clues of to 20th Century changes to the house so has a low historic value.

1. Removal of the chimney breast at first floor level back to a stack around the flue servicing the ground floor log burner. Retaining external appearance of chimney. Loss of 20th Century fabric, mock fireplace at first floor cannot be operational, with fireplace retained at ground floor level and the chimney externally, the changes to the chimney at first floor level have a very low impact on the heritage.

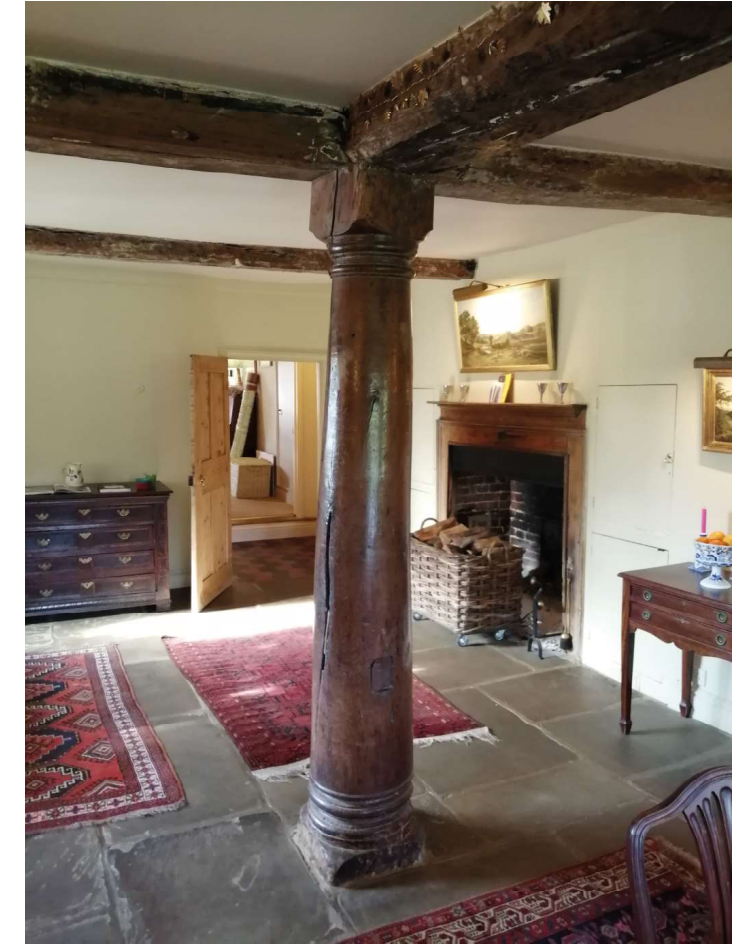
Photo looking at the ground floor area of the 15th Century Medieval Hall with the later extension east, removal of the wall and insertion of the round column in place of the wall. Fireplace is a 17th/18th Century addition, referred to as the north fireplace in the extracts from the Jon Lowe Heritage Report.

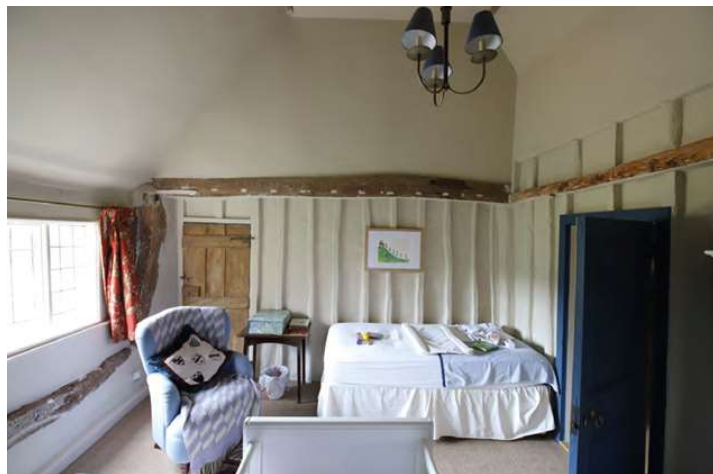
Photo of Bedroom 4 (looking west) in location of original 15th Century Medieval Hall, first floor insertion later addition. Small void above apex visible in loft space.

Blackened timbers in this roof space mostly over Bedroom 4 within the void above the higher ceiling level and what looks to be some fading out into the space above bedroom 5/the ensuite are signs of the original Hall house where fires would have been lit in the centre of the floor before the introduction of the chimneys and fireplaces. This is of significant evidential value.

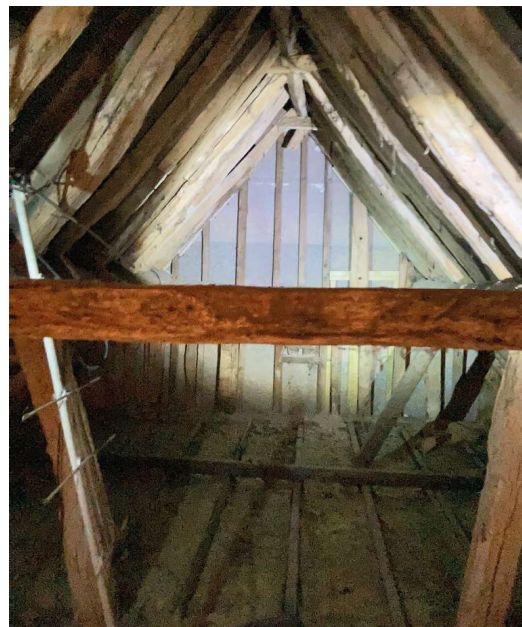
Photo of loft space over bedroom 5&6 looking north towards end gable. New breathable render carrier board visible between the end timber studs.

The end gable has been restored externally and the new breathable render carrier boards are visible internally, these would be rendered internally too with lime plaster/ insulated lime plaster, leaving the face and some depth of the wall studs visible.

9. Lime render internal face of new render carrier boards on end gable, leaving timber studs visible. The studs will remain visible, the rear side of the render carrier boards will be lime rendered, this wall will look like the internal walls on the first floor. This has no impact on the heritage.

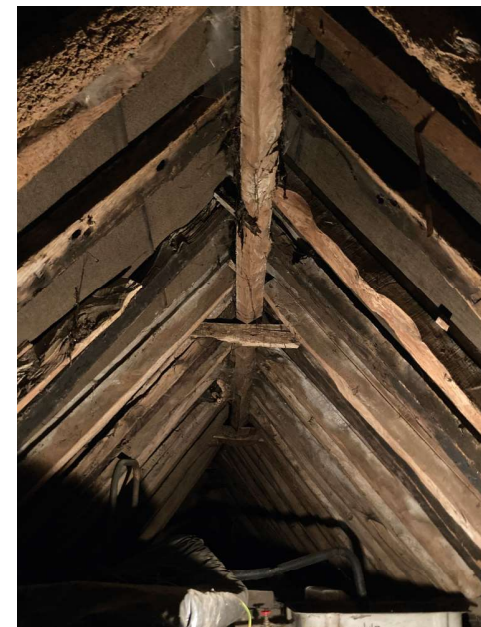
Photo of loft space over bedroom 5 looking south into the void over the ceiling above Bedroom 4 (15th Century Medieval Hall House)

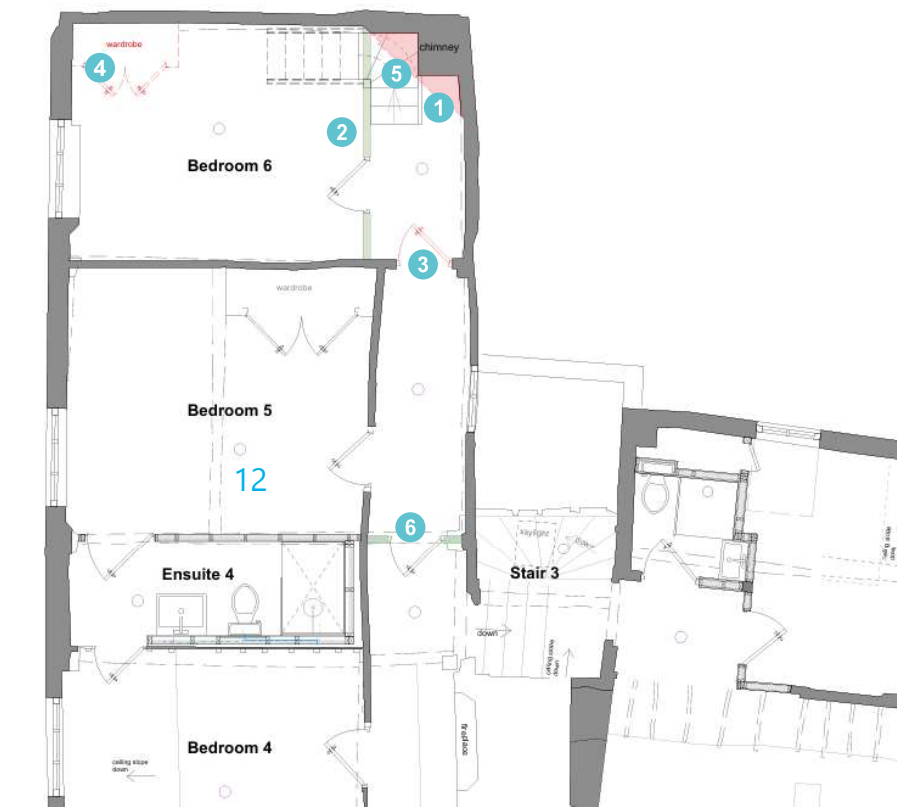
Proposed Plan First Floor Level (Part Plan North wing)

1. Removal of the chimney breast at first floor level back to a stack around the flue servicing the ground floor log burner. Retaining external appearance of chimney.

2. New partition wall in Bedroom 6 making a smaller bedroom and extended hallway for locating stairs to the loft space.
3. Move existing door into bedroom 6 to the new partition wall, essentially retaining the existing entrance door to the bedroom but in a new location.

4. Removal of built in wardrobe in Bedroom 6.
5. New timber staircase to loft space.
6. New door opening placed in hallway at first floor level to provide fire escape protection, use of salvaged hardwood door (which is in storage on site) and matches style of some other first floor doors.

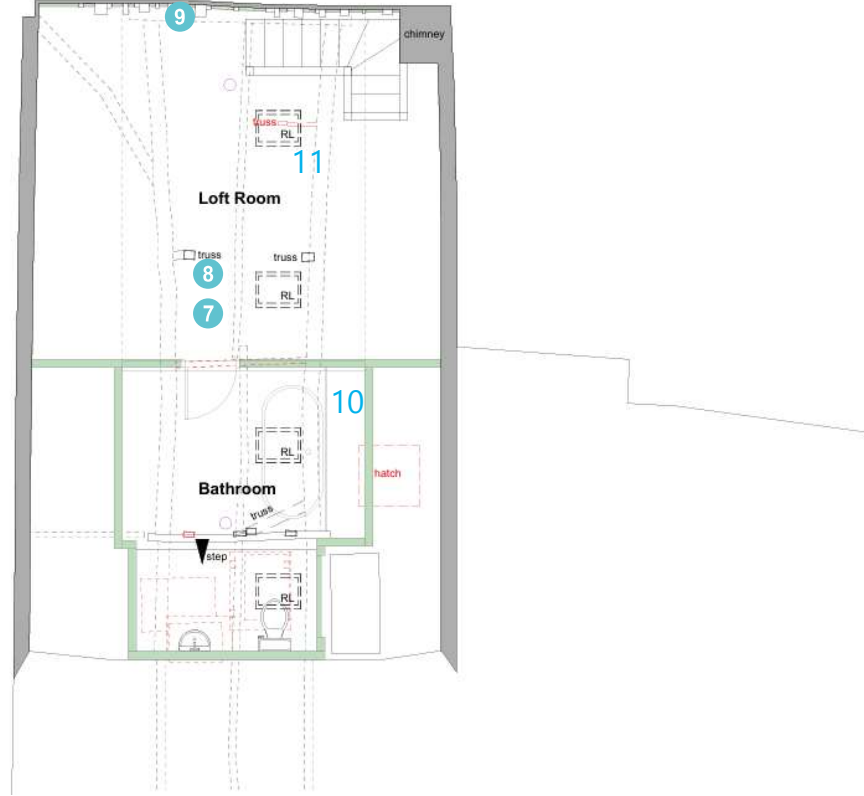
Proposed Plan Loft Floor Level (Part Plan North wing)

7. New floor joists installed alongside the existing ceiling joists at loft level and boarding to create structural floor at loft level. Retain lath and plaster ceilings at first floor level.

8. New breathable insulation to underside of roof with historic rafters left visible.
9. Lime render internal face of new render carrier boards on end gable, leaving timber studs visible.

10. Install partition walls creating bathroom space at loft level. Main loft space left 'open' to eaves to retain visual impact of the volume and views of the historic roof frame. (Space under eaves has limited head room down to 0mm). Existing truss within Bathroom space left in place.

11. Insertion of 4no rooflights to north pitch of roof.
12. Installation of upgraded fire protection system.

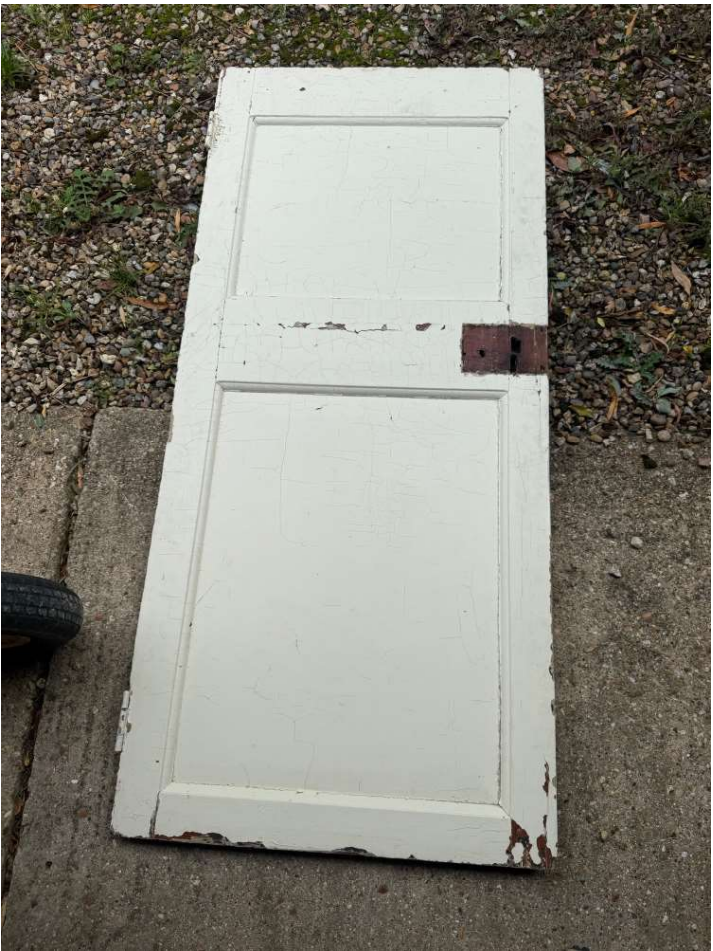
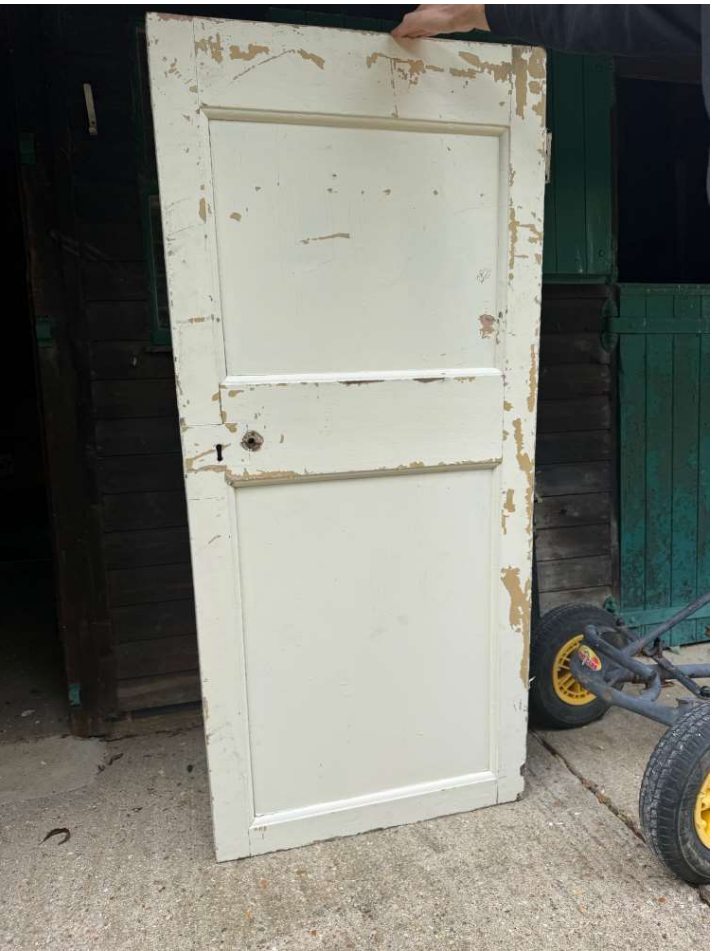
Photos of the salvaged hardwood door for use in the hallway

One existing door to be relocated into the adjacent new partition and one ‘new’ door to be installed to the hallway for which a salvaged hardwood door of a similar style is proposed for use (photos opposite), this is in storage on site and likely came out of the house.

6. New door opening placed in hallway at first floor level to provide fire escape protection, use of salvaged hardwood door (which is in storage on site) and matches style of some other first floor doors. The door is likely to have come out of the house and is of a similar style to those on the first floor, so there is benefit in reinstating historic material (although not to an original location, this is unknown). The new doorway doesn't require any loss of fabric, its partitioning of the hallway is considered to have a very low impact on the heritage.
