## Appendix D PHOTOGRAPHIC RECORD

### SITE RECONNAISSANCE SURVEY NOTES

### **TECHNICAL BACKGROUND**

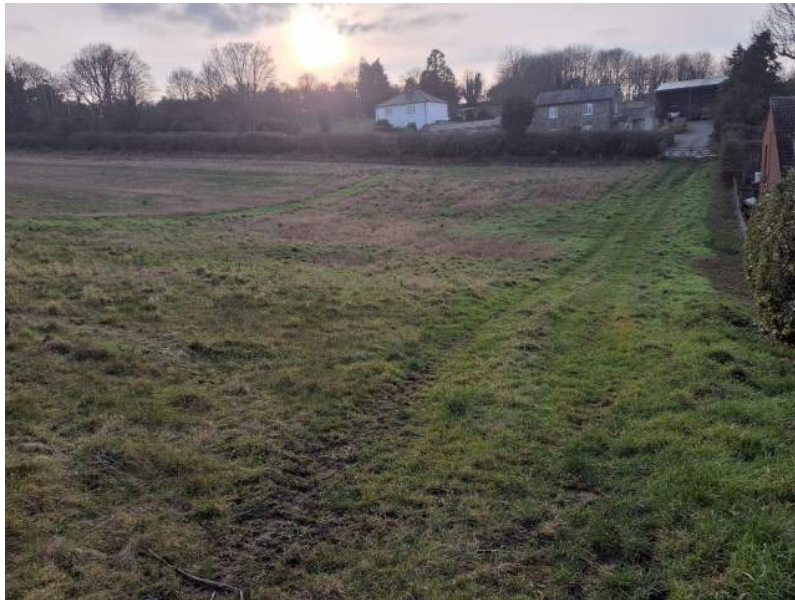
| <b>Photo no.</b><br><b>1</b> | <b>Date:</b><br>17/02/2025 |

Field in west, viewed from the northern site boundary showing the site (grassland) as well as residential properties

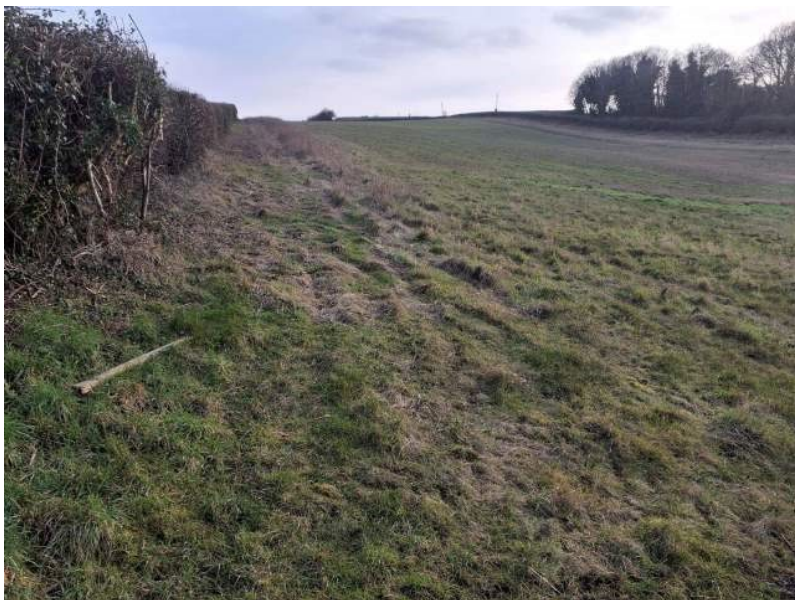
| <b>Photo No.</b><br><b>2</b> | <b>Date:</b><br>17/02/2025 |

Looking south from the western site boundary at site land use -grassland

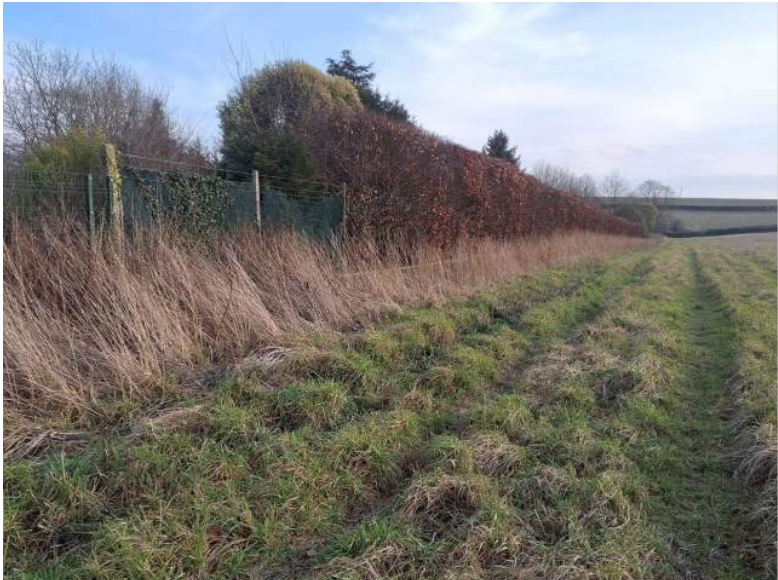
| <b>Photo No.</b><br><br>3 | <b>Date:</b><br><br>17/02/2025 | |

| <b>Description:</b><br><br>Showing the eastern site boundary | | |

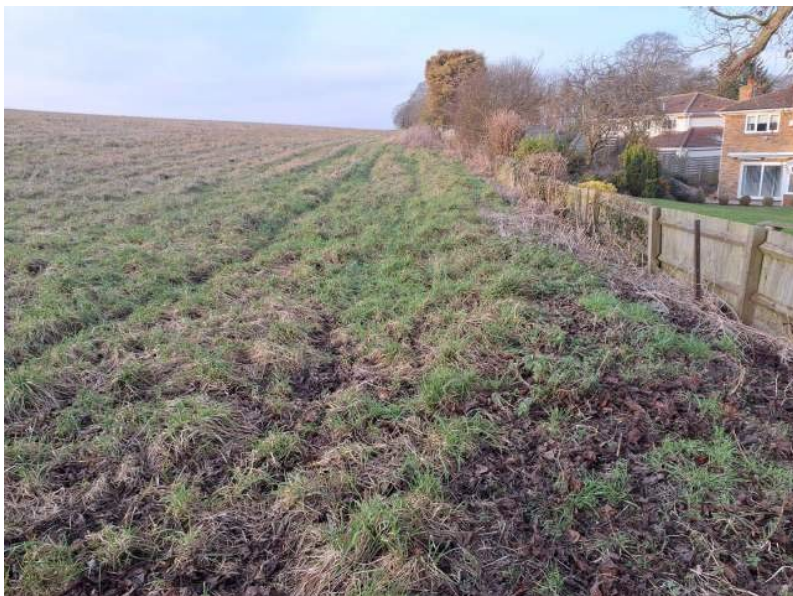
| <b>Photo No.</b><br><br>4 | <b>Date:</b><br><br>17/02/2025 | |

| <b>Description:</b><br><br>Showing the eastern site boundary with adjacent residential properties | | |

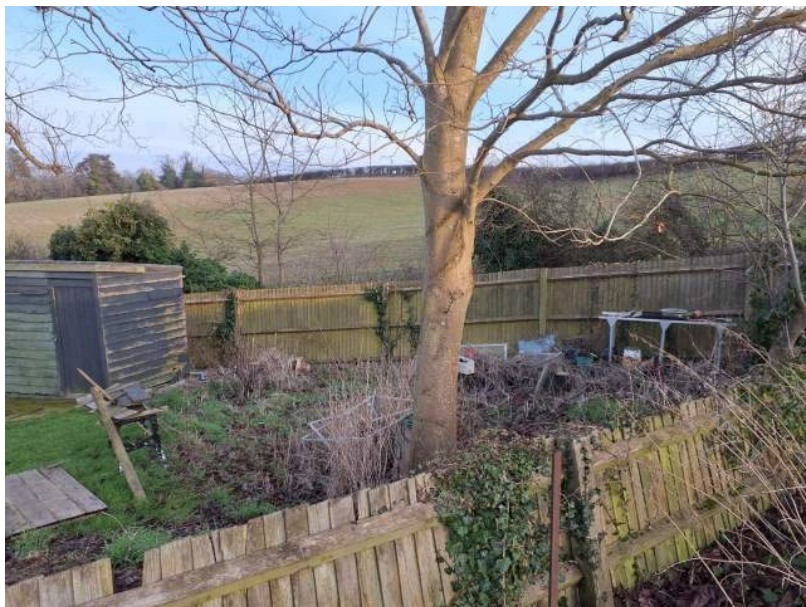
| <b>Photo No.</b><br><b>5</b> | <b>Date:</b><br>17/02/2025 | |

| <b>Description:</b><br>Residential properties to east<br>and Agricultural field to<br>southeast | | |

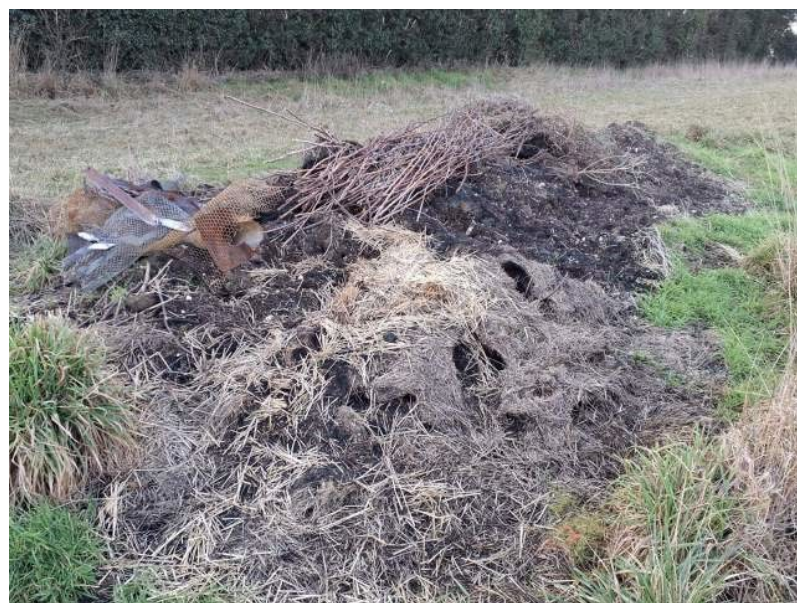
| <b>Photo No.</b><br><br>6 | <b>Date:</b><br><br>17/02/2025 | |

| <b>Description:</b><br><br>Waste heap / burn pile<br>identified in the south of the<br>site | | |

| Feature observed | Presence Y/N | Description |
|---|---|---|
| 24. Fly-tipping | Y | Burn pile identified onsite |
| 27. Fire history | Y | There was a burn / bonfire identified onsite |
| 28. Is there any visual evidence of potential contamination on site? | Y | Burnt plant material onsite possible contaminates but unlikely |

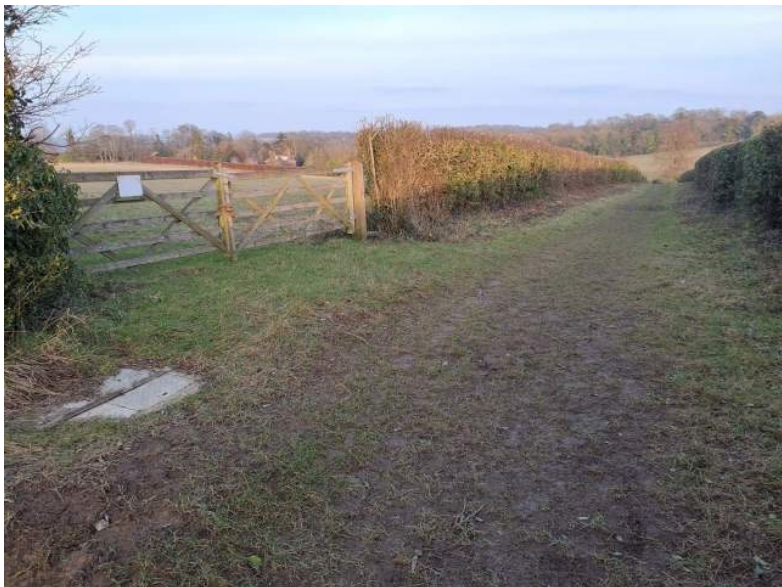
| <b>Photo No.</b><br><br>7 | <b>Date:</b><br><br>17/02/2025 |

| <b>Description:</b><br><br>Double gate on southern site boundary and underground service covers on the track | |

A photograph showing a dirt and grass track leading to a closed wooden double gate. To the right of the gate is a tall, dense hedge. In the background, there are trees and a clear sky. A concrete slab, likely an underground service cover, is visible on the track in the foreground.

| Feature observed | Presence Y/N | Description |
|---|---|---|
| 12. Buried and overhead services present | Y | Underground services: inspection covers identified on track immediately west of the site |

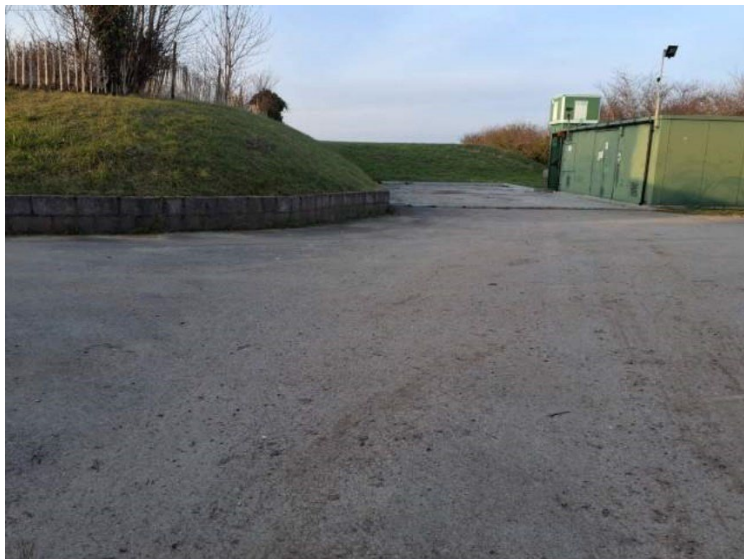
| 8 | 17/02/2025 | |

| Pumping station southwest of the site. Grass mounds are probably part buried water tanks | | |

| Feature observed | Presence Y/N | Description |
|---|---|---|
| 13. Underground structures | Y | Off site Semi buried tanks to southwest in relation to the reservoir |

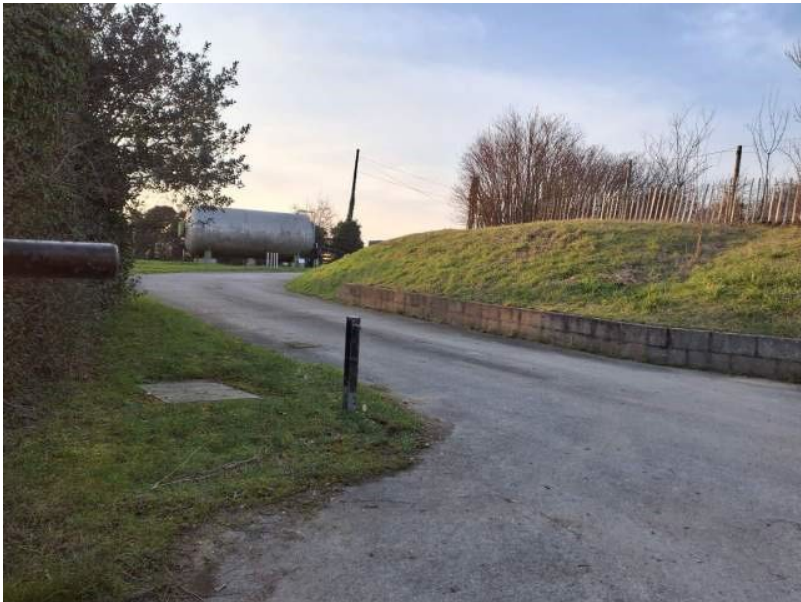
| <b>Photo No.</b><br>9 | <b>Date:</b><br>17/02/2025 | |

| <b>Description:</b><br>Pumping station | | |

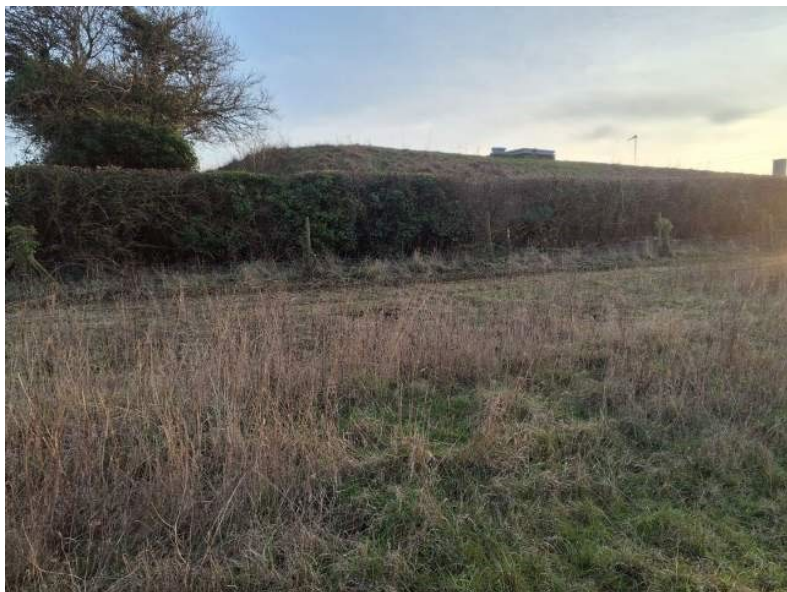
| <b>Photo No.</b><br><b>10</b> | <b>Date:</b><br>17/02/2025 | |

| <b>Description:</b><br>Southern site boundary, showing the northern edge of reservoir and pumping station | | |

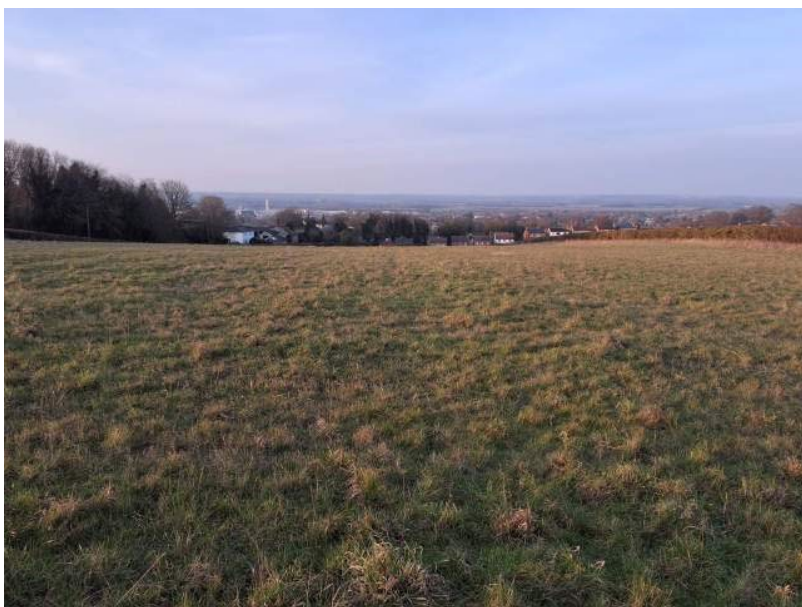
| <b>Photo No.</b><br><br>11 | <b>Date:</b><br><br>17/02/2025 | |

| <b>Description:</b><br><br>Western area of the site -<br>grassland | | |

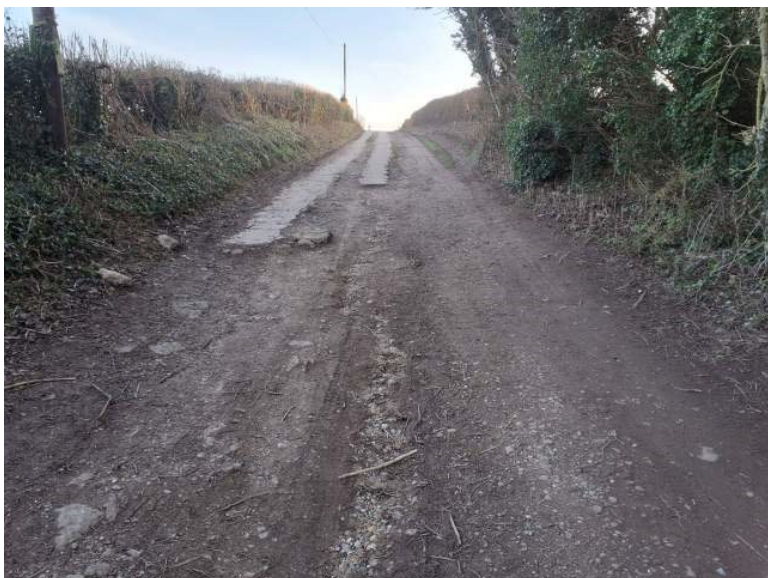
| <b>Photo No.</b><br><b>12</b> | <b>Date:</b><br>17/02/2025 | |

| <b>Description:</b><br>Western site boundary facing south showing overhead phone line | | |

| Feature observed | Presence Y/N | Description |
|---|---|---|
| | Y | Above ground services: Overhead phone line on western boundary |

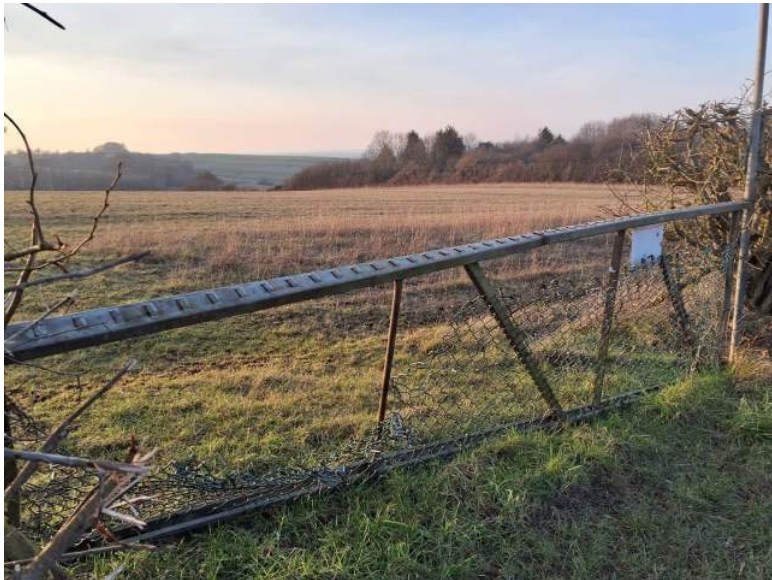
| <b>Photo No.</b><br><b>13</b> | <b>Date:</b><br>17/02/2025 | |

| <b>Description:</b><br>Land use Offsite to west/southwest- agricultural land | | |

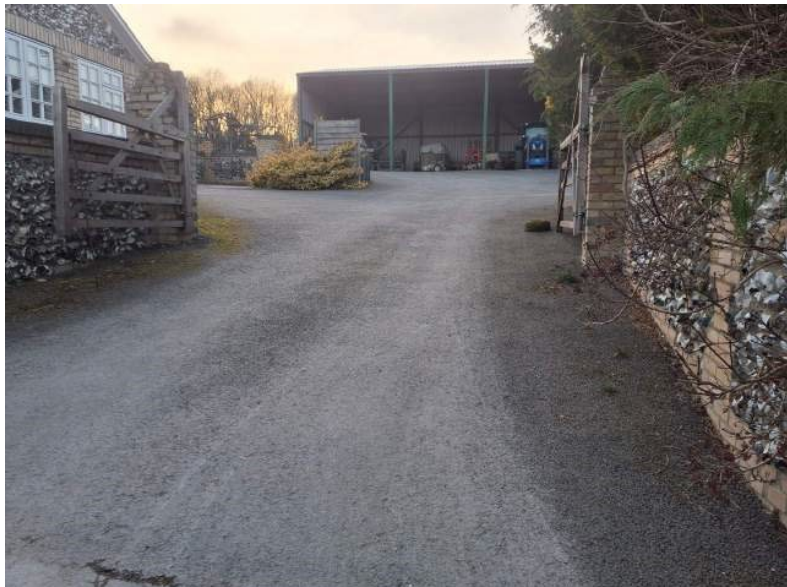
| <b>Photo No.</b><br><b>14</b> | <b>Date:</b><br>17/02/2025 |

| <b>Description:</b><br>Adjacent land use : Heath farm<br>to the west of the site | |

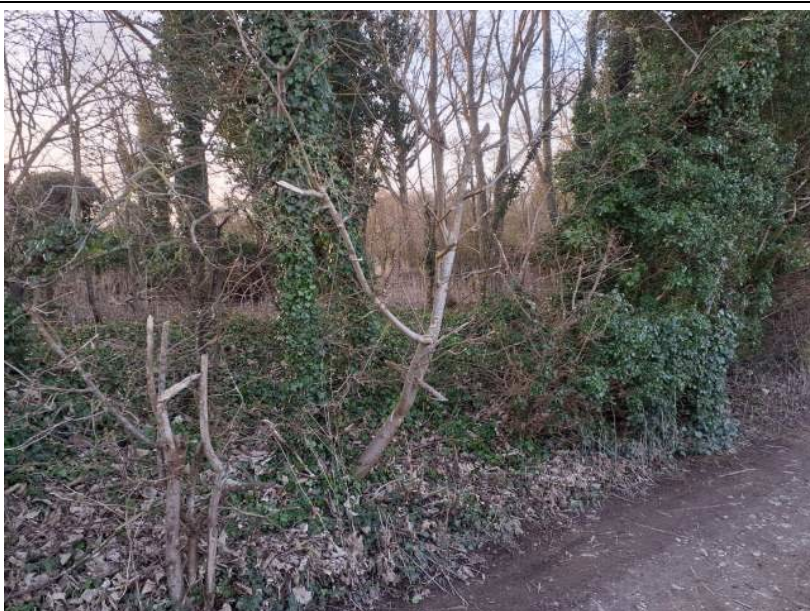
| <b>Photo No.</b><br><b>15</b> | <b>Date:</b><br>17/02/2025 | |

| <b>Description:</b><br>Adjacent land use: Sparse woodland to west of the site and track | | |
