Ref: 25/01094/FP  
Att: Thomas Howe

**Land To The Rear 34, Arlesey Road, Ickleford, Hitchin, Hertfordshire, SG5 3UU**  
**Erection of nine dwellings including access, parking and landscaping.**

**Consultee comments;**

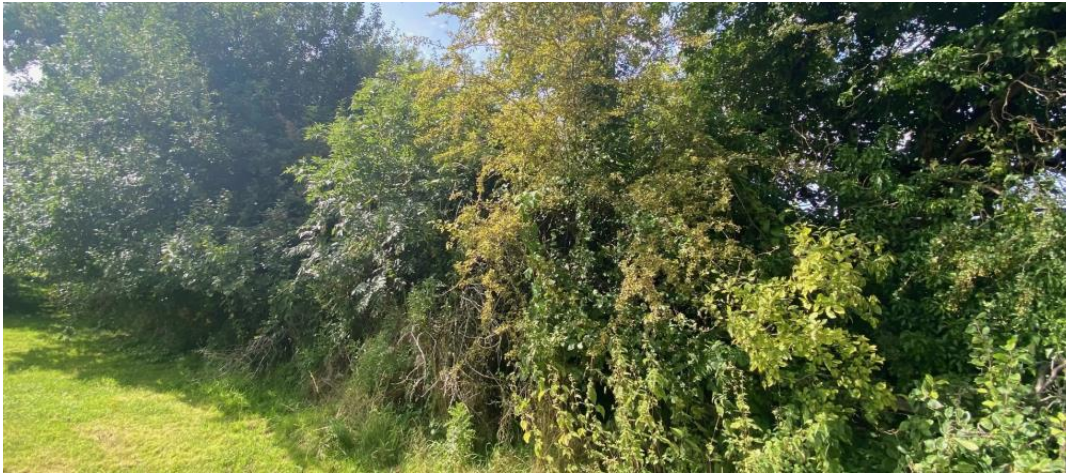
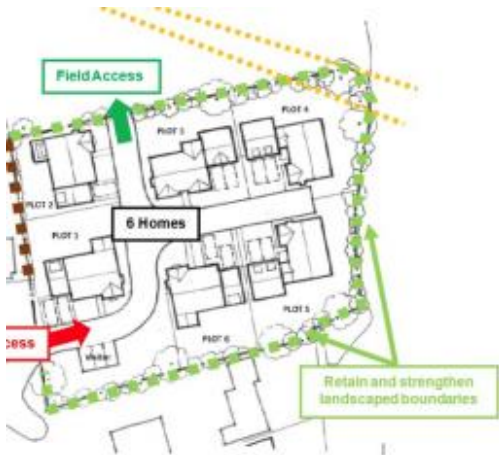
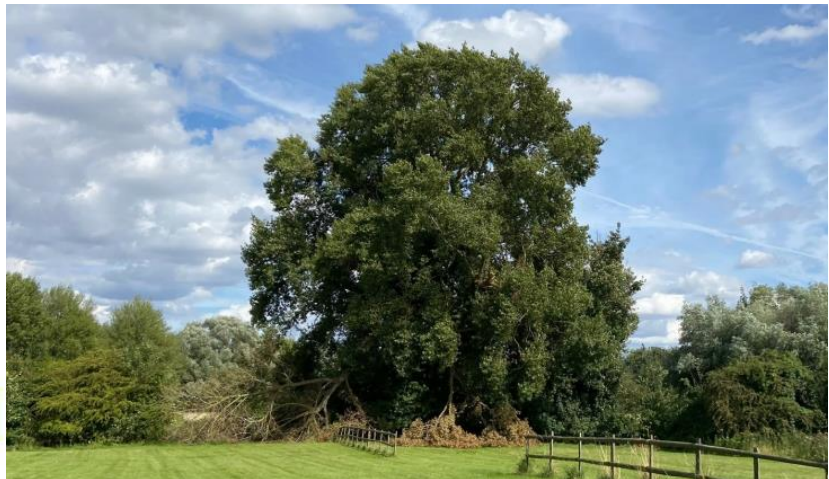
The site proposal has considered keeping the north east corner free from development but has failed to consider the value of the existing vegetation / greenery. Image below from site photos on case file.

The loss of the poplar is deeply regrettable but even with the absence of the veteran tree this proposal fails to give sufficient buffering to the site boundaries and shows no intention to retain existing vegetation on the eastern edge. The felled poplar shows good signs of regeneration and could potentially come back as a coppiced feature were sufficient space provided for a functioning corridor and not the minimal 1m shown on the landscape masterplan. Beyond this, a 1m wide planted native hedgerow will not have sufficient space to grow when located 1m from the new homes in plots 7 and 8.

Initial pre-app advice in 2023 advised on the importance of retained and strengthened boundaries with a layout showing a greater offset from trees and hedgerow. The Ickleford Design Code produced to support the Neighbourhood Plan advises that 'new development will need to take a proactive approach to mitigate their impact and to adapt to the specific landscape within and surrounding the area.'

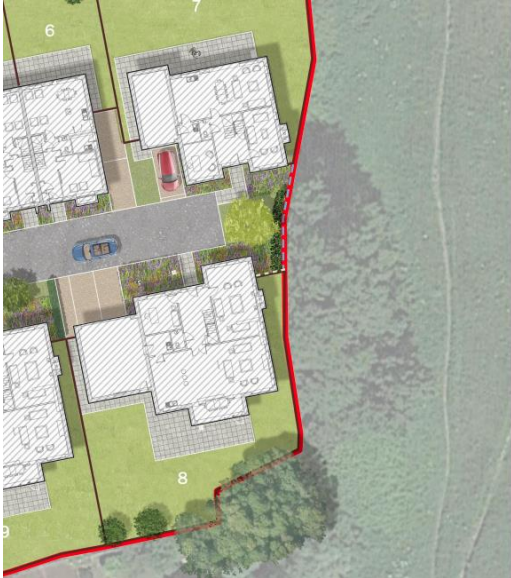
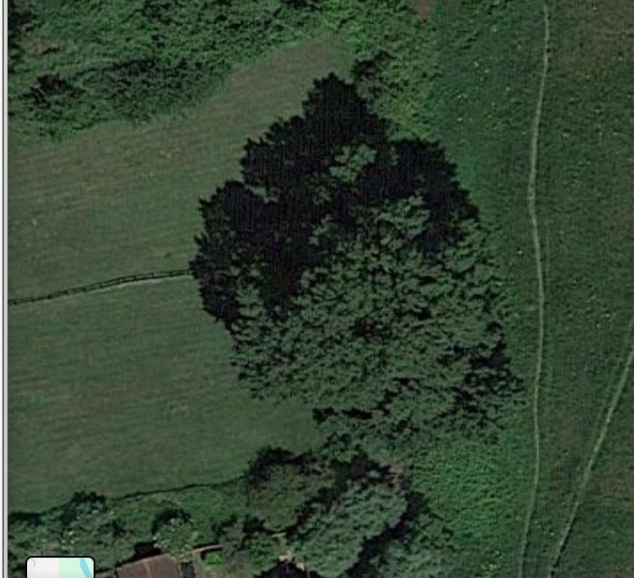
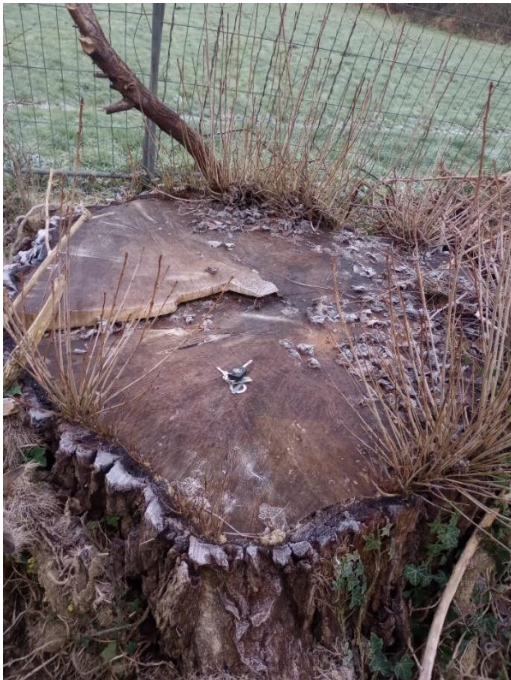
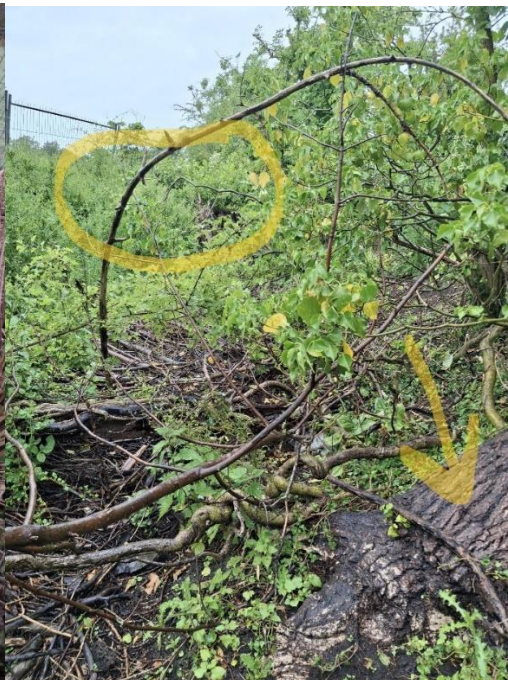
It is noted that the application states the veteran tree is outside of the application area but even if the main stem is just outside the red line the tree roots would be well into the development site. Any development within the RPA of the tree would likely cause it damage, let alone felling it. Were the tree to have remained, if it was not being effectively protected (i.e. RPA remaining development free) as part of the development then it should count this as an impact i.e. a reduction in condition.

Image showing size of veteran tree stump over 1.5m in diameter. Yellow circle indicates location of tree stump and yellow arrow shows location of T3.

The applicant needs to revisit the layout, as it is currently laid out it will not be able to achieve the suggested enhancements as proposed.
