# Phase 1 Desk Study

Bendish Stables - Hitchin

| Report Type | Phase 1 Desk Study |
| Report Ref | R400-PH1-01.0_5534 |

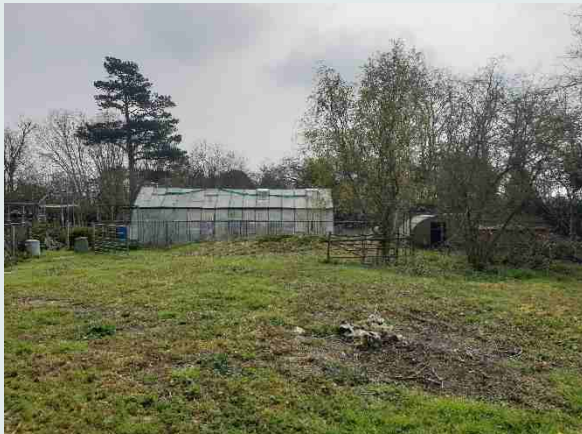
View across south-western section

- 2.4 The site was accessed via a wooden gate along Hollybush Lane that opened up to the south-western quadrant of the site. This section comprised rough grassland with several semi-mature trees, two disused livestock coops, a small stockpile of wood chips, and two beehives. A **burning ground** with ash and charcoal was observed at the base of one of the trees. A small area of old concrete was noted nearby the adjacent large greenhouse. The south-eastern quadrant comprised a vacant grassed field with a couple of mature trees and pile of wooden pallets / debris.

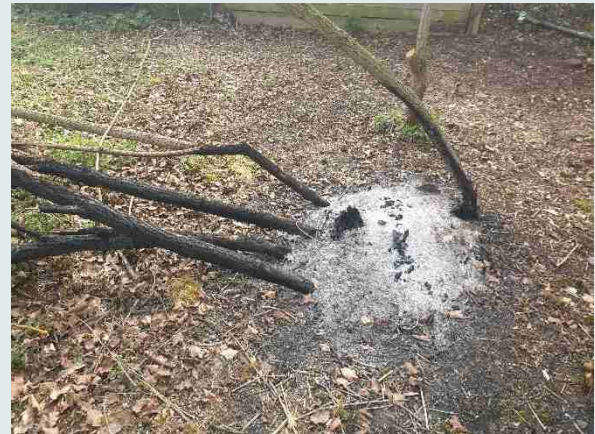
Burning ground in SW quadrant

therefore considered low. Burning grounds are common at domestic garden sites and an area of recent burning with ash and charcoal was present in the south-western quadrant during the walkover. Furthermore, ash and charcoal were sporadically observed within the shallow soils in this quadrant.

ash and charcoal were sporadically observed within the shallow soils across this quadrant. Overall contamination is anticipated to be minimal with potential for localised hotspots around identified sources (e.g. burning ground, ACS below hardstanding of greenhouse, small-scale hazardous storage in wooden shed / workshop, vegetable patch), with demolition works and general landscaping expected to disturb soils further and potentially spread contaminated soils.

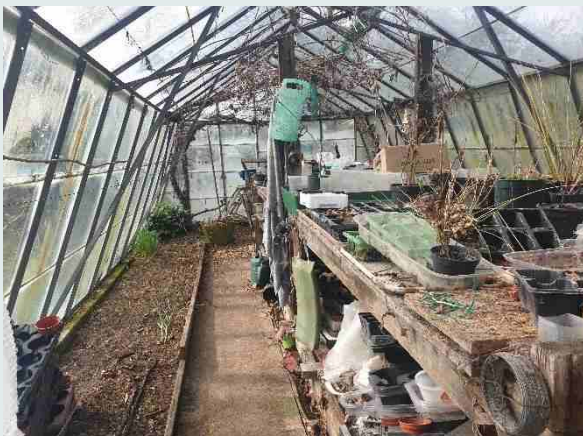
- 2.5 A greenhouse composed of glass panels around a metal frame separated the south-western and south-eastern sections of the site. The glasshouse was laid to concrete hardstanding with raised soil beds around the edges. It appeared to have been used for gardening activities with the following items observed internally: plastic pots, manual gardening tools (e.g. shovels, watering cans, shears etc) and bags of compost / soil. A small wooden shed was present to the south-east of the glasshouse and was observed to contain a single lawn mower overlying a wooden board. A water trough was also noted immediately adjacent to the large greenhouse.

Greenhouse interior

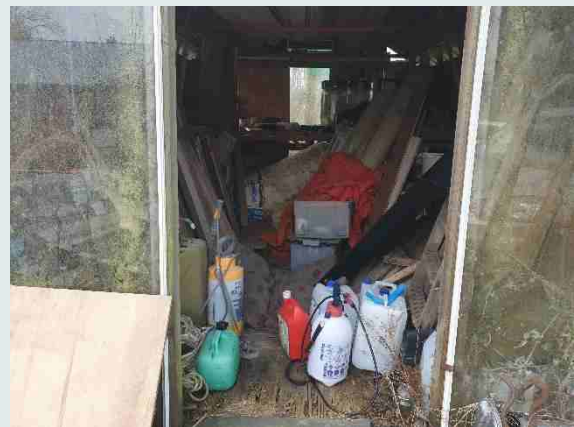
Shed with small-scale hazardous storage

- 2.13 Some **small-scale hazardous material storage** was observed onsite in the workshop building and the wooden shed closest to the off-site Bendish Stables property. The following items were observed: several cans of paint / varnish, spray bottles, various jerry cans of unknown contents (possibly fuel, oil and/or detergent) and two containers of Ad Blue. Anecdotal evidence from the residents stated that the spray bottles contained diluted detergent (washing up liquid) for spraying vegetables. Although not observed during the walkover, there is potential for the workshop to have previously housed other hazardous substances such as small volumes of fuels, adhesives, wood treatment compounds, resins, cleaning products and solvents. The wooden floor of the shed was in a state of disrepair, and any spills or leaks of these potentially hazardous substances would likely have entered the underlying soils. The

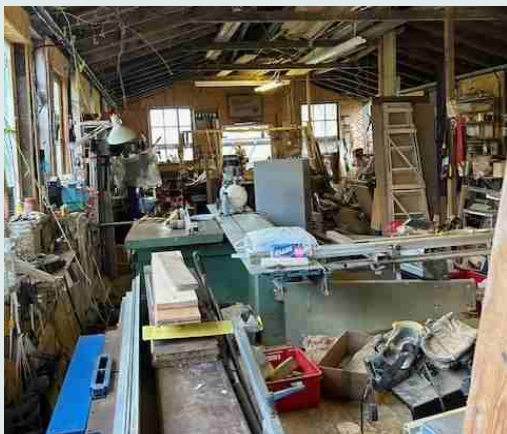
- 2.9 The north-eastern quadrant comprised a single-storey workshop building, a small overgrown pond, a small orchard garden also associated with Bendish Stables. The workshop building was mainly constructed of wood and appeared to be used for storage and domestic construction activities such as woodworking. The following items were observed within the workshop: wooden debris, wooden furniture, manual and electric tools, machinery for woodworking (e.g. planar, grinder, saw etc), dry goods and several cans of paint / varnish. The ground cover internally comprised wood and concrete.

Workshop in north-eastern corner (internal)

floor inside the workshop appeared to be in fair condition which would have afforded some protection from any uncontrolled releases of hazardous substances.

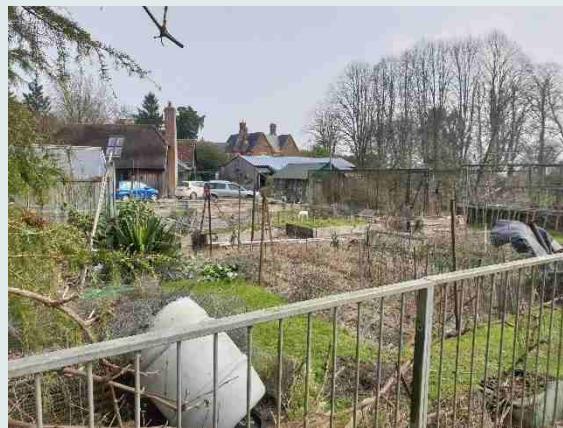
- 2.8 The north-western quadrant of the site was being used as a kitchen garden associated with the adjacent Bendish Stables property. This section largely comprised vegetable patches and raised gardening beds, but a smaller glasshouse was also observed in this area which contained gardening materials such as manual tools and plastic pots. A perished oil can was observed in this area but was noted to be empty. This area was separated from the grassland in the south-west by a metal fence.

View across north-western section
