**Statement of Significance**

**The Biggin, refurbishment**  
Listed Building consent

February 2026  
Hitchin Unite d Charities

**Michael Collins Architect Ltd**

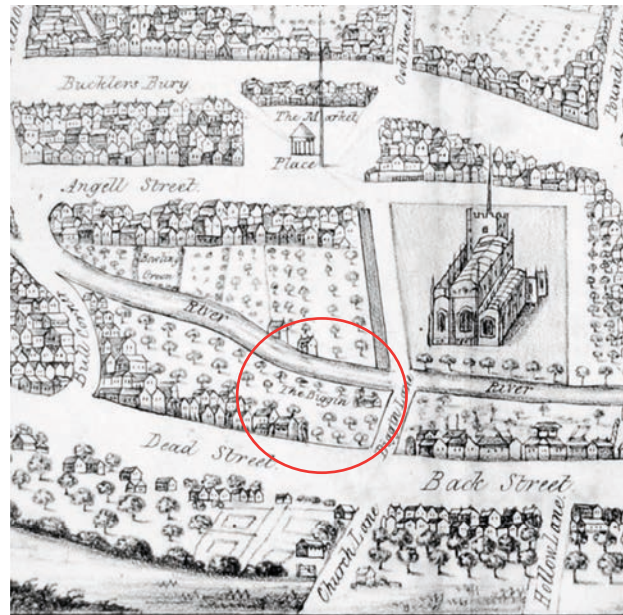
1700, (Chauncy) - set as a standalone building

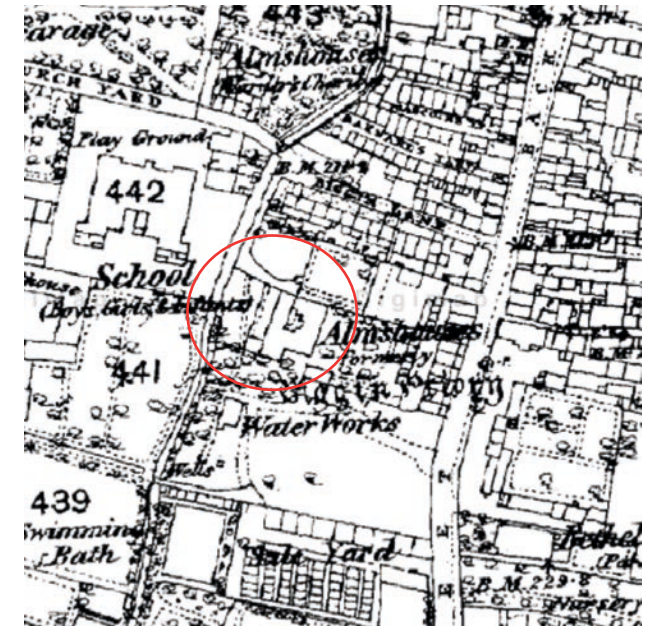
1880 - amalgamation within a group of buildings

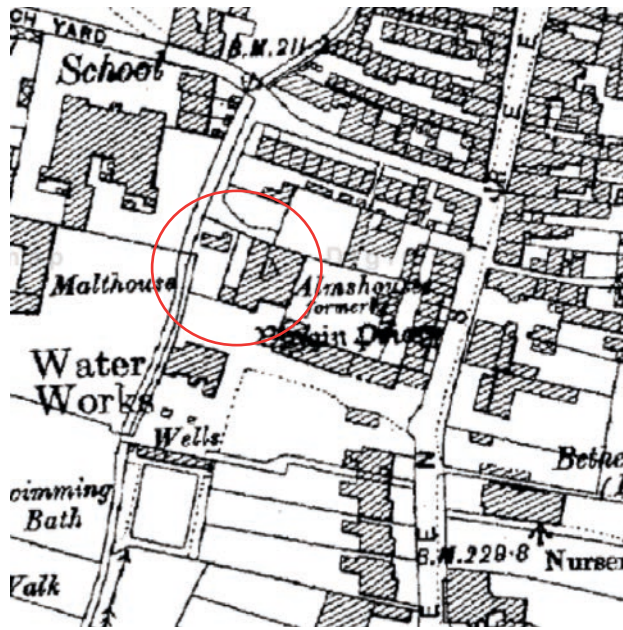
1900 - Note the outbuilding adjacent to the river

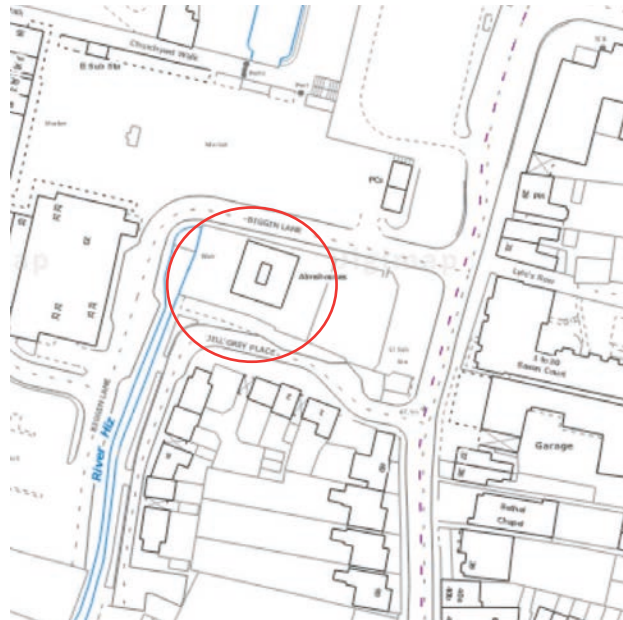
1970-2005 - The Churchgate and open market space to the north

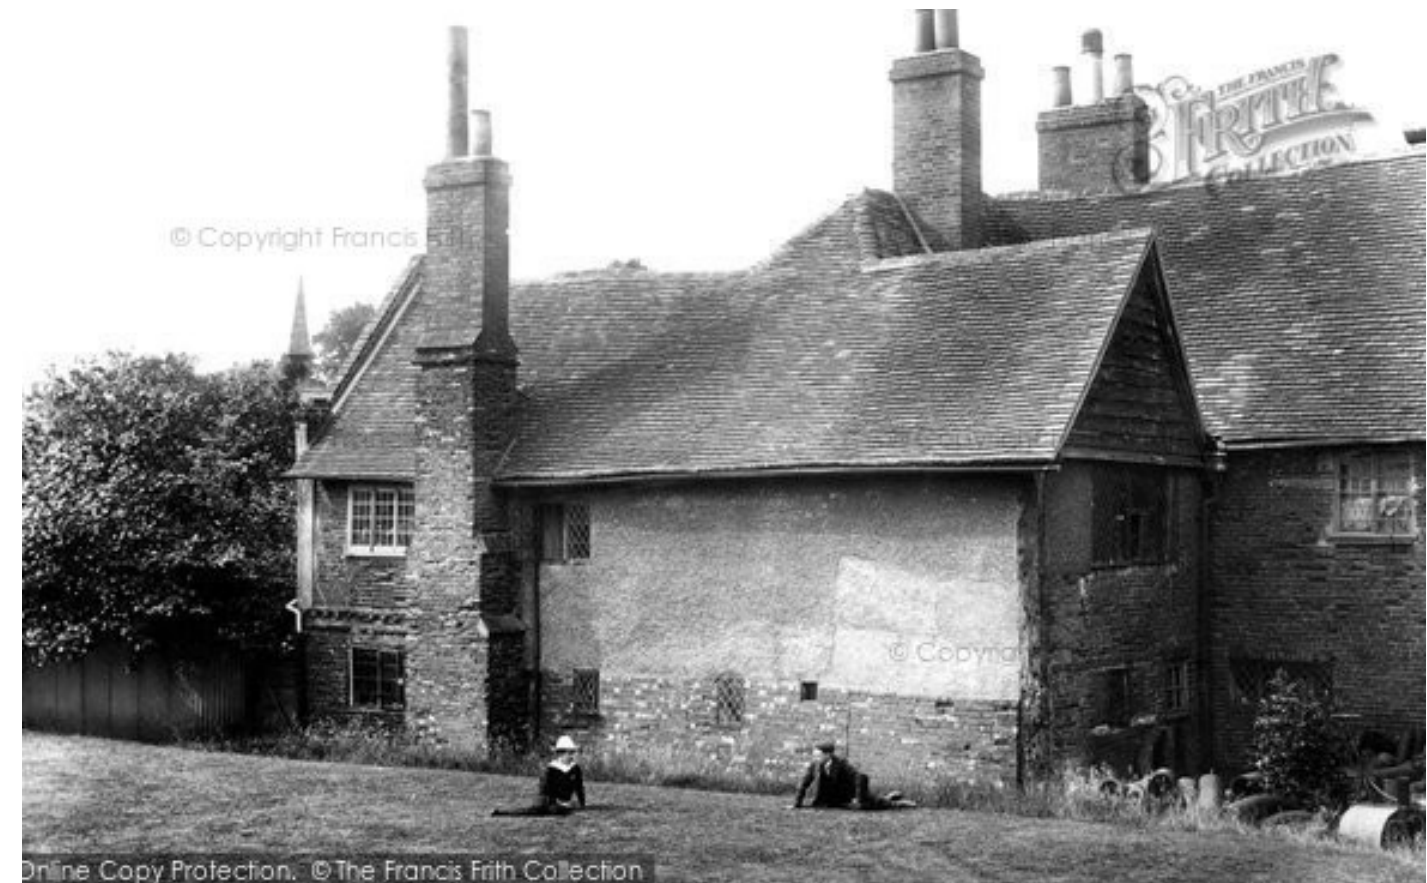
The Southern Side of The Biggin, note the 17th C addition has now been demolished.

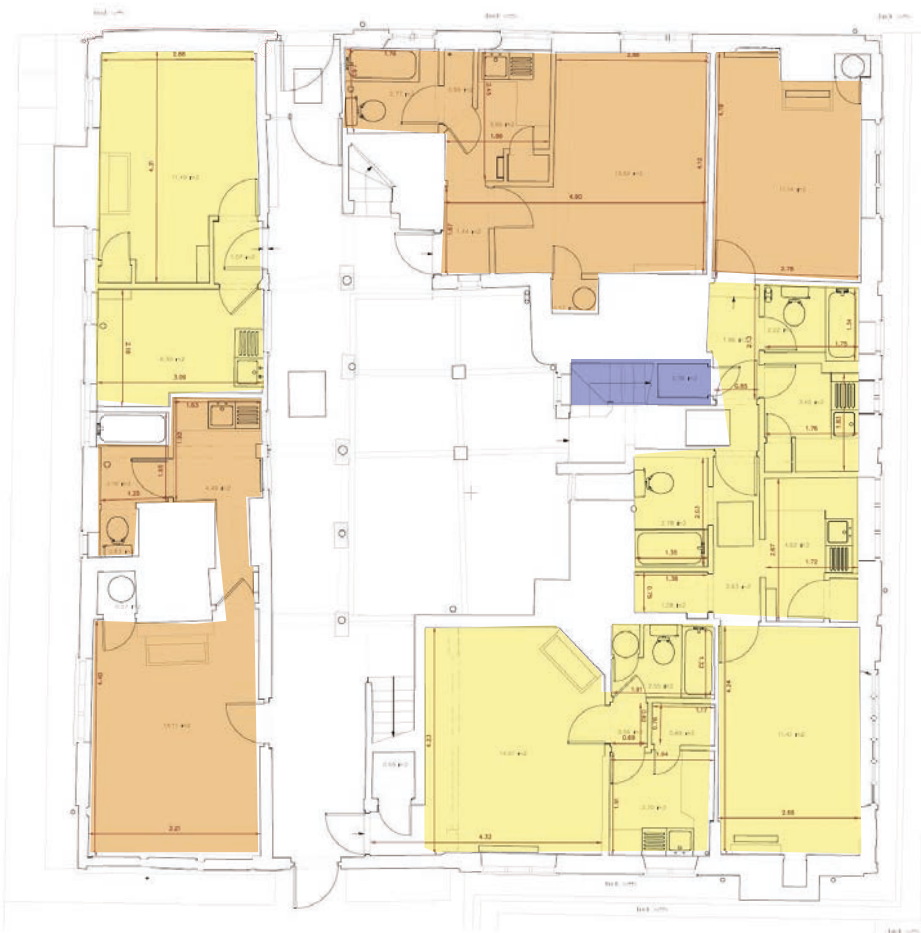
Ground Floor

A guide to the grading levels is outlined below and highlighted on the accompanying colour coded floor plan:

- Exceptional
- Considerable
- Moderate
- Low
- Harmful
