# 299 - The Biggin

Landscape Strategy

02/26: Planning Issue

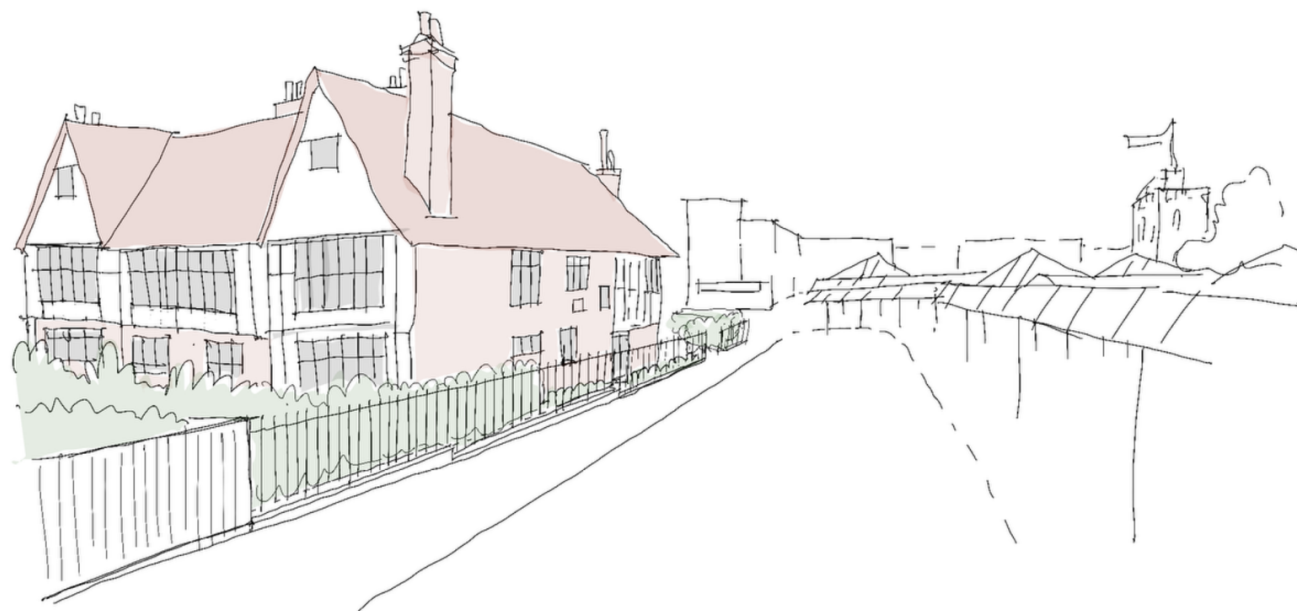
Concept Sketches - The Biggin from Hitchin Market/Biggin Lane

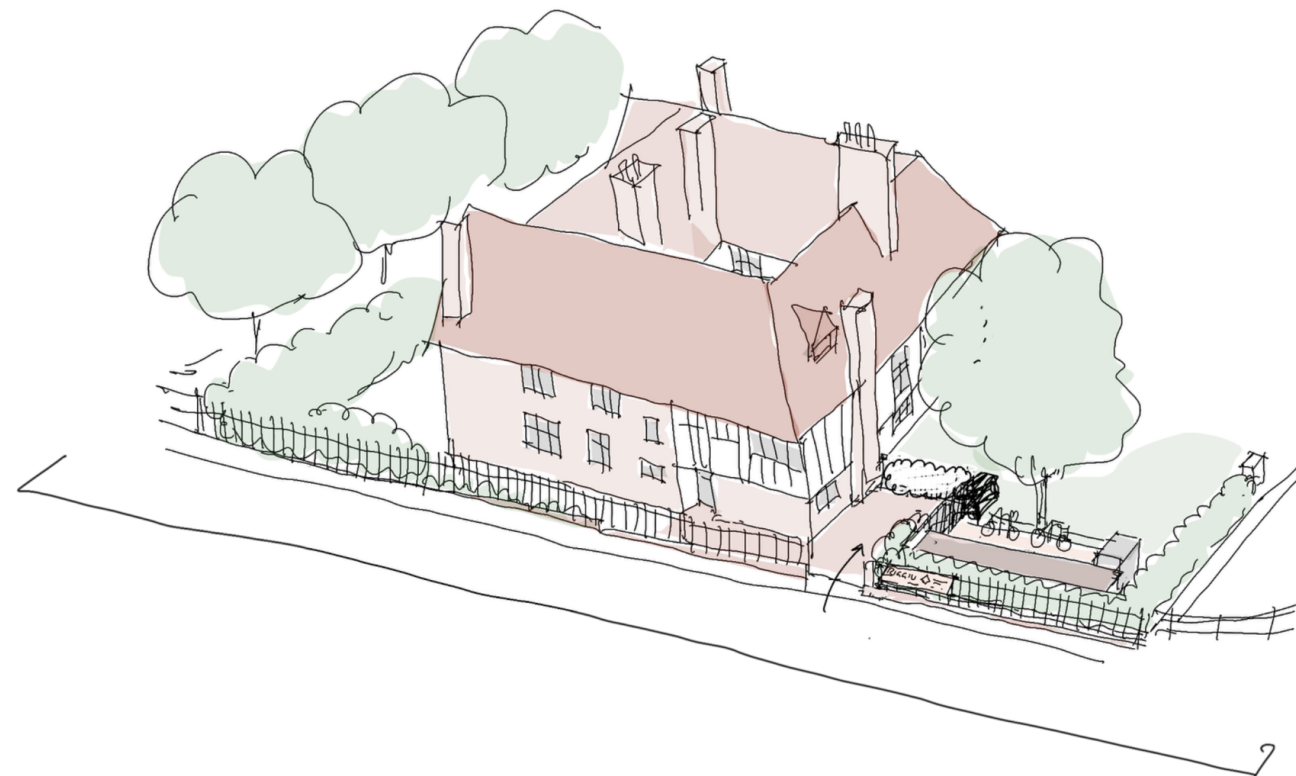
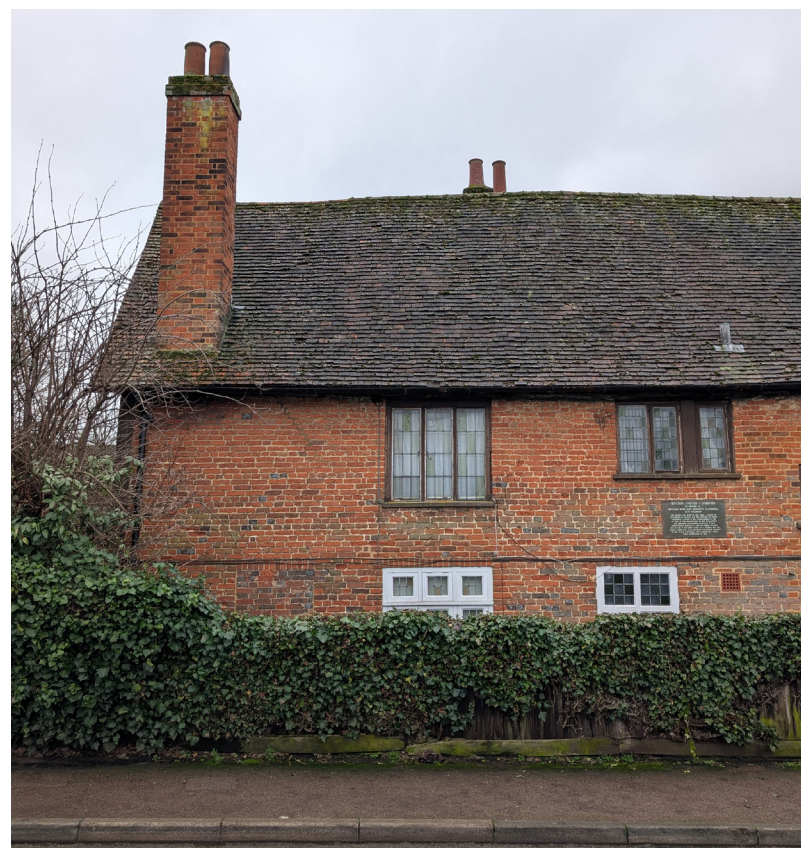
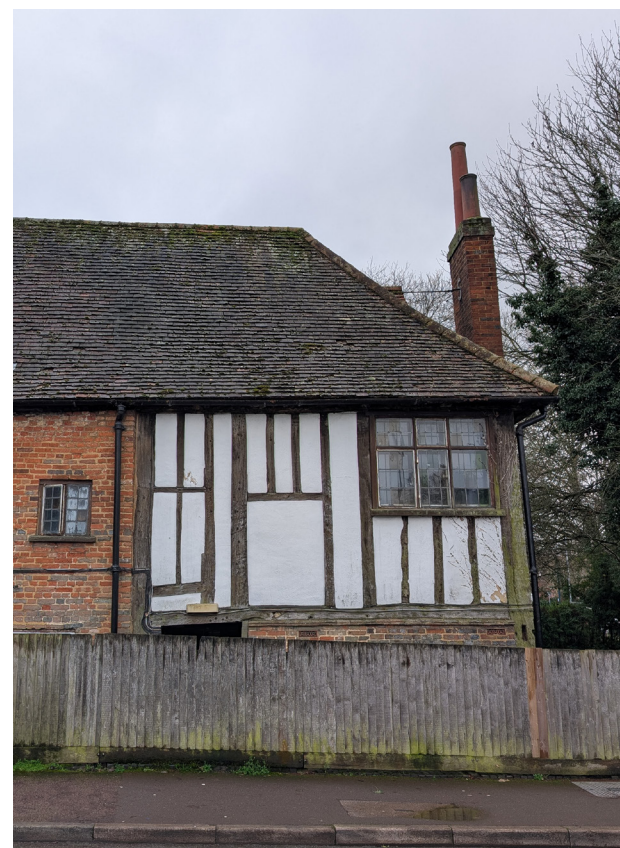
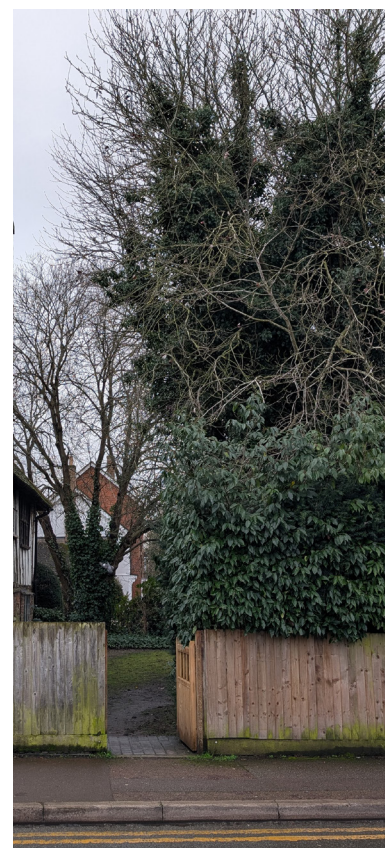
Existing Street Condition, North Elevation

When approaching The Biggin from Hitchin Market, the building is obscured by a worn timber fence which is in extremely poor condition, with signs of rot and overgrown shrubbery. The timber fence is considered to have no historical significance. The site is accessed through a new timber gate opening in the fencing.

The intention is to improve the relationship between The Biggin and the market by improving sight lines. It is proposed that the current fencing is removed and replaced with a more traditional iron cast railing on a brick plinth which will both open up views to the building and be more in-keeping with the historic fabric. A historic building information panel will be incorporated the railing.

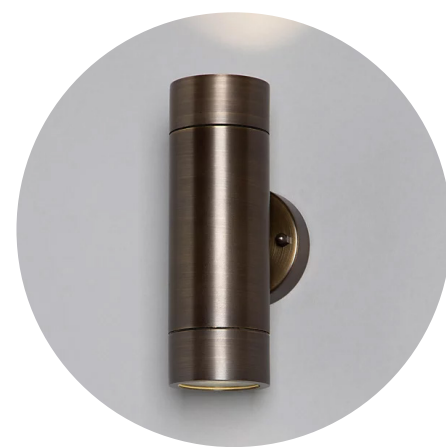
Bronze tone light fittings at doorway

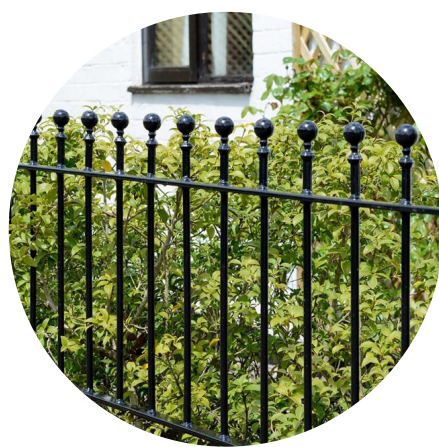
Ball Top Cast Iron Railing

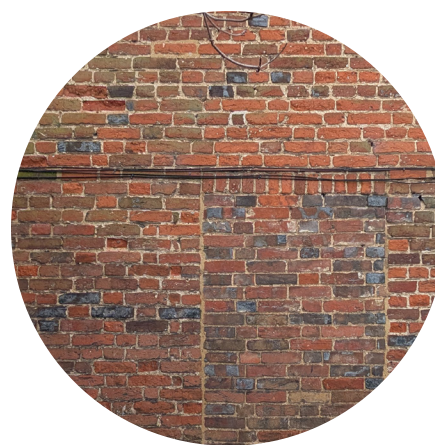
Brick Retaining Wall to match The Biggin in colour and texture

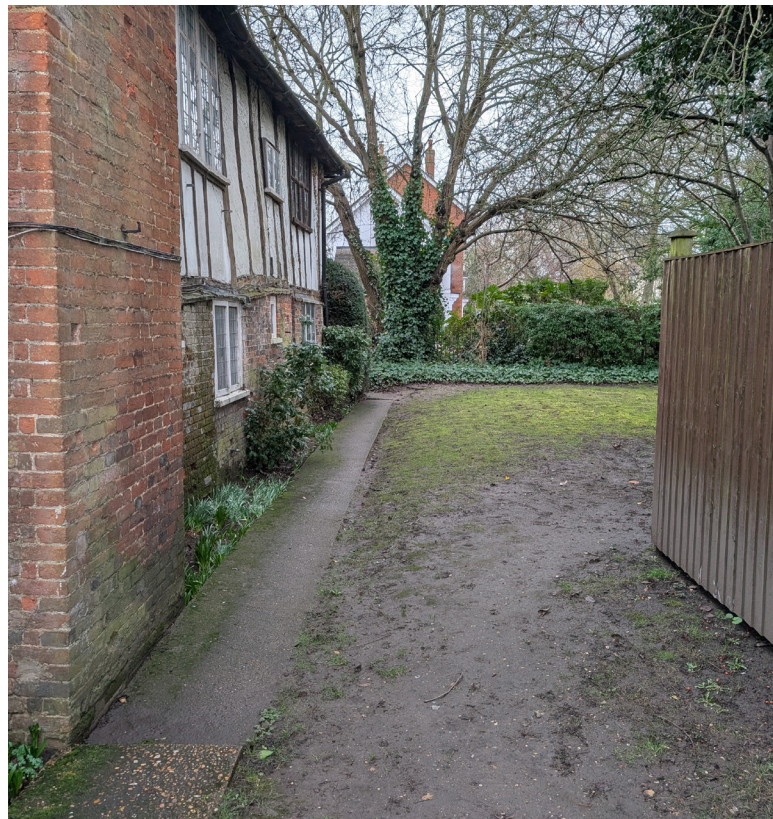
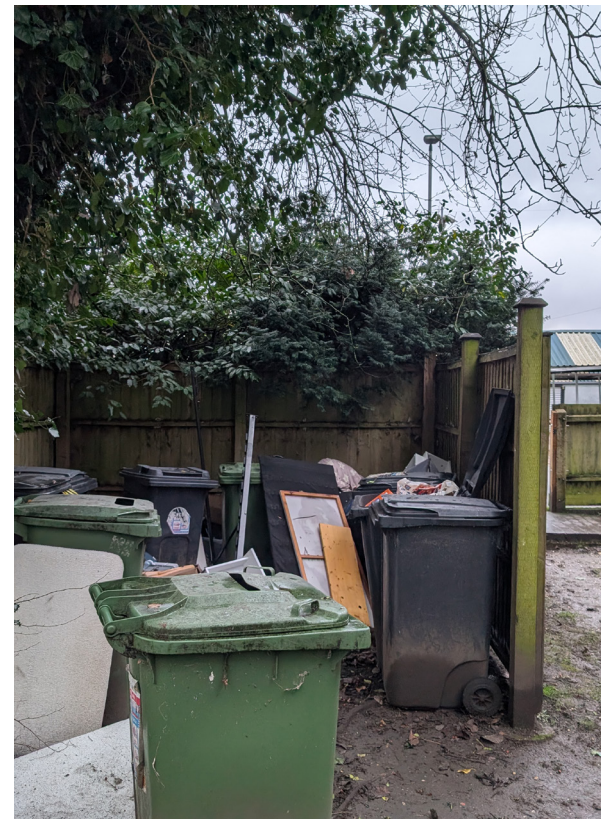
Existing Bin Store Upon Entrance

The existing bin store is poorly managed and in very poor condition. For collection, bins have to be pulled along soft landscaping and lifted up a step.

The intention will be to separate the bin store from the garden and introduce solid paving to improve accessibility for collection. A larger more appropriate area will reach the desired capacity for the proposed flats, the option of communal or partially communal bins is to be defined.

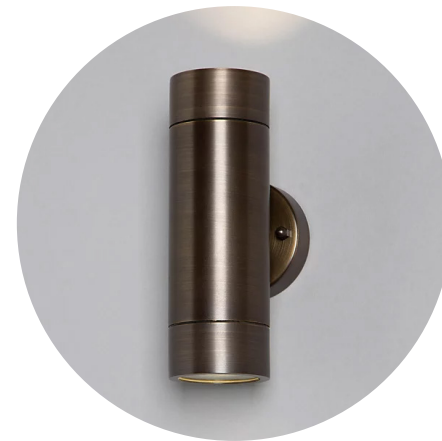
Bronze tone light fittings a stairwells

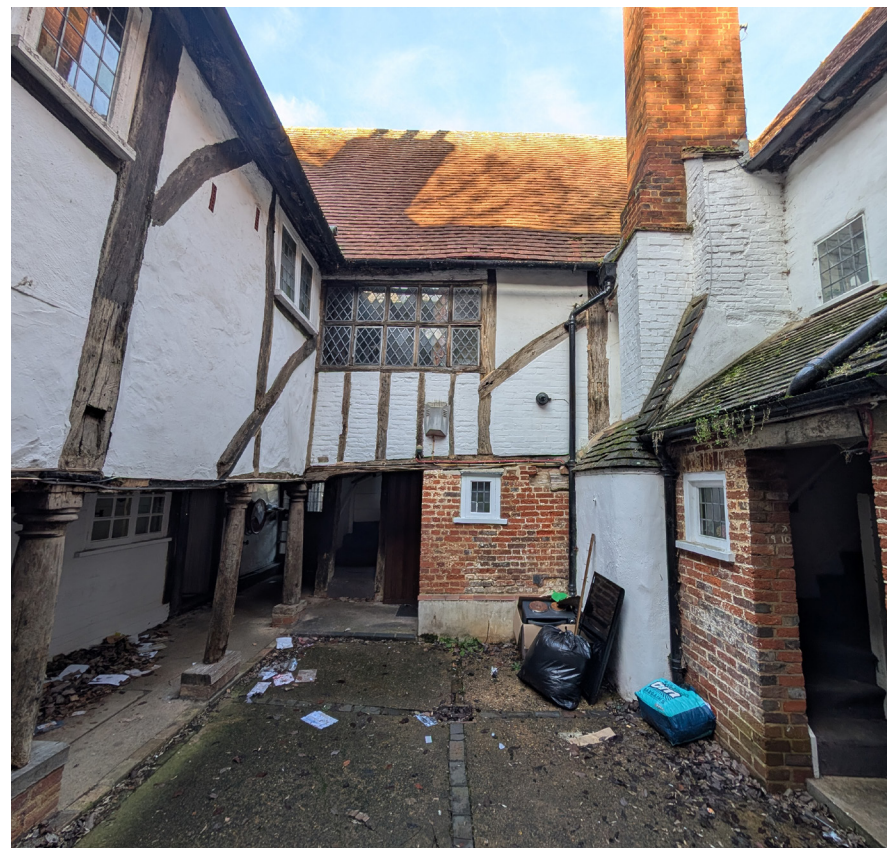
Existing Courtyard in very poor condition, damp and littered

The existing courtyard is in very poor condition due to significant levels of moisture build up. An exposed aggregate ground finish fails to drain surface rainwater leading to moss and algae growth. The space is littered. All flats are accessed via stairwells which lack presence from the courtyard.

The intention will be to restore the environmental condition of the courtyard by addressing the damp and moisture build up and reinstating historic features. The exposed aggregate surface paving will be removed and permeable surface materials brought in whilst minimising the extent to which ground is excavated, due to the sensitive and archaeological significance of the ground. A water feature will be incorporated within the courtyard, echoing the historic imagery from 1895 picturing a water pump within The Biggin courtyard. Wayfinding to flat stairwells will be improved with subtle bronze light fittings matching those introduced on the north and south external elevations.

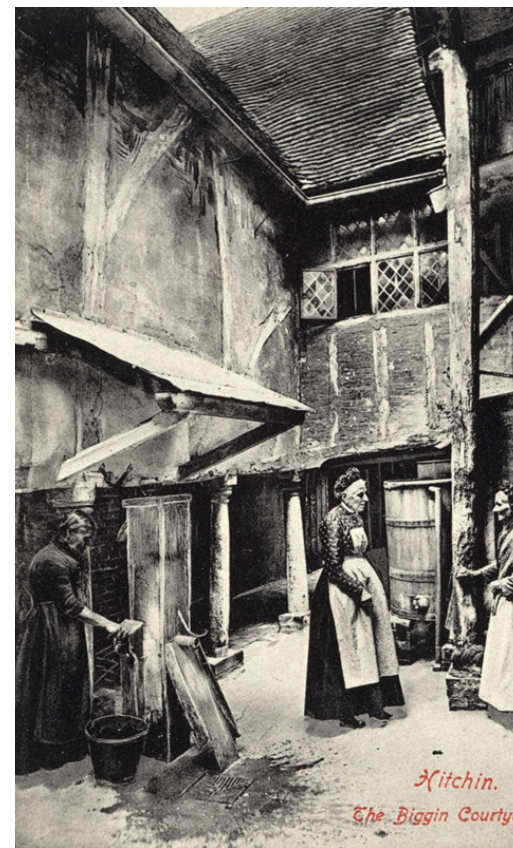
Water pump pictured in The Biggin courtyard 1895

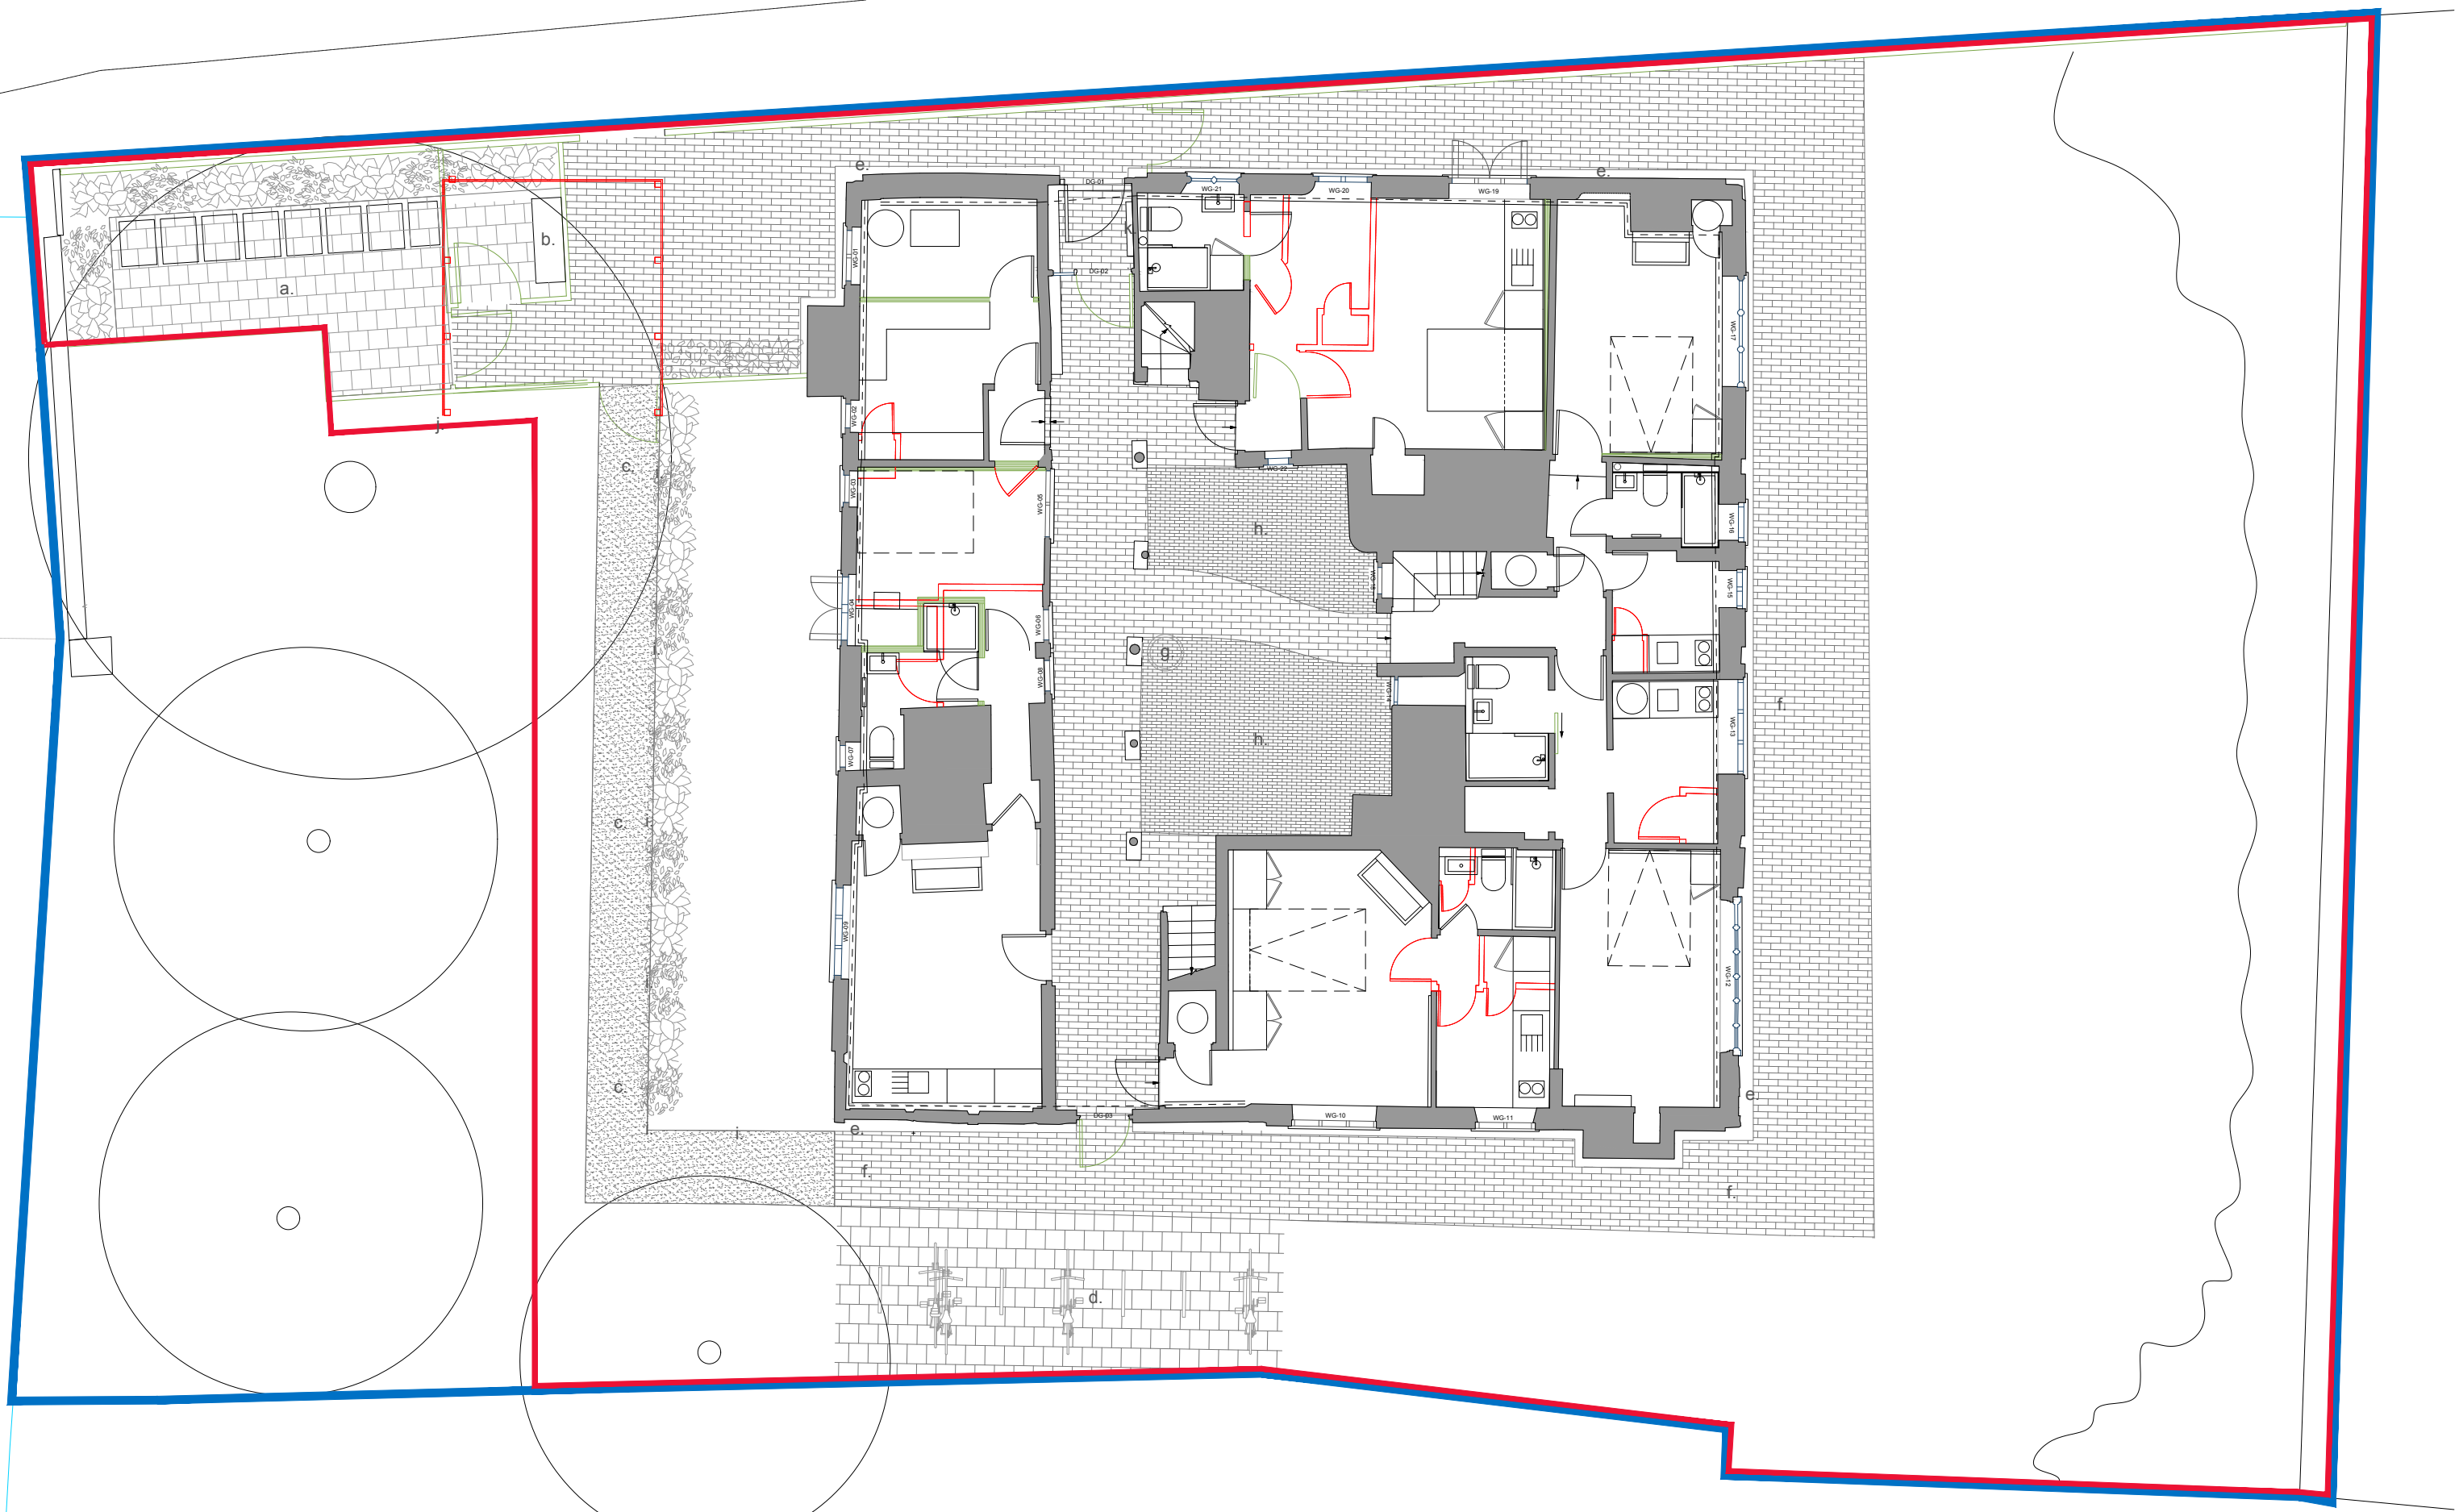
The Biggin  
Job No. 299 Site Plan as Proposed  
Stage: Stage 3  
Status: For Information

- a. New paved communal bin store
- b. New ASHP restricted access
- c. Gravel pathway
- d. New bike store
- e. New French drain around building perimeter
- f. Restored brick sett paving
- g. Historic water pump reinstated
- h. Permeable paving
- i. Low level lighting guiding to bike store
- j. Removal of existing bin store fencing
- k. New post box
