## Preliminary Ecological Appraisal and Roost Assessment

Land to rear of 62 Green Street, Royston, Hertfordshire, SG8 7BA

This report is prepared to inform a planning application with the North Herts District Council. The proposal is described as: building of two 4 bed houses.

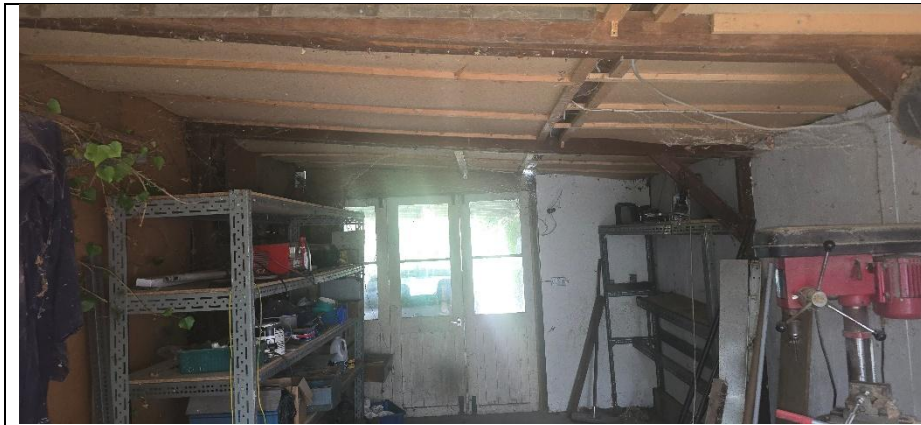
Figure 1: the internal look of B1.

| | <p><b>Roosting habitat</b></p> <p>Two buildings are located within the site boundary, both of which are of similar age and construction, and were subject to preliminary internal and external inspections to assess their potential to support roosting bats.</p> <p><b>External Inspection</b></p> <p>Building 1 (B1) is partially obscured by dense vegetation, with extensive coverage of English ivy present along the western and southern elevations. This ivy growth limited visibility of the exterior structure during inspection and may conceal potential roosting features such as lifted tiles, gaps in soffits, or crevices in the brickwork. However, where the building was visible, the roof covering appeared to be in sound condition, with no obvious signs of significant damage, missing tiles, or large gaps that would typically be associated with bat access points. The timber elements visible externally were found to lay flat against the structure, offering limited opportunity for roosting bats.</p> <p><b>Internal Inspection</b></p> <p>The interior of the building does not contain any roof voids or loft spaces typically used by roosting bats. The internal structure is boarded, providing limited access to crevices or cavities suitable for roosting. Additionally, the space is well lit during daylight hours due to multiple windows and doorways located on the northern and southern elevations. This high level of natural light, combined with the lack of enclosed, undisturbed voids, reduces the building's suitability for species that favour dark, enclosed roosting environments, such as brown long-eared or Myotis bats.</p> <p><b>External Inspection</b></p> <p>Building 2 is heavily screened by dense vegetation, including introduced shrubs and mature trees, particularly along</p> |

| | <p>the northern, eastern, and western elevations. This vegetation not only limits visual access for surveyors but also reduces the likelihood of bats easily locating or accessing potential roosting features on the external structure. No obvious gaps or crevices were identified on the visible sections of the building, and there were no clear signs of bat use such as staining, droppings, or feeding remains. However, due to the limited visibility caused by vegetation cover, a full assessment of all elevations was not possible.</p> <p><b>Internal Inspection</b></p> <p>Internally, building 2 lacks any roof voids, loft spaces, or cavity features commonly associated with roosting bats. The internal space is open and exposed, with no dark, undisturbed areas suitable for roosting. Lighting levels are relatively high during the day due to multiple openings, which would likely deter bat occupation. No evidence of current or historic bat use (e.g. droppings, staining, or feeding remains) was identified during the inspection.</p> <p>B1 and B2 are considered negligible for roosting bats.</p> |

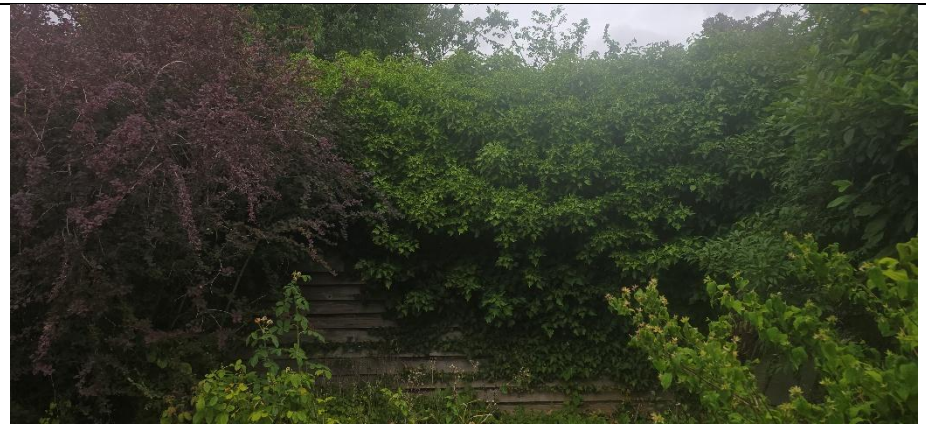
Figure 2: west elevation of B1.

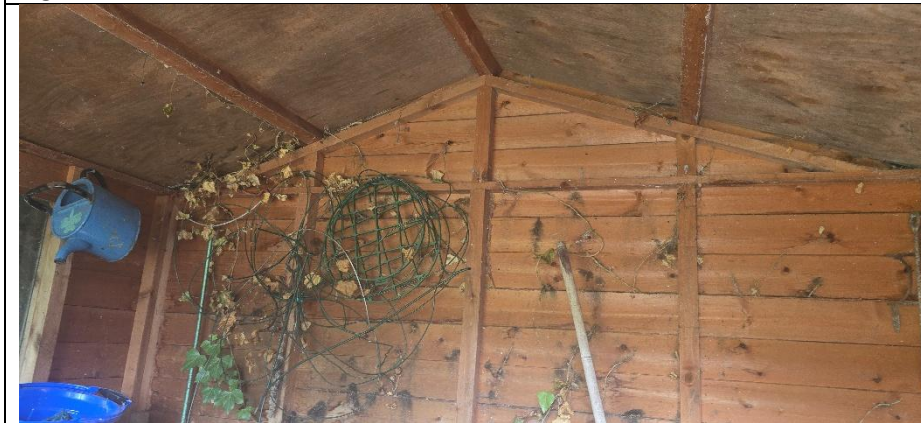
Figure 3: internal view of B2.

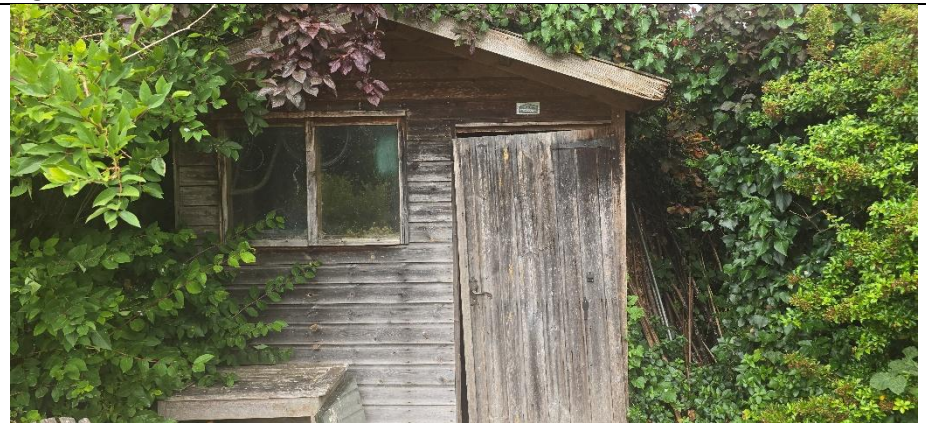
Figure 4: southern elevation of B2.

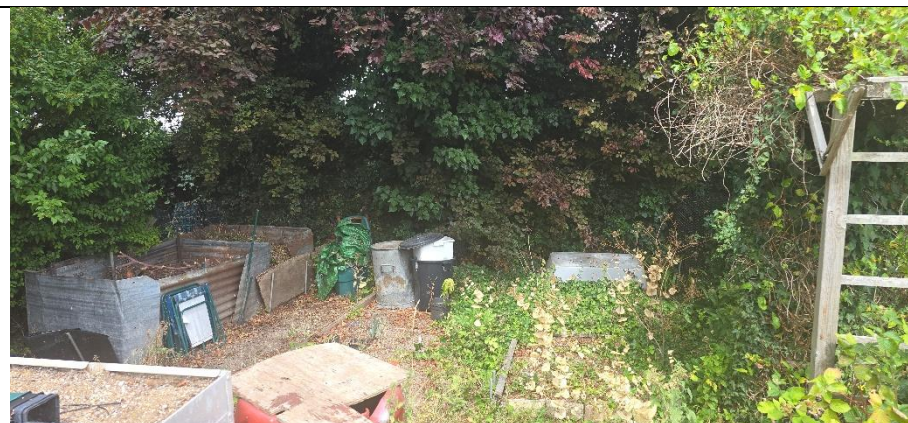
To the north of the site, a group of raised beds have been left unmanaged. These are interspersed with large, seemingly active compost bins. Vegetation in this section is sparse and dominated by English ivy, perfoliate alexanders, and patches of bare ground.

Figure 6: bare ground, with compost heaps.

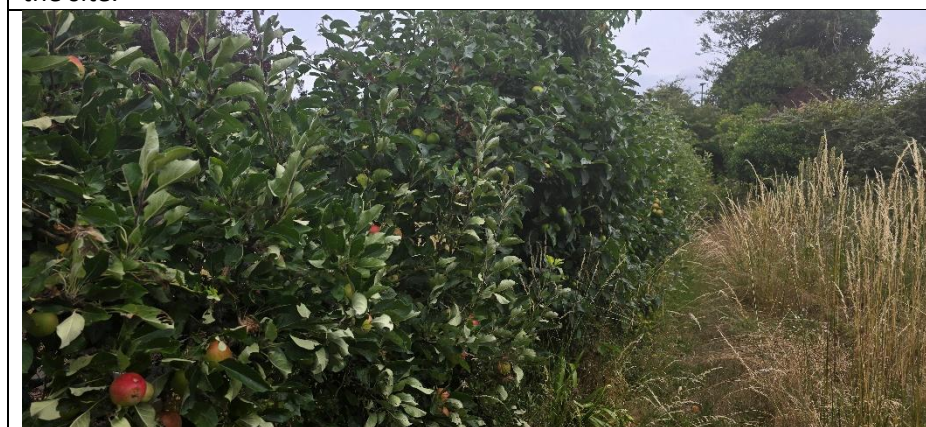
Through the centre of the garden runs a native hedgerow, primarily composed of mature apple and pear trees. Estimated to be over 20 years old, the hedgerow is beginning to show signs of senescence, with several of the trees exhibiting structural ageing such as thinning canopies, gnarled or dead branches, and limited new growth. The

dominance of fruit trees, which are not traditionally robust hedgerow species, appears to have reduced the structural diversity typically expected of native hedgerows.

At the time of the survey, the hedgerow bore a small number of developing fruits; however, foliage was notably sparse, despite the survey taking place during the peak growing season. This lack of leaf cover may be indicative of stress factors such as age, soil nutrient depletion, or historical management practices.

Figure 7: native hedgerow in the middle of the site.

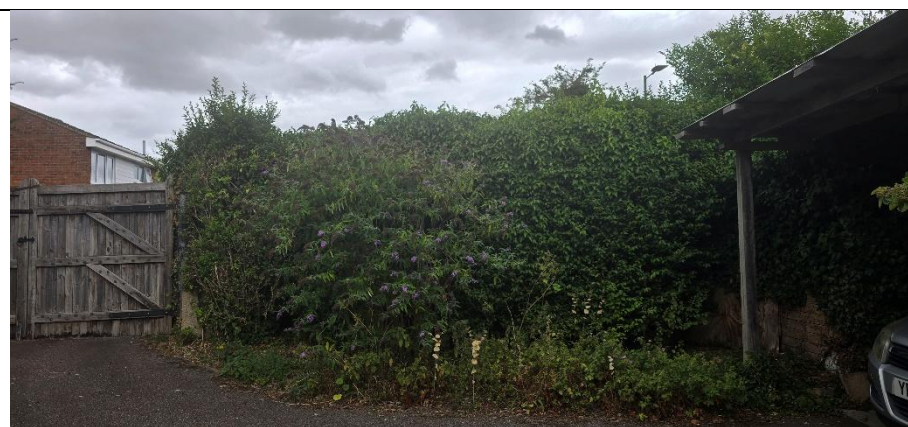
| | <p>The site boundaries are predominantly defined by well-maintained privet hedgerows, particularly along the eastern and western edges. These hedgerows are approximately 3 metres in height and 1.5 metres in width, providing a consistent, dense visual and physical boundary around the site. While the structure of the hedgerows appears healthy and regularly managed, some sections show encroachment by English ivy, particularly at the base and lower trunks. If left unmanaged, the ivy has the potential to dominate and suppress the hedgerow's growth over time, potentially reducing its ecological value and structural integrity. The hedgerows species composition and non-native nature, means that it is automatically of a poor condition.</p> <p><b>Surrounding priority habitats</b></p> <p>Several priority habitats have been identified within a 2 km radius of the site, indicating the broader ecological context and potential connectivity of habitats in the surrounding landscape:</p> <ul style="list-style-type: none"> <li>• <b>Lowland Calcareous Grassland</b> is located approximately 670 metres north of the site. This habitat is notable for its species-rich communities and importance for invertebrates and flora adapted to alkaline soils.</li> <li>• <b>Deciduous Woodland</b> lies around 1,530 metres to the west of the site. Such woodlands provide vital habitats for a range of birds, mammals, and invertebrates, supporting biodiversity and acting as ecological corridors.</li> <li>• <b>Traditional Orchard</b> is found approximately 1,850 metres southwest of the site. Traditional orchards are valuable habitats supporting diverse plant and animal species, including important pollinators and rare invertebrates.</li> </ul> <p>While these habitats contribute to the regional ecological network, the site itself does not contain or directly link to these priority habitats.</p> |

Figure 8: part of the non-native hedgerow on the east boundary of the site.

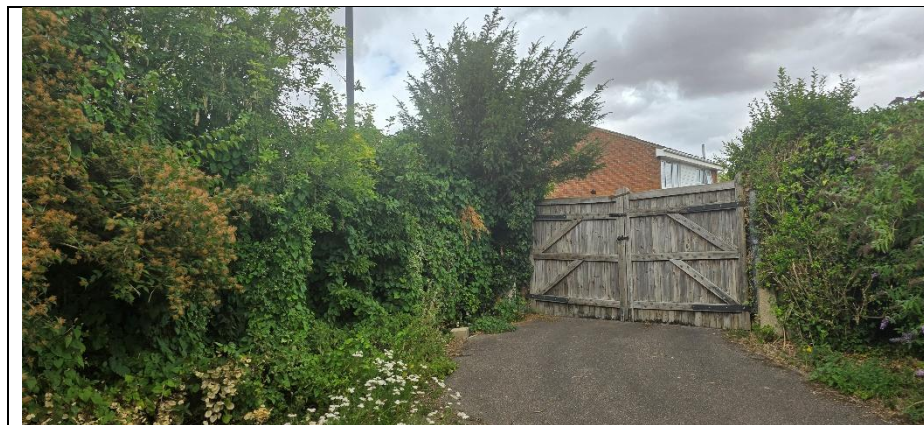
Scattered patches of introduced shrub species are present across the site, including red clusterberry, culinary sage, hawthorn, Japanese barberry, Japanese aucuba, buddleia, cherry laurel, and mahonia. The ground layer supports a variety of both naturalised and ornamental species such as ferns, dog rose, chickweed, cranesbill, and repeated presence of English ivy and common nettle.

Figure 9: introduced shrub and hardstanding.

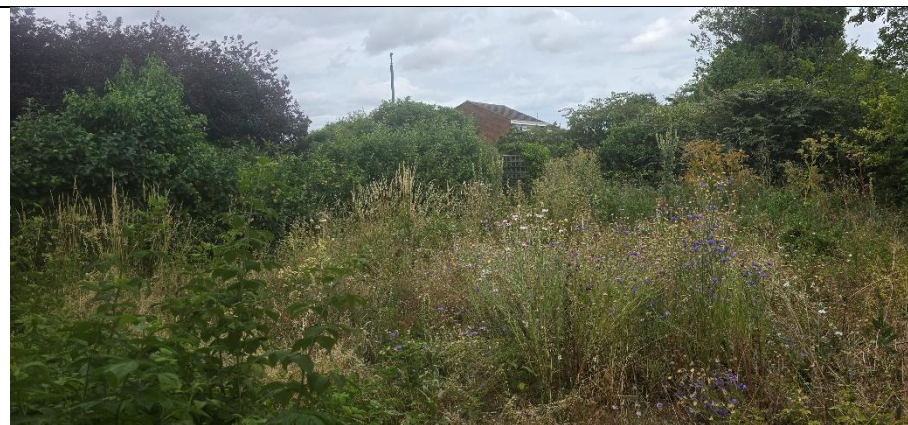
Some areas, previously used as vegetable beds, have undergone partial succession. These now support a mixture of former crop species and colonising grassland flora, including false oat-grass, woodland sage, ribwort plantain, golden ragwort, hawksbeard, morning glory, avens, mullein, dog rose, field thistle, bramble, cornflower, barren brome, oxeye daisy, and holly. The floristic composition and structure of these areas most closely resemble unmanaged grassland habitat.

Figure 10: unmanaged vegetable patch.
