## Groundschool, Irongate Farm (255)

Listed Building Consent Report  
July 2025

Applicants: Weston Park Farms

### Michael Collins Architects

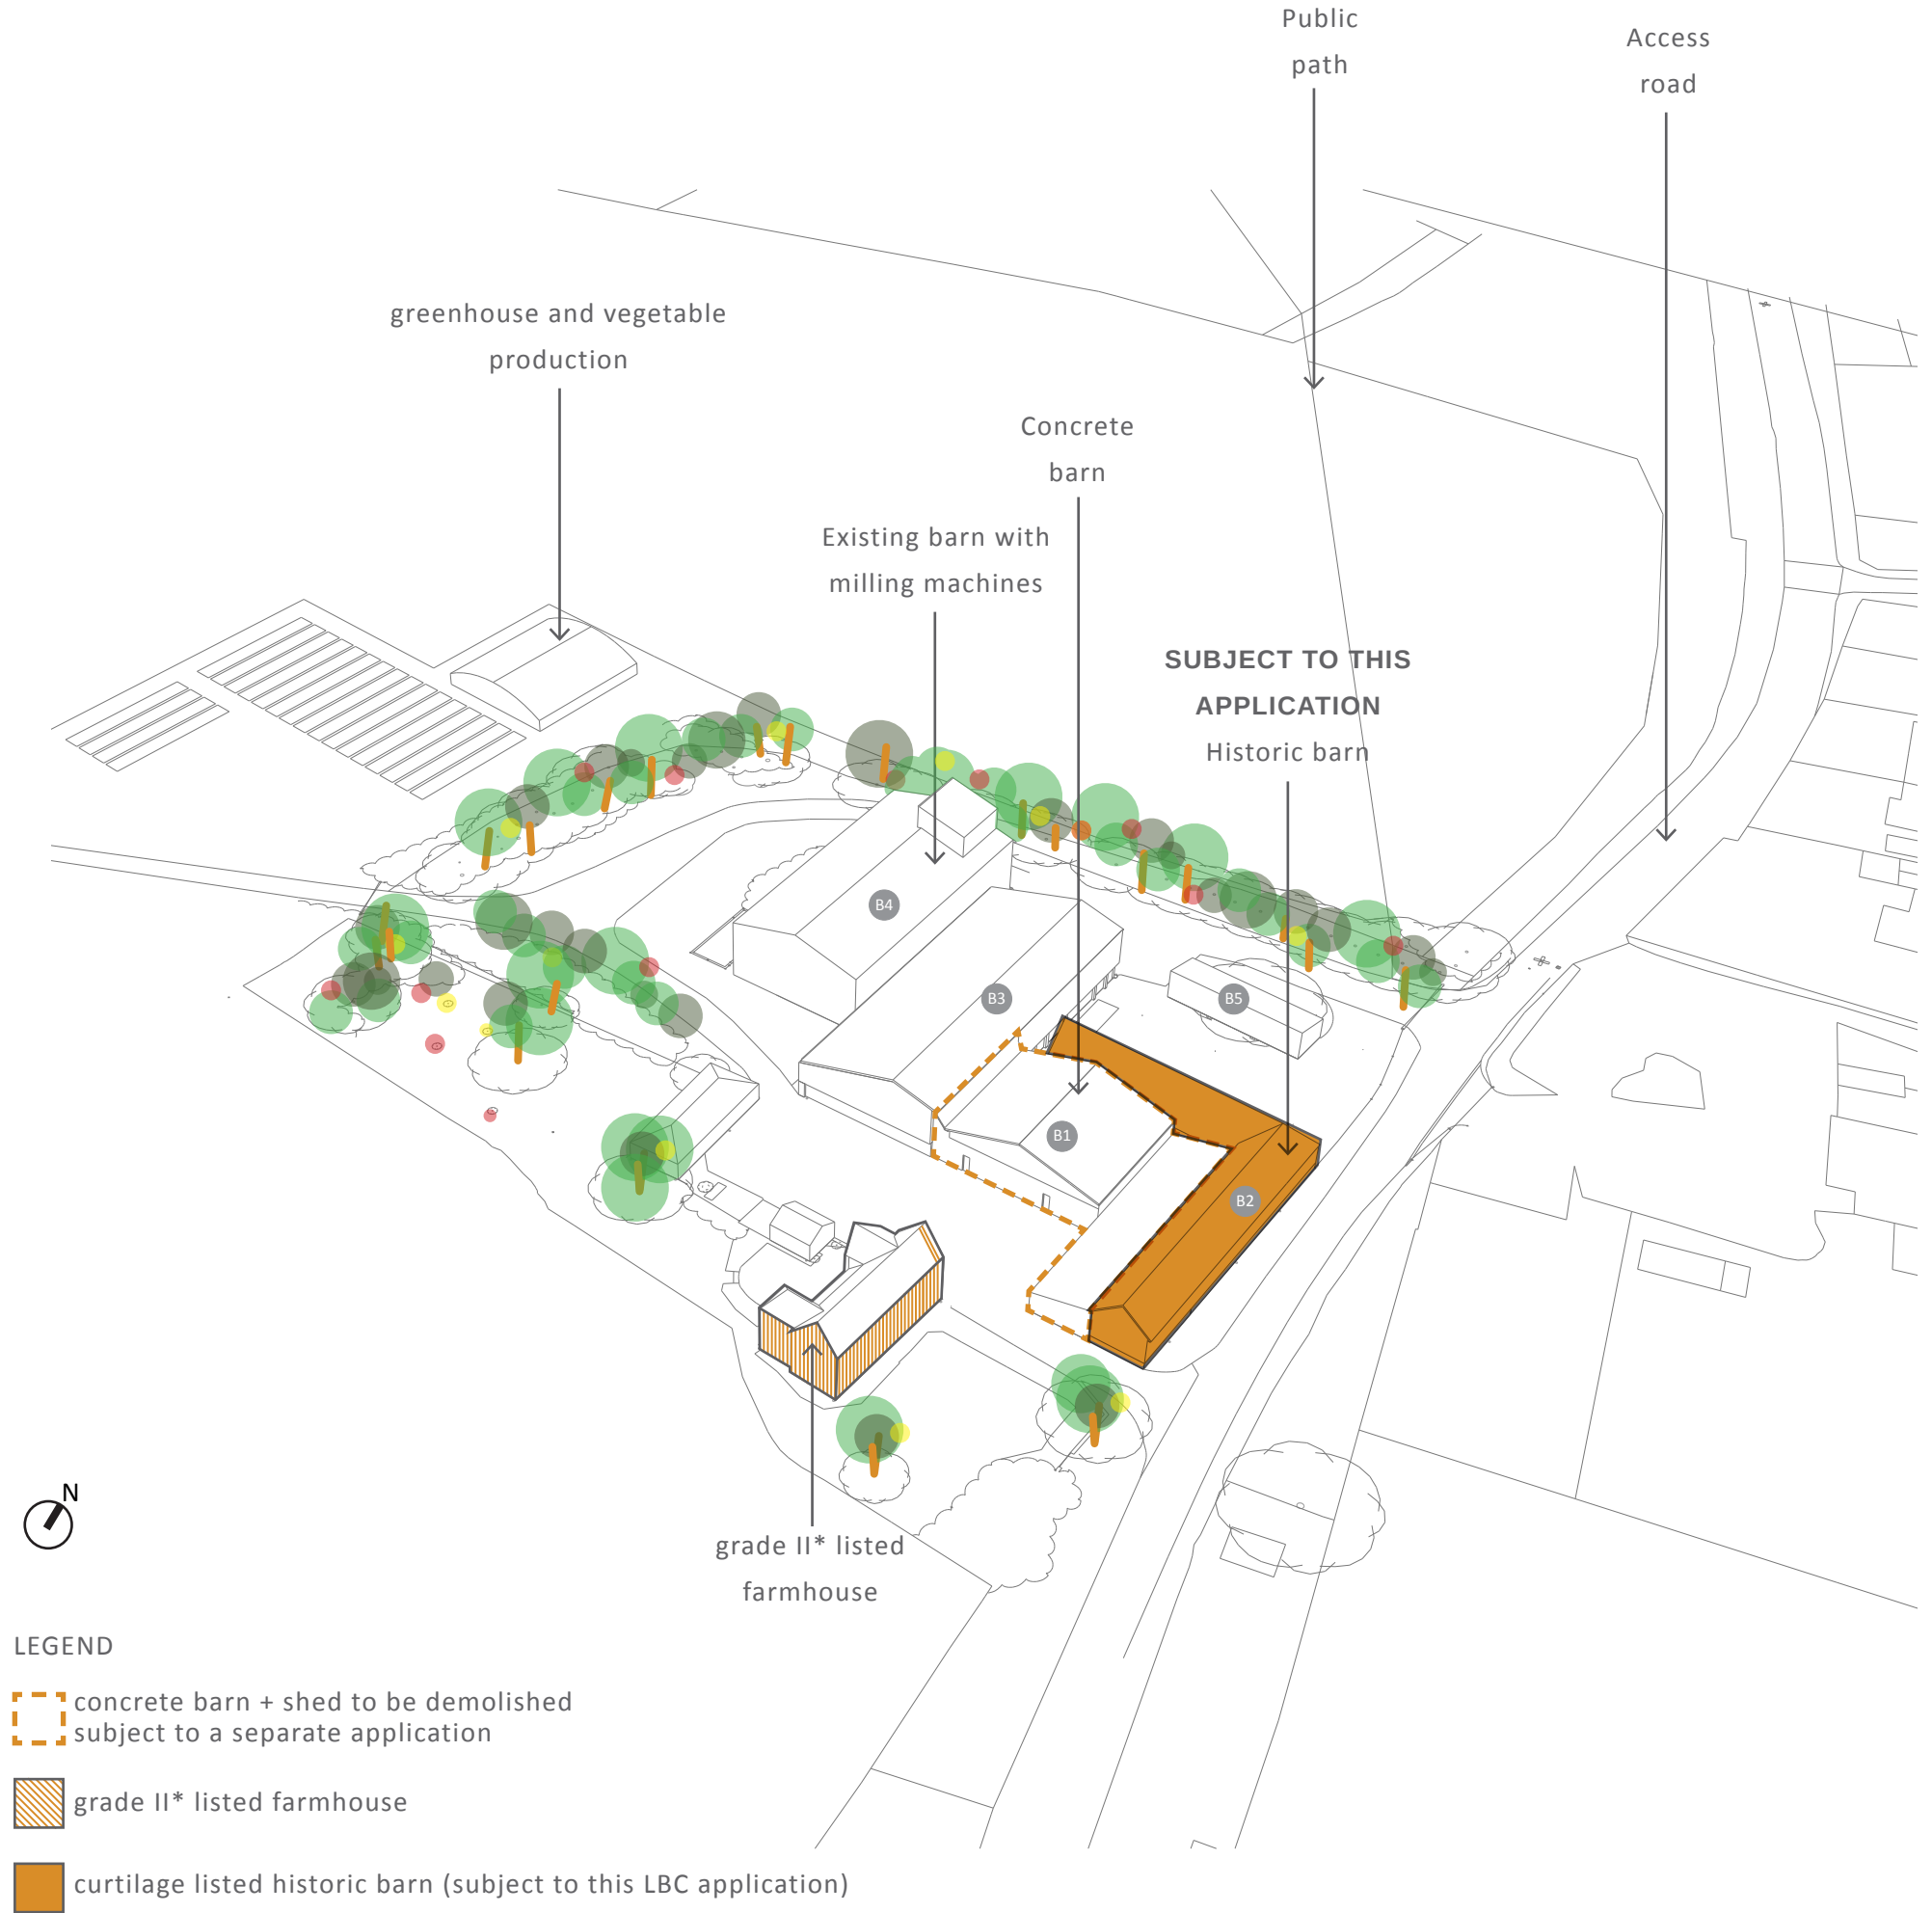
The scope of the project is highlighted in white on the aerial view on this page.

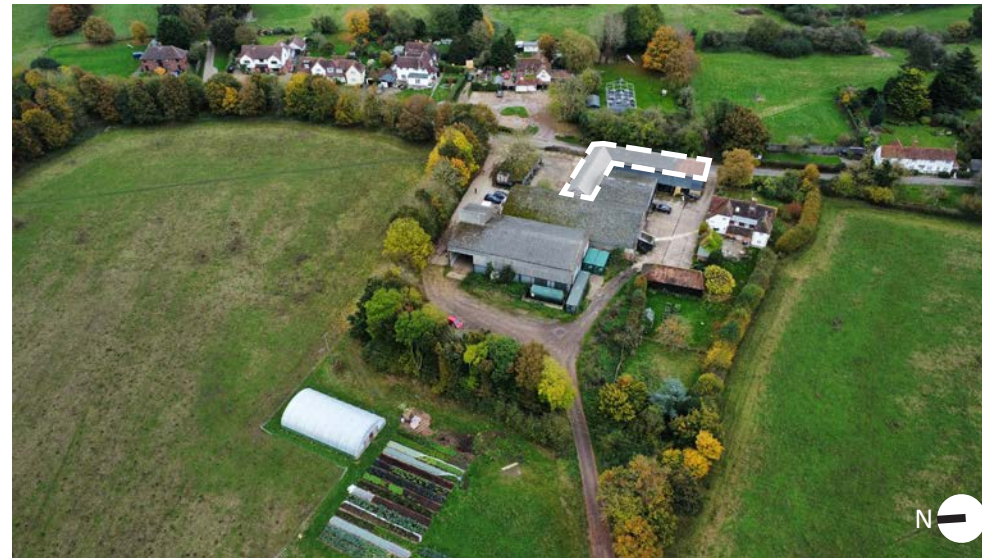
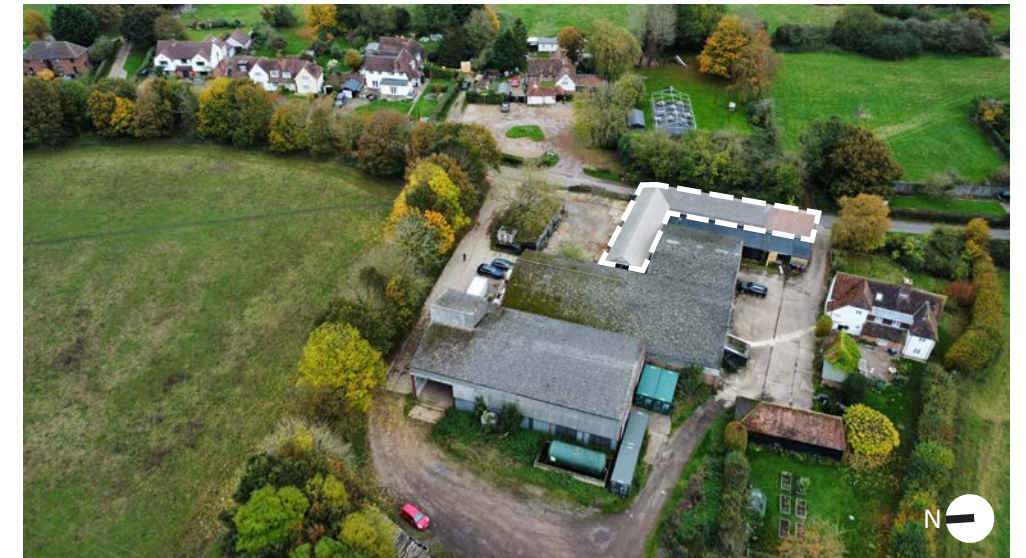
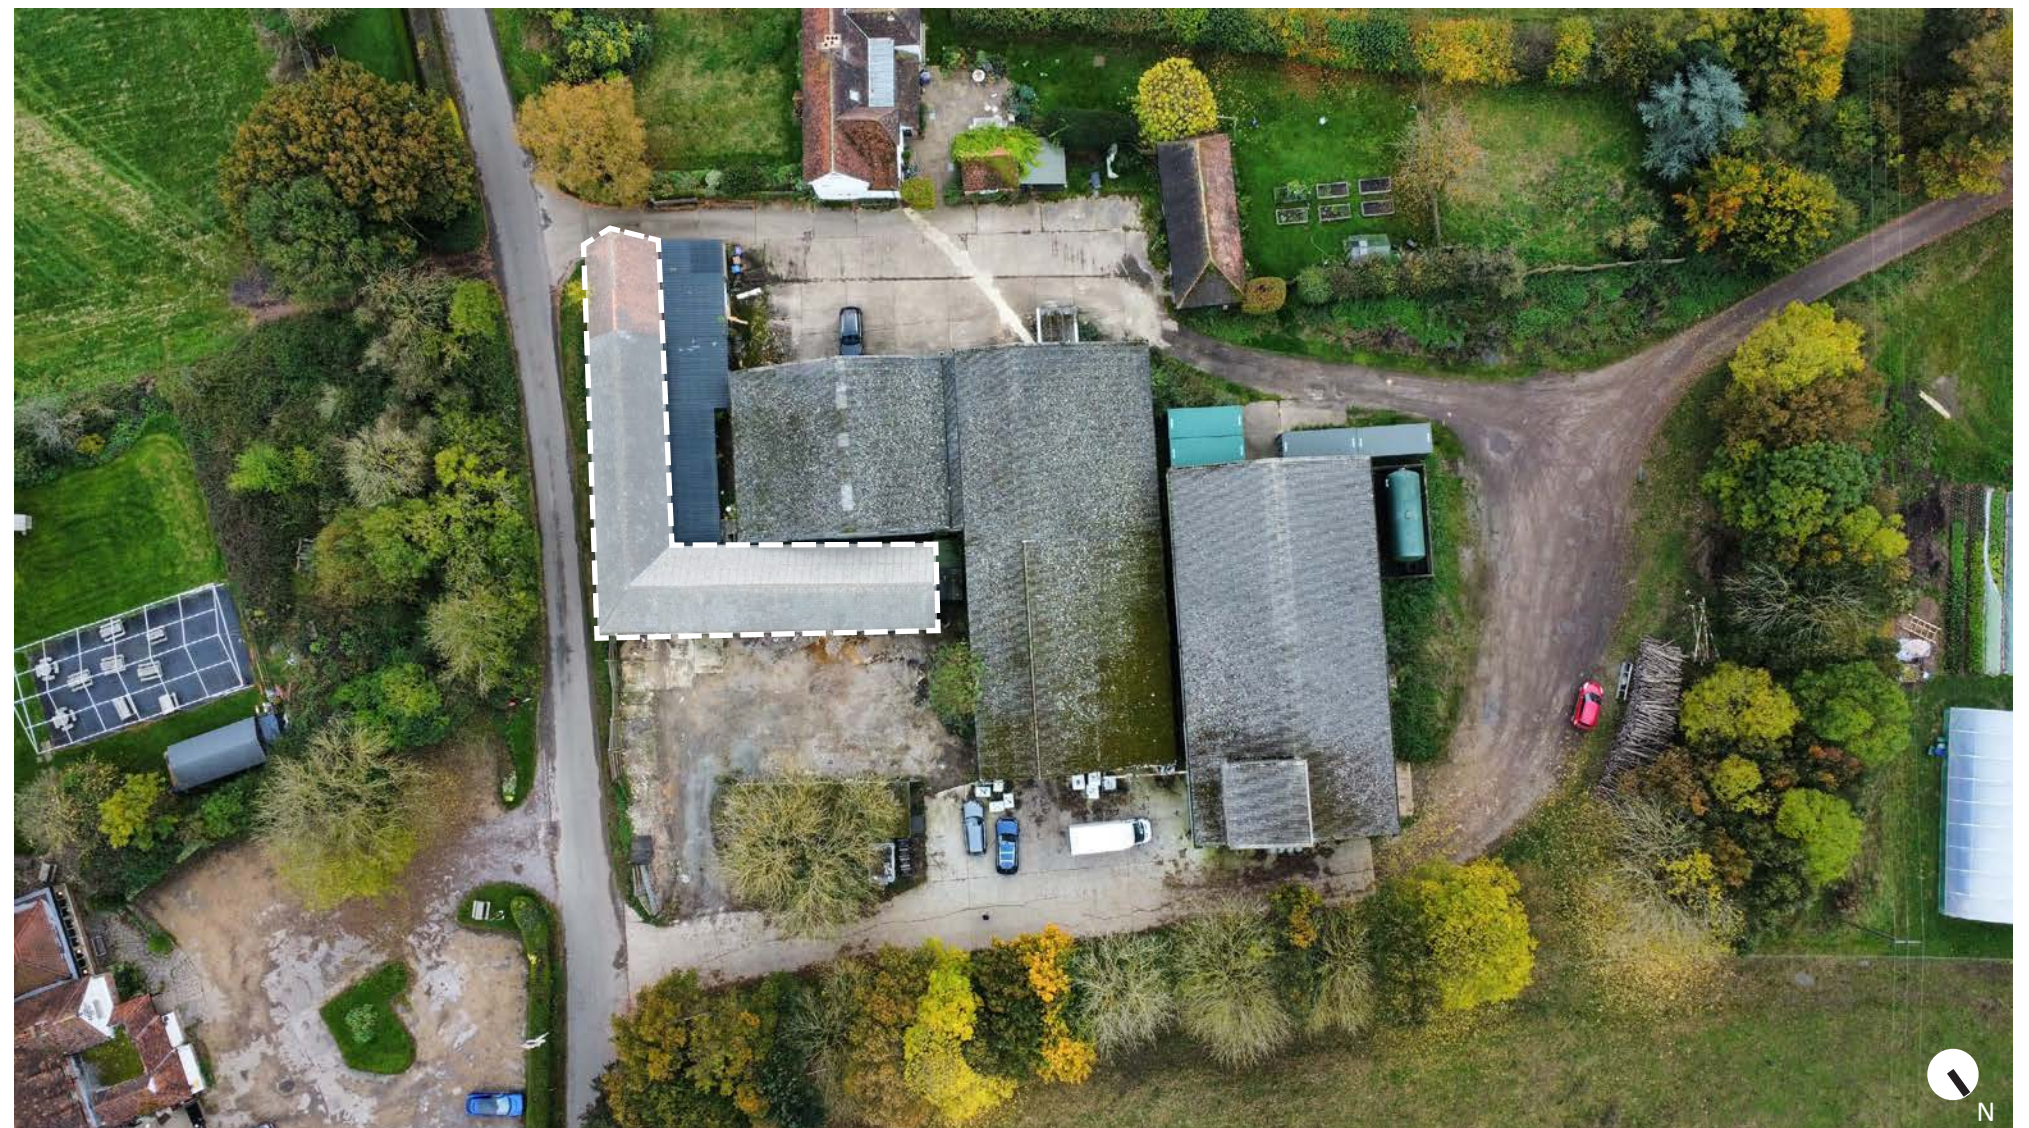
1.4 Photographic survey of the condition of the buildings

Historic barn - internal views

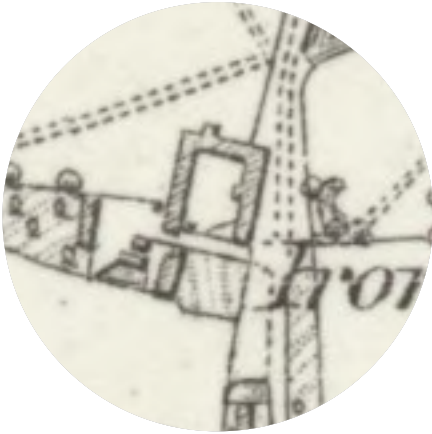
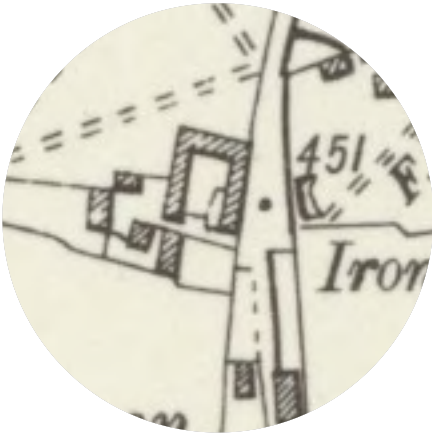
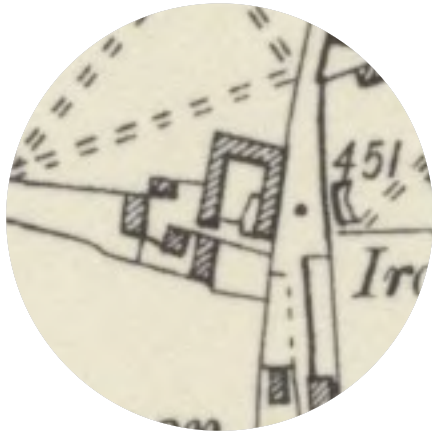
1884

An examination of archive maps indicates that the forms of the barns date from the late 19th century (see illustration on the right). The site has historically functioned as a farm and includes the Irongate Farmhouse, listed grade II\* since 1987 under reference number 1347439.

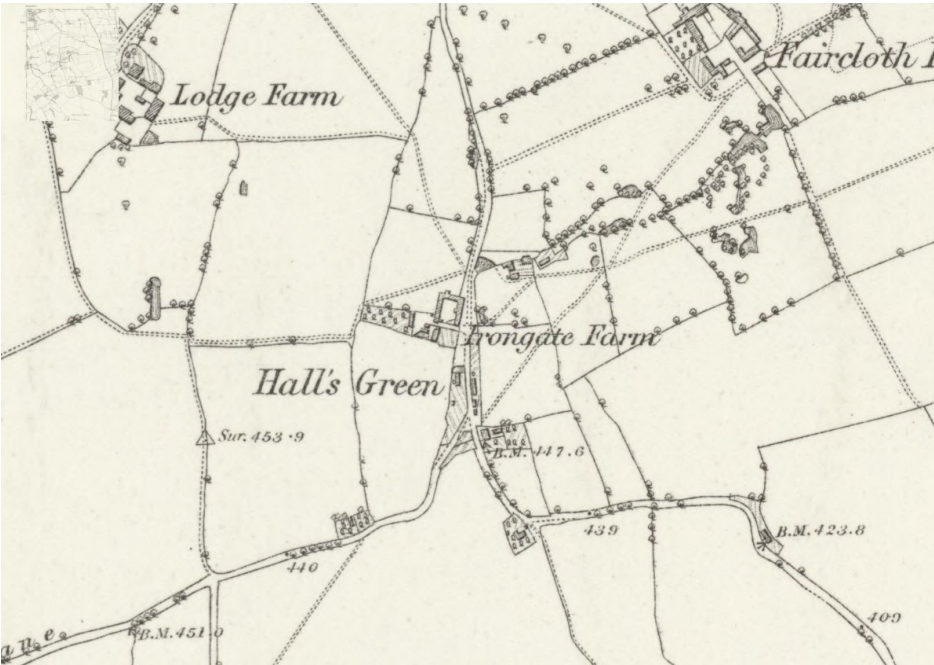
The pedestrian paths have been in place for many years, as indicated on the 1884 map, and they remain in use today.

The historic barn, illustrated in maps from 1884 to 1960, has a horseshoe shape and was likely the primary barn associated with the farmhouse for many years. Between 1884 and 1950, there was very little change in terms of buildings and land use, as suggested on the following page.

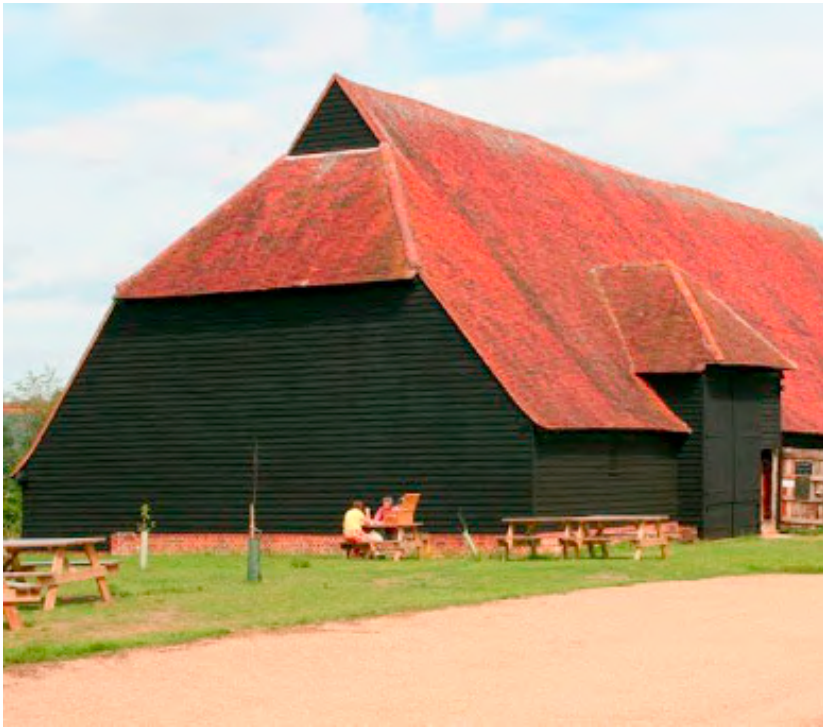
clay products such as tiles and brickwork are commonplace for civic buildings and those with a higher status. The use of timber framing however was widespread within rural settings across the county. This was partly the result of large supplies of suitable timber in the area. In addition to expressive timber structures, decorative geometric fenestration techniques also emerged. Pevsner also refers to the widespread use of timber weatherboarding as exemplified at the great barn at Croxley Green.

The great barn at Croxley Green

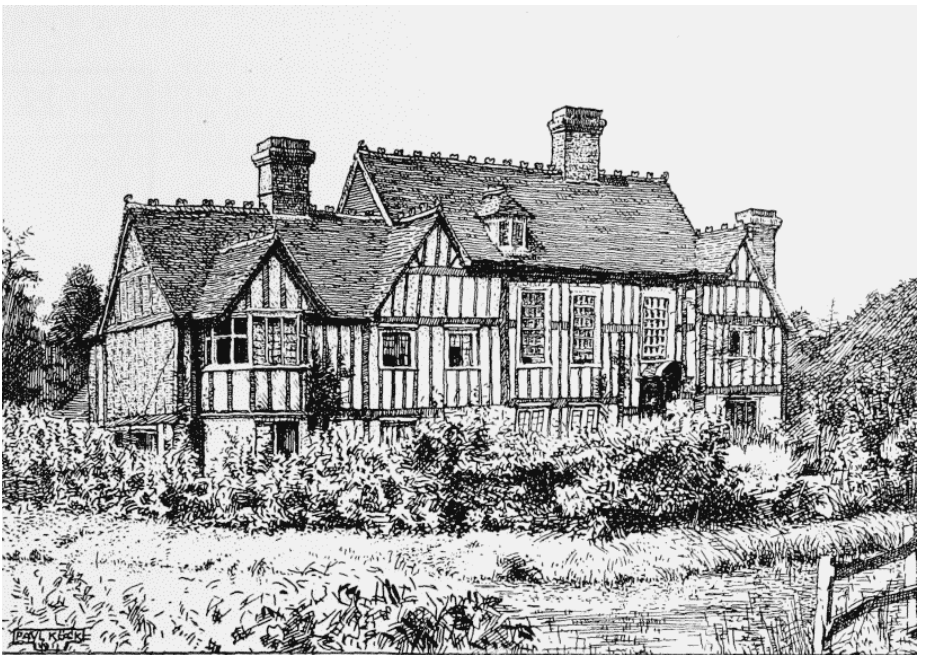
of structures in the rural environment following the widespread rebuilding of farm buildings in the 15th century. This included more efficient trusses and regulated framing which prolonged the longevity of these structures. Pirton Grange is an example of a typical internal plan with an emphasis on a full height volume from ground to roof with a large hearth.

Pirton Grange, ref: (C) British History Online

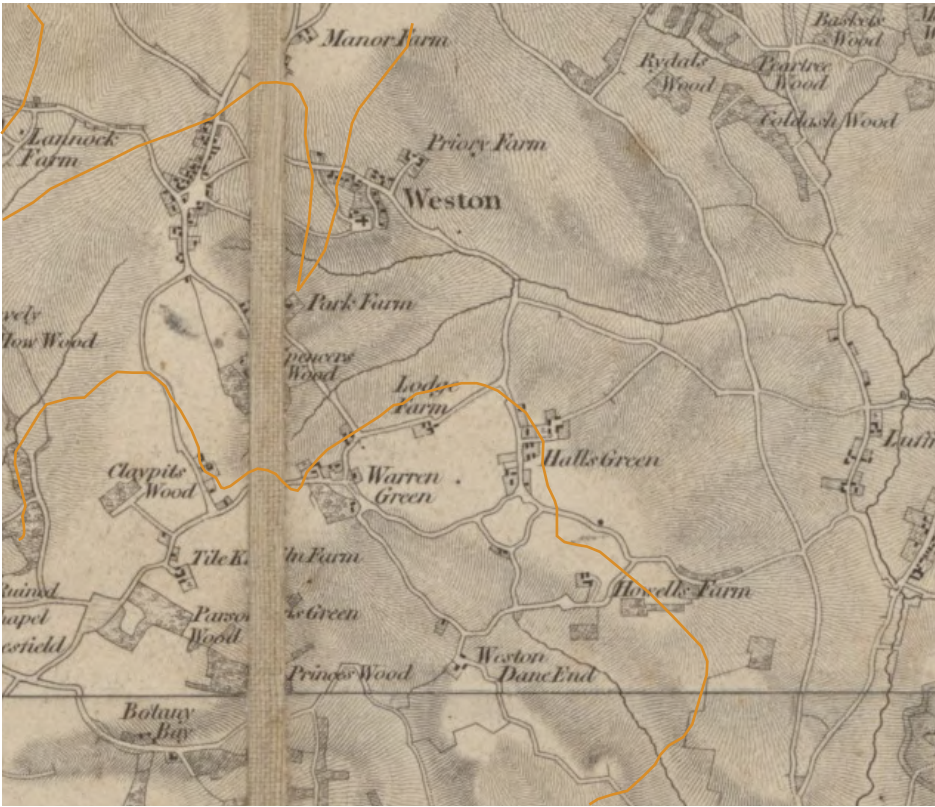
19th Century map illustrating the pattern of farms around Weston

© National Library of Scotland (2025). Surveyed 1804-1815, revised 1831-1834.

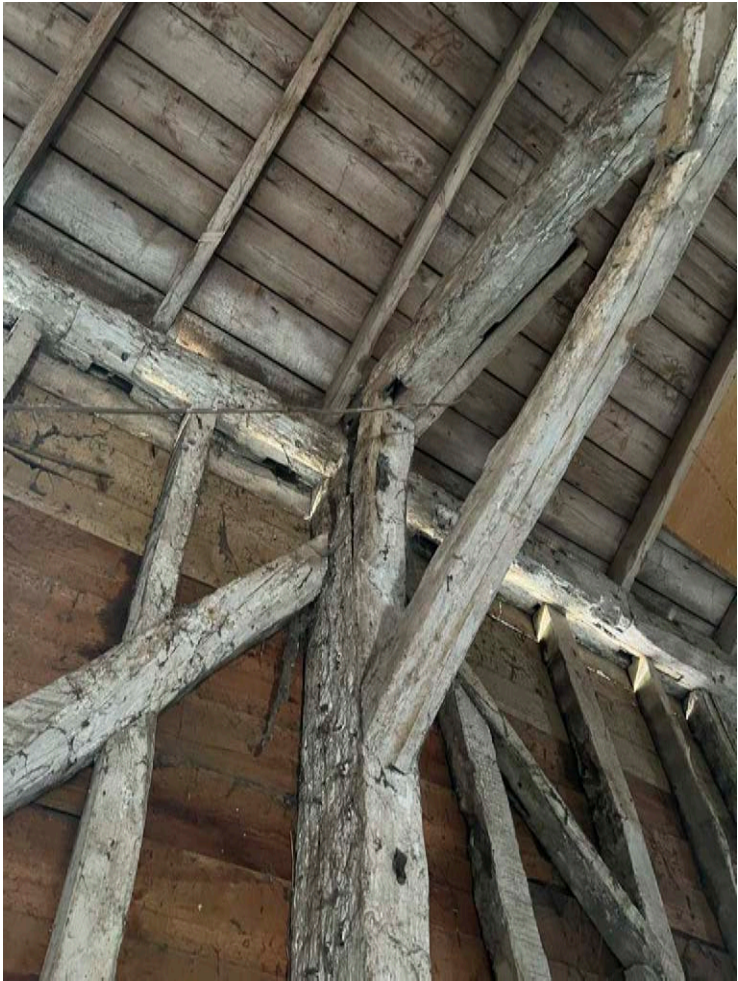
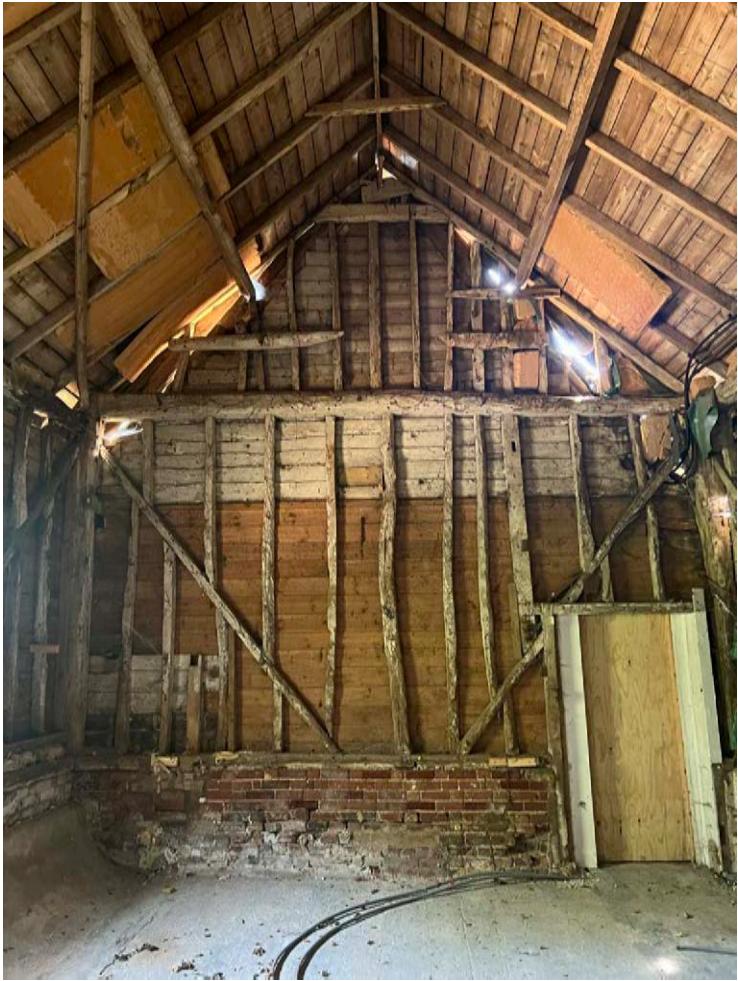
The dwarf walls are subject to extensive damage potentially from successive mucking out but also the introduction of new concrete floors.

The presence of two entrances from historic mapping and differential floor levels between both barns may suggest the presence of a partition wall between both barns.
