**Land to the rear of 83 Whitehill Road,  
Hitchin  
Hertfordshire  
SG4 9HP**

**Phase 2 Contamination Risk Assessment**

**On behalf of Soil Investigation (Eastern) Ltd**

**Document Reference: 12248**

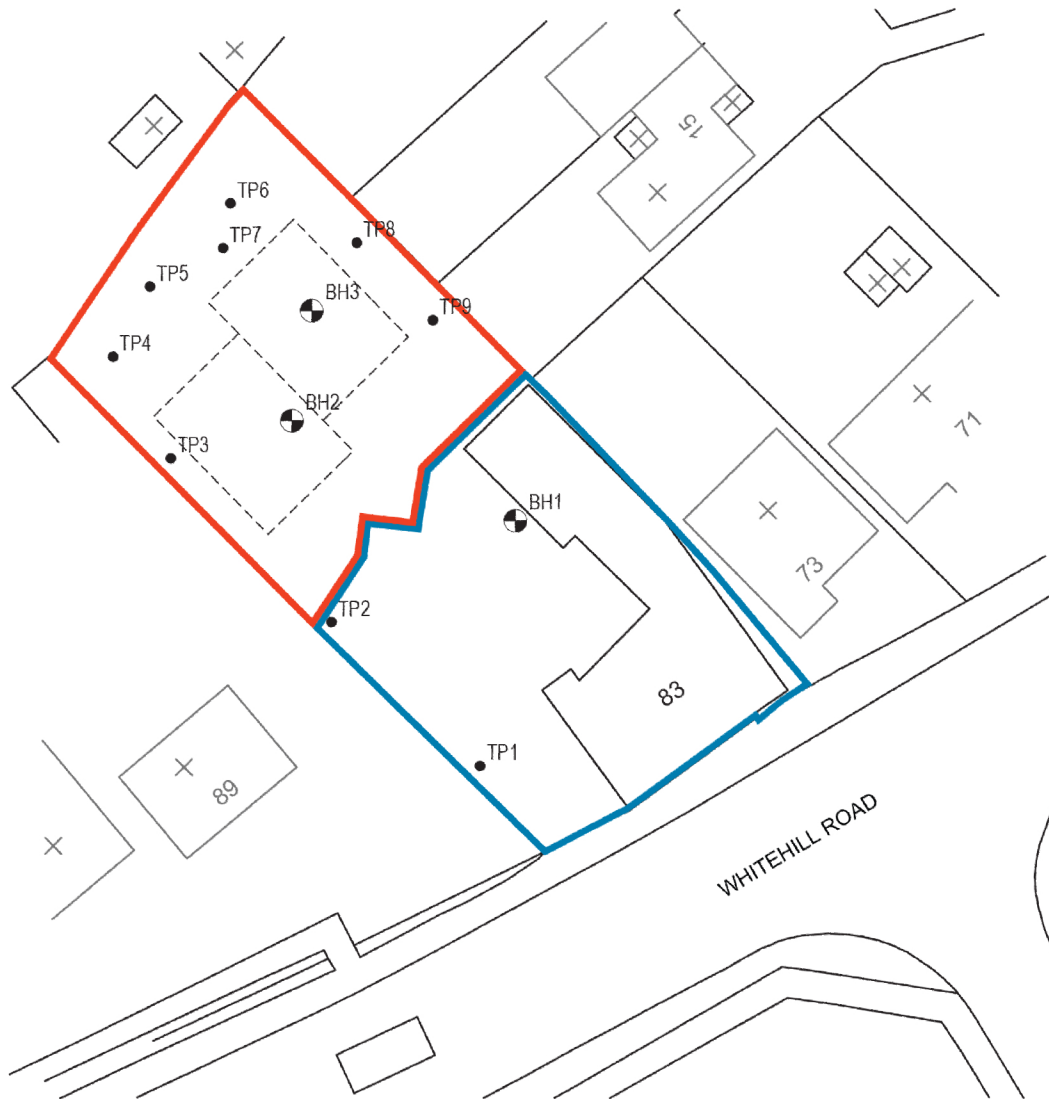
Site: 83 Whitehill Road, Hitchin.

The positions of the above works on the site are indicated on Figure 1, Site Location Plan.
