| Description | |
|---|---|
| Project | Walnut Tree Farm<br>Luffenhall<br>Stevenage SG2 7PX |
| Drawing | WINDOW DETAILS<br>EXISTING & PROPOSED |

20079-P009-A

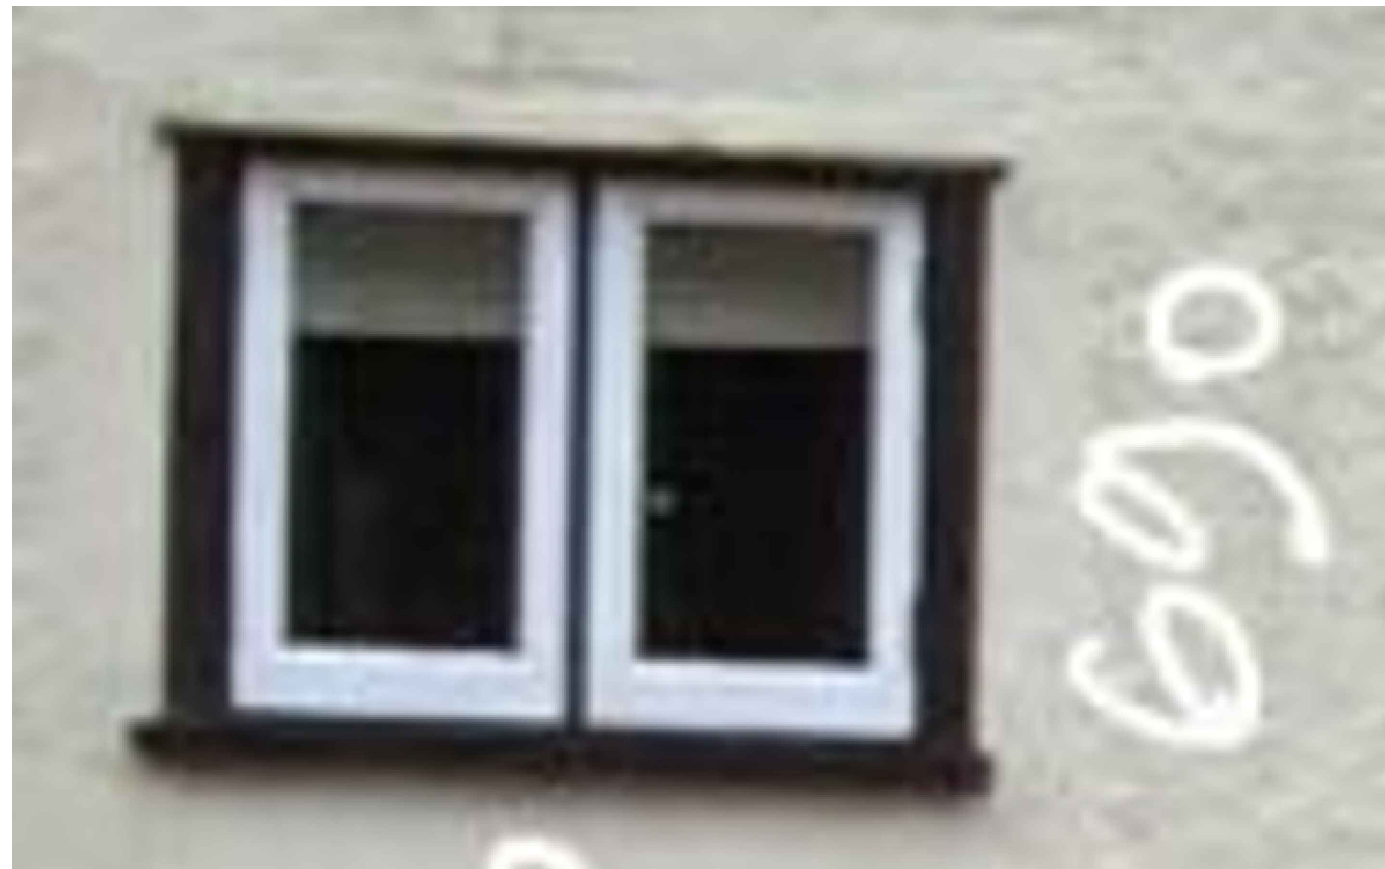
W20

A-A  
Double sash windows,no bars both opening

This double casement style window shows a very high moisture content with loose failed putties to the casement sashes resulting in moisture ingress over a long period of time resulting in the sash base rails cracking and softening particularly around the joints with distortion and loss of strength and discolouration of the exposed bear wood with some fungal growth which is a trait of “wet rot”. The cill also has been affected in the same way it would not be possible to patch repair the affected areas at the structural integrity of the window has been compromised. We recommend replacement of this window as the most cost-effective long-term solution.

- Material : saple (hardwood)  
Finish : 2 coats primer 1 top coat  
Colour : sashes white  
Colour : frames black  
Glazing : 4-4-4  
Furniture : 3 point locking  
: monkey tail handles  
: stays to match existing

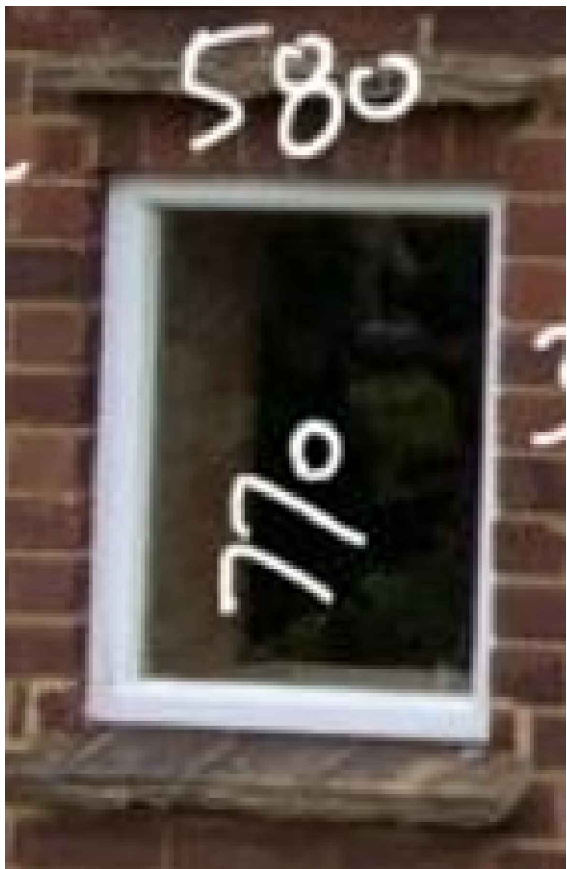
W21

Fixed non-opening single sash window

This single casement style window shows a very high moisture content with loose failed putties to the casement sashes resulting in moisture ingress over a long period of time resulting in the sash base rails cracking and softening particularly around the joints with distortion and loss of strength and discolouration of the exposed bear wood with some fungal growth which is a trait of “wet rot”. The cill also has been affected in the same way it would not be possible to patch repair the affected areas at the structural integrity of the window has been compromised. We recommend replacement of this window as the most cost-effective long-term solution.

04/06/2024 window 21 to be fixed non-opening single sash window Rev A
