Report prepared for: Leon Cassidy and Hannah Cassidy

For the Site of: Holborn Farmhouse, Therfield, Herts, SG8 9RH

# Emergence and Activity Bat Survey (EBS)

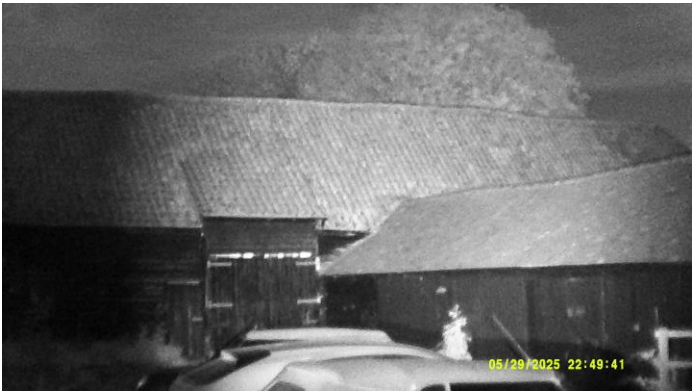
| Surveyor | Building, Tree or Structure | Dates, Times and Survey Type | Bat Activity Observed |
|---|---|---|---|
| SK | B1 | 29/05/2025<br>20:52 to 22:53<br>SS: 21:07 | <p>Unidentified pipistrelle heard at 21:39.</p> <p>Figure 2: IR still from the northern elevation.</p> |

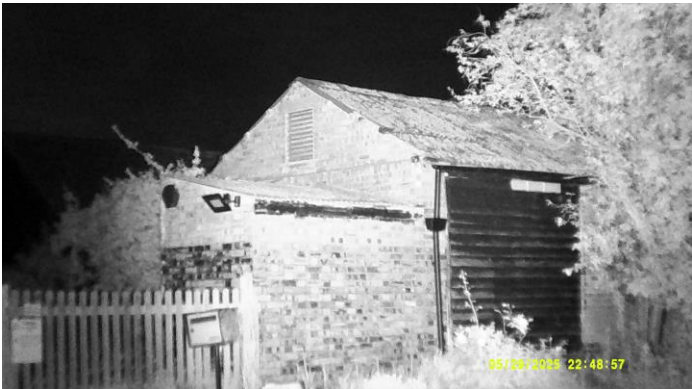
| SD | B1 | As above | <p>Common pipistrelle were seen foraging and commuting regularly along the road between 21:31 and 21:45 from which there was constant activity until 22:20. Common pipistrelle were also heard between 21:34 and 22:31. Barbastelle were heard between 22:11 and 22:20. Brown long eared heard at 22:23.</p> <p>Figure 5: IR still from the western elevation.</p> |

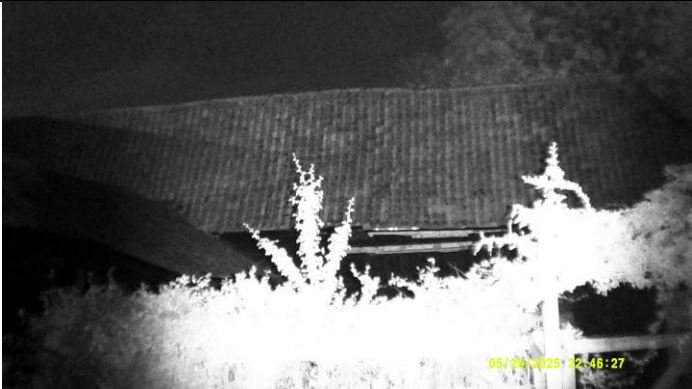
| KG | B1 | As above | <p>Common pipistrelle was seen passing at 21:58. A soprano pipistrelle was seen passing at 22:00 and a brown long eared was heard at 22:25.</p> |

| | | | <p>Figure 6: IR still from the northern elevation.</p> |

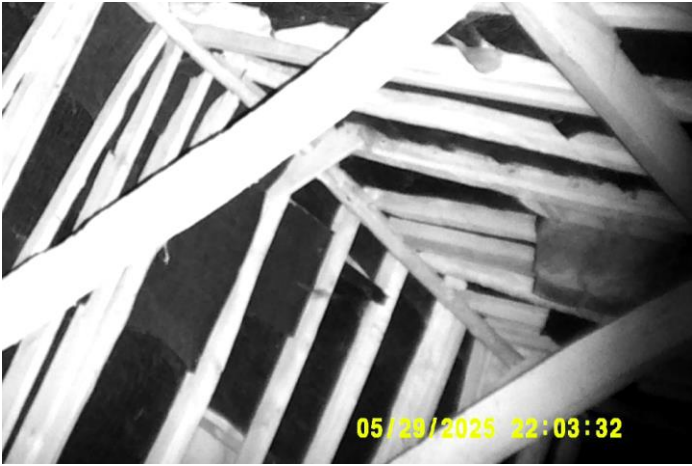
| Camera | B1 | As above | <p>Four brown long eared bats were seen flying in the barn at 21:45.</p> <p>Figure 7: IR still from the barn interior.</p> |

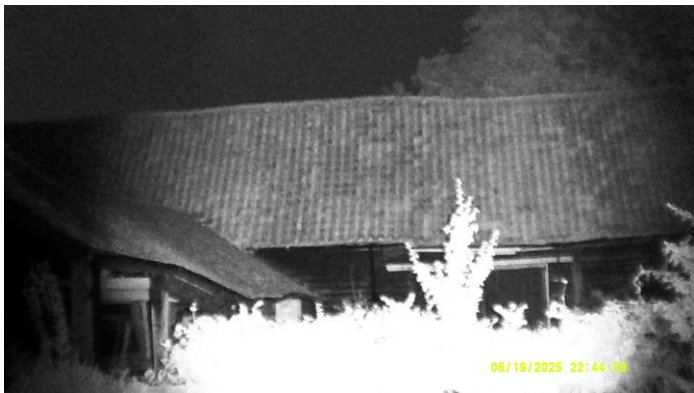
| KG | B1 | <p>19/06/2024<br/>21:09 to 23:09<br/>SS: 21:24</p> | <p>A CP was heard not seen at 21:35, 22:30 and 22:35. A BLE passed at 22:18. A Leislars bat (L) was HNS at 22:45. No</p> |

| | | | <p>further activity was recorded after 22:45.</p> <p>Figure 8: IR still from the northern elevation.</p> |

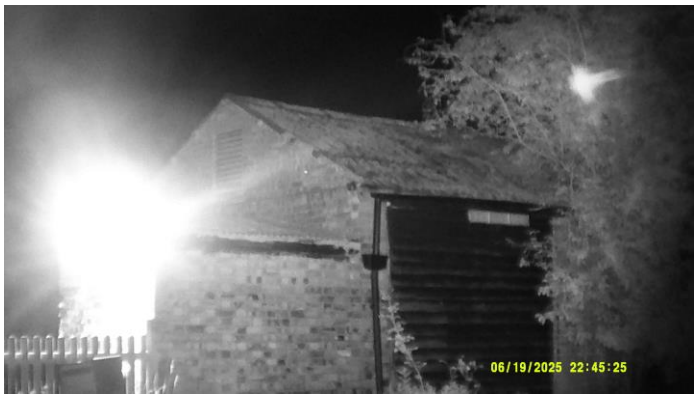
| GL | B1 | As above | <p>Figure 9: IR still from the western elevation.</p> |

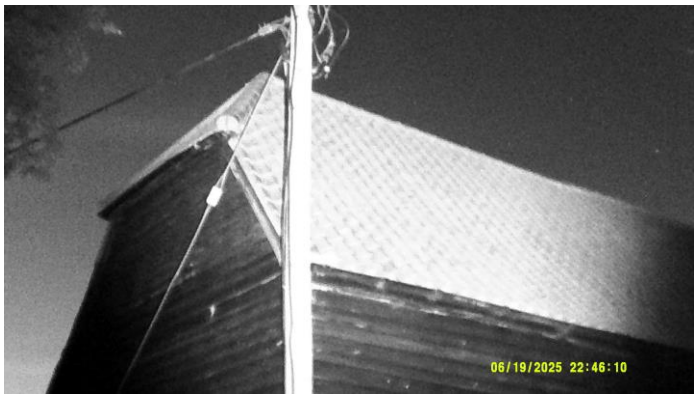
| SL | B1 | As above | <p>CP was seen foraging along the hedgerow between 21:49 and 22:26. There was no further activity after 22:27.</p> <p>Figure 10: IR still from the southern elevation</p> |

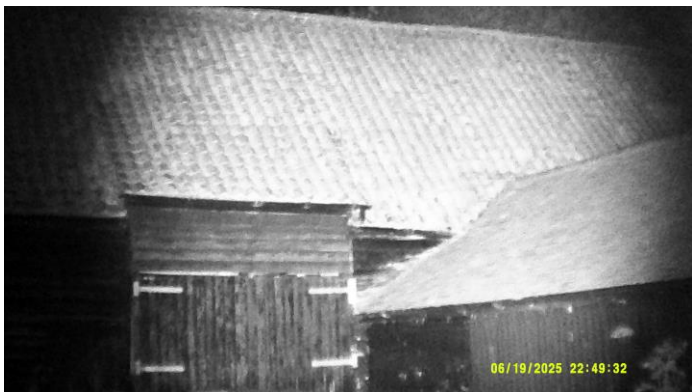
| CD | B1 | As above | <p>A CP passed between 21:49 and 22:35. A BLE was HNS at 22:42 and 22:48.</p> <p>Figure 11: IR still from the northern elevation.</p> |

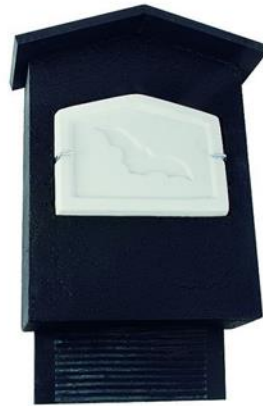
Figure 14: Chillon Woodstone Bat Box (British-made)

| <p>Mitigation and compensation to be installed via a Standard Licence application</p> | <p><b>Standard Licence:</b></p> <p>A maternity roost for BLE and a day roost for CP x 3 has been located within the barn and, therefore, the timing of the works will be restricted as follows:</p> <p>No works can be undertaken during the period of May to October whilst the maternity roost is <i>in situ</i>. Works can occur outside of these times under the work schedule.</p> <p>Any re-roofing/demolition will require the supervision of a bat-licensed ecologist. The suitable roosting features will be stripped by hand only. All areas within the roof will be checked for bats i.e. endoscope. If bats are found, these will be removed by hand and placed in bat boxes that will be in place before works begin.</p> <p>Bat boxes will be installed on retained trees or buildings; it is currently understood that there are buildings/trees that can be used for this purpose.</p> <p>A minimum of three Chillon Woodstone bat boxes will be hung on the buildings/trees at a minimum of 3m from ground level and face south/southwesterly. These boxes are known to be used by Brown Long-Eared bats (BLEB) and crevice-dwelling species.</p> |

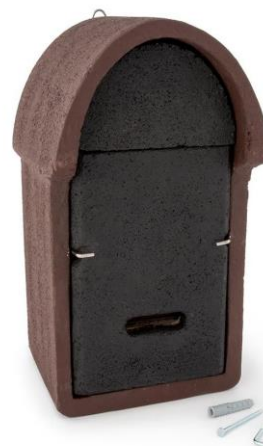
Figure 15: Large maternity/hibernation box (British-made)

At least three maternity bat boxes e.g. large multi-chamber bat box must be installed at the same orientation and height and must have the same solar gain to ensure it replicates the current roost as closely as possible. These boxes will be used as a roosting feature which the maternity roost can utilise during the works period but will be retained on completion.
