# Preliminary Ecological Appraisal & Roost Assessment

9 Whitethorn Lane, Letchworth Garden City, Herts SG6 2DN

This report is prepared to inform a planning application with North Hertfordshire District Council. The project can be described as an infill to rear extension and replacement bi-fold doors.

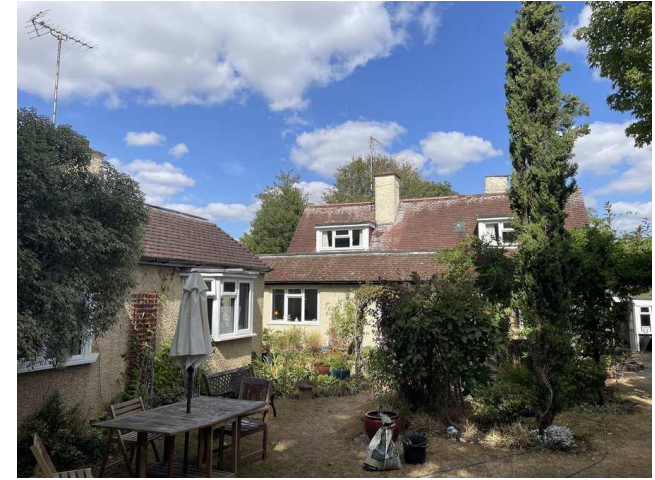
*Building B1*

The building is a residential dwelling constructed with brick walls and a clay tile roof. While the walls and eaves showed no defects or suitable roosting features, small gaps were identified where replaced roof tiles met original ones on the southern elevation, presenting potential access for crevice dwelling bat species. The internal void, lined with plywood panelling and bitumen felt, was found to be in good condition with no noted access points for bats. No bat evidence was recorded during the survey. The building has **low** habitat value.

The proposed development will not affect any of the features that could be used by roosting bats which were noted on B1 during the survey and therefore no impacts to bat roosts are anticipated. However, the proposed development could result in disturbance to any bats present in the building at the time of the works due to noise, vibration or lighting. Bats are very unlikely to be roosting within B2, B3, B4 and B5 and as such, there are not anticipated to be any impacts on bats in these locations as a result of the proposed development.

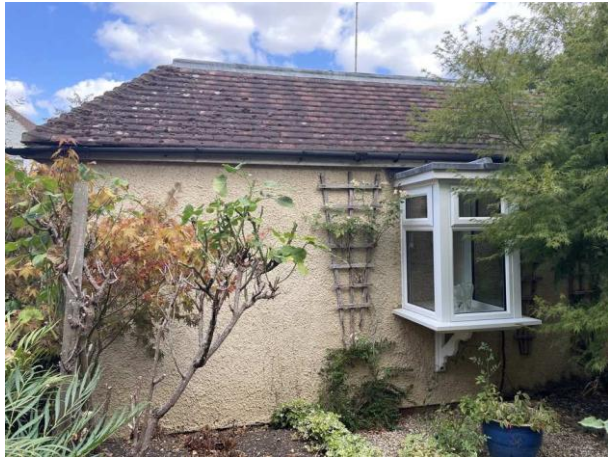
| Feature | Materials/Details | Condition / description / suitability | Photograph |
|---|---|---|---|
| Walls | Brick with paint render | <p><b>Condition/description</b><br/>The walls are in good condition with no defects.</p> <p><b>Suitability/access/evidence of bats</b><br/>No suitability for roosting bats.</p> | <p><i>B1 walls</i></p> |

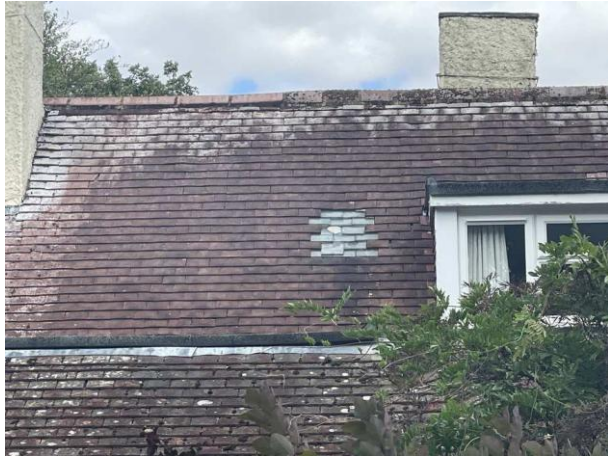
| Feature | Materials/Details | Condition / description / suitability | Photograph |
|---|---|---|---|
| Roof | Clay tiles | <p><b>Condition/description</b><br/>The tiles are in relatively good condition. On the southern elevation there is an area of missing tiles that have been replaced. On the northern elevation there are three instances of lifted tiles.</p> <p><b>Suitability/access/evidence of bats</b><br/>Where the replaced tiles meet the original tiles there are small gaps suitable for crevice dwelling species. The lifted tiles on the northern elevation are suitable for crevice dwelling species, these features were torched and no bats or evidence was</p> | <p><i>B1 roof</i></p> |

| | | found. | |

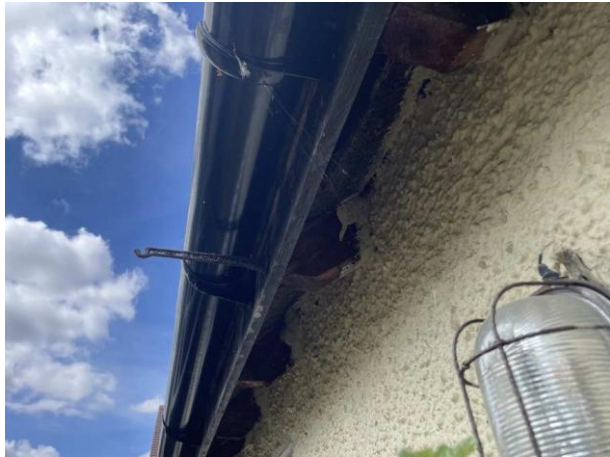
| Eaves | uPVC and timber | <p><b>Condition/description</b><br/>The eaves and barge boards are in good condition with no defects.</p> <p><b>Suitability/access/evidence of bats</b><br/>No suitable roosting features for bats recorded.</p> | <p>B1 eaves</p> |

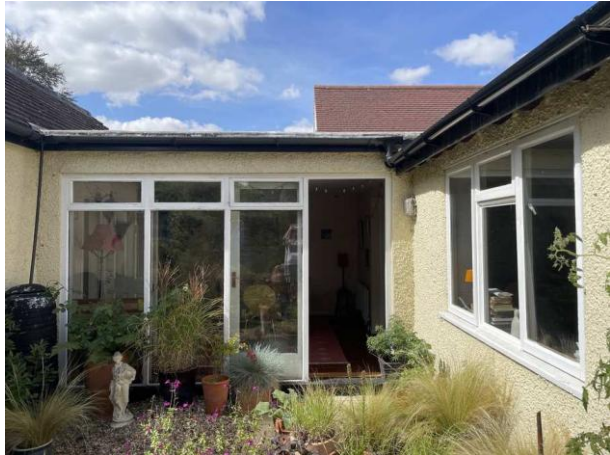
| Windows | uPVC | <p><b>Condition/description</b><br/>The windows and doors are in good condition with no defects.</p> <p><b>Suitability/access/evidence of bats</b><br/>No suitable roosting features were recorded.</p> | <p>B1 window / doors frames and lintels</p> |

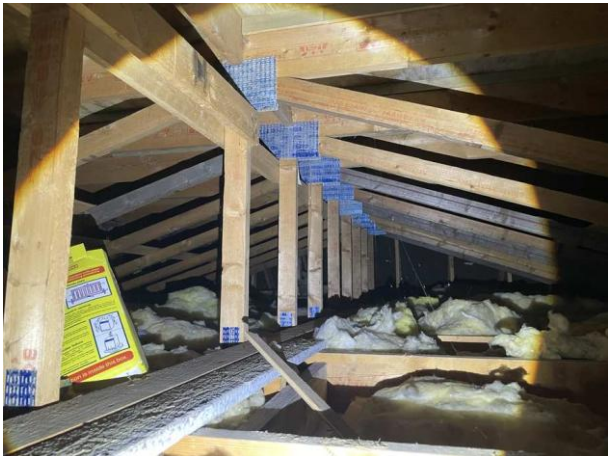
| Internal void 1 | Plywood panelling and bitumen felt. | <p><b>Condition/description</b></p> <p>The void is in good condition with plywood panelling on the roof providing no access into the area. There is bitumen flet lining on the southern elevation in good condition. No evidence of bats was noted.</p> <p>Dimensions (approx): 8m length x 6m width x 1m height</p> <p><b>Suitability/access/evidence of bats</b></p> <p>No suitable roosting for bats due to lack of access points.</p> | <p><i>B1 internal void 1</i></p> |

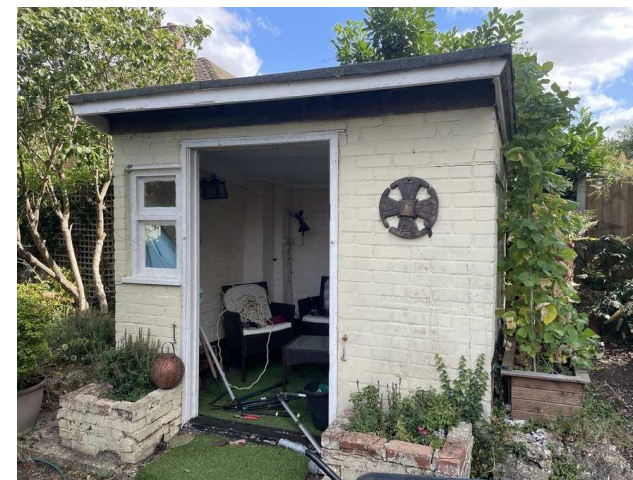
*Building B2*

B2 is a summer house, of brick construction and a flat bitumen flet roof. The building is in good condition with no defects. No suitable roosting features for bats were recorded, and no evidence of bats was found. B2 is assessed as having **negligible** habitat value.

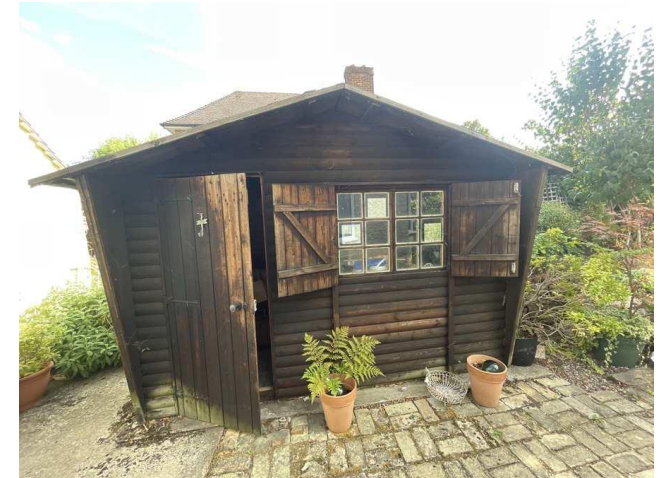
*Building B3*

B3 is a timber shed, with a gable ended bitumen felt roof. The building is in good condition with no defects. No suitable roosting features for bats were recorded, and no evidence of bats was found. B3 is assessed as having **negligible** habitat value.

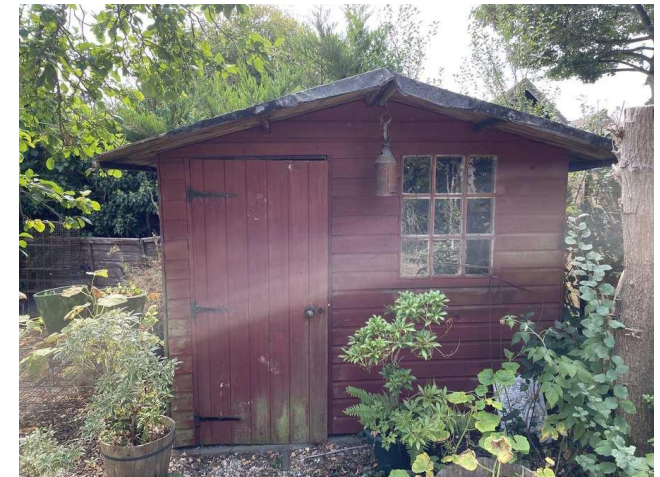
*Building B4*

B4 is a timber shed, with a gable ended bitumen felt roof. The building is in good condition with no defects. No suitable roosting features for bats were recorded, and no evidence of bats was found. B4 is assessed as having **negligible** habitat value.

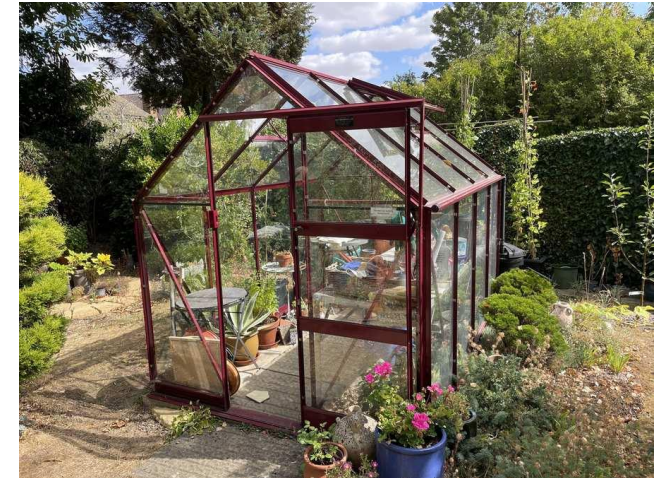
*Building B5*

B5 is a gable ended green house of glass construction. The building is in good condition with no defects. No suitable roosting features for bats were recorded, and no evidence of bats was found. B5 is assessed as having **negligible** habitat value.

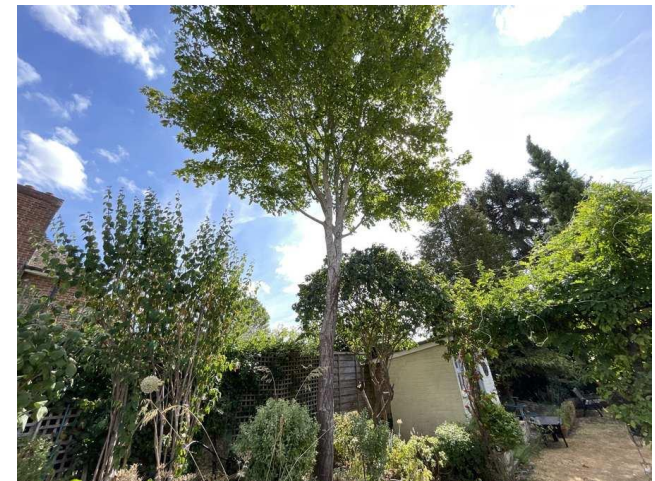
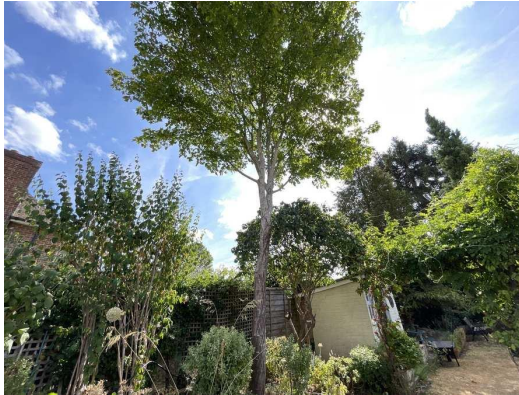
Scattered trees; T1

T1 is a sycamore. The tree has a DBH of 23cm.

No roosting features were identified for any of the trees onsite.

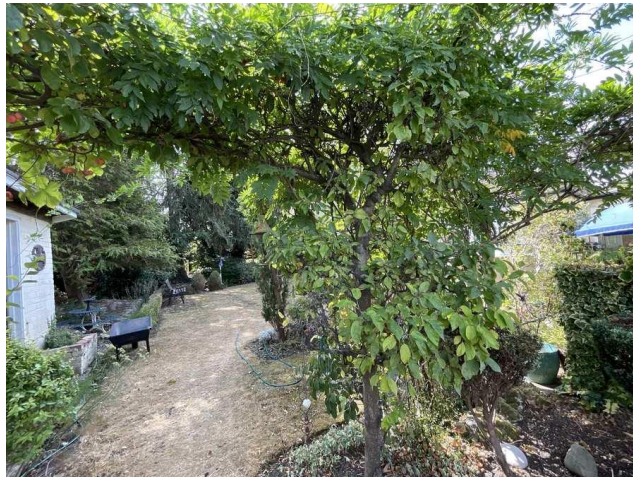
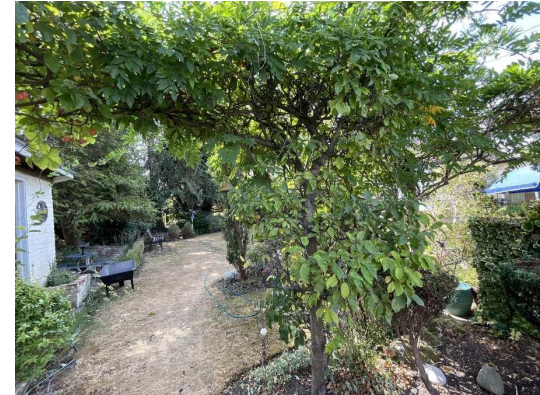
Scattered trees; T2

T2 is an apple. The tree has a DBH of 10cm.

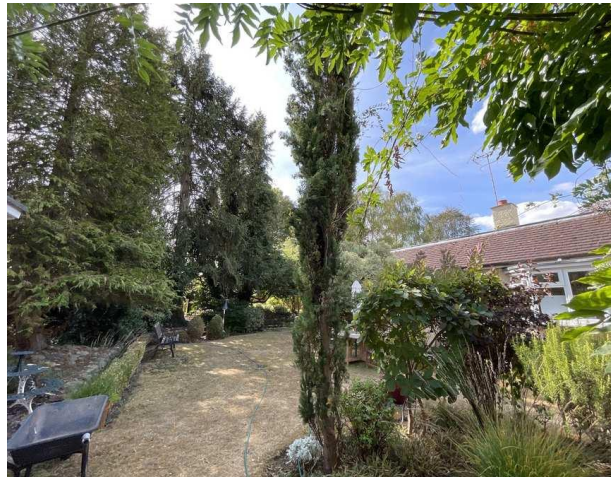
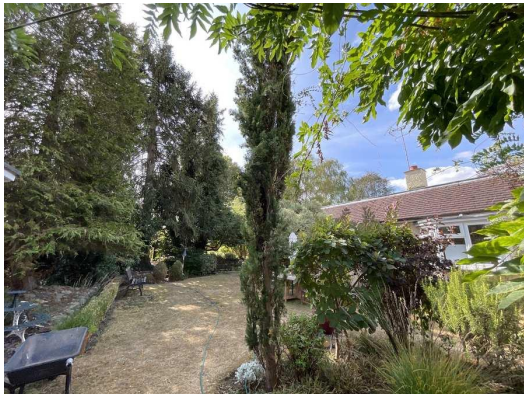
Scattered trees; T3

T3 is an Italian cypress. The tree has a DBH of 12cm.

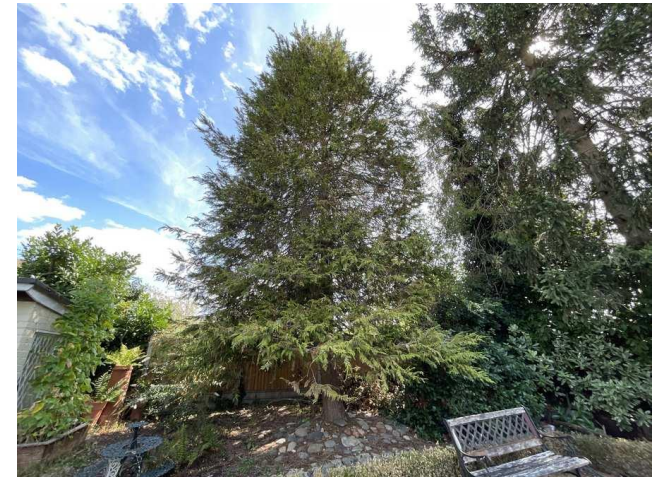
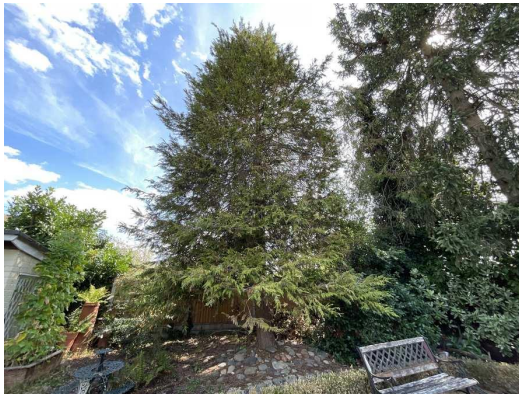
Scattered trees; T4

T4 is a Lawson cypress. The tree has a DBH of 30cm.

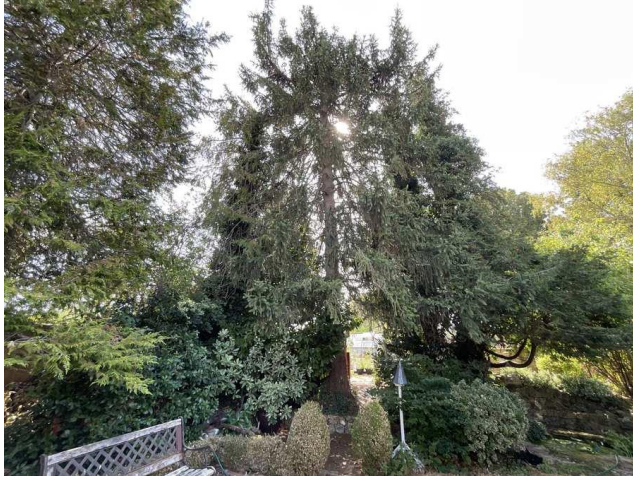
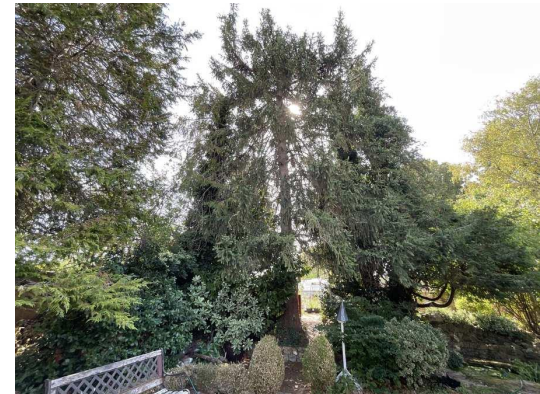
*Scattered trees; T5*

T5 is a Norway spruce. The tree has a DBH of 40cm.

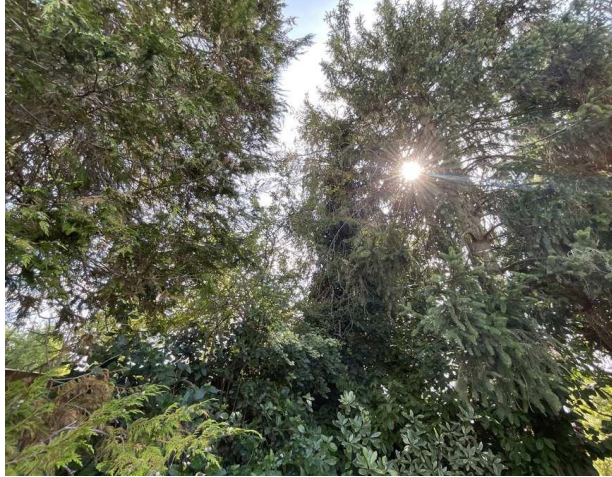
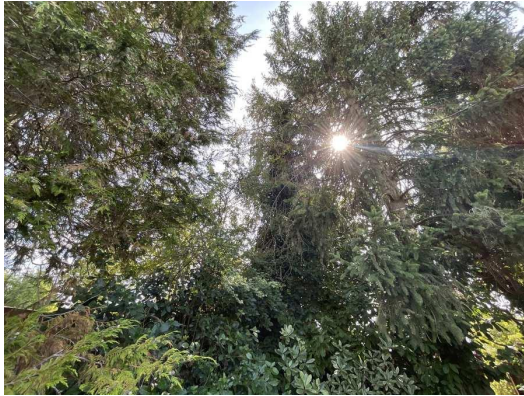
*Scattered trees; T6*

T6 is a Lawson cypress. The tree has a DBH of 30cm.

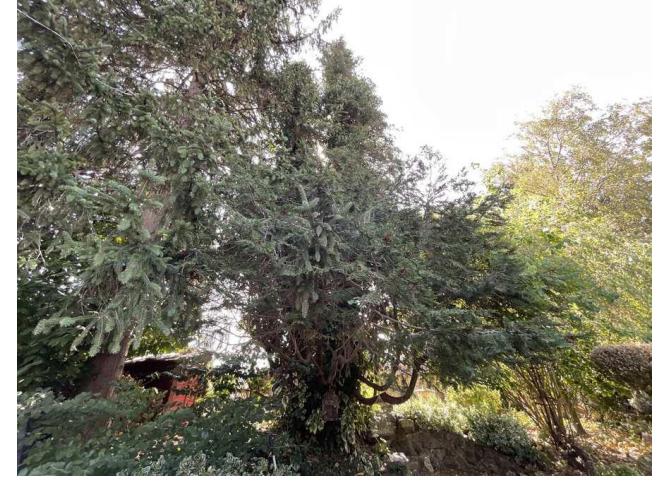
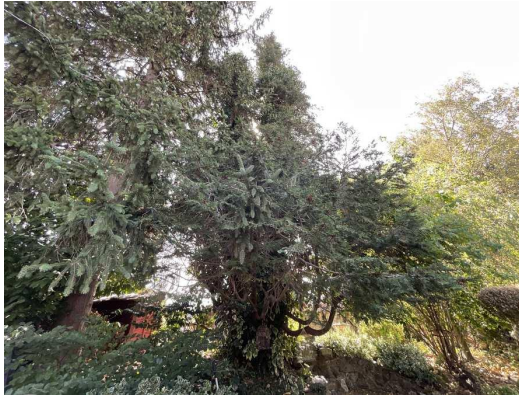
*Scattered trees; T7*

T7 is a Lawson cypress. The tree has a DBH of 45cm.

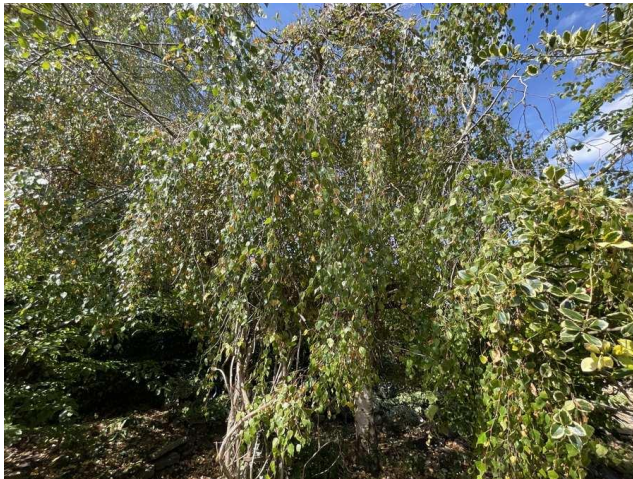
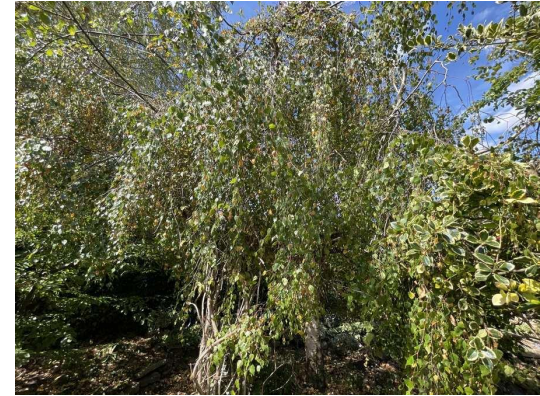
*Scattered trees; T8*

T8 is a silver birch. The tree has a DBH of 21cm.

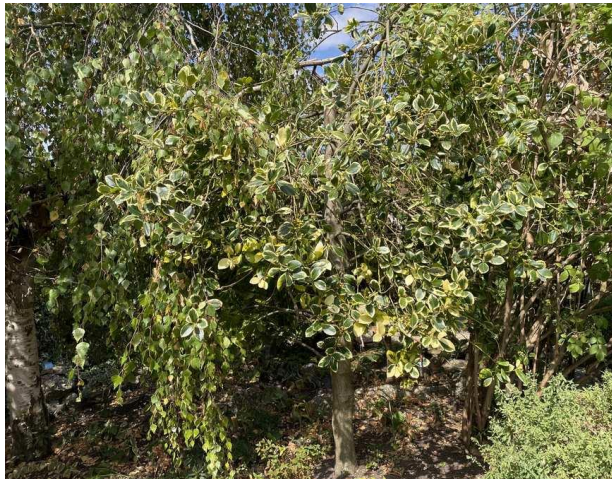
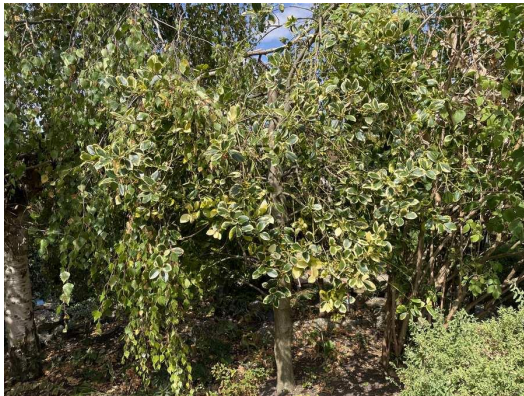
*Scattered trees; T9*

T9 is a common holly. The tree has a DBH of 21cm.

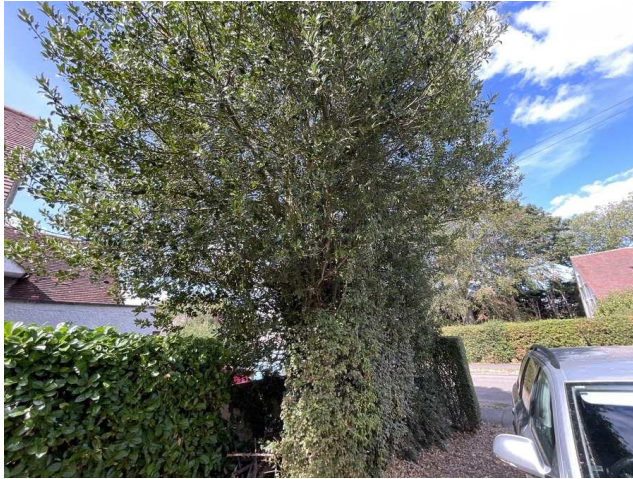
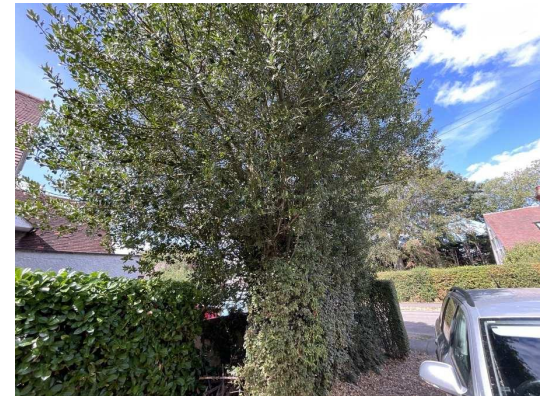
*Scattered trees; T11*

T11 is a common holly. The tree has a DBH of 30cm.

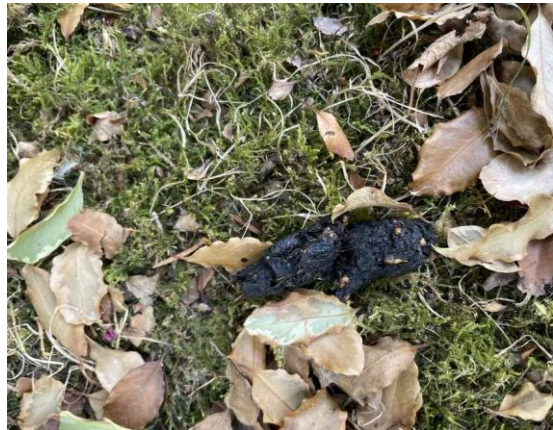
One hedgehog dropping was identified onsite within the grassland of the vegetated garden. It measured ~4cm in length and looked relatively fresh. The introduced shrub and fruit trees onsite provide foraging and commuting opportunities for hedgehogs, and other small mammals.

*Hedgehog droppings found on site*

If any hedgehogs or other small mammals are found in the working area these should be allowed to disperse of their own accord or, if at immediate risk, should be moved by hand to a sheltered, vegetated area away from disturbance.

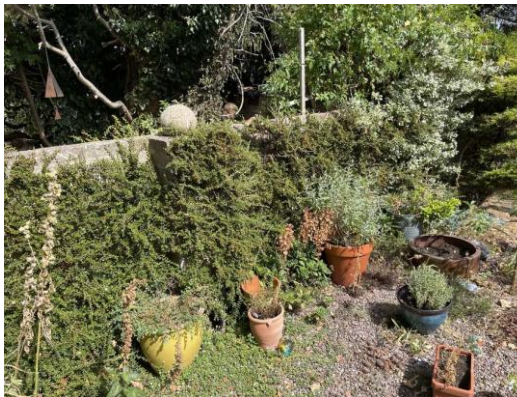
Wall cotoneaster (*Cotoneaster horizontalis*) was identified on the site which is listed as an invasive, non-native species under Schedule 9 of the Wildlife and Countryside Act 1981.

*Artificial unvegetated, unsealed surface, wall  
cotoneaster*

Any plants present on Schedule 9 of the Wildlife and Countryside Act 1981 are prohibited from release into the wild due to their capacity to cause ecological, environmental or socio-economic harm. Where Schedule 9 species are grown in private gardens, larger scale gardens, estates and amenity areas reasonable measures will be taken to confine them to the cultivated area so as to prevent their spreading to the wider environment and beyond the landowner's control. As such, not preventing the spread of Wall cotoneaster currently present on site, into the wild (*i.e. surrounding areas*), this could constitute an offence. As such it is recommended that Wall cotoneaster is dug up, including roots, and disposed of in line with appropriate controlled waste measures, or controlled during construction works to prevent the spread off-site.

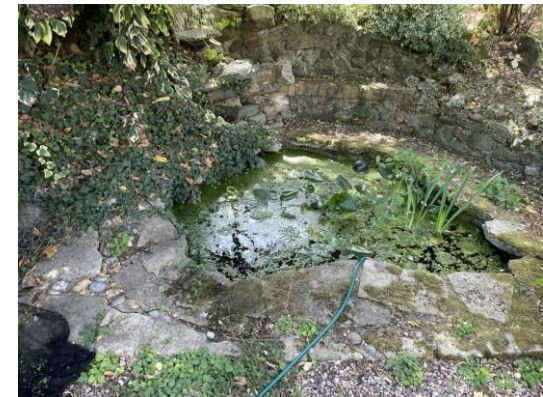
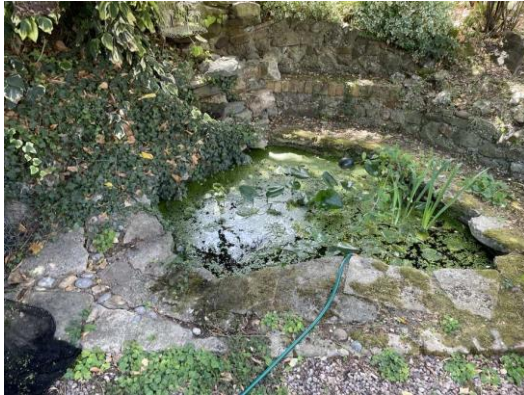
*Pond P1*

There is a small ornamental pond within the vegetated garden measuring ~6m<sup>2</sup>. The pond is covered in duck weed, and homes three fish, and aquatic snails. Common and palmate newts have been seen within the pond. Other submergent and floating plants are present. Species present within this habitat include European frogs bit (*Hydrocharis morsus-ranae*), common duckweed (*Lemna minor*), yellow flag (*Iris pseudacorus*) and variegated yellow pond-lily (*Nuphar lutea*).

Pond P1 is a man-made pond, supplied with water from a hose and the rain. The pond is an ornamental pond within a vegetated garden. There is duckweed, and other floating and emergent species present. The pond has an area of ~6m<sup>2</sup>, measuring ~2m x3m, and retains water all year round due to the supply of water from the rain and a hosepipe. Three fish are present within the pond and common and palmate newts have been noted within during the active seasons. The border of the pond is made of paving slabs and the habitat of vegetated garden and introduced shrubs continues in all directions from the edge. As a result of the Habitat Suitability Index (HSI), P1 scored 0.51, indicating below **average** suitability to support great crested newts.

*Ornamental pond NON-WOODLAND*

- Best practice pollution prevention measures will be implemented to minimise impacts to nearby aquatic habitats, including the pond onsite, that amphibians could use.
- Any chemicals or pollutants used or created by the development should be stored and disposed of correctly according to COSHH regulations.
- If any common amphibians are found in the working area these should be allowed to disperse of their own accord or, if at immediate risk, should be moved by hand to a sheltered, vegetated area away from disturbance.
- In the unlikely event that a great crested newt is identified, works must cease and advice must be sought from a suitably qualified ecologist.
