LANGLEY BOTTOM FARM BARN

LONDON ROAD, LANGLEY  
HERTFORDSHIRE

PRELIMINARY ROOST ASSESSMENT

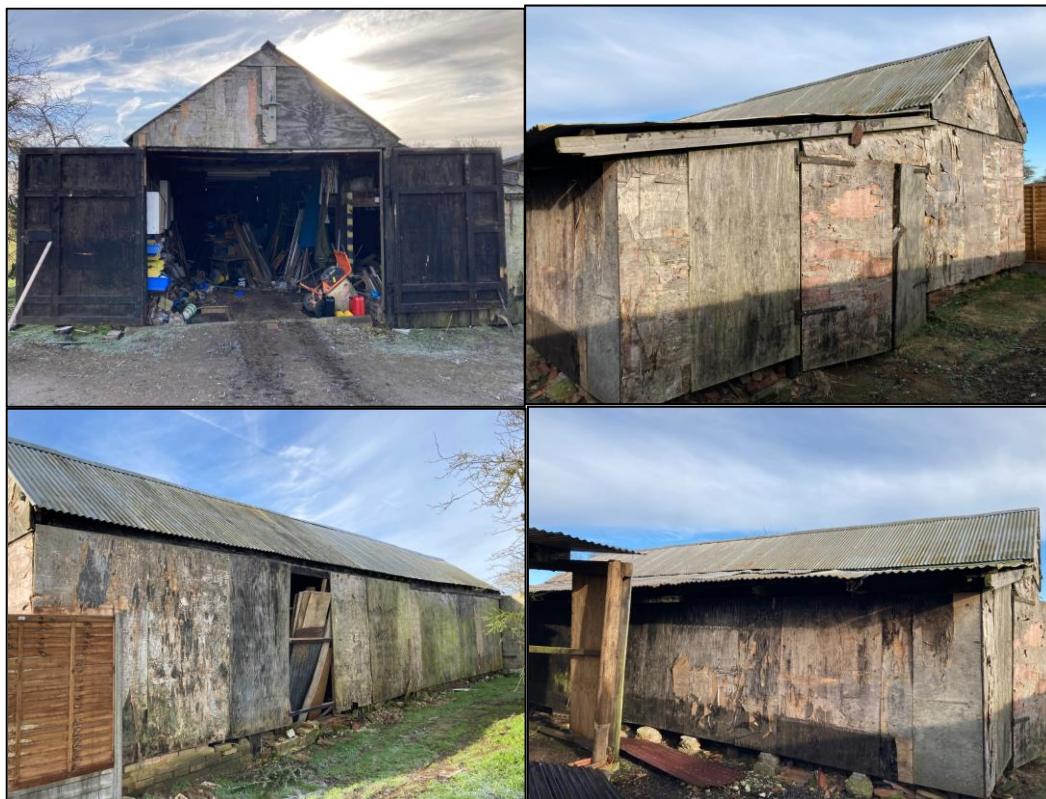
This barn (see photographs 1 - 4 below) is a relatively modern unit, notwithstanding its dilapidated condition, which is currently in use for the storage of sundry materials.

The barn has large double doors on the front elevation and an open, damaged section on one side elevation, giving a draughty and well-lit interior. On the

The walls are largely made of single-skinned chipboard and other wooden sheeting, with no cavity walls present.

Photographs 1 - 4: Barn A - Front, rear & side elevations

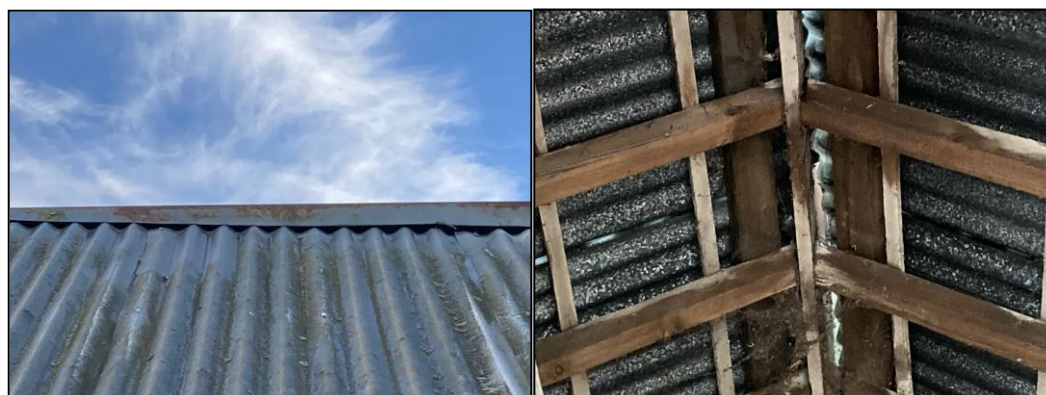
The building has a pitched, corrugated metal roof (see photographs 5 - 6 below), with no loft void. There is no central, internal ridge beam and the ridge is protected externally with a metal covering. The roof is unlined and there is no insulation present.

Photographs 5 - 6: Barn A - Corrugated iron roof

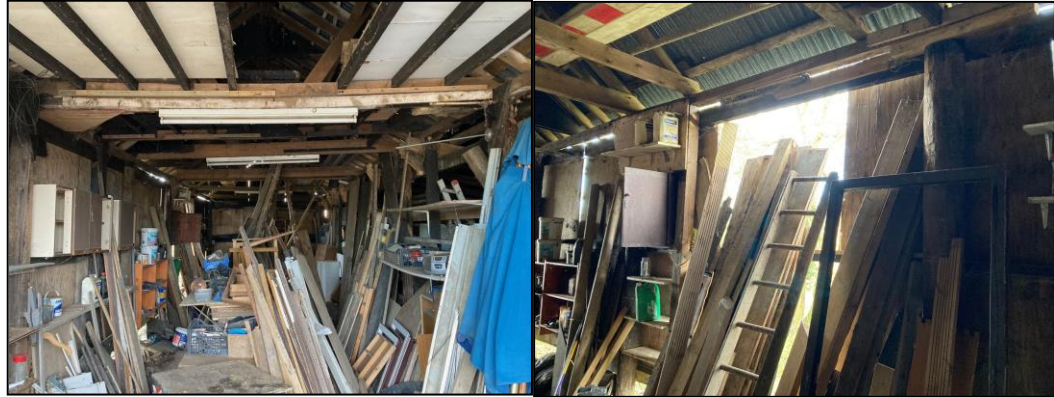
The rafters are of modern-sawn timbers, commensurate with the recent age of the structure, and lack any gaps, crevices or open joints that could afford potential roosting locations for bats (see photographs 7 - 8 below).

Photographs 7 - 8: Barn A - Internal void

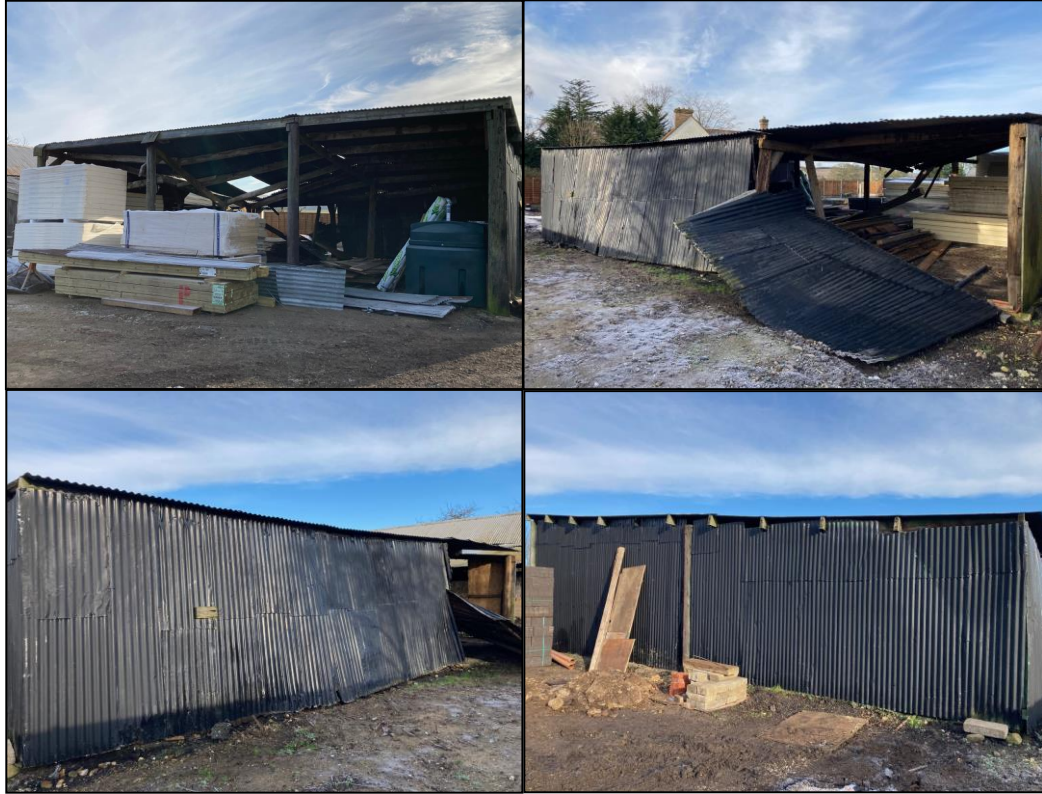
This barn (see photographs 9 - 12 below) is also a relatively modern unit, notwithstanding its derelict and near collapsing condition, which is currently in use for the occasional storage of sundry materials.

The barn has an open-sided front elevation and a large section of the wall on the rear elevation is damaged and open, giving a draughty and well-lit interior.

The walls are made entirely of single-skin corrugated iron sheeting, with no cavity walls present.

Photographs 9 - 12: Barn B - Front, rear & side elevations

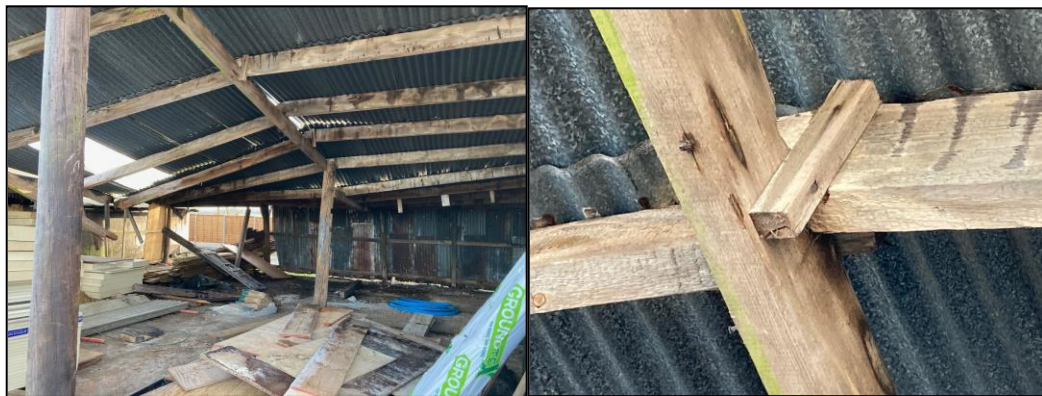
The building has a sloping, corrugated metal roof (see photographs 13 - 14 below), with no loft void. There is no central, internal ridge beam and the roof is unlined, with no insulation present.

Photographs 13 - 14: Barn B - Corrugated iron roof

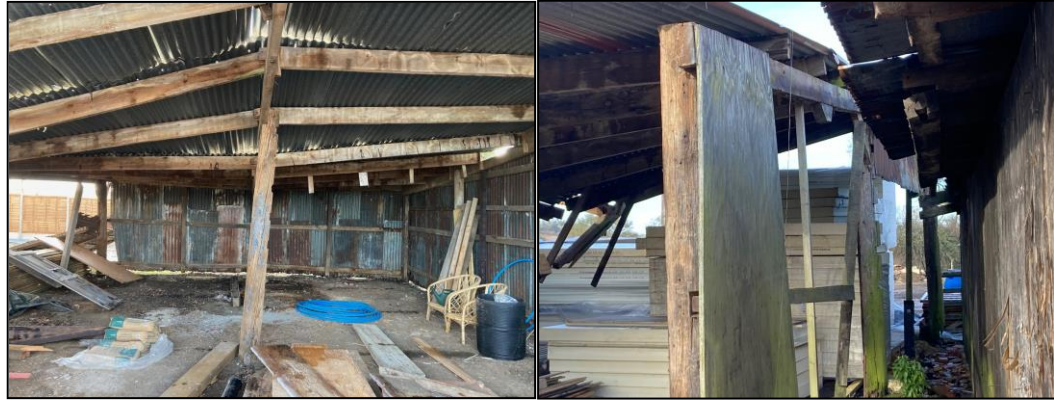
The rafters are of modern-sawn timbers, commensurate with the recent age of the structure, and lack any gaps, crevices or open joints that could afford potential roosting locations for bats (see photographs 15 - 16 below).

Photographs 15 - 16: Barn B - Internal void

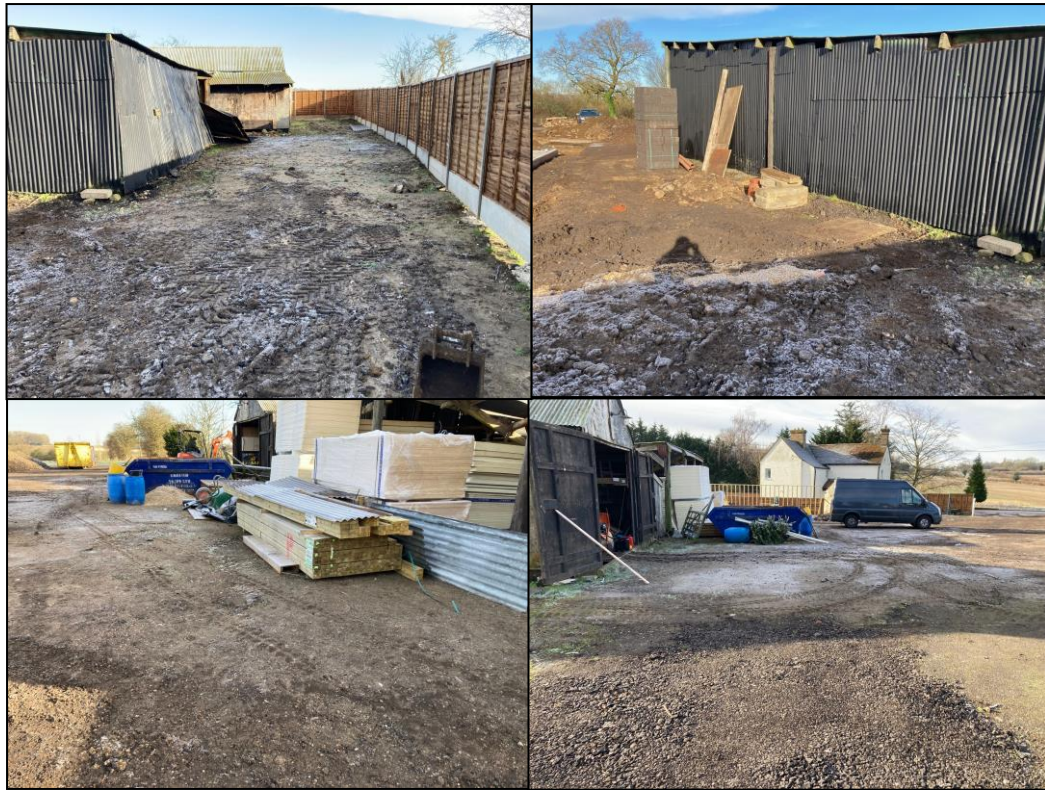
A new fence has recently been installed to the rear of Barn A and Barn B. There is no natural habitat present surrounding the two barns within this fence (see photographs 17 - 20 below).

Photographs 17 - 20: No natural habitat present surrounding the two barns within the new fence-line

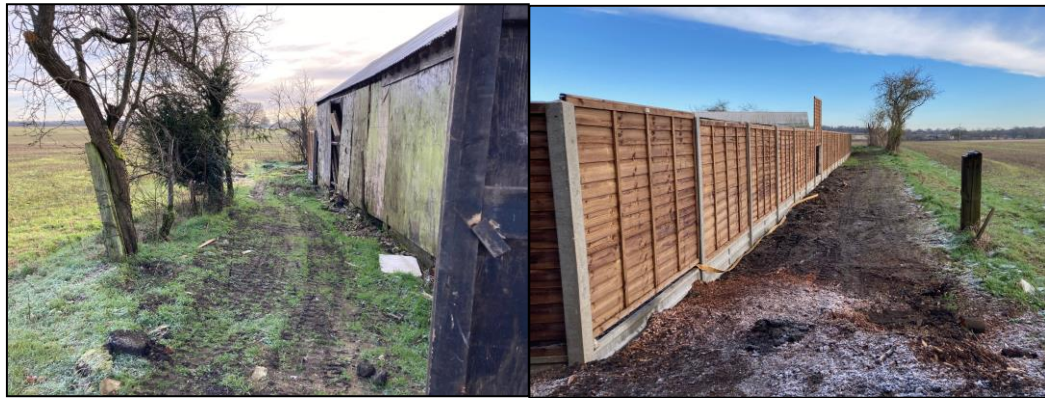
The only 'natural' habitat present is a very narrow compartment of improved grassland, together with some ruderal vegetation and bare ground, to the rear of the new fence (see photographs 21 - 22 below).

The field boundary hedgerow along the adjoining field margin has long been lost, leaving only isolated Elder, Apple and Common Hawthorn shrubs remaining.

This linear compartment was determined to have no ecological value, even when assessed at a local (parish) level.

Photographs 21 - 22: Linear compartment to the rear of the new fence
