## PHOTOGRAPHIC LOG

| <b>Client Name:</b><br>Shell UK Oil Products | <b>Site Location:</b> Shell Hitchin 10019011<br>Bedford Road, Hitchin, Hertfordshire, SG5 2TY | <b>Project No.</b><br>46370079 |

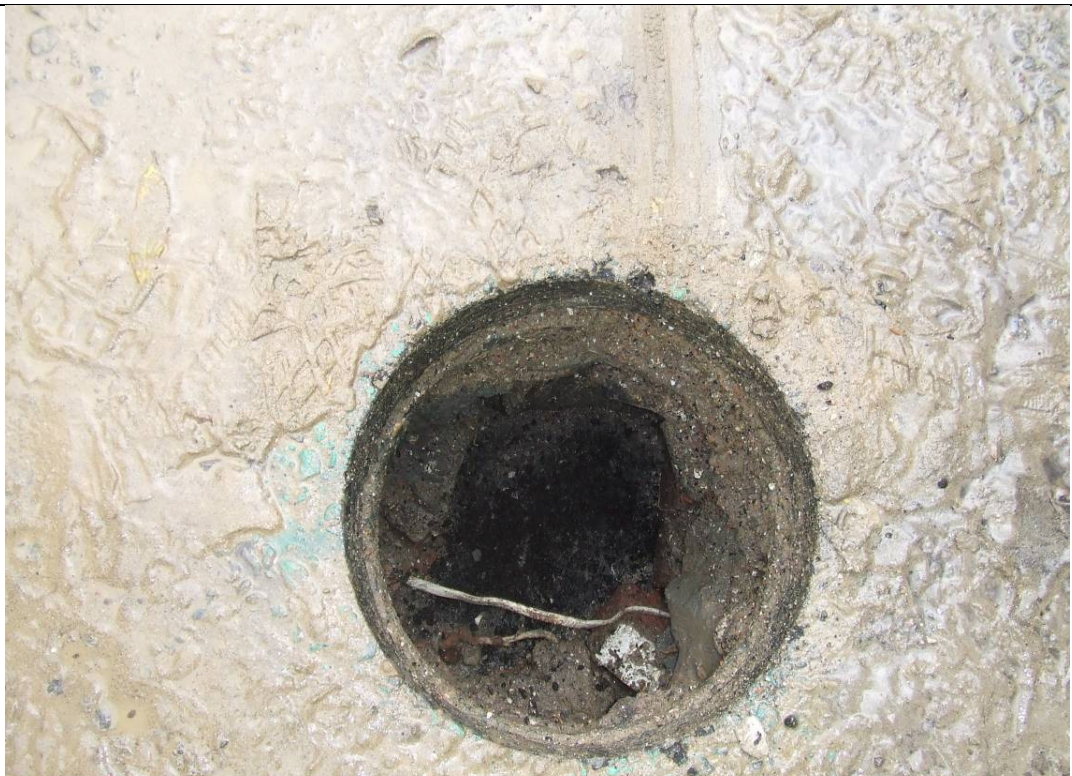
| <b>Photo No.</b><br>1 | <b>Date:</b><br>October<br>2011 | |

| <b>Description:</b><br><br>Refusal at BH104 on service. | | |

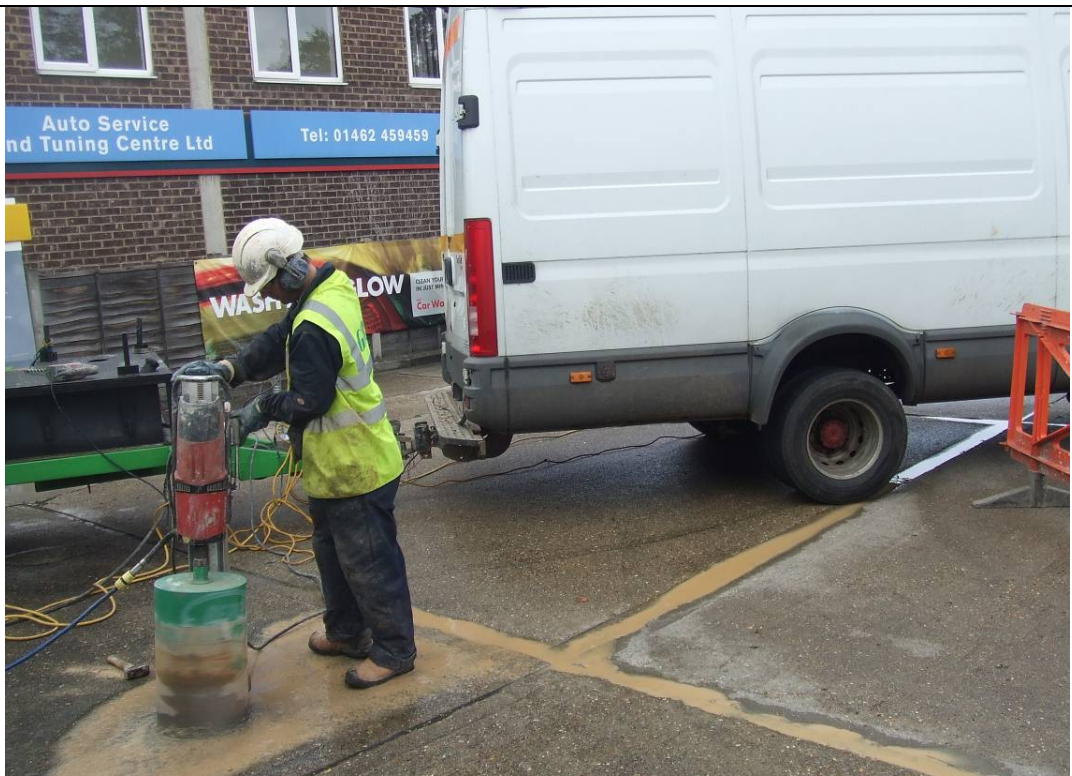
| <b>Photo No.</b><br>2 | <b>Date:</b><br>October<br>2011 | |

| <b>Description:</b><br><br>Concrete coring of VP103<br><br>Photo aspect is north. | | |

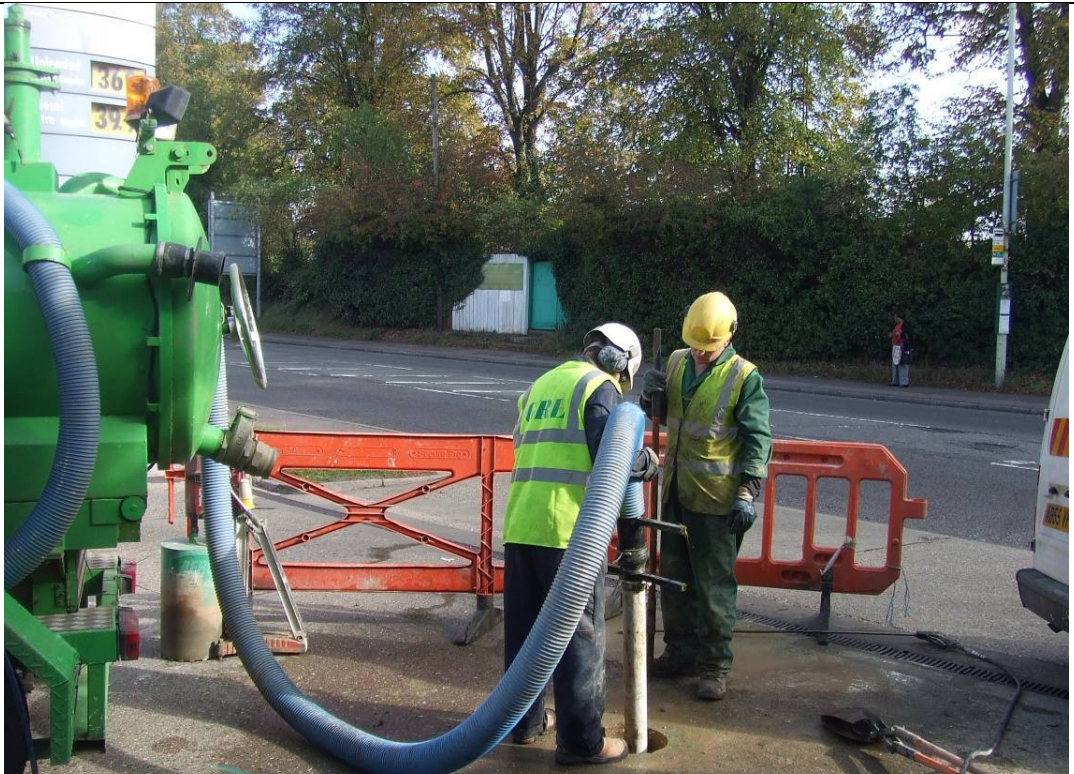
| <b>Photo No.</b><br>3 | <b>Date:</b><br>October<br>2011 | |

| <b>Description:</b><br><br>Vacuum excavation of<br>BH103<br><br>Photo aspect is east | | |

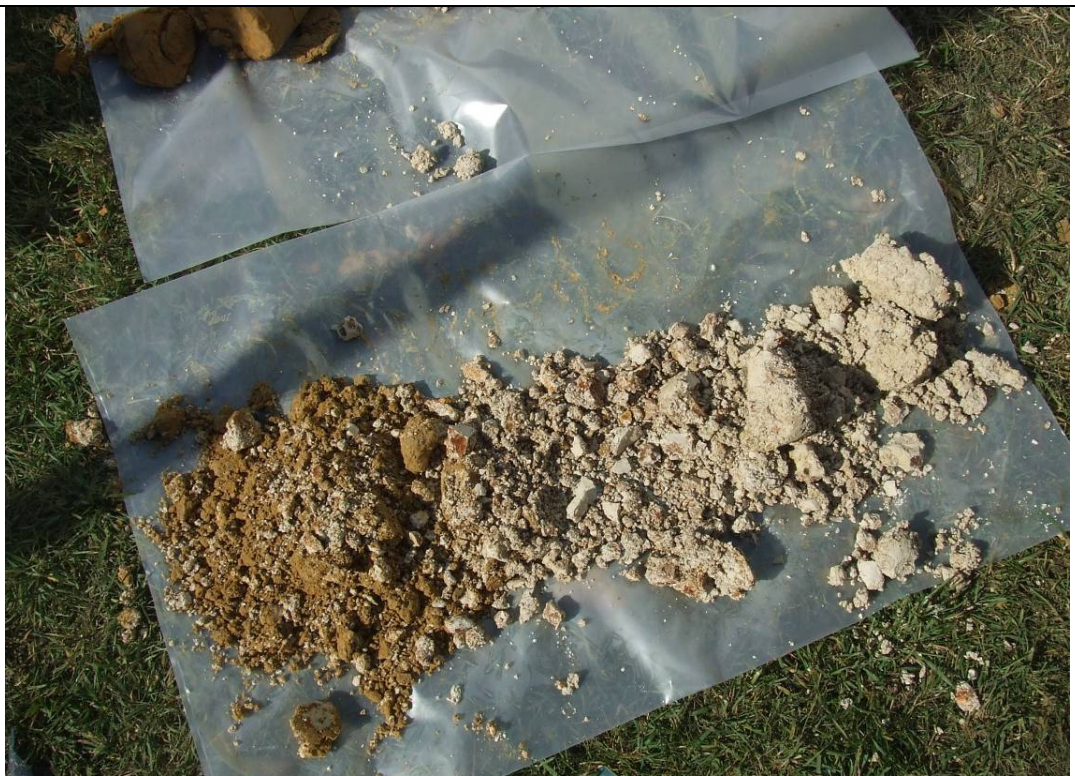
| <b>Photo No.</b><br>4 | <b>Date:</b><br>October<br>2011 | |

| <b>Description:</b><br><br>Soil sample from BH105 .<br><br>Chalk encountered at 5.8m<br>bgl | | |

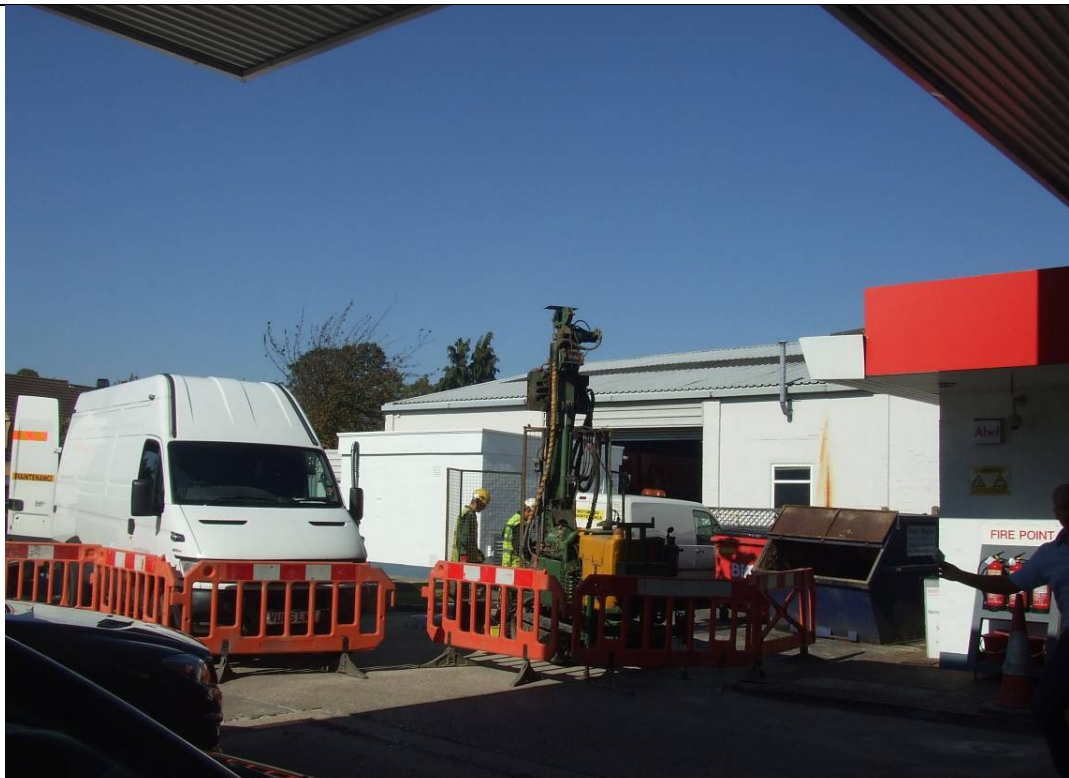
| <b>Photo No.</b><br>5 | <b>Date:</b><br>October<br>2011 | |

| <b>Description:</b><br><br>Drilling setup at BH105<br><br>Photo aspect is north. | | |

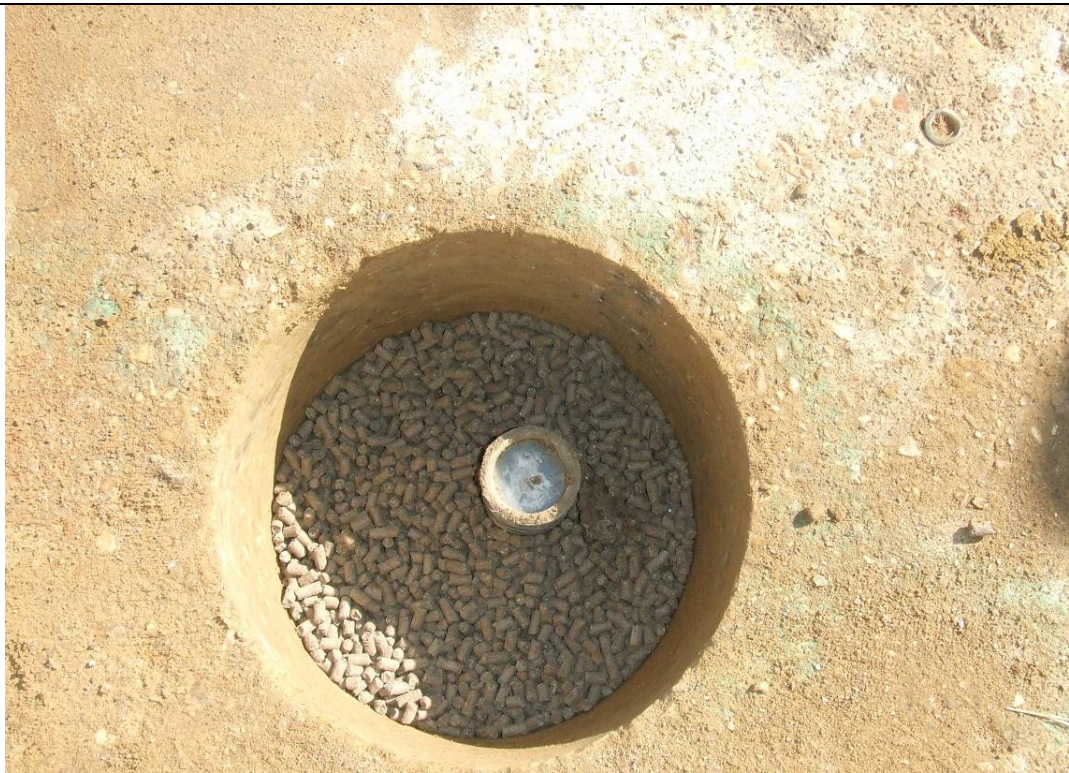
| <b>Photo No.</b><br>6 | <b>Date:</b><br>October<br>2011 | A photograph showing a circular hole in the ground, filled with gravel. A metal cap is visible in the center of the hole. The surrounding ground is dry and sandy. |

| <b>Description:</b><br><br>Monitoring well installation<br>for BH105. | | |

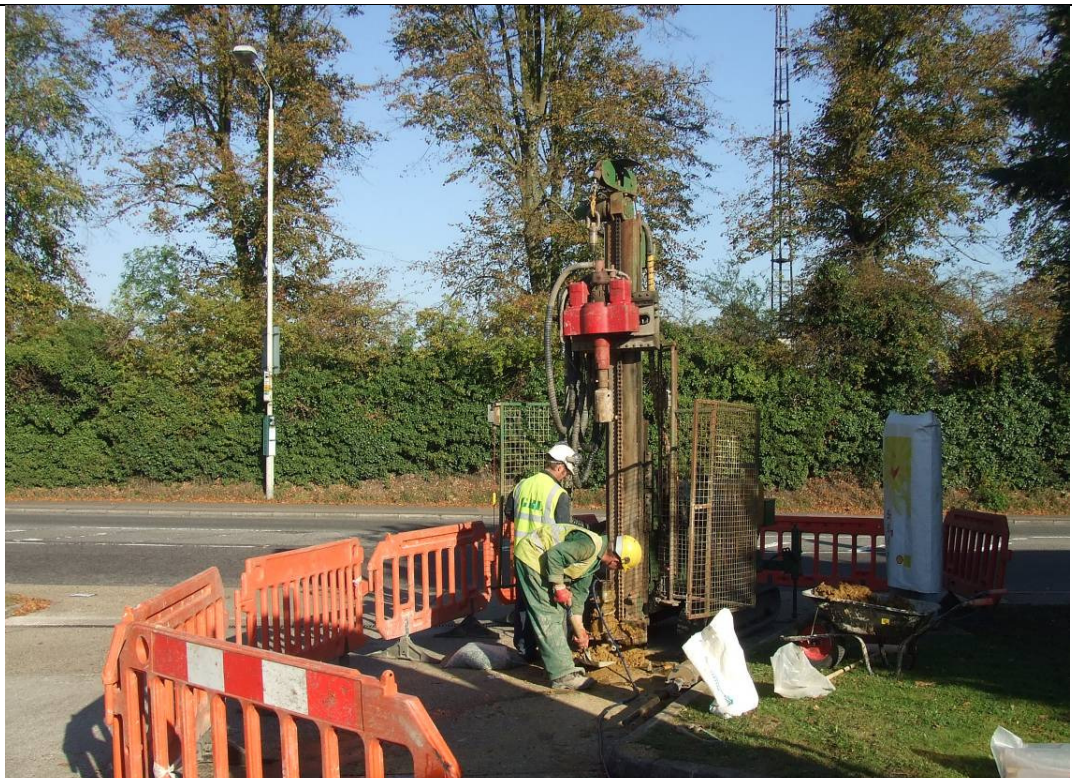
| <b>Photo No.</b><br>7 | <b>Date:</b><br>October<br>2011 | |

| <b>Description:</b><br><br>Drilling setup at BH103.<br><br>Photo aspect is south east. | | |

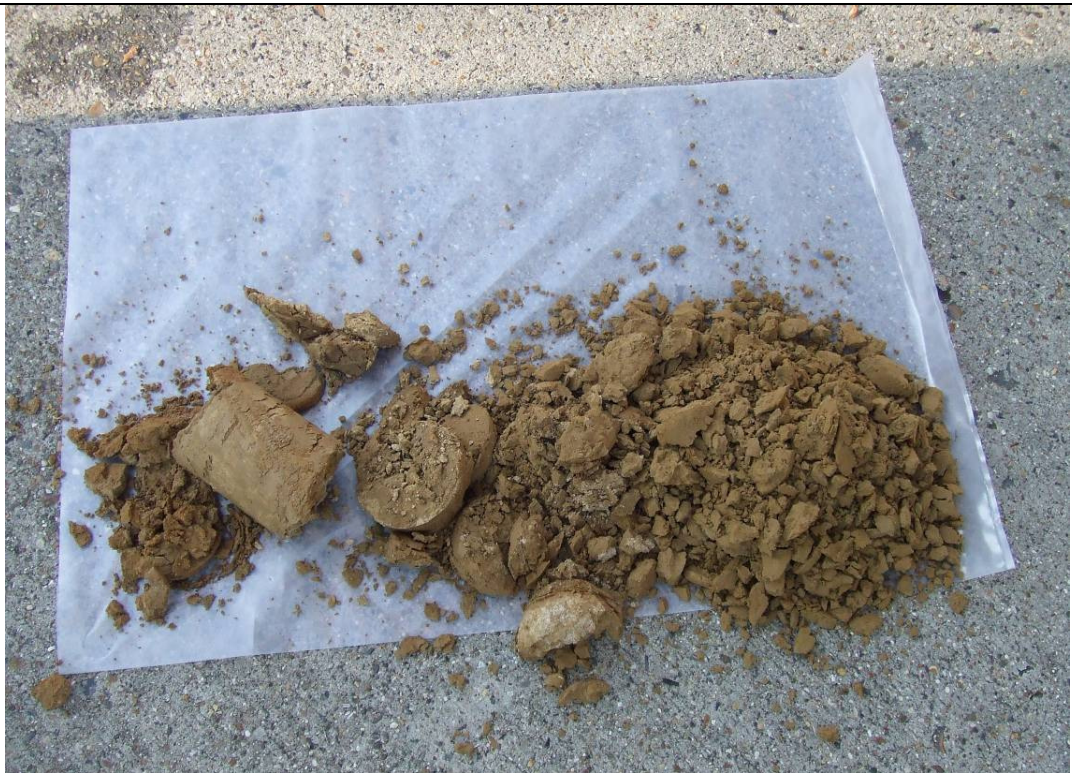
| <b>Photo No.</b><br>8 | <b>Date:</b><br>October<br>2011 | |

| <b>Description:</b><br><br>Soil sample from BH103.<br><br>Sands found at 4.5m bgl. | | |

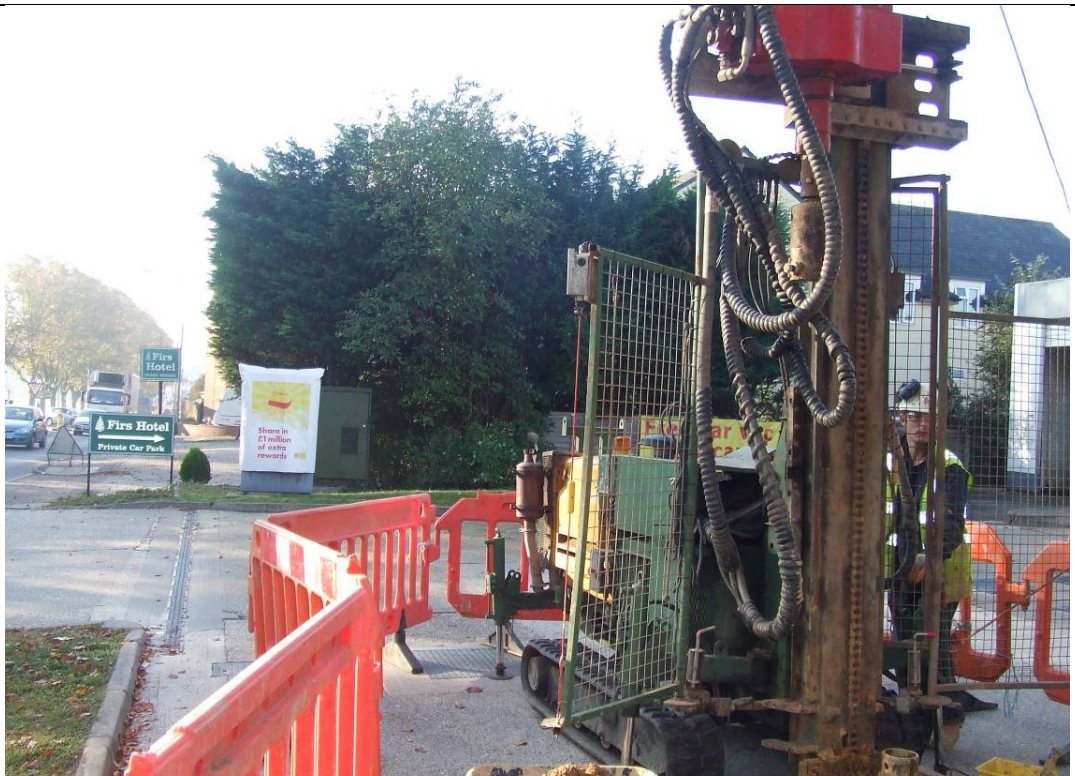
| <b>Photo No.</b><br>9 | <b>Date:</b><br>October<br>2011 |

| <b>Description:</b><br><br>Drilling of BH102.<br><br>Photo aspect is south west. | |

A large drilling rig is positioned on a paved area next to a road. A worker in a high-visibility vest is standing near the rig. In the background, there are trees, a sign for 'Firs Hotel', and a white van. Orange safety barriers are in the foreground.

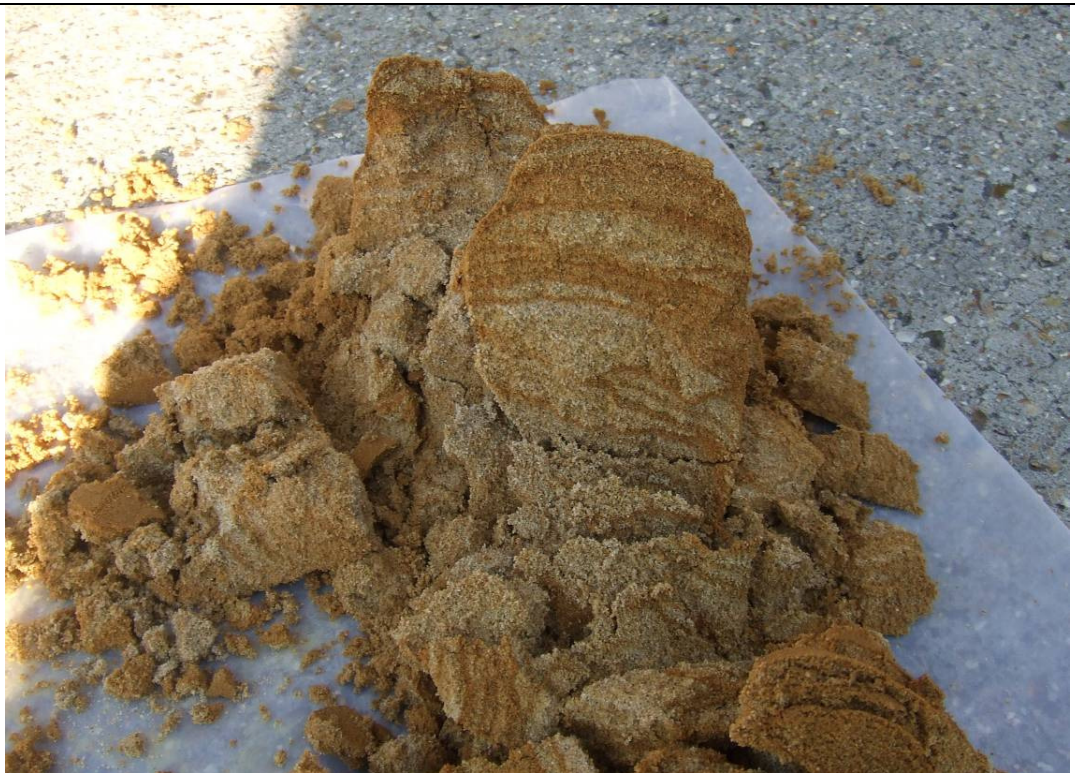
| <b>Photo No.</b><br>10 | <b>Date:</b><br>October<br>2011 | |

| <b>Description:</b><br><br>Soil sample from BH102.<br><br>Sample at 4m bgl showing<br>banding of the sands. | | |

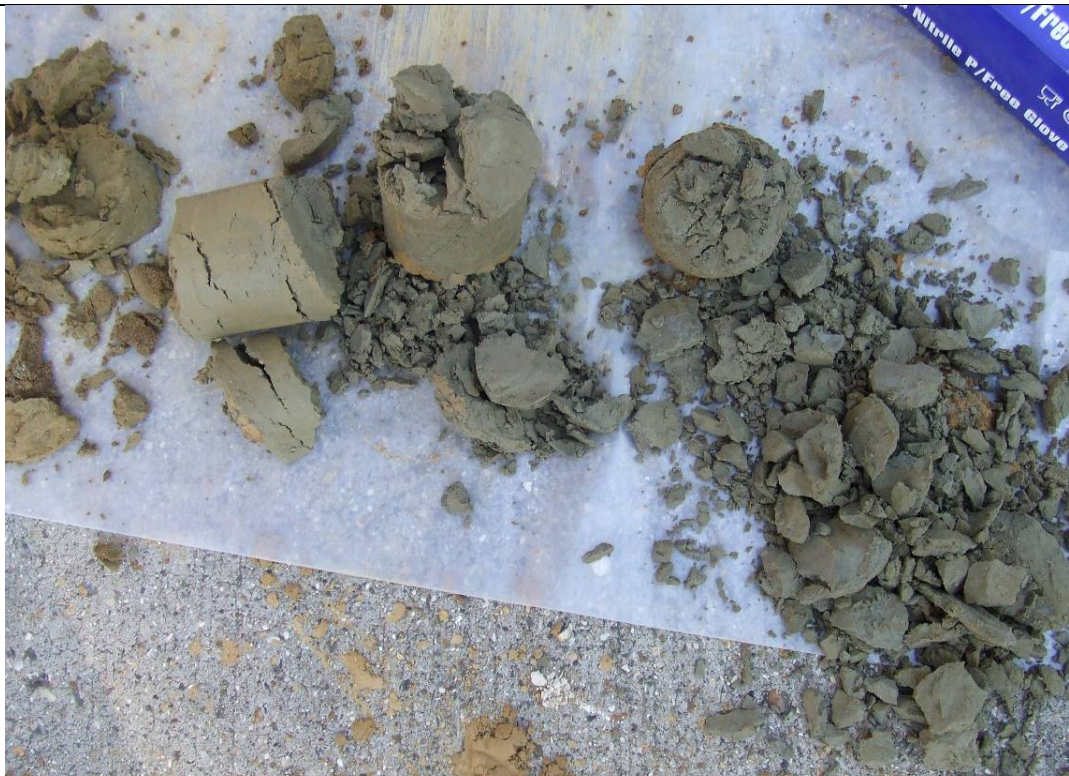
| <b>Photo No.</b><br>11 | <b>Date:</b><br>October<br>2011 | |

| <b>Description:</b><br><br>Soil sample from BH102.<br><br>Silty clay found at 6.5m bgl. | | |

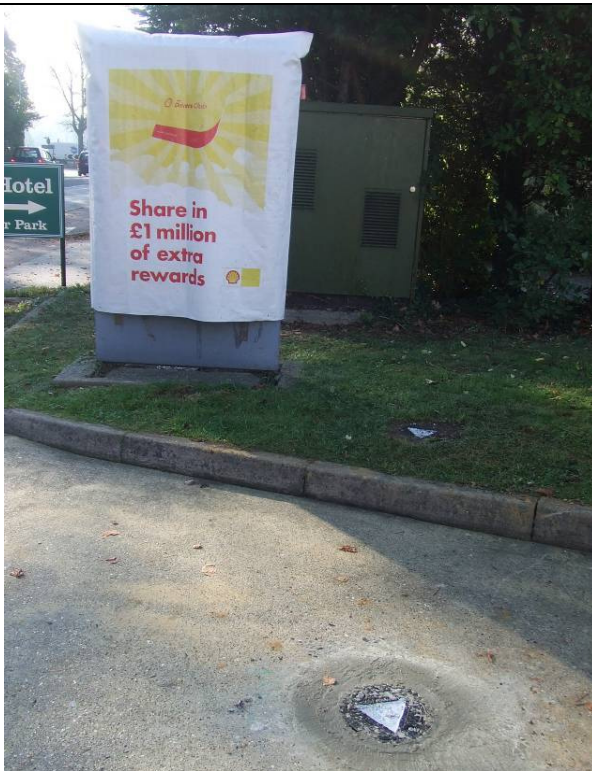
| <b>Photo No.</b><br>12 | <b>Date:</b><br>October<br>2011 | |

| <b>Description:</b><br><br>Installation of BH103 and<br>VP102 (on the grass).<br><br>Photo aspect is south. | | |

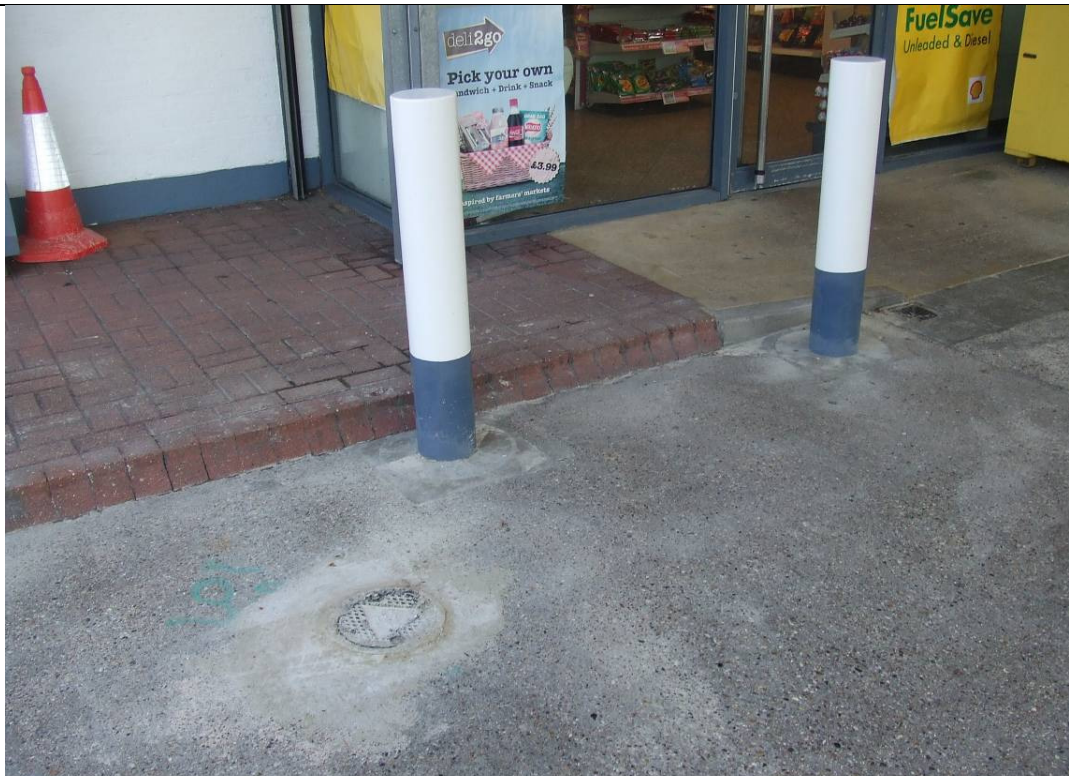
| <b>Photo No.</b><br>13 | <b>Date:</b><br>October<br>2011 |

| <b>Description:</b><br><br>Installation of VP101<br>located in front of the shop. | |

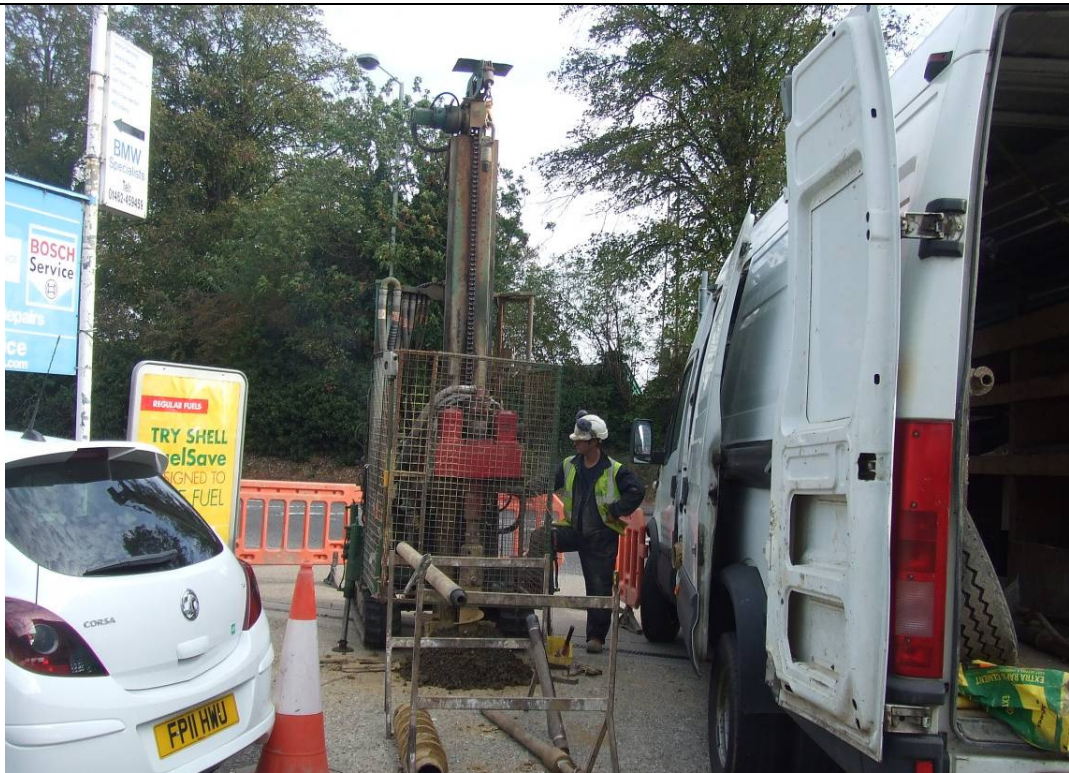
| <b>Photo No.</b><br>14 | <b>Date:</b><br>October<br>2011 | |

| <b>Description:</b><br><br>Drilling of BH 101.<br><br>Photo aspect is west | | |

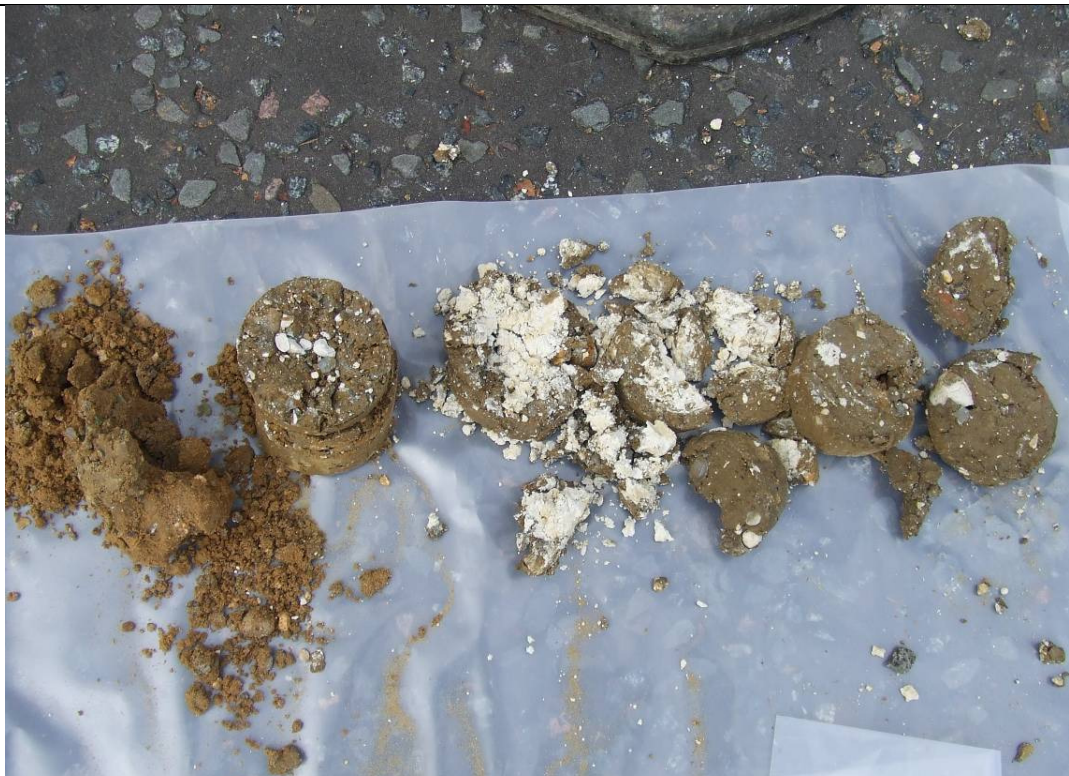
| <b>Photo No.</b><br>15 | <b>Date:</b><br>October<br>2011 | |

| <b>Description:</b><br><br>Soil sample from BH101,<br>chalky sands at 2m bgl. | | |

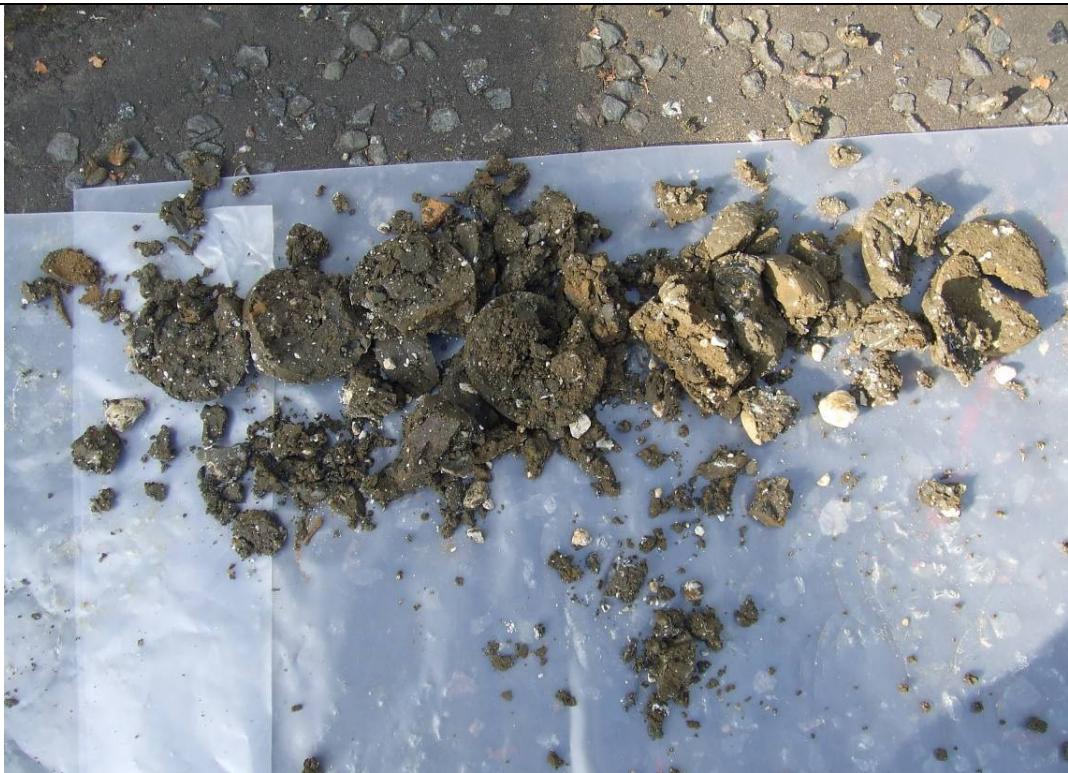
| <b>Photo No.</b><br>16 | <b>Date:</b><br>October<br>2011 | |

| <b>Description:</b><br><br>Soil sample from BH101,<br>slightly chalky sands at 7m<br>bgl. | | |

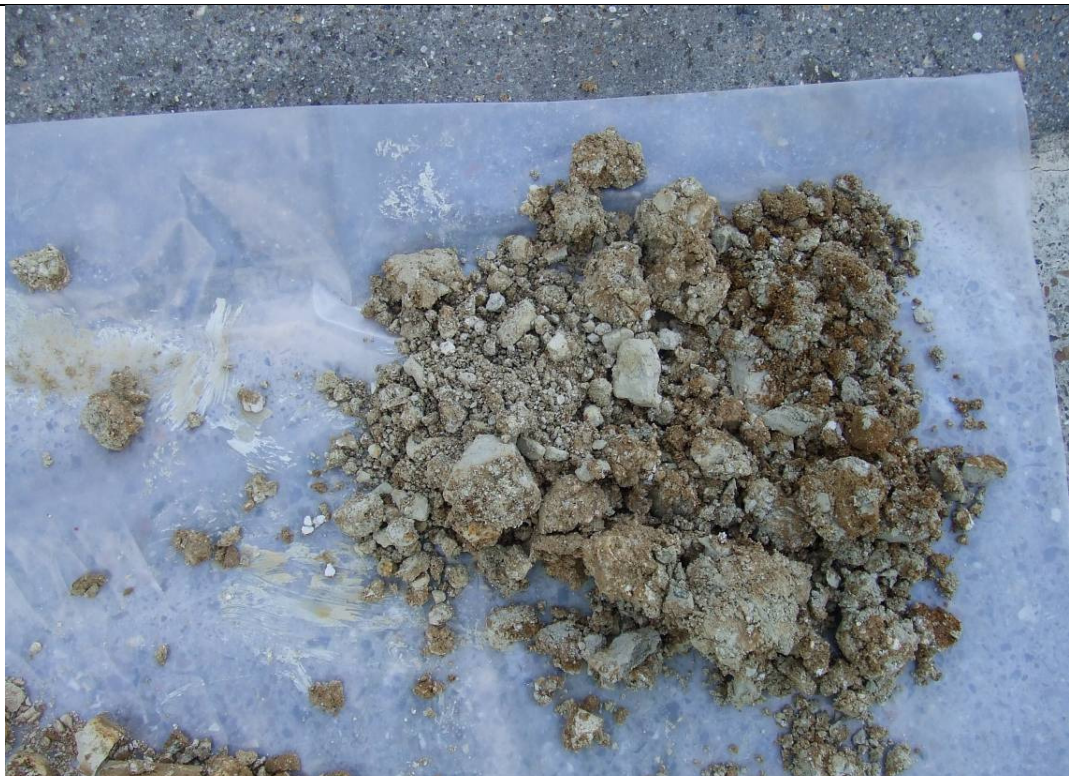
| <b>Photo No.</b><br>17 | <b>Date:</b><br>October<br>2011 | |

| <b>Description:</b><br><br>Soil sample from BH106,<br>chalky sands at 5.4m bgl. | | |

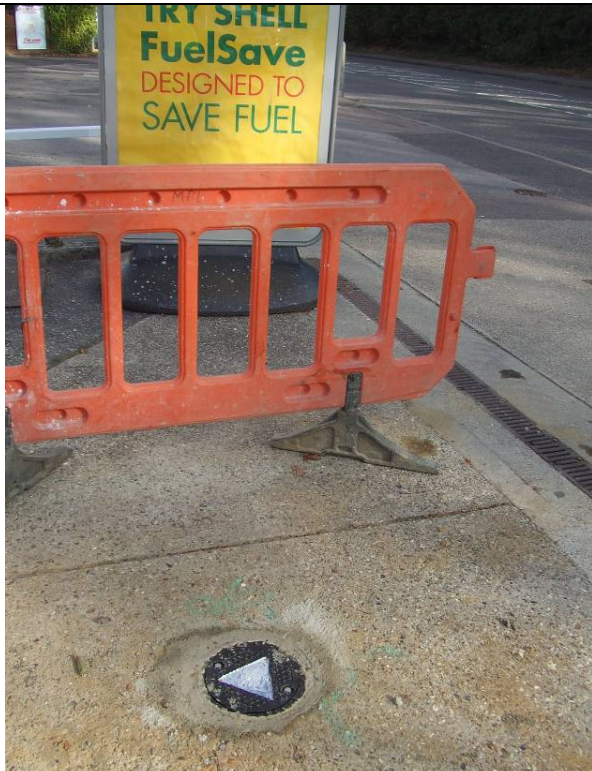
| <b>Photo No.</b><br>18 | <b>Date:</b><br>October<br>2011 | |

| <b>Description:</b><br><br>Installation of BH101.<br><br>Photo aspect is north east. | | |
