Report prepared for: David White

For the Site of: The White House, Valley Rise, Royston, SG8 9GH

# Emergence and Activity Bat Survey (EBS)

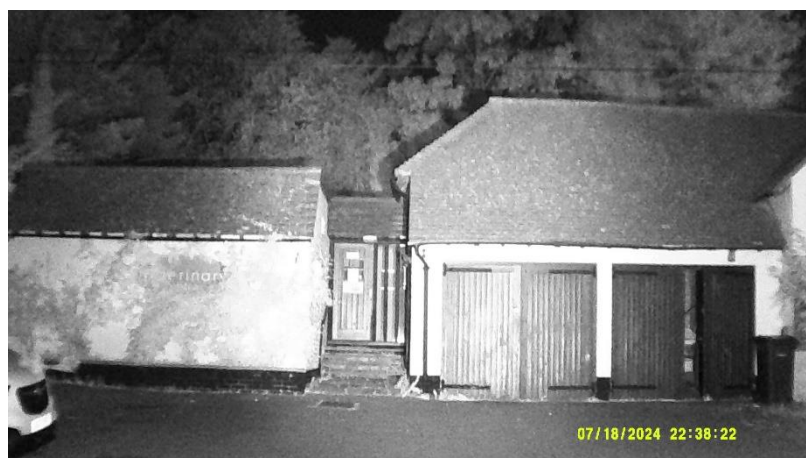
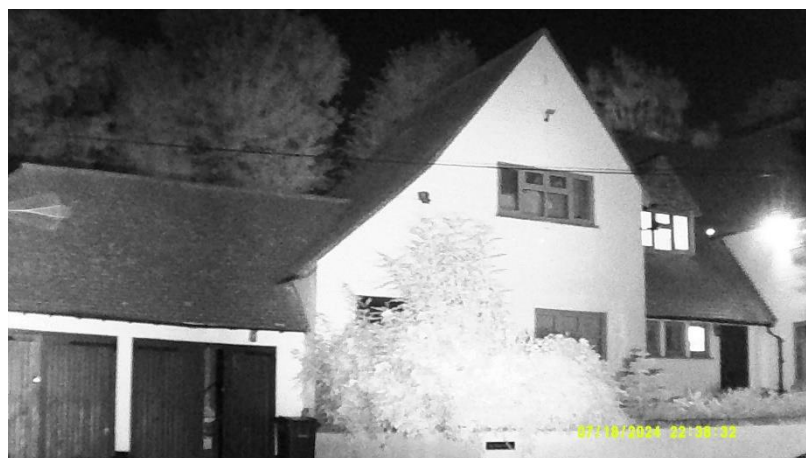
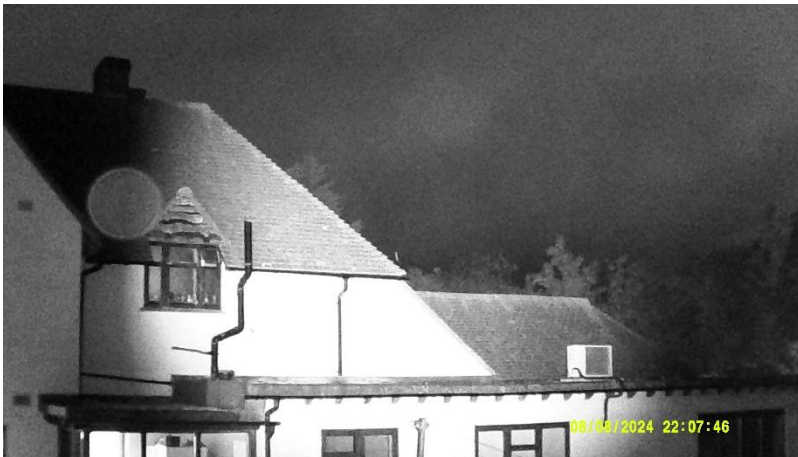
**IR at the darkest point:**

18/07/2024 - No bat emergences

08/08/2024 - No bat emergences
