# **Drainage Strategy Update**

**Proposed Residential Development  
Land off Gray's Lane  
Hitchin  
Hertfordshire**

**Revision B: July 2025  
Report Reference: 1318-FRA-01-B**

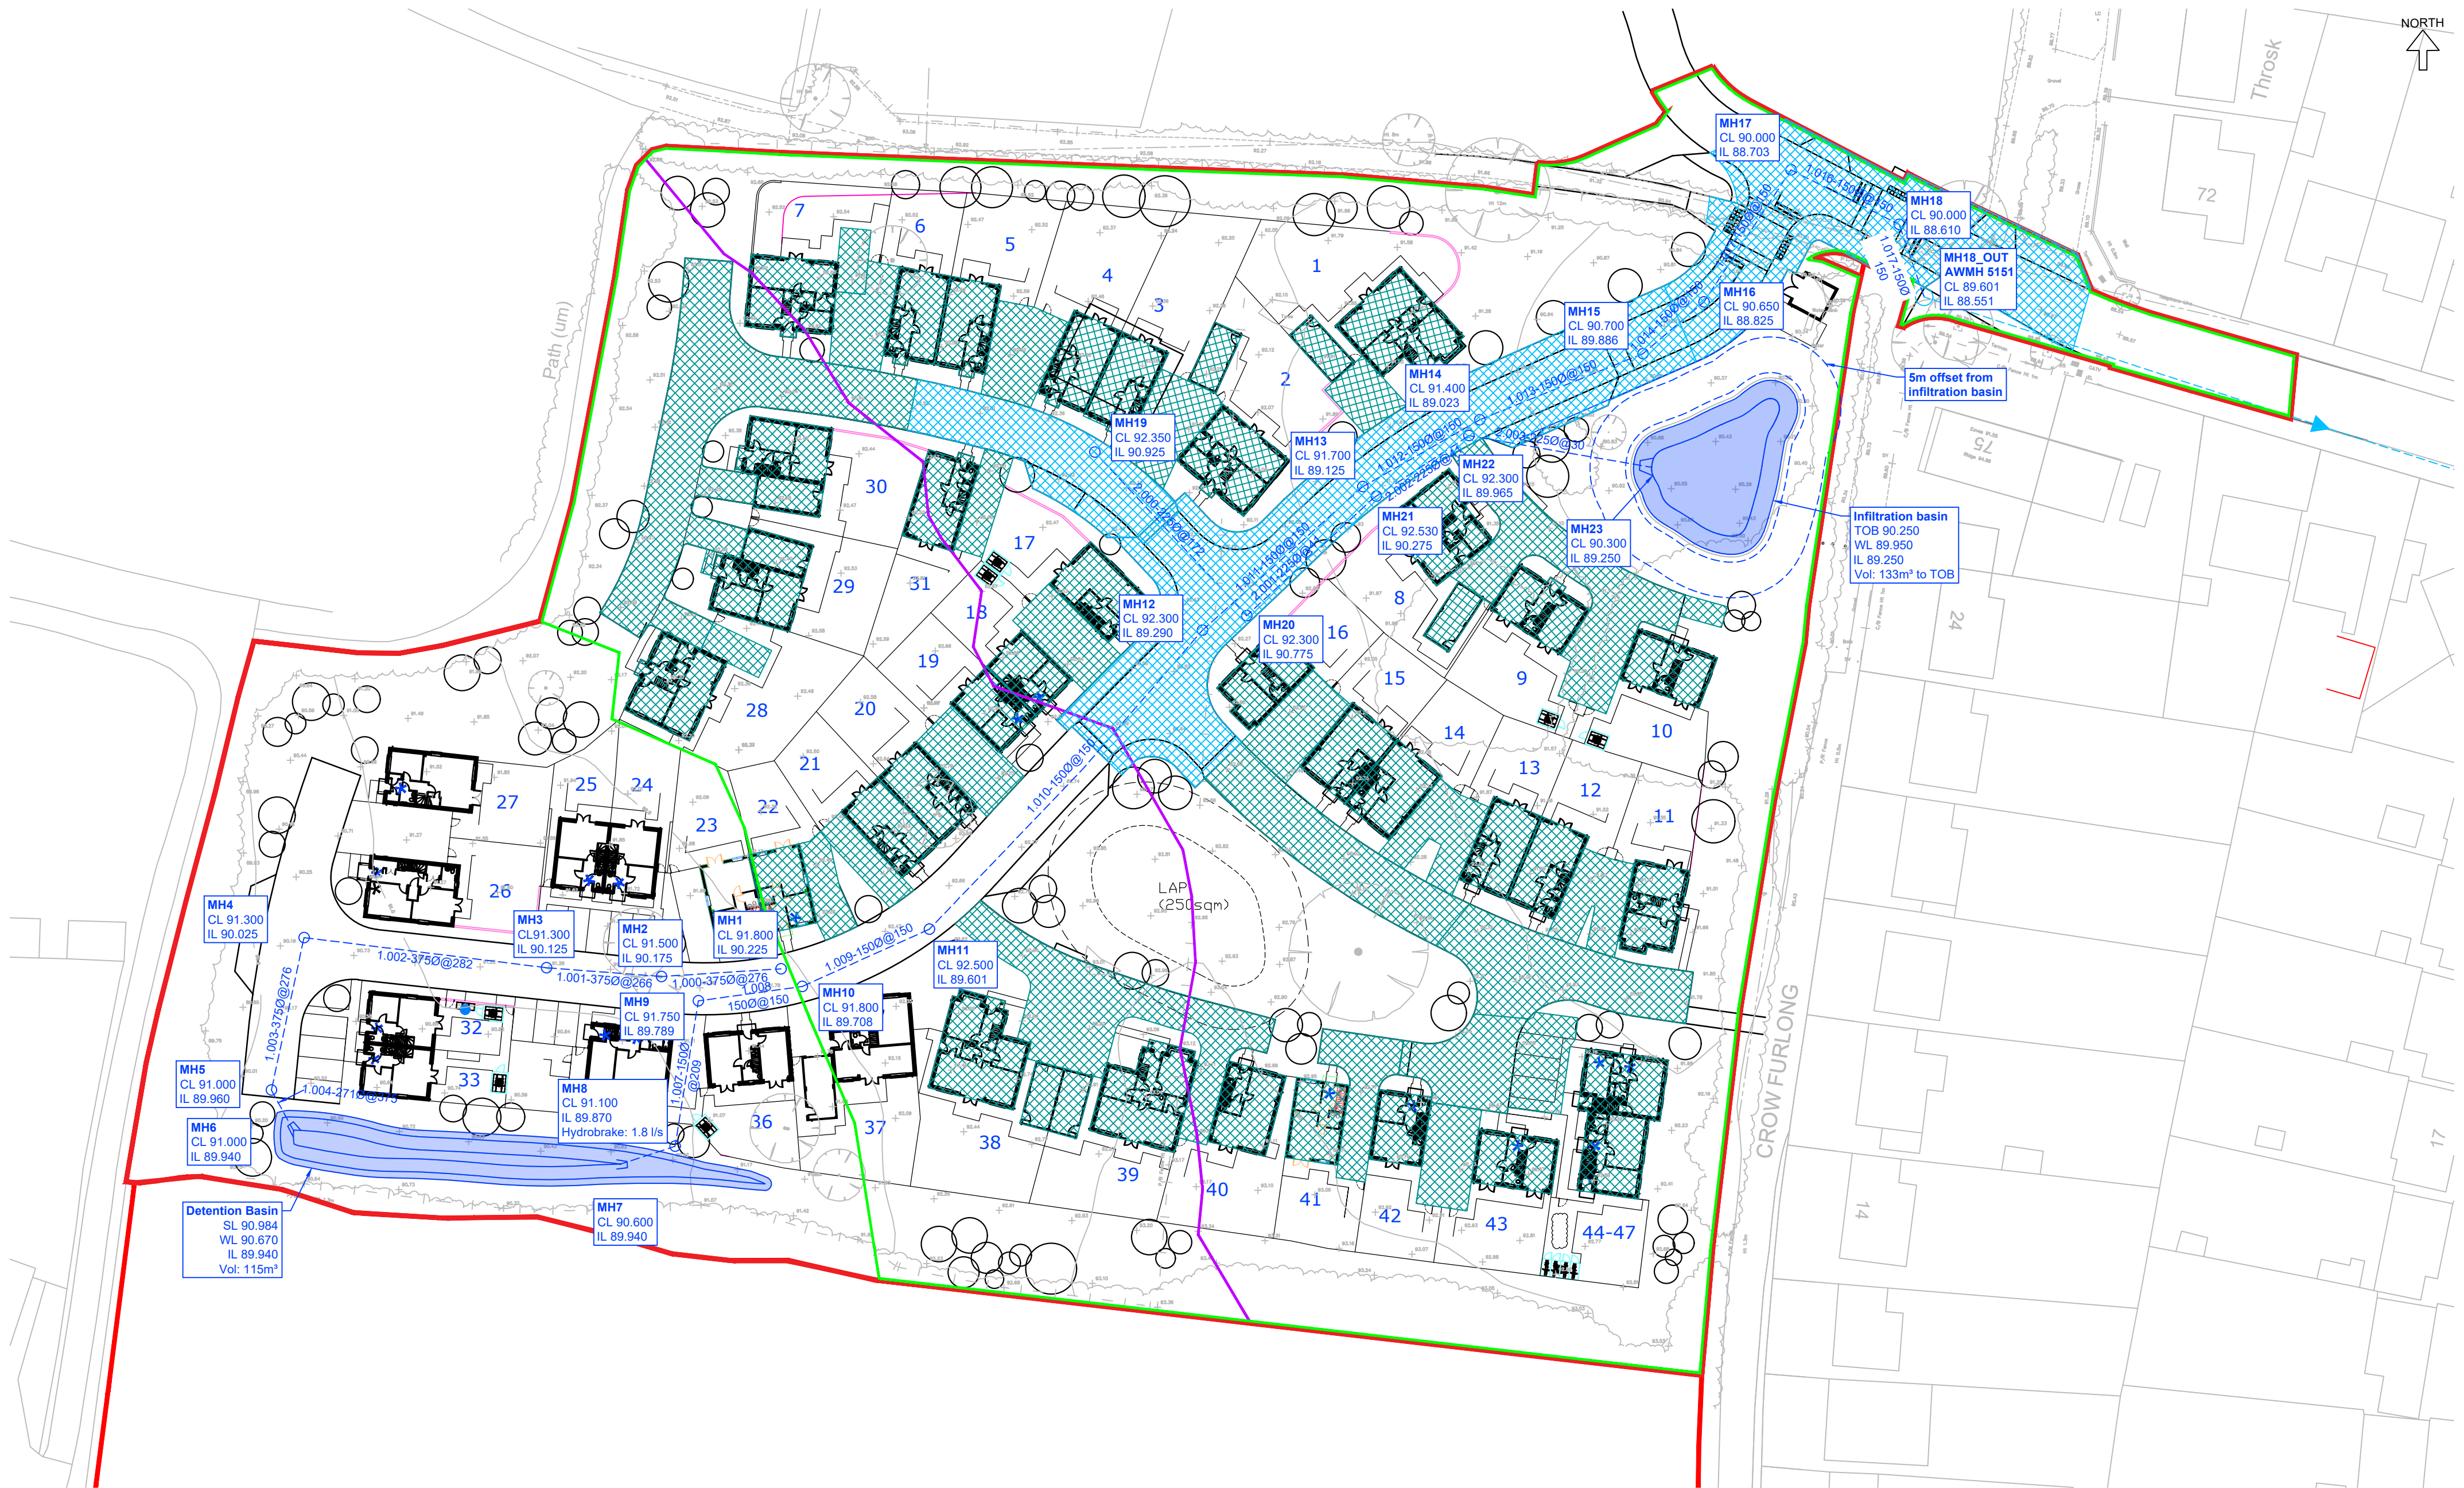
Proposed Drainage Strategy  
MAC drawing no. 1318-FRA113C  
and  
Indicative Extent of Permeable Paving  
MAC drawing no. 1318-FRA114B

- Boundary where infiltration techniques are to be used as permeable paving
- Pipe code - diameter @ fall
- Drains to infiltration basin
- Drains to permeable paving

2.4.1 Surface water discharge from the proposed development will utilise infiltration techniques where these are viable in the form of permeable paving and an infiltration basin. For the other areas of the site surface water will outfall to the surface water sewer located in Gray's Lane. It is not feasible to use the infiltration basin for these areas due to the level differences. Where surface water discharges from the site the rate of discharge will be restricted to minimum viable run-off rates to ensure that the rate of surface water run-off from the site does not increase as a result of the proposed development.

- A piped network.
- Hydrobrake flow control.
- Permeable paving - untanked and tanked for private drives.
- Infiltration basin
- Online detention basin.

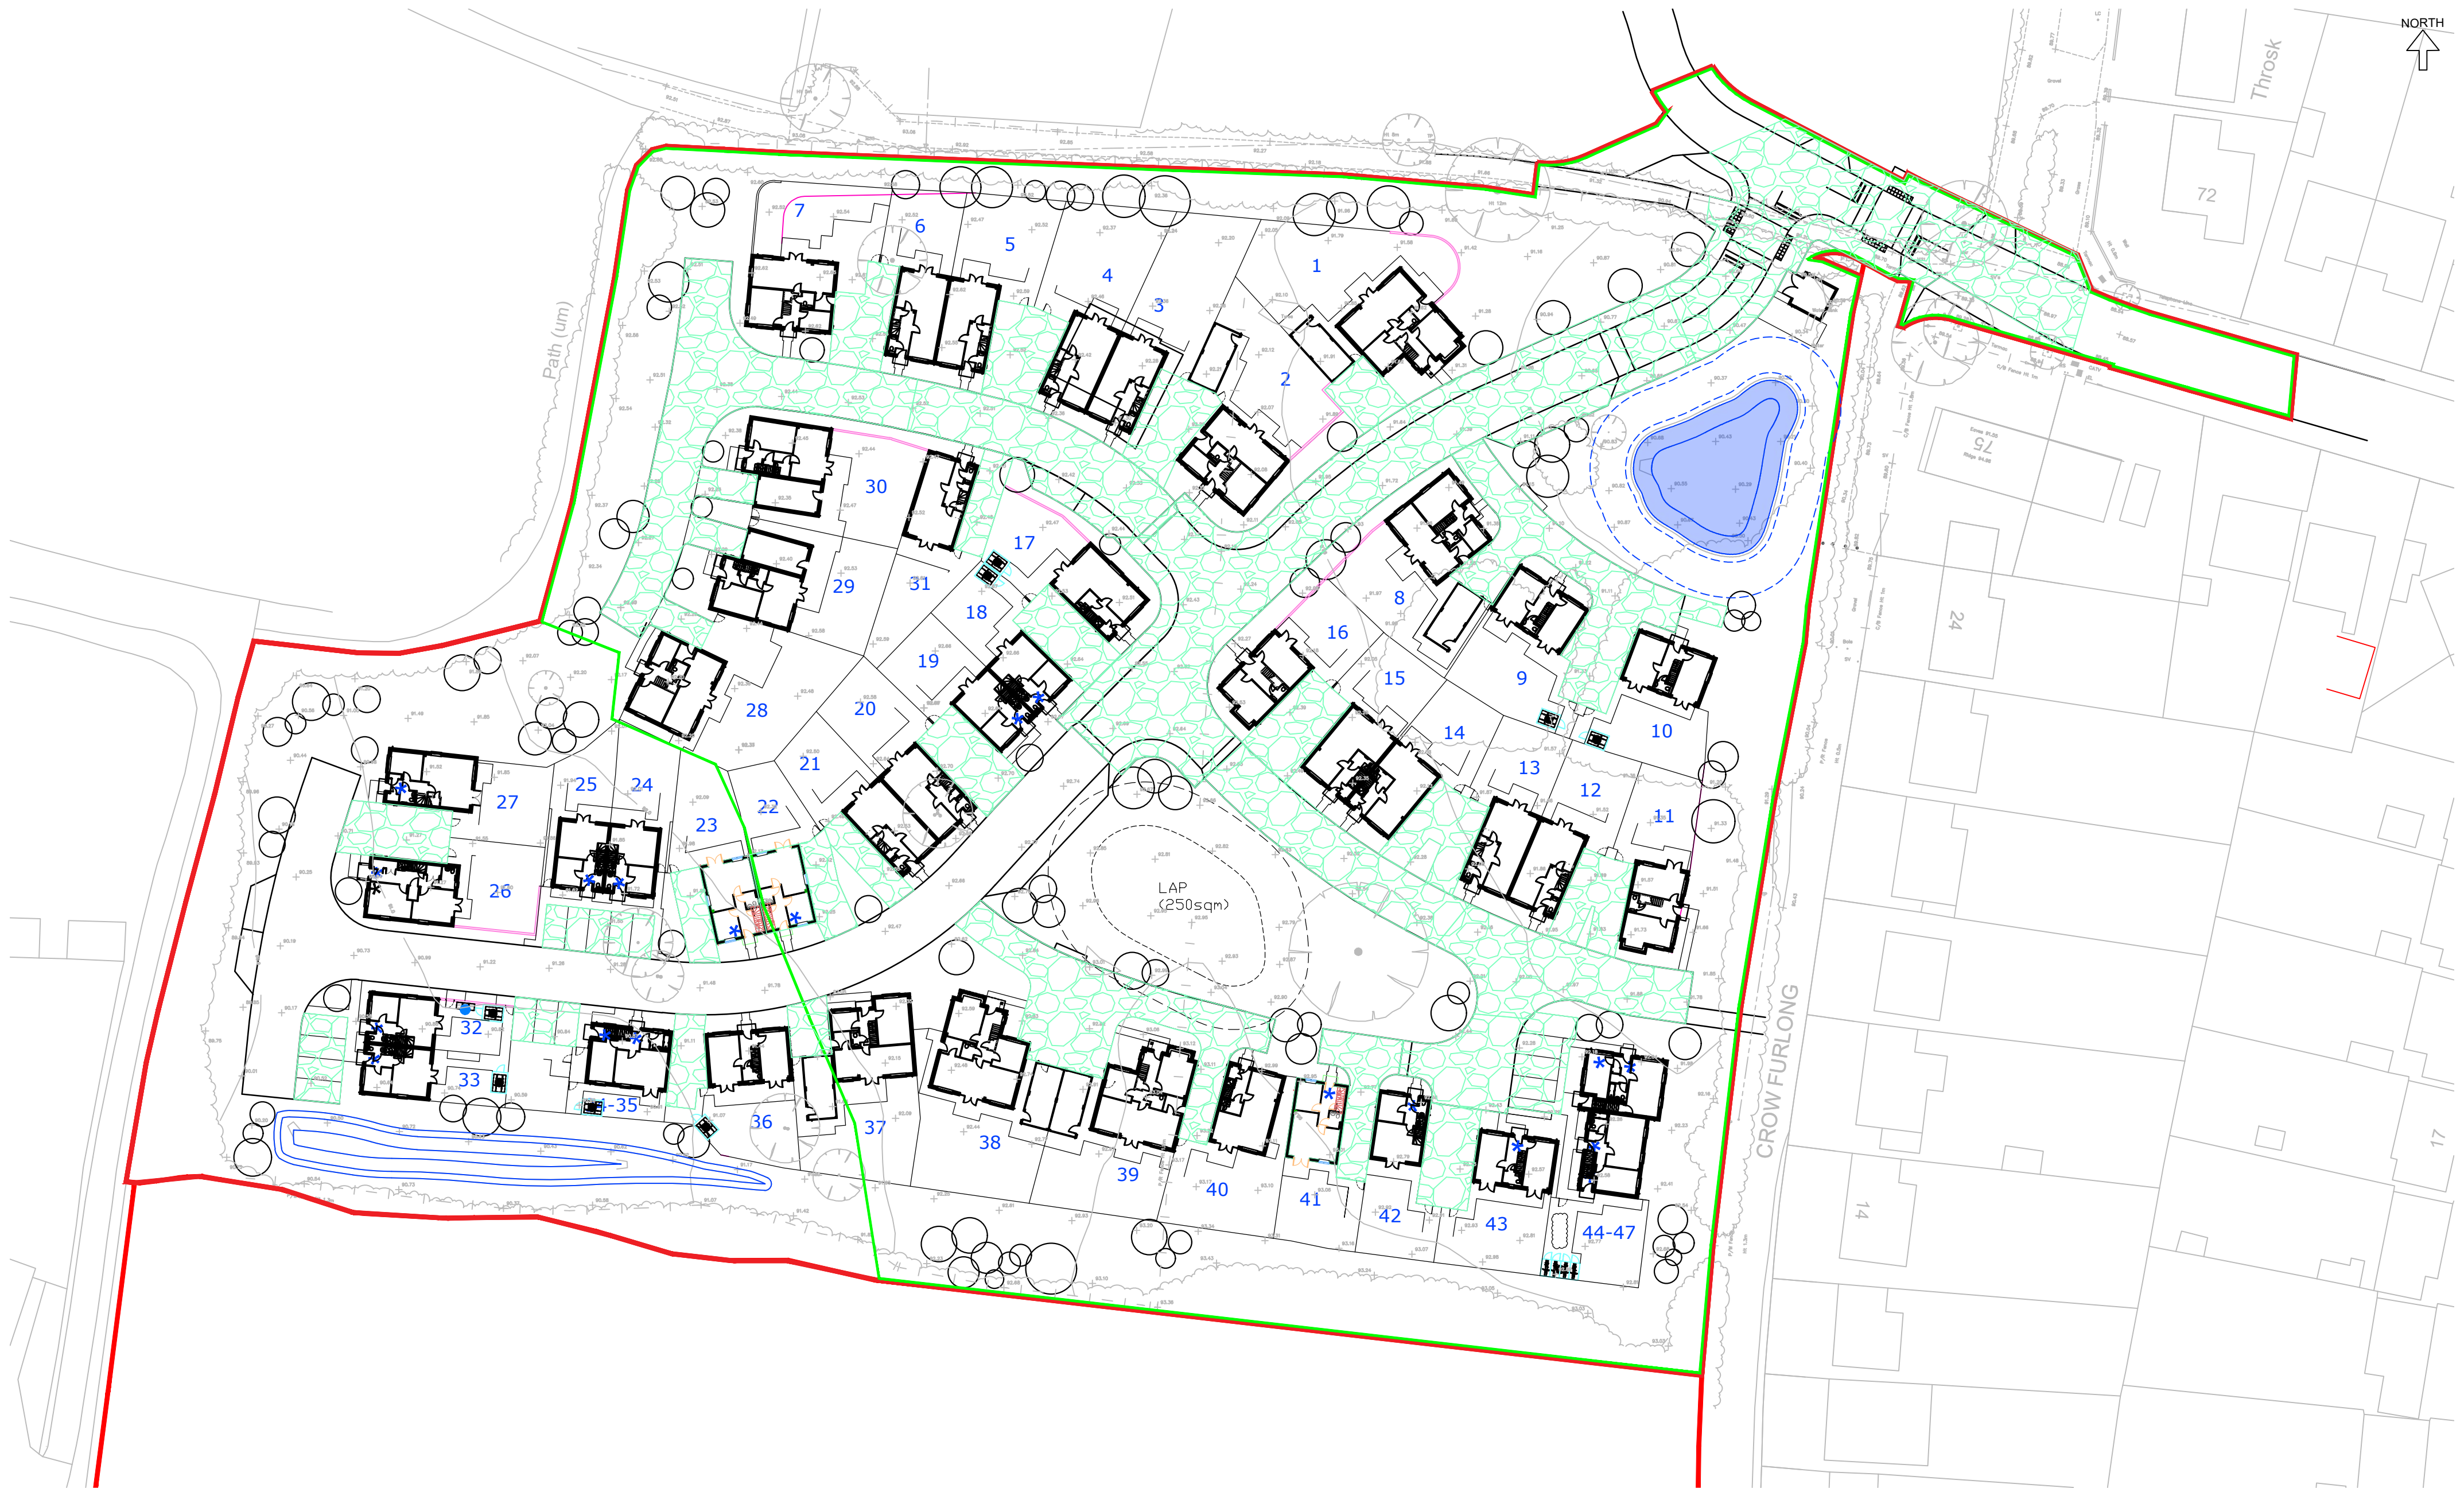
Key  
— Site Boundary = 21,935m<sup>2</sup>

Indicative Extent of Permeable Paving - tanked where infiltration is unviable with connection to proposed SW drainage system

2.6.1 Permeable paving will be utilised to drain parts of the site where infiltration is viable. This will typically be used for private, shared drives and dwelling roofs. The infiltration design is based on the worst-case infiltration rate for the test nearest to the infiltration area, using the values set out in **Table 2.4**. The minimum depths of sub-base or subbase replacement (SR) required to achieve adequate storage for a 1 in 100 year plus climate change event is set out in **Table 2.7**. Full calculations are enclosed in **Appendix E**.

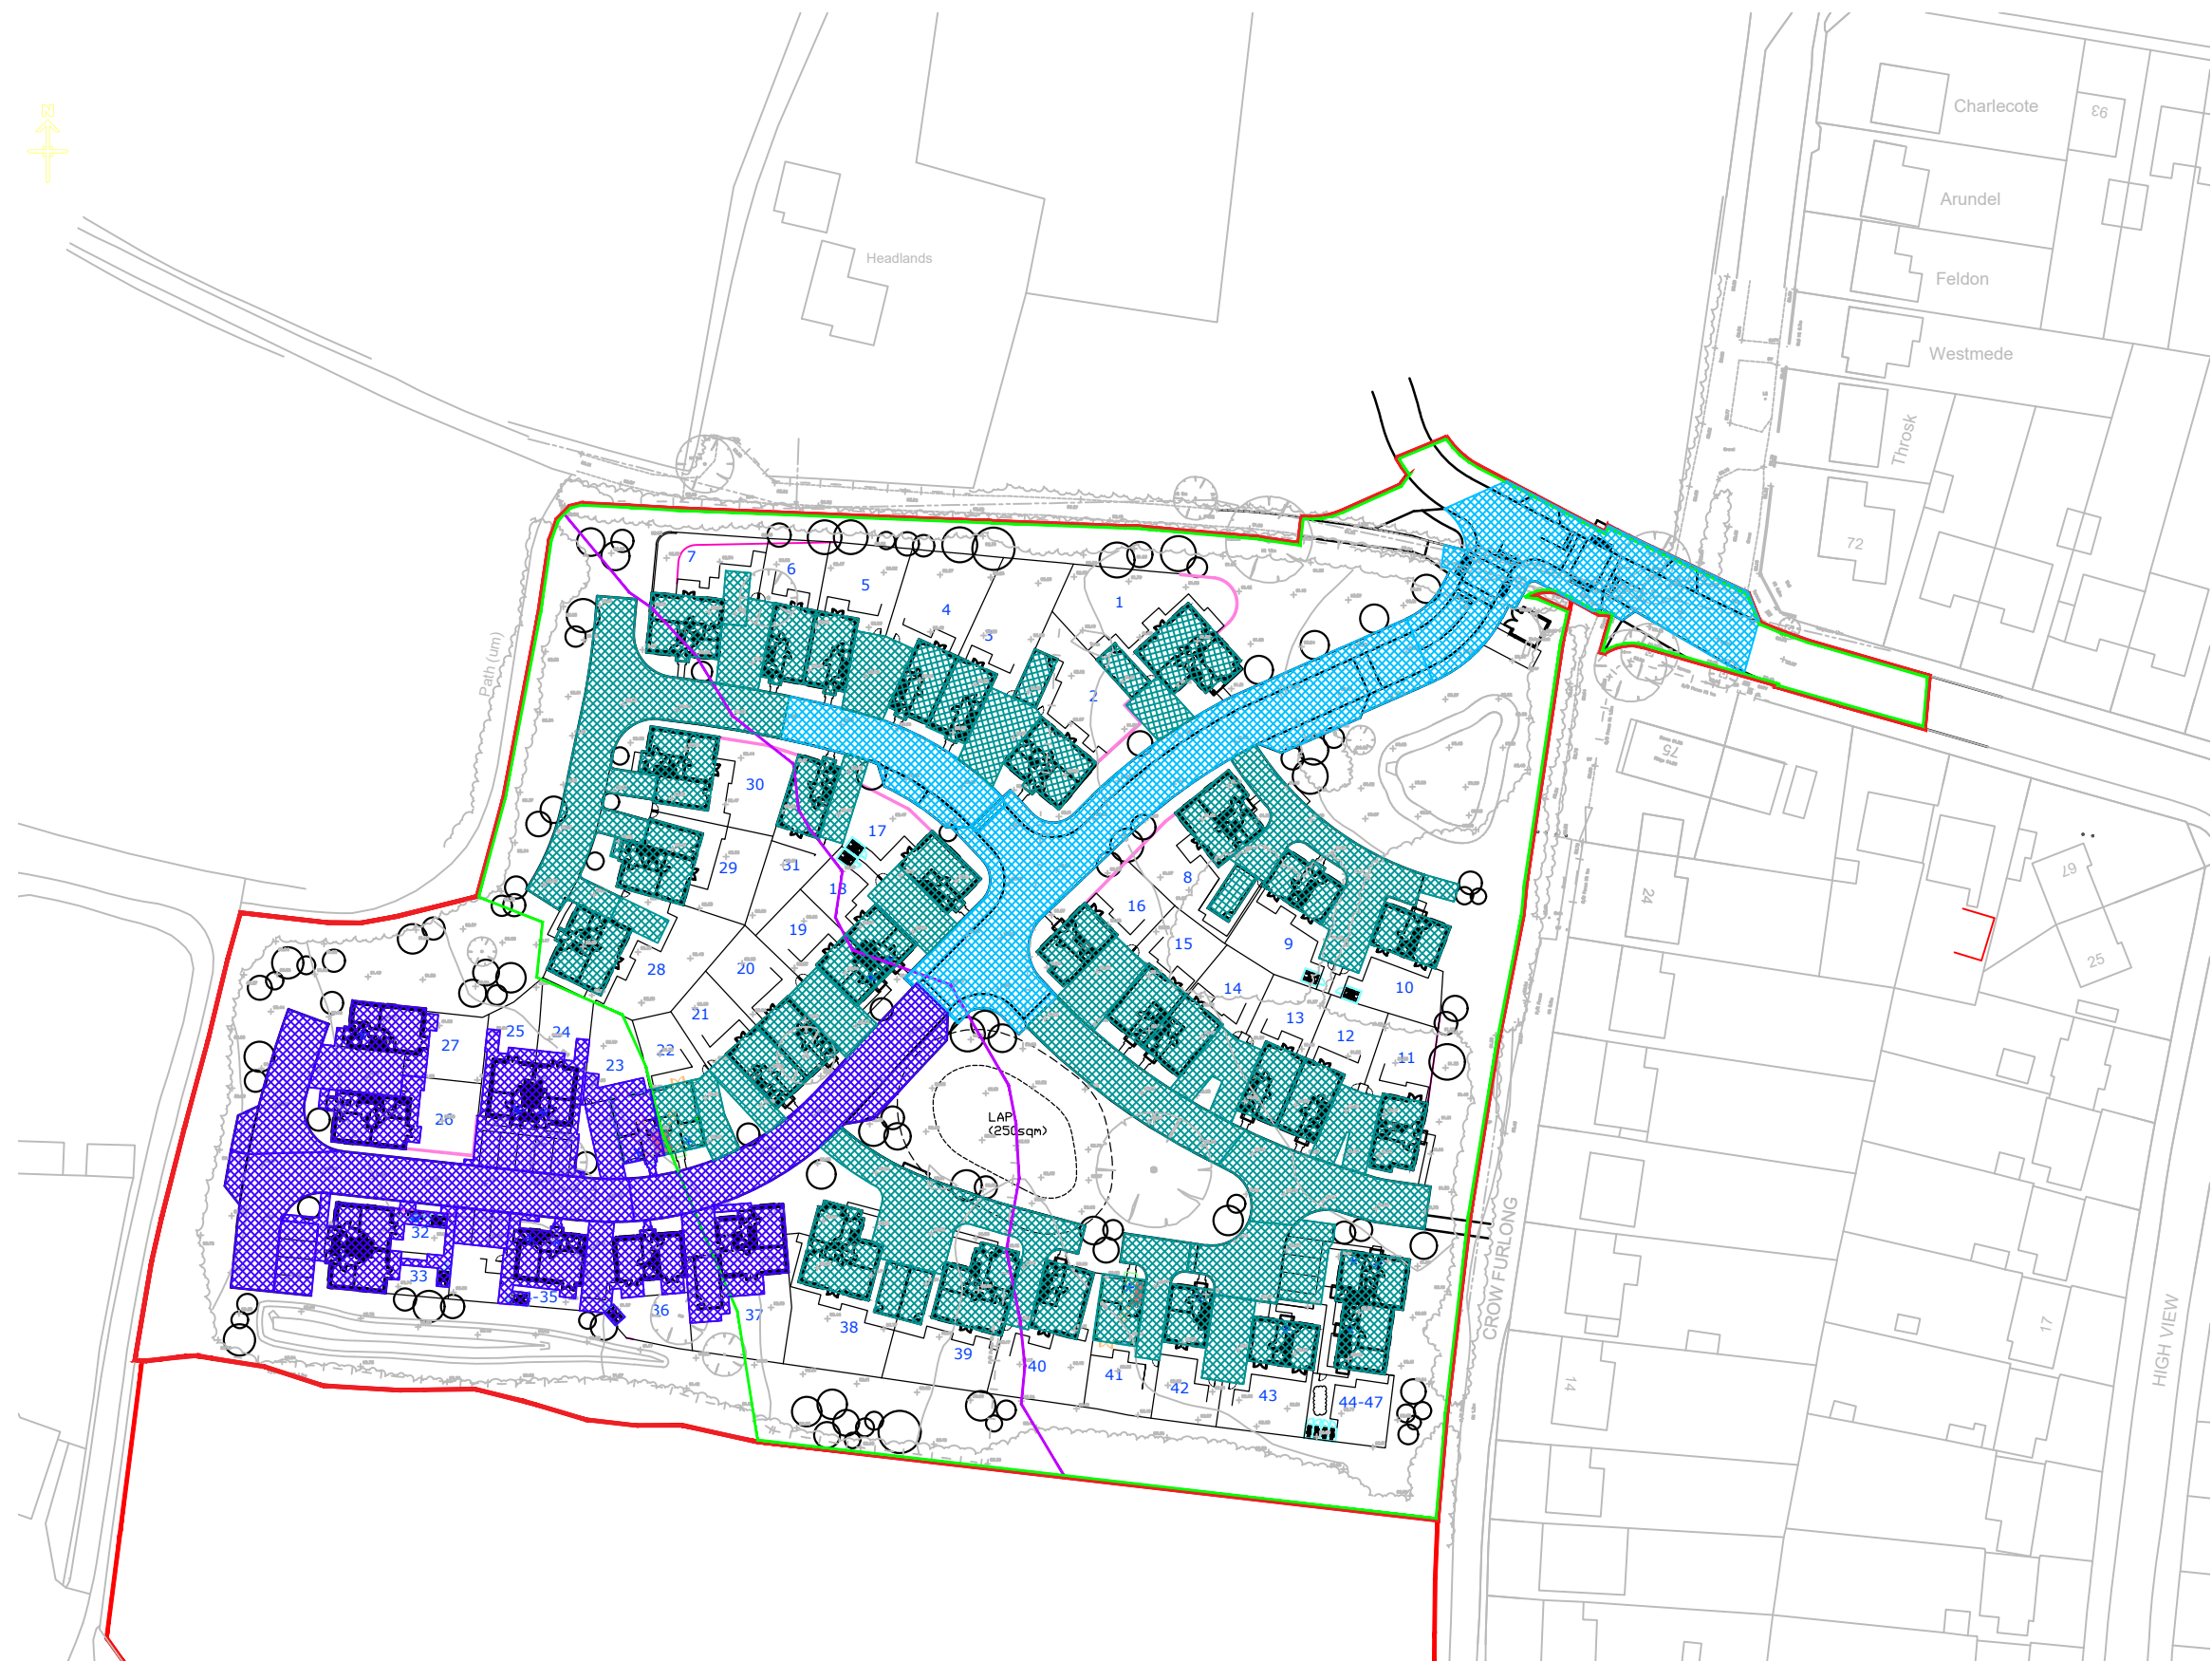
Proposed Impermeable Area  
MAC drawing no. 1318-FRA112B

- Key:
- Site Boundary = 21,935m<sup>2</sup>
  - Indicative Ridge Line of Drainage Catchment
  - Boundary where infiltration techniques are to be used as permeable paving

- Proposed Impermeable Area
- Eastern Catchment
- To Infiltration Basin = 1,723m<sup>2</sup>
  - To Permeable Paving = 5,047m<sup>2</sup>
- Western Catchment = 2,233m<sup>2</sup>
- Total = 9,023m<sup>2</sup>

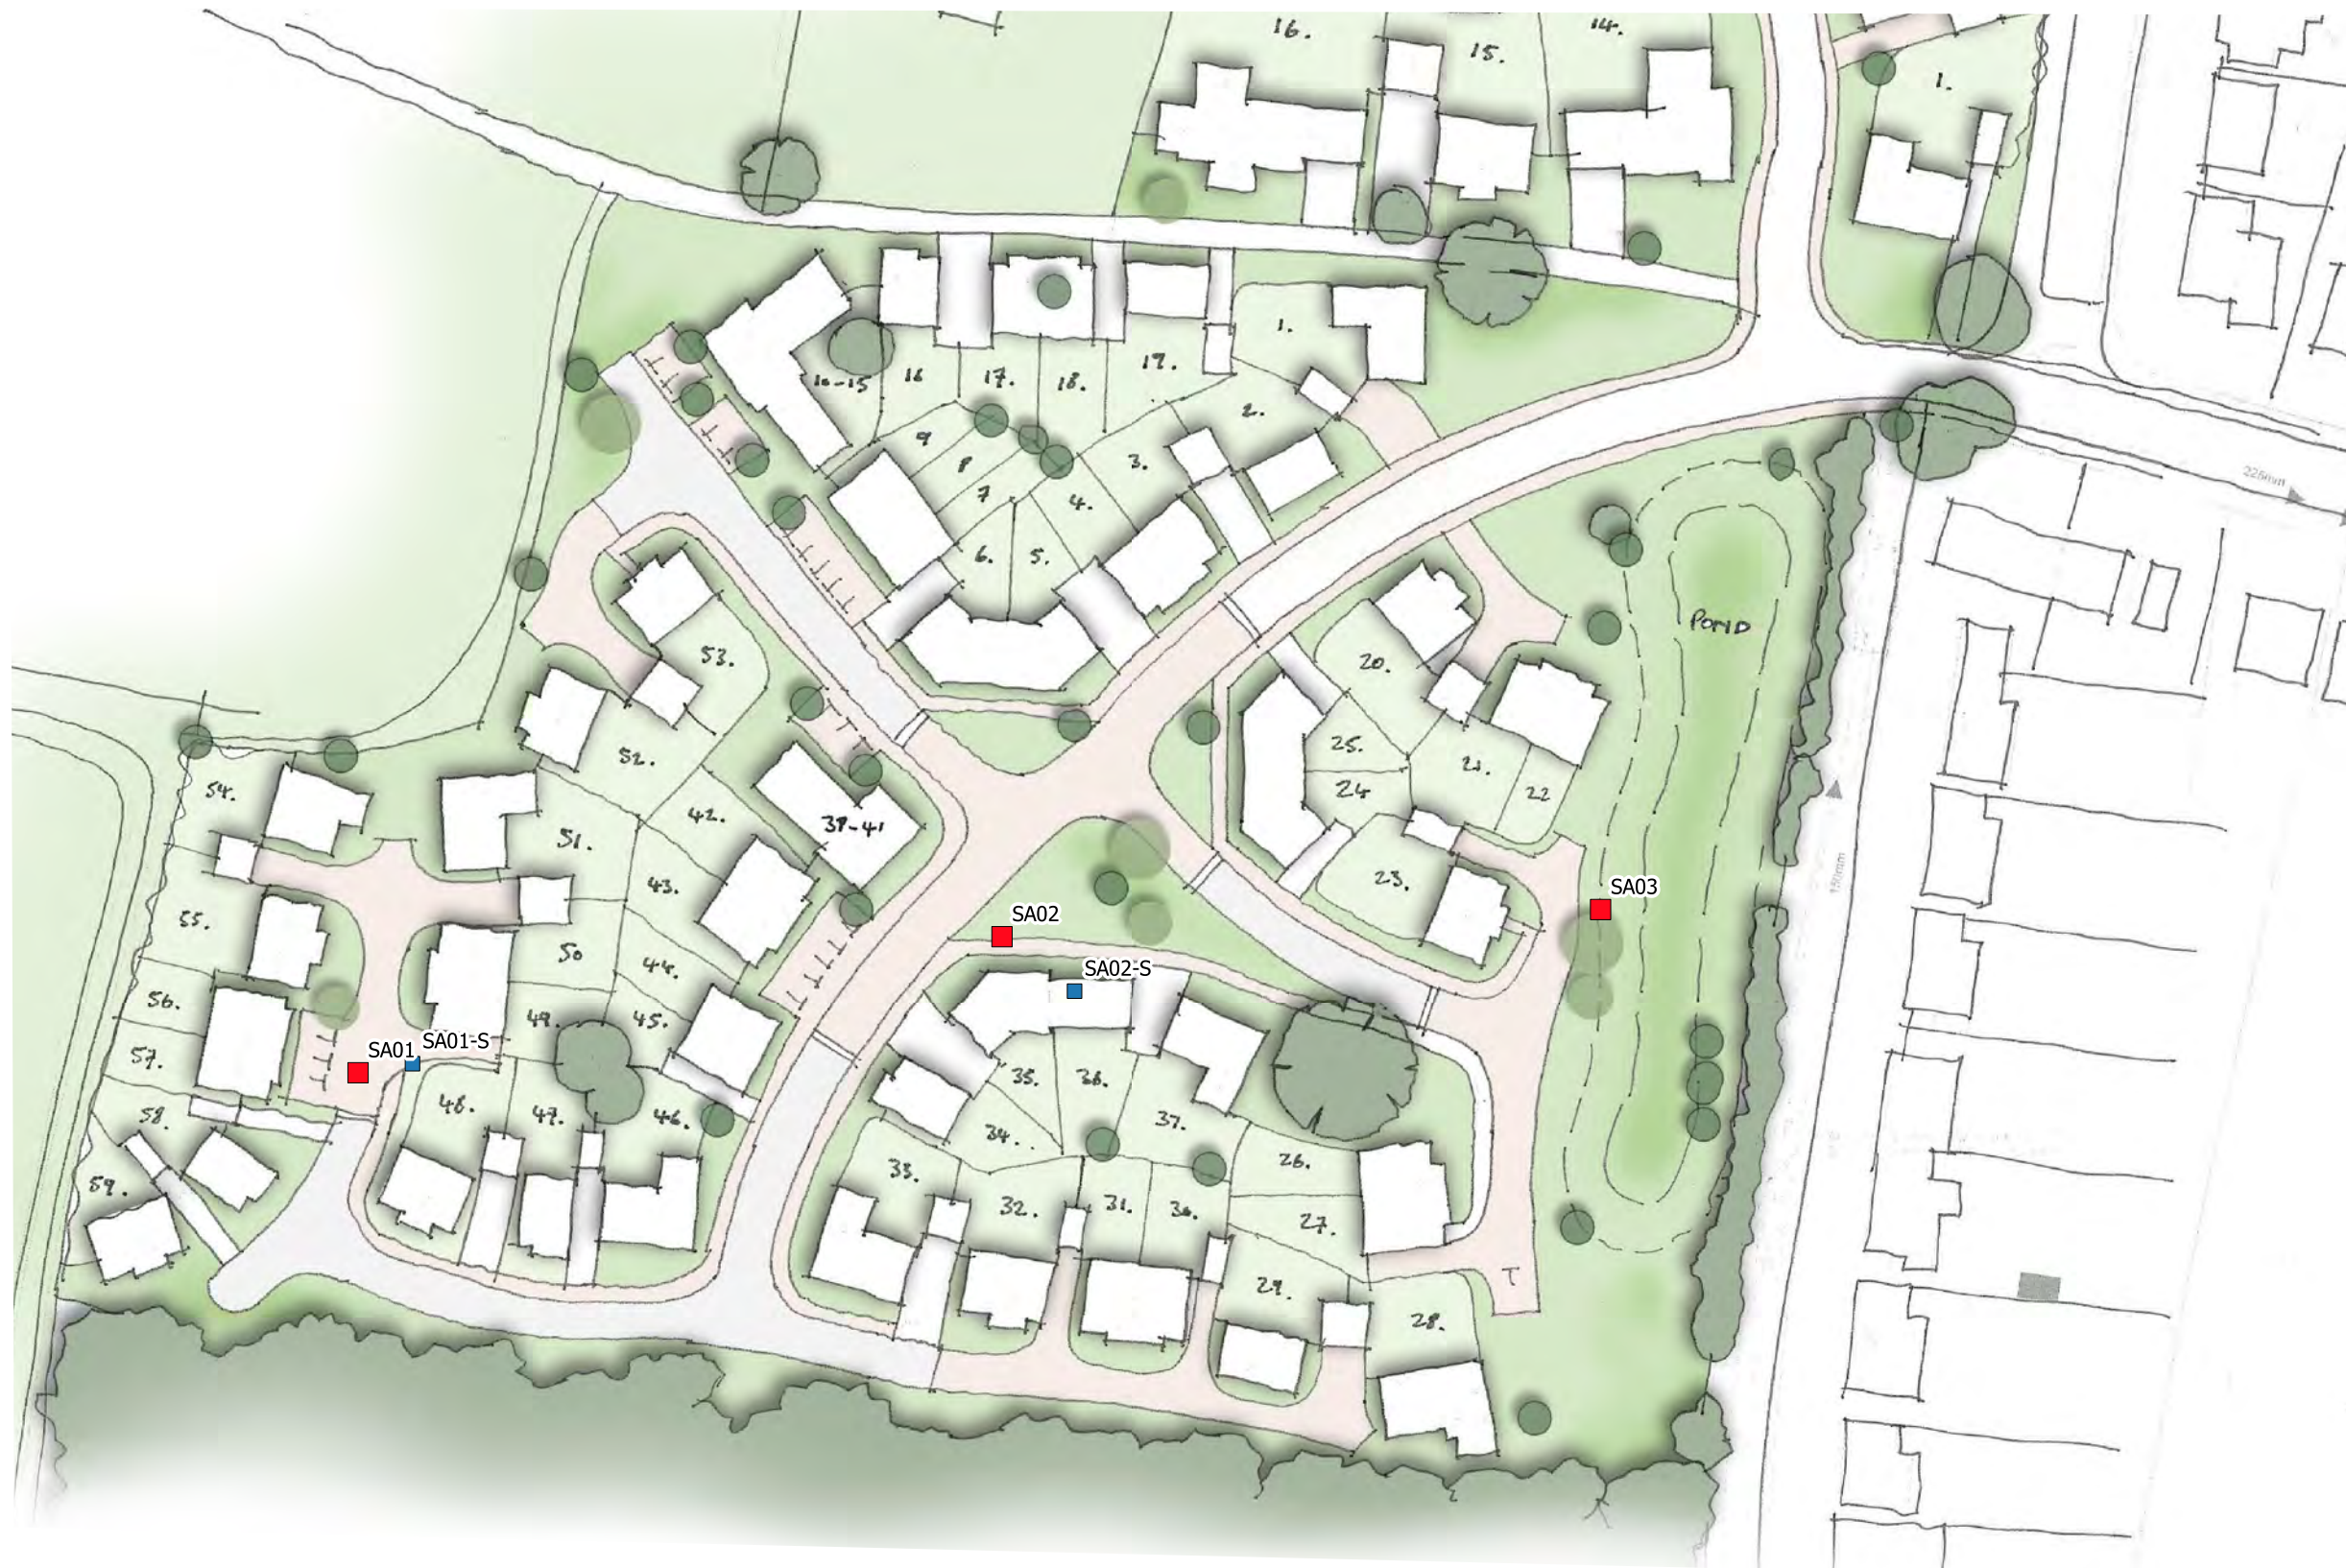
- Soakaway test location (conventional)
- Soakaway test location (permeable paving)

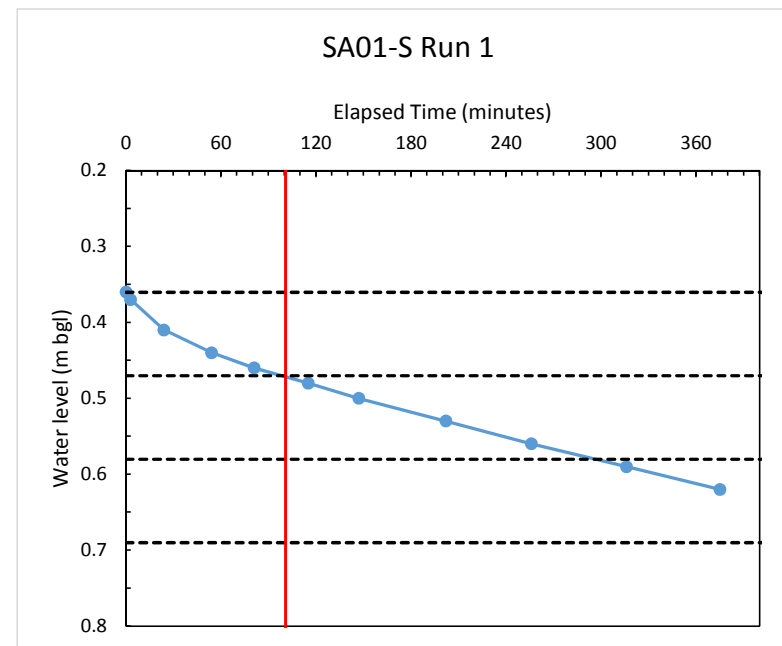
Project Name: Gray's Lane, Hitchin  
 Project Number: EMS6636  
 Date of Test: 19/12/2016  
 Test Location: SA01-S Run 1  
 The test pit was not filled with gravel.

Depth of pit (m): 0.80  
 Width of pit (m): 0.50  
 Length of pit (m): 1.00

$V_{p75-25} = 0.11$   
 $a_{s50} = 1.16$   
 $t_{p75-25} = \text{N/R}$  minutes  
 **$f$  (soil infiltration rate) = N/A** m/s

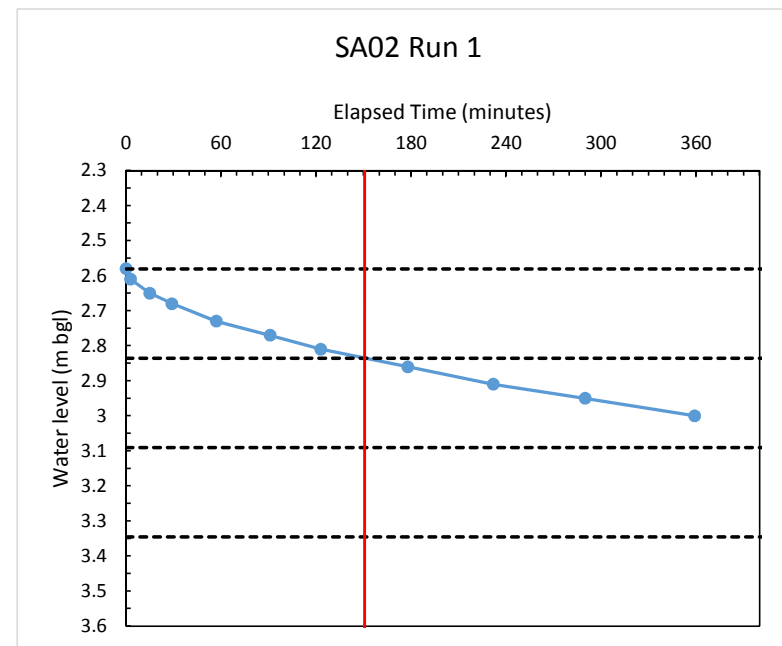
Project Name: Gray's Lane, Hitchin  
 Project Number: EMS6636  
 Date of Test: 19/12/2016  
 Test Location: SA02 Run 1  
 The test pit was not filled with gravel.

Depth of pit (m): 3.60  
 Width of pit (m): 0.50  
 Length of pit (m): 1.60

$V_{p75-25} = 0.41$   
 $a_{s50} = 2.94$   
 $t_{p75-25} = \text{N/R}$  minutes  
 **$f$  (soil infiltration rate) = N/A** m/s

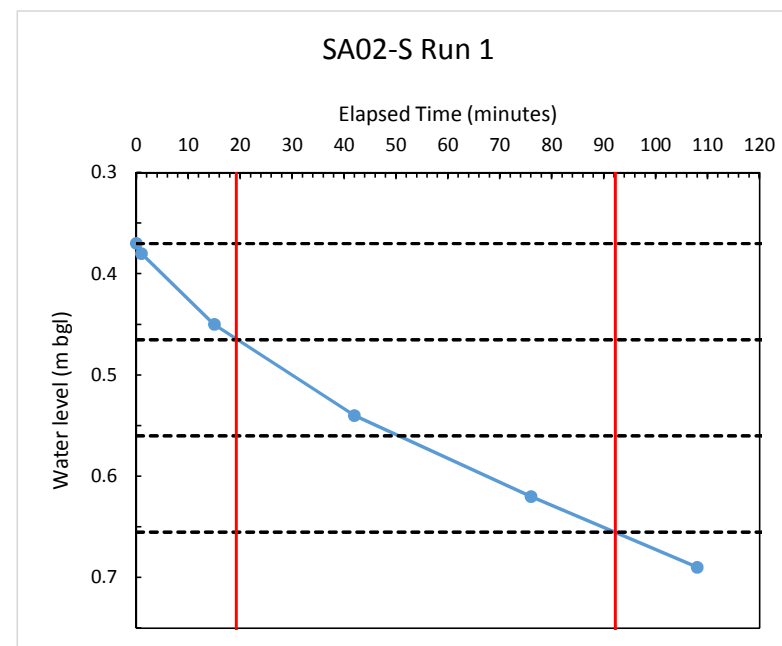
Project Name: Gray's Lane, Hitchin  
 Project Number: EMS6636  
 Date of Test: 19/12/2016  
 Test Location: SA02-S Run 1  
 The test pit was not filled with gravel.

Depth of pit (m): 0.75  
 Width of pit (m): 0.50  
 Length of pit (m): 1.10

$V_{p75-25} = 0.10$   
 $a_{s50} = 1.16$   
 $t_{p75-25} = 73 \text{ minutes}$   
 **$f$  (soil infiltration rate) =  $2.06E-05 \text{ m/s}$**

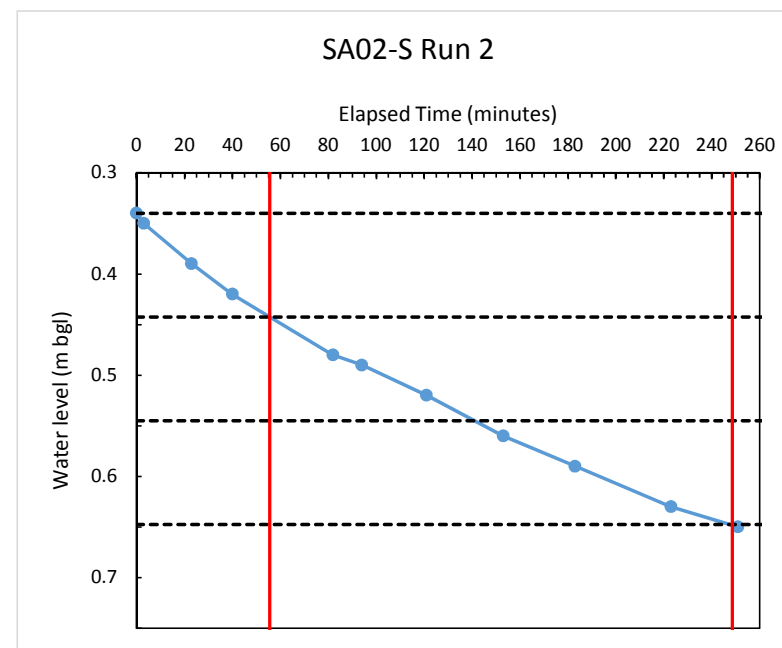
Project Name: Gray's Lane, Hitchin  
 Project Number: EMS6636  
 Date of Test: 19/12/2016  
 Test Location: SA02-S Run 2  
 The test pit was not filled with gravel.

Depth of pit (m): 0.75  
 Width of pit (m): 0.50  
 Length of pit (m): 1.10

$V_{p75-25} = 0.11$   
 $a_{s50} = 1.21$   
 $t_{p75-25} = 193$  minutes  
 **$f$  (soil infiltration rate) =  $8.07E-06$  m/s**

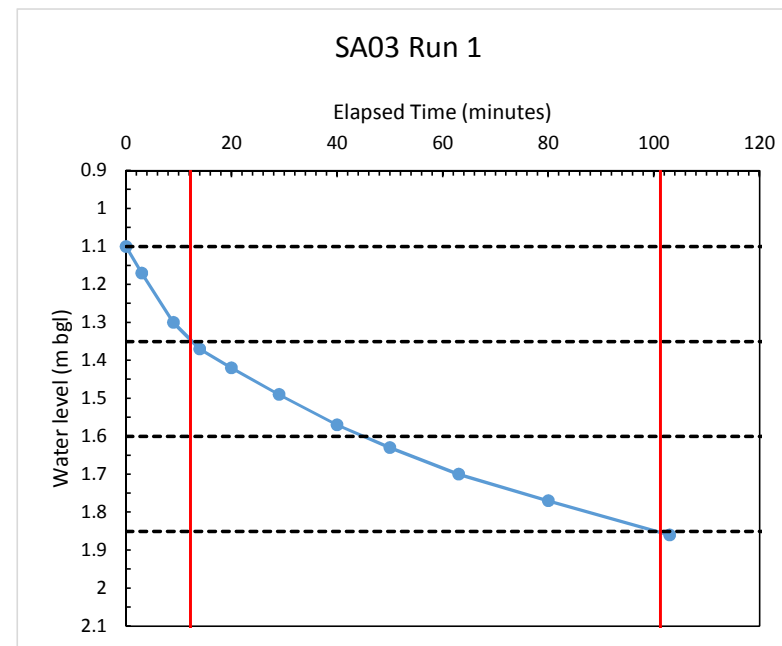
Project Name: Gray's Lane, Hitchin  
 Project Number: EMS6636  
 Date of Test: 19/12/2016  
 Test Location: SA03 Run 1  
 The test pit was not filled with gravel.

Depth of pit (m): 2.10  
 Width of pit (m): 0.50  
 Length of pit (m): 1.80

$V_{p75-25} = 0.45$   
 $a_{s50} = 3.20$   
 $t_{p75-25} = 89$  minutes  
 **$f$  (soil infiltration rate) =  $2.63E-05$  m/s**

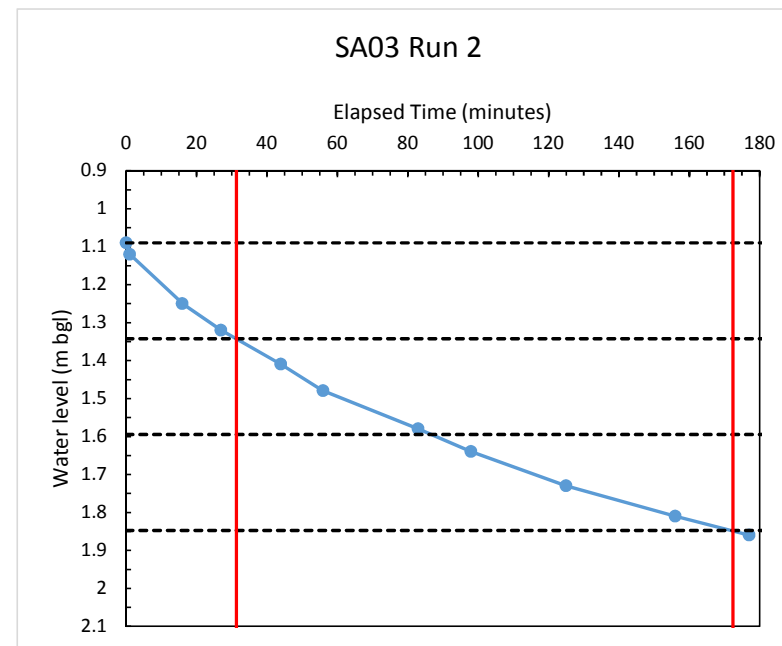
Project Name: Gray's Lane, Hitchin  
 Project Number: EMS6636  
 Date of Test: 19/12/2016  
 Test Location: SA03 Run 2  
 The test pit was not filled with gravel.

Depth of pit (m): 2.10  
 Width of pit (m): 0.50  
 Length of pit (m): 1.80

$V_{p75-25} = 0.45$   
 $a_{s50} = 3.22$   
 $t_{p75-25} = 141$  minutes  
 **$f$  (soil infiltration rate) =  $1.67E-05$  m/s**

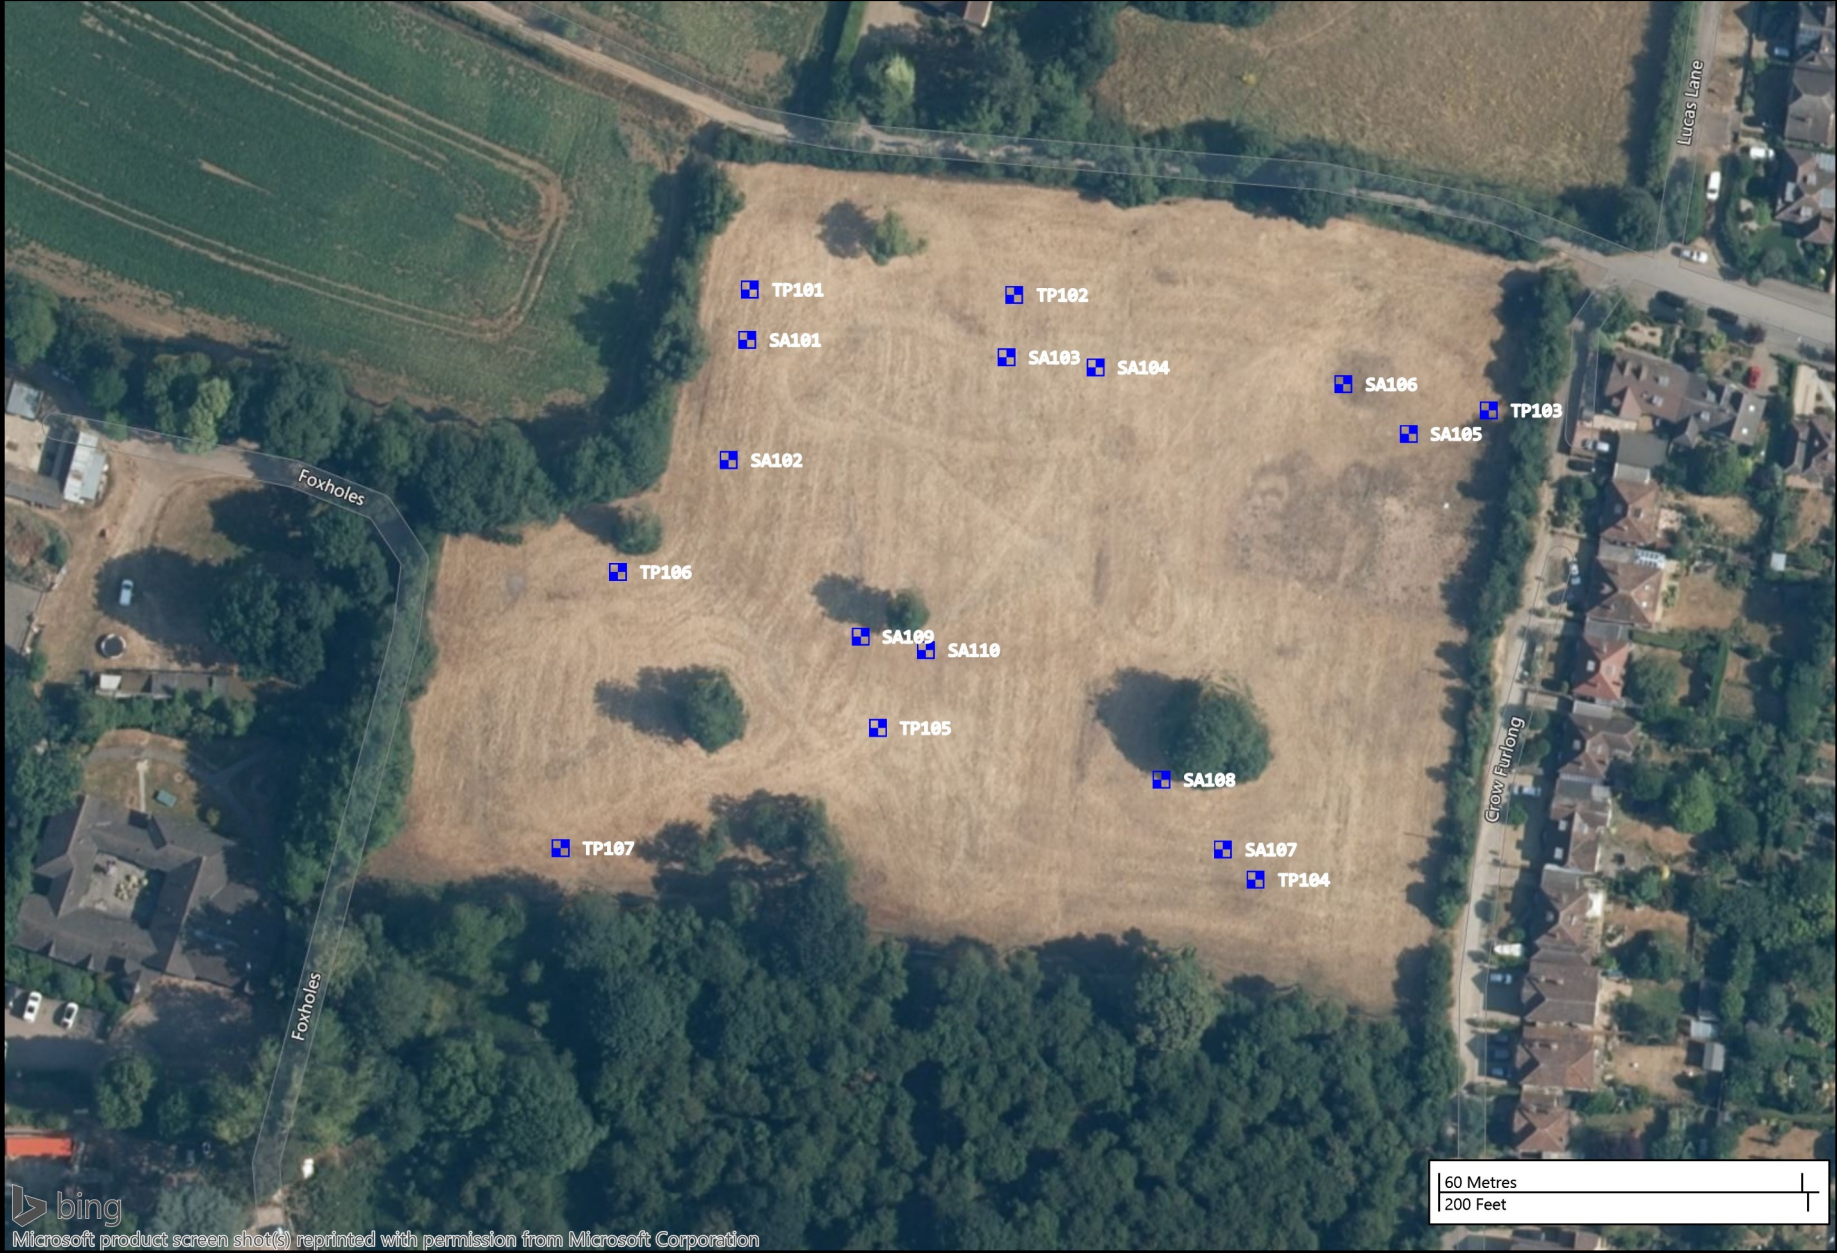
- Legend Key
- Locations By Type - Empty
  - Locations By Type - TP
