# **Drainage Strategy Update**

**Proposed Residential Development  
Land off Gray's Lane  
Hitchin  
Hertfordshire**

**Revision B: July 2025  
Report Reference: 1318-FRA-01-B**

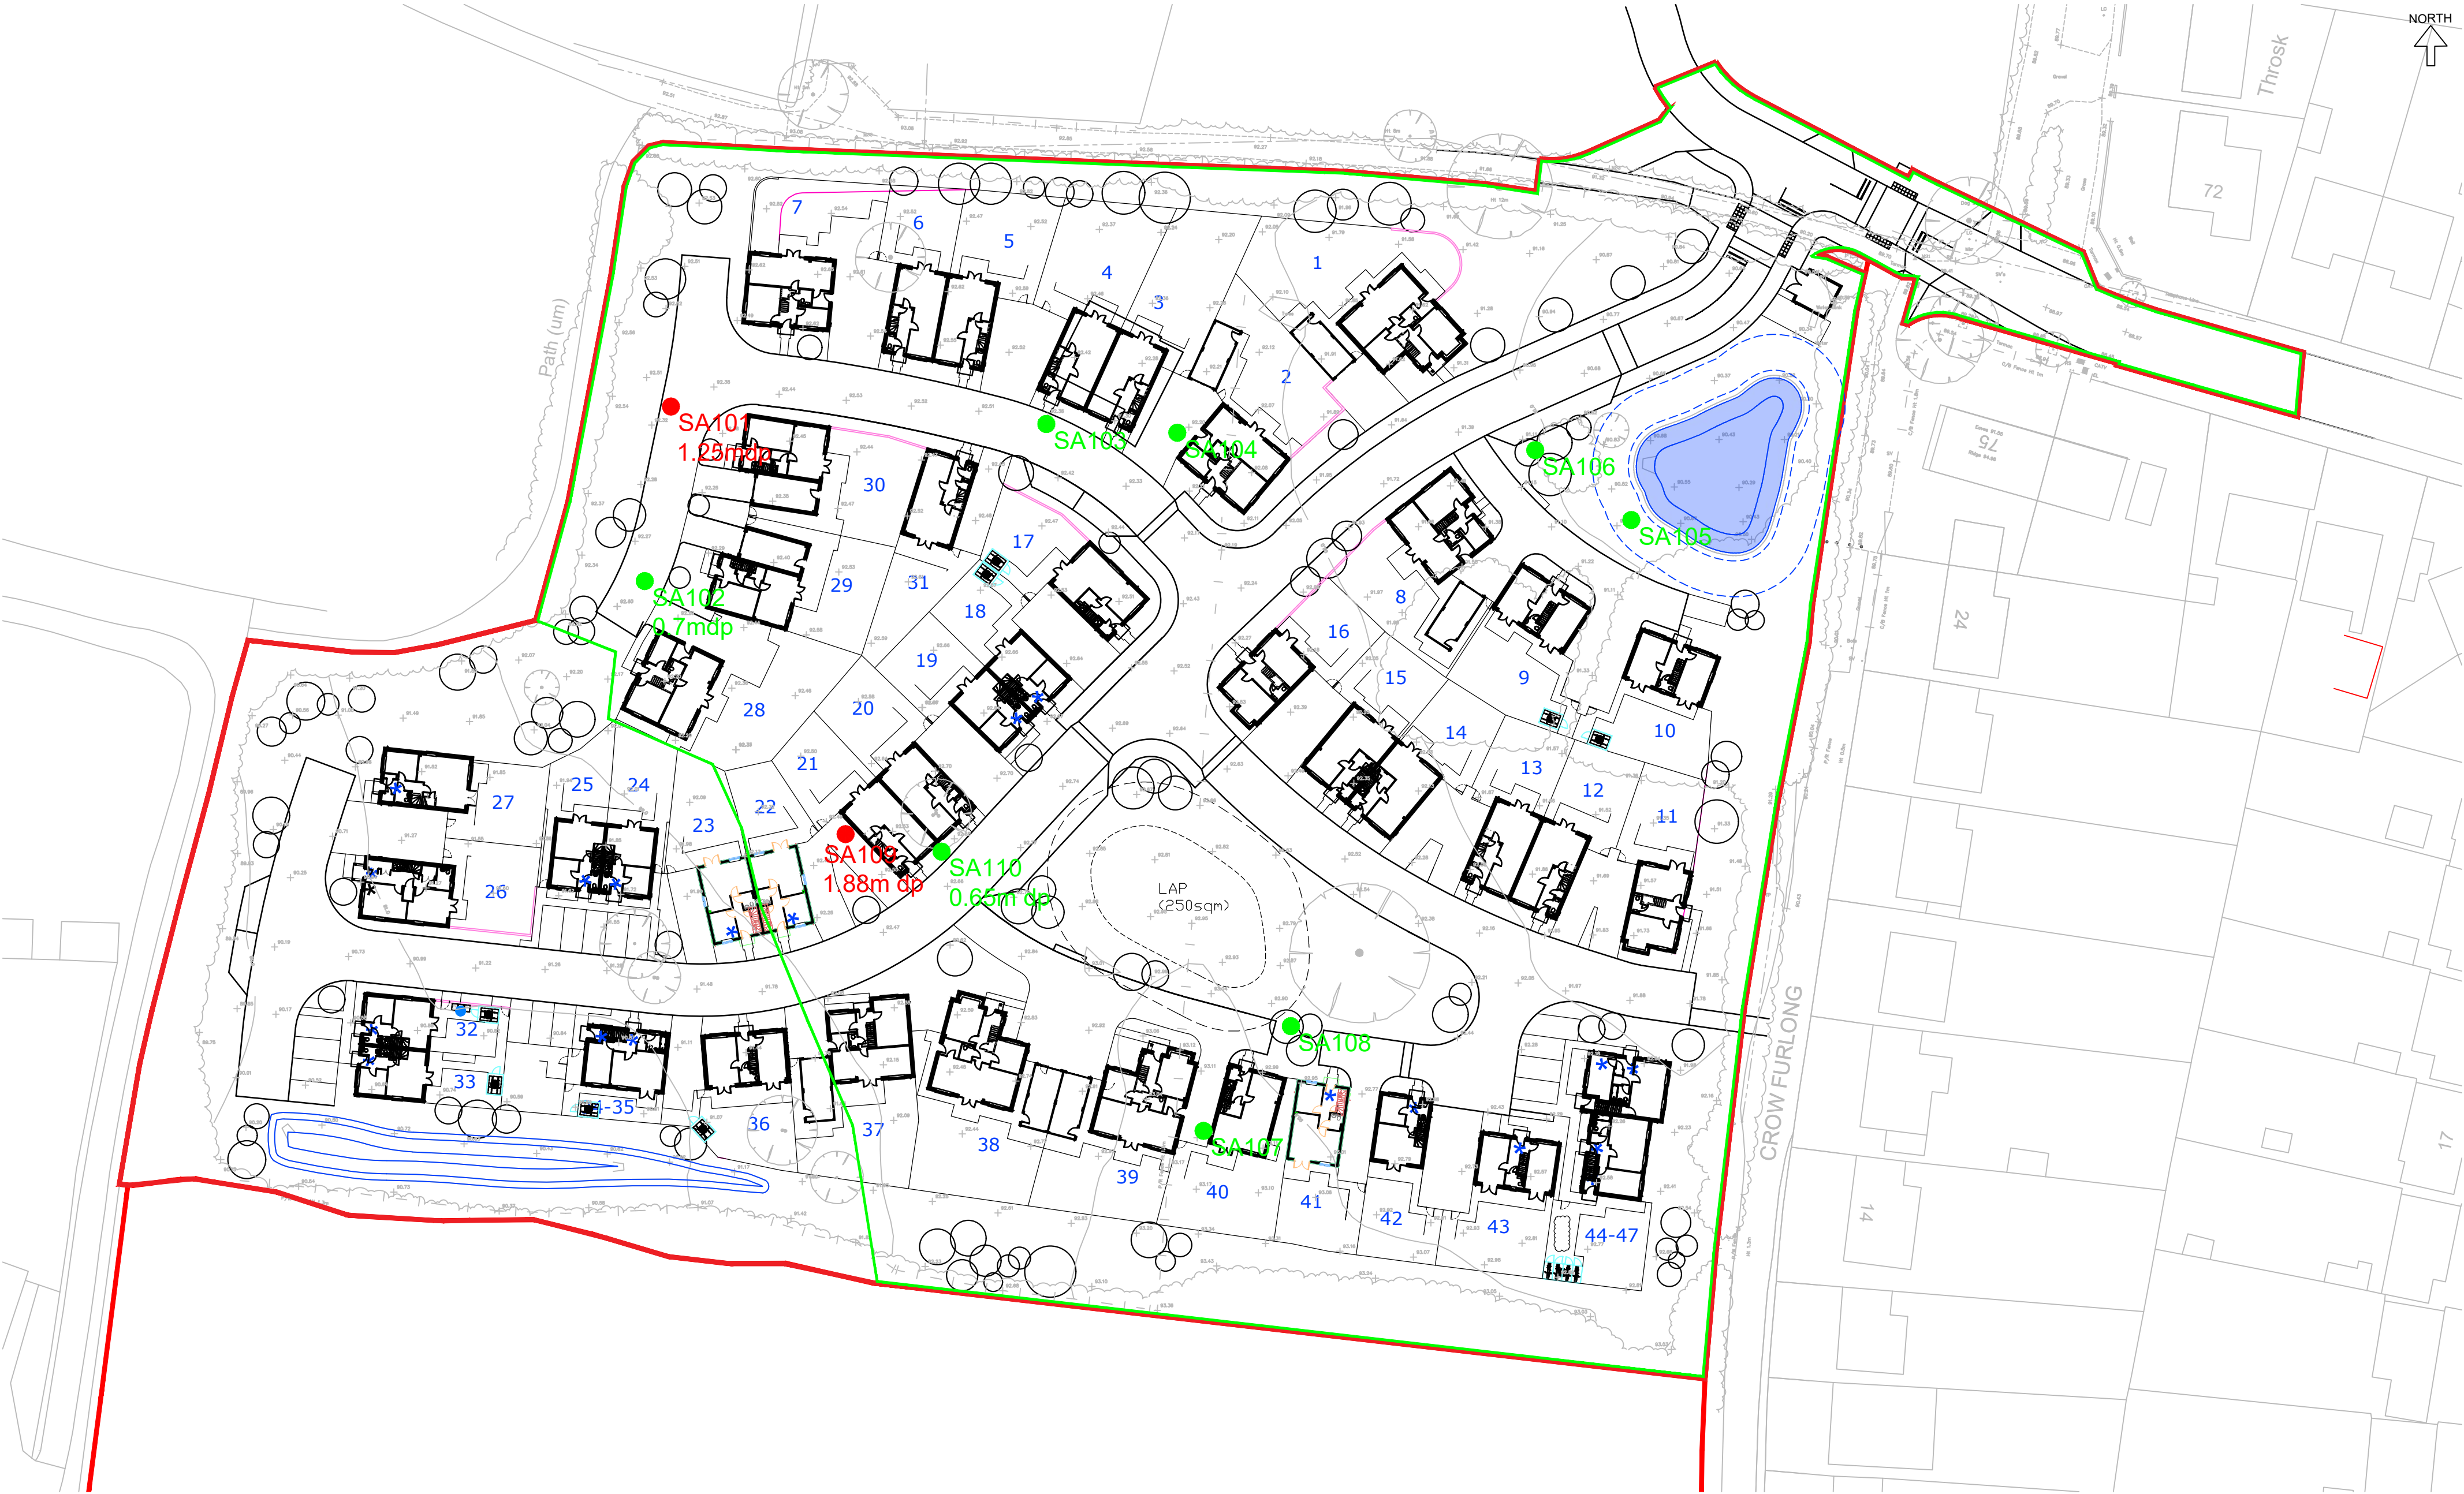
- Based on MSurv 'Topographical Survey', drawing number 1215/1649/1 dated 09/10/15.
- Based on Hill Residential Limited 'Proposed Layout Section 73', drawing number 181-PA-2-001 A dated 29/04/25.
- Extent of permeable paving is indicative. Exact areas to be confirmed once surfacing types have been fixed.
