## The White Horse, Kimpton, Hertfordshire

Archaeology and Heritage Assessment

P20-249

OCTOBER 2020

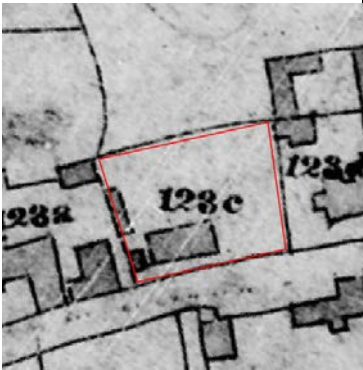
| Date | Description | Map Extract |
|---|---|---|
| 1837 | The Kimpton tithe map depicts the a standalone rectilinear building adjacent to High Street in the southern half of the site, with a small outbuilding to its west and a range of outbuildings along the western side of the site. The plot is labelled 123c, which does not have a corresponding entry in the apportionment. | A black and white photograph of a section of a 1837 tithe map. A rectangular plot is outlined in red and labeled '123c'. To its west is a smaller plot labeled '123a', and to its east is another plot labeled '123d'. The map shows various building footprints and street layouts. |

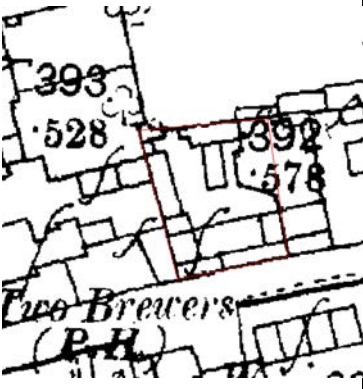
| Date | Description | Map Extract |
|---|---|---|
| 1881 | By 1881 the earlier central building had been extended to the west (now No. 24 High Street), a brace indicating the extension was part of the original structure, and a small outhouse between the rear of the extension and the range of outbuildings against the western boundary. The building was also adjoined to the east by No. 20, incorporating a cart entrance with accommodation above. The eastern boundary kinks into the site, suggesting a temporary alteration of the plot, while additional outbuildings were constructed, including a T | A black and white photograph of a section of an 1881 Ordnance Survey map. The map shows a complex of buildings with various labels including '393', '528', '392', and '578'. A red line traces a path through the buildings. Below the buildings, the text 'Two Brewers (P.H.)' is visible. The map shows the evolution of the site's layout compared to the 1837 tithe map. |

| | shaped range extending into the site from the northern boundary and two small structures in the north west corner of the plot | |

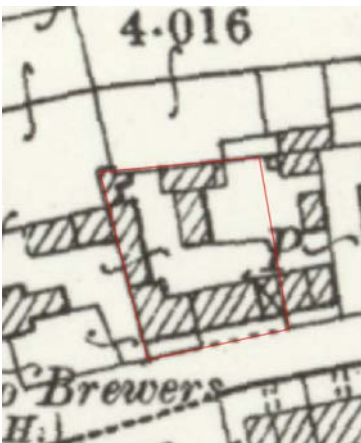
| 1898 | The situation remained largely unchanged in 1898 with the exception that there is an internal division shown between the central range of No. 22 and No. 25 to its west. The eastern boundary is also shown connecting to the south east corner of the central outbuilding. | |

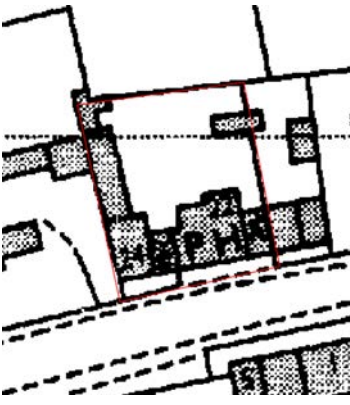
| 1975 | By 1975 the White Horse remained the same. Forge view had been internally divided creating No. 24 and No 24a. The outbuilding against the northern boundary had been removed, leaving a short range against the eastern boundary. Curiously this map reverts to showing a continuous range of outbuildings along the western boundary, and does not illustrate the shed depicted in the 1954 deed plan. This is perhaps a mapping error. | |

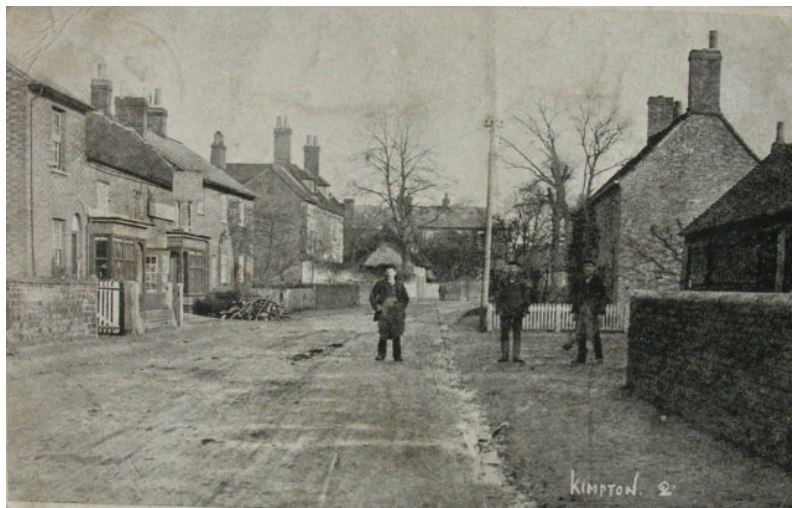
**Figure 11: The White Horse (left) in the late 19<sup>th</sup> century**

- 6.31 Photographs of the White Horse in the late 19<sup>th</sup> and early 20<sup>th</sup> century (Figure 11) indicate that from at least this date the front of the pub included the existing three flat-roofed window bays at ground floor level. These are all of timber construction. The more substantial eastern and western bays are set on dark brown glazed brick plinth walls, and incorporate door openings. The smaller central window is set on a rendered plinth wall.
