**Netherdown (Herts) Ltd.**

**Ground Investigation Report**

**Lordship Farm**

**Report No: 24-12-15**

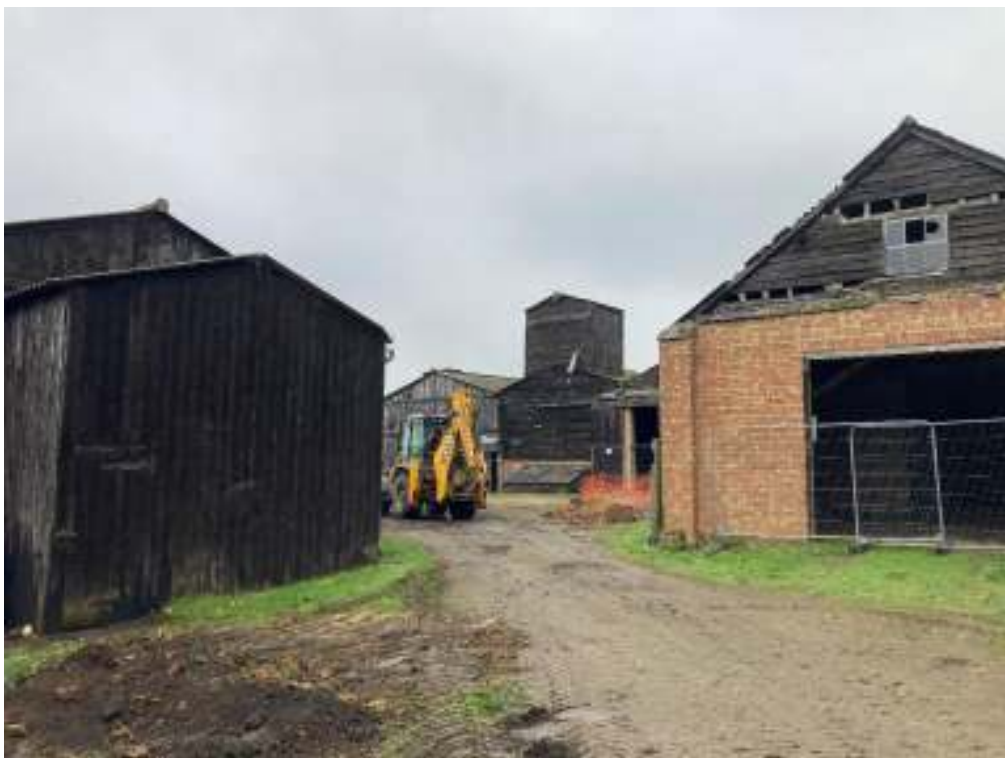
Entrance to courtyard, cart shed on left, grade listed building on the right

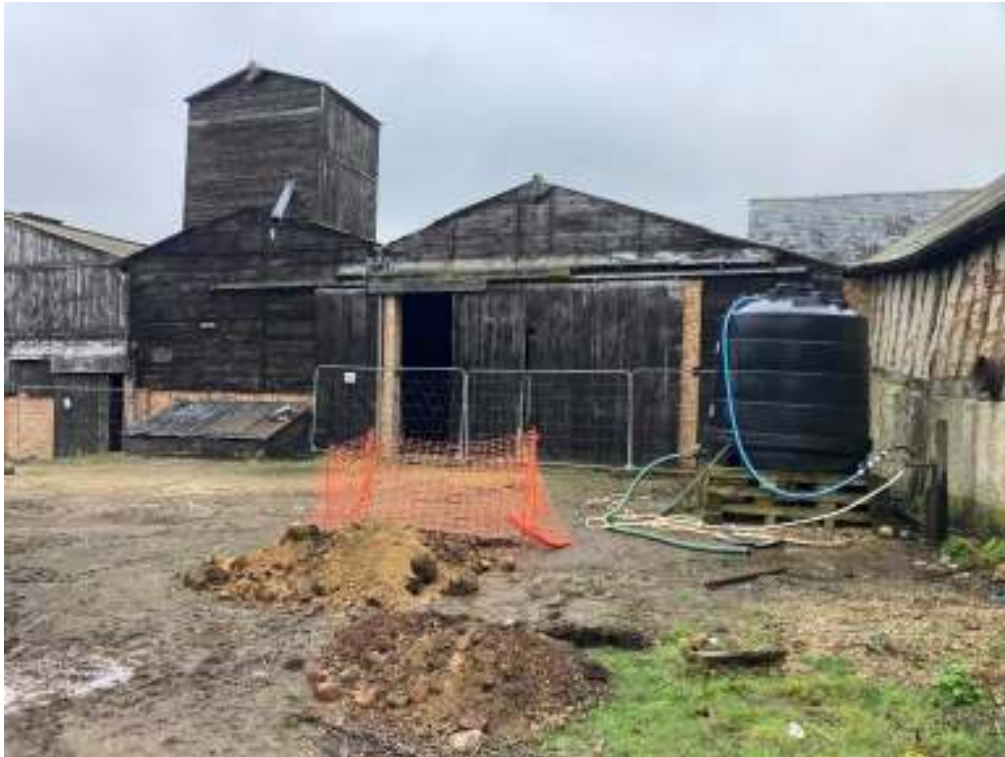
Above groundwater tank and SA1 – granular soils

The granular soils of the Glaciofluvial Deposits encountered within SA1 and SA4 enabled three repeat tests as stipulated within BRE365 guidance. Average infiltration rates obtained within SA1 and SA2 were calculated to be  $2.07 \times 10^{-5} \text{m/s}$  and  $2.91 \times 10^{-5} \text{m/s}$ , respectively.

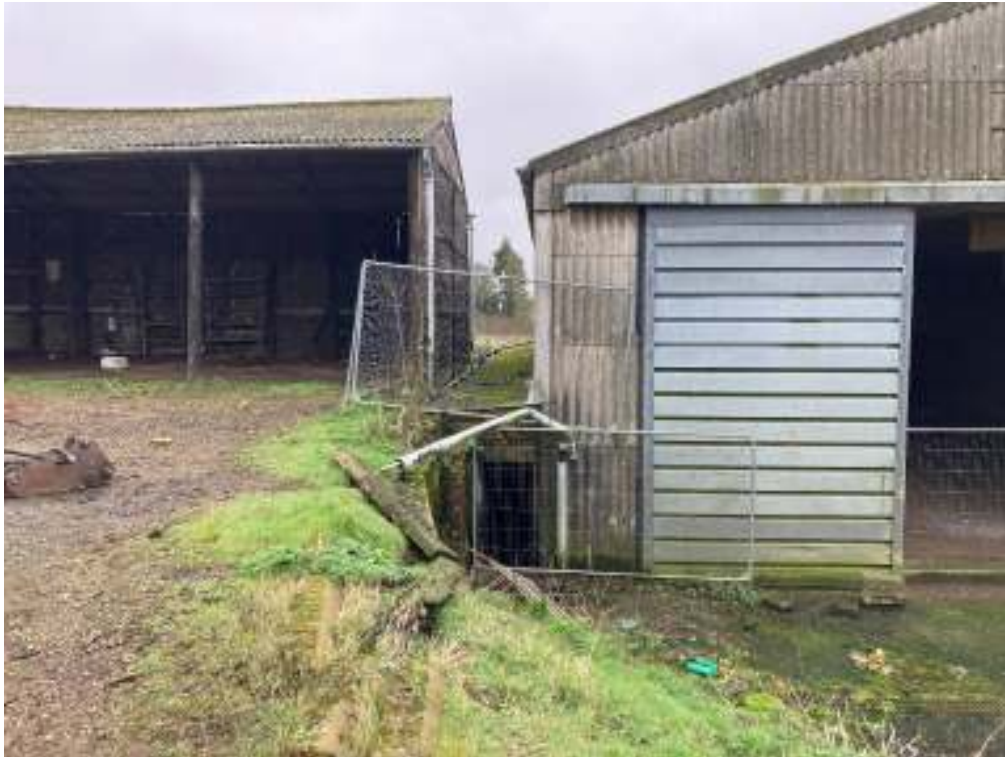
Cart shed on left, adjacent barn on the right (retaining wall at the centre)

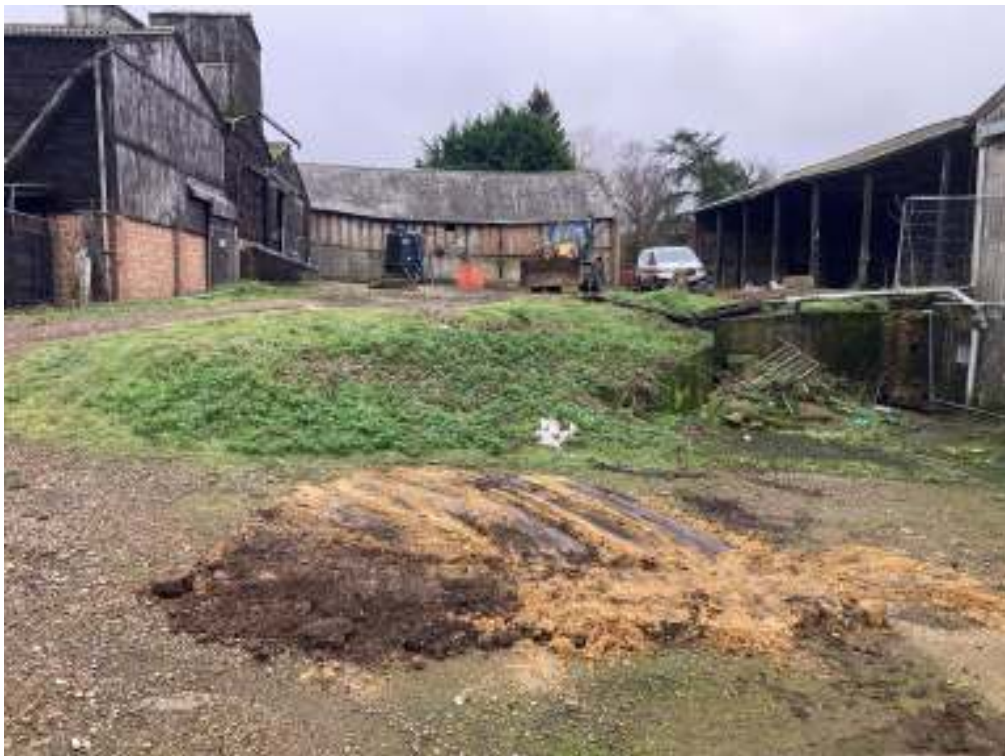
Made-up levels, retaining wall at the right

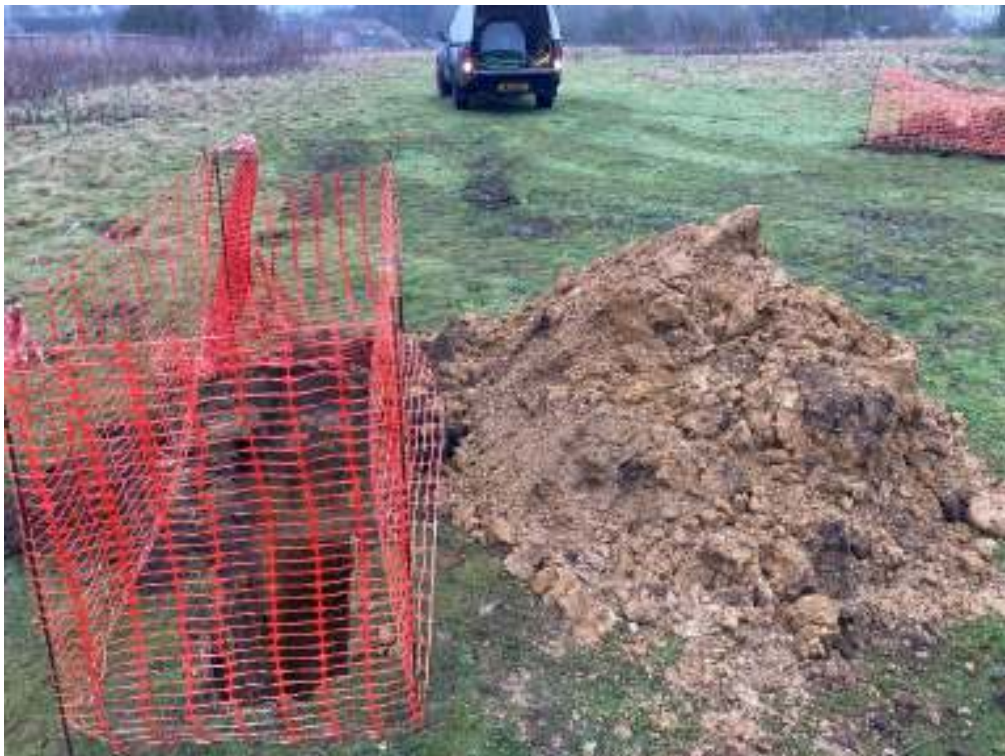
Encountered locally within SA2 from ground level down to a depth of 0.35m bgl. The material was encountered as loose, dark brown, clayey organic silt.

SA2 – Cohesive soils

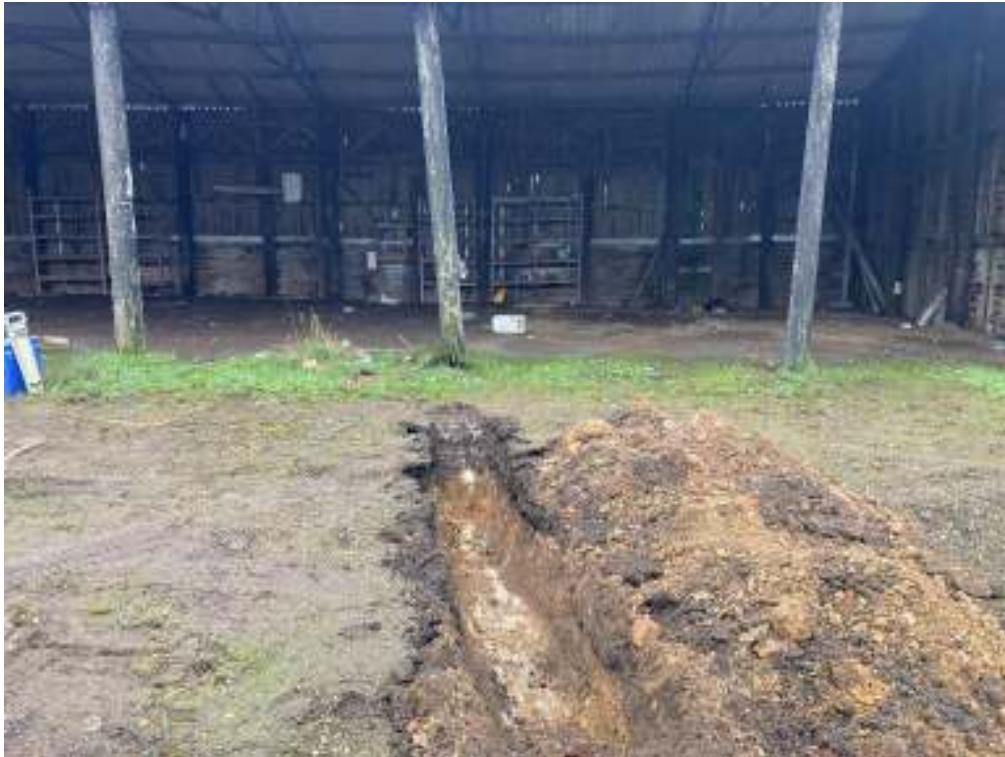
Within the courtyard area the exploratory holes TP1, BH1, TP5 and SA1 recorded the deepest Made Ground soils down to depths ranging between 0.80m and 1.80m bgl encountered as layers of loose, brown, red, black, clayey, silty gravel, concrete fill (concrete boulders), and soft green, brown, black, slightly organic, silty gravelly clay. Gravels were encountered as fine to coarse, brick, concrete, metal, flint, chalk and ash.

TP1 (Concrete fill at base)

In the areas where the existing buildings will be demolished, foundations will need grubbing out during the construction phase. In addition, the Made Ground soils underlying the courtyard comprised significant obstructions including boulders of concrete fill which may require specialist breaking equipment to remove.

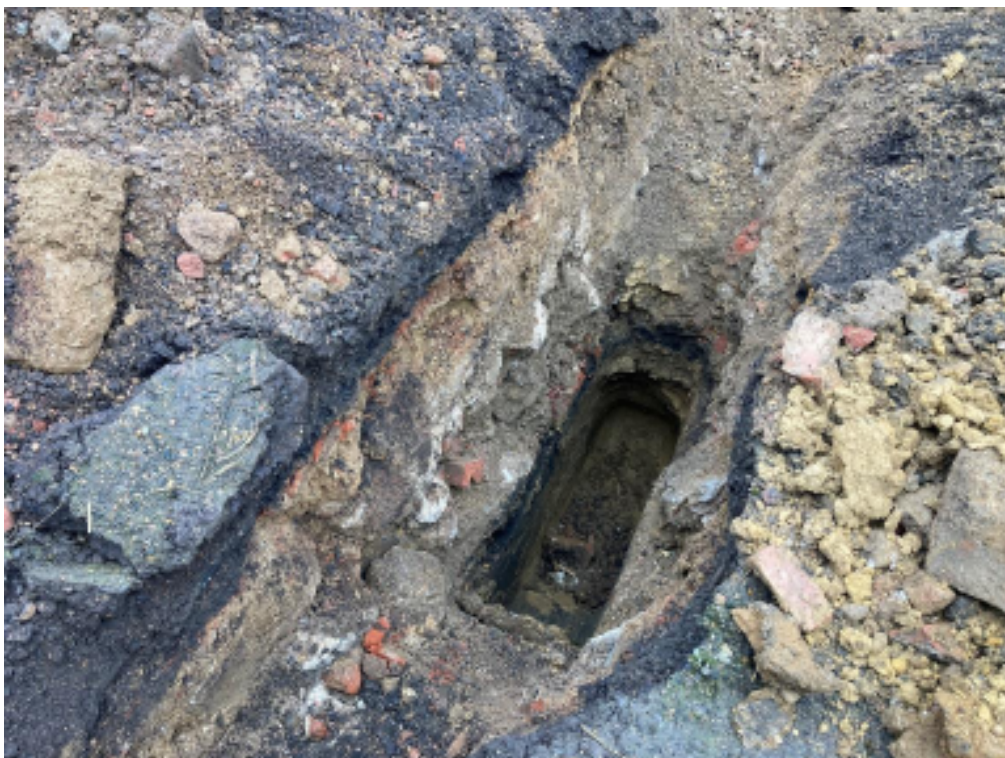
TP1 (deepened Made Ground)

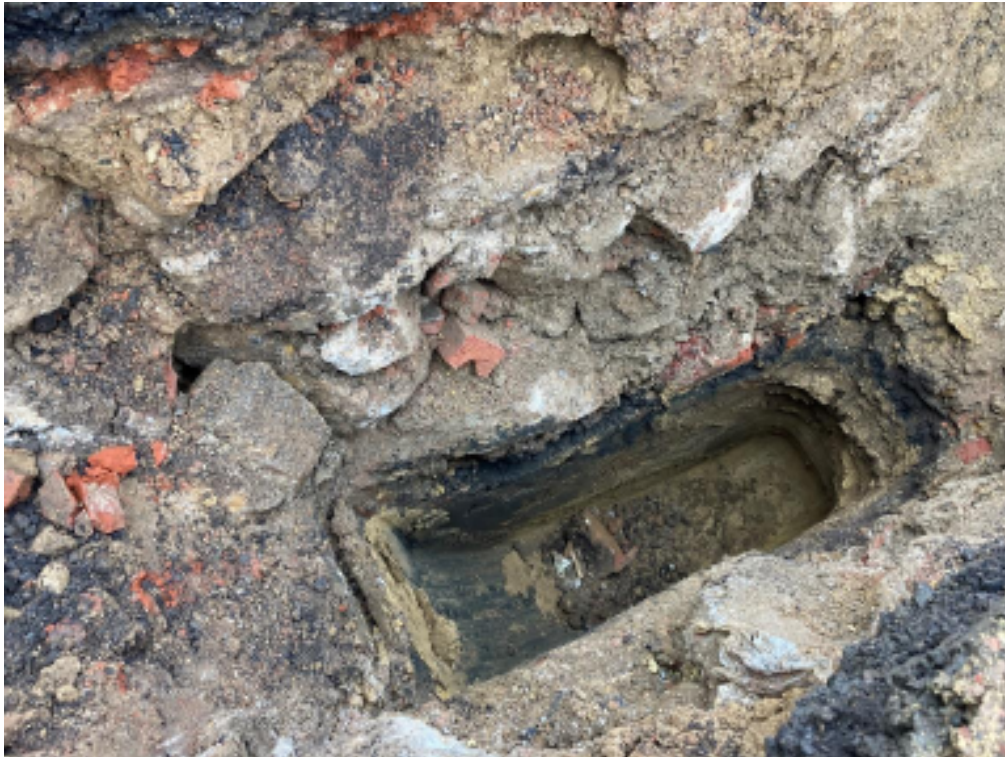
TP1 (concrete fill)

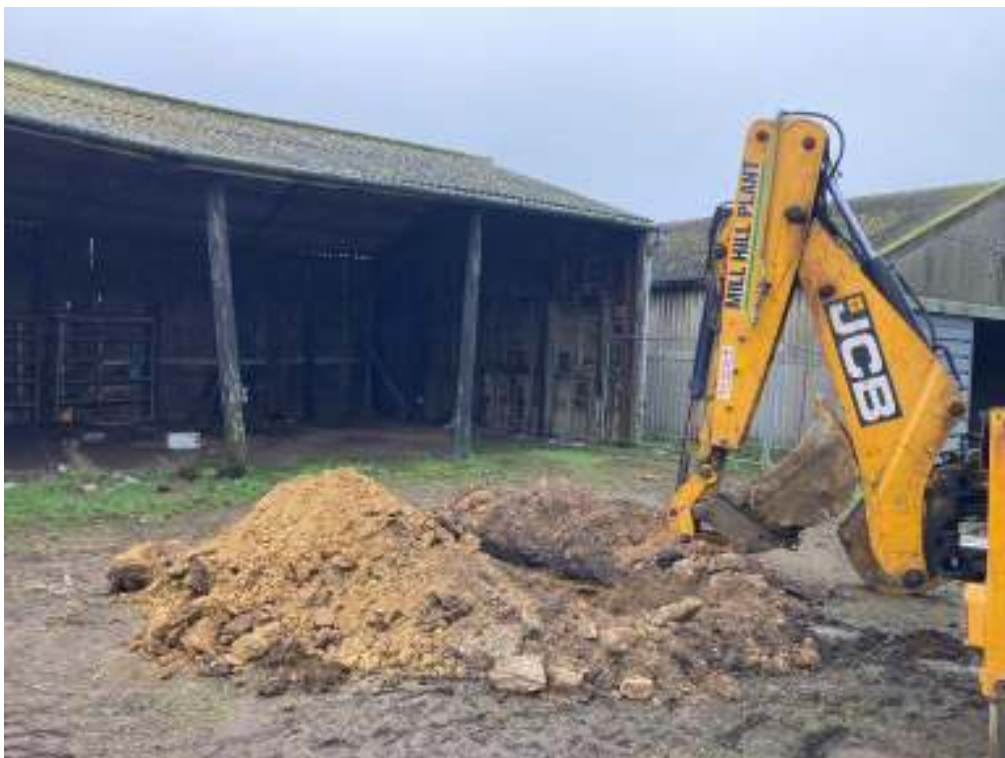
TP1 – Natural granular soils (Glaciofluvial Deposits)

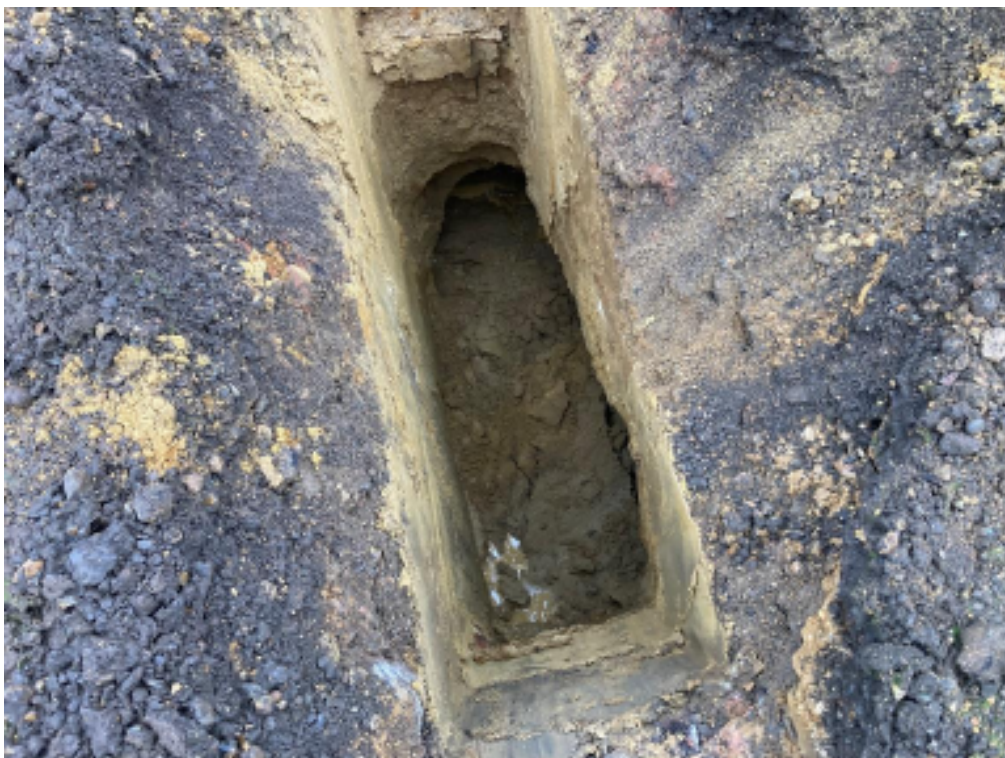
The granular layers within glacial deposits can allow significant perched water levels which may cause instability when excavated also known as running sand.

The proposed development will include the construction of five residential units (Units 2-6) and the restoration of an existing grade listed building (Unit 1). Given the ground conditions encountered during this investigation, it is considered excavating shallow foundations may be problematic due to the loose, unconsolidated nature of the near surface granular soils combined with shallow groundwater levels. It should be understood that trenches excavated below 1.00m bgl may be unstable in the short term with running sand and collapsing soils encountered within TP2. TP2 was

TP2 – collapsing sides and running sand

Shoring should be made available for excavations, and it is important to remember that entry into excavations is strictly prohibited without it. It is considered excavating below 1.00m bgl will be problematic locally across the site due to the loose nature of the superficial soils and shallow groundwater levels which may affect the proposed foundation design.

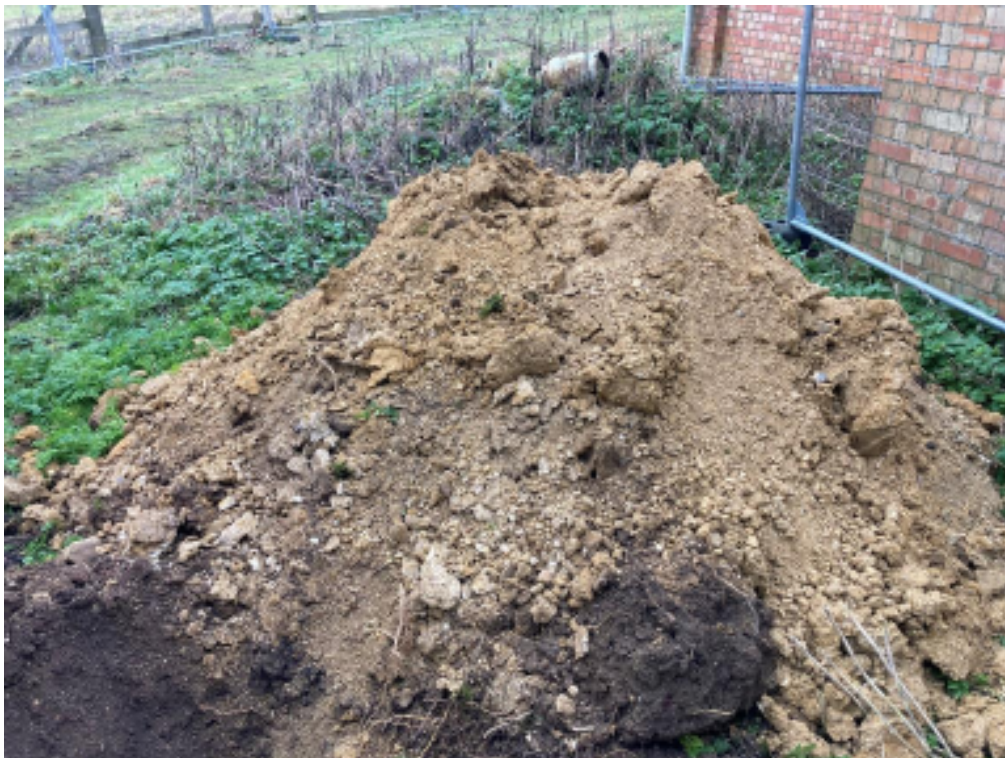
In addition, given the heterogeneous nature of the superficial soils foundations crossing both granular and cohesive soils may encounter differential settlement and therefore may require suitable reinforcing.

TP3 – variable natural soils (layers of granular and cohesive soil)

Foundations should be suitably reinforced to combat differential settlement given the fact that foundations will cross both cohesive and granular soils.

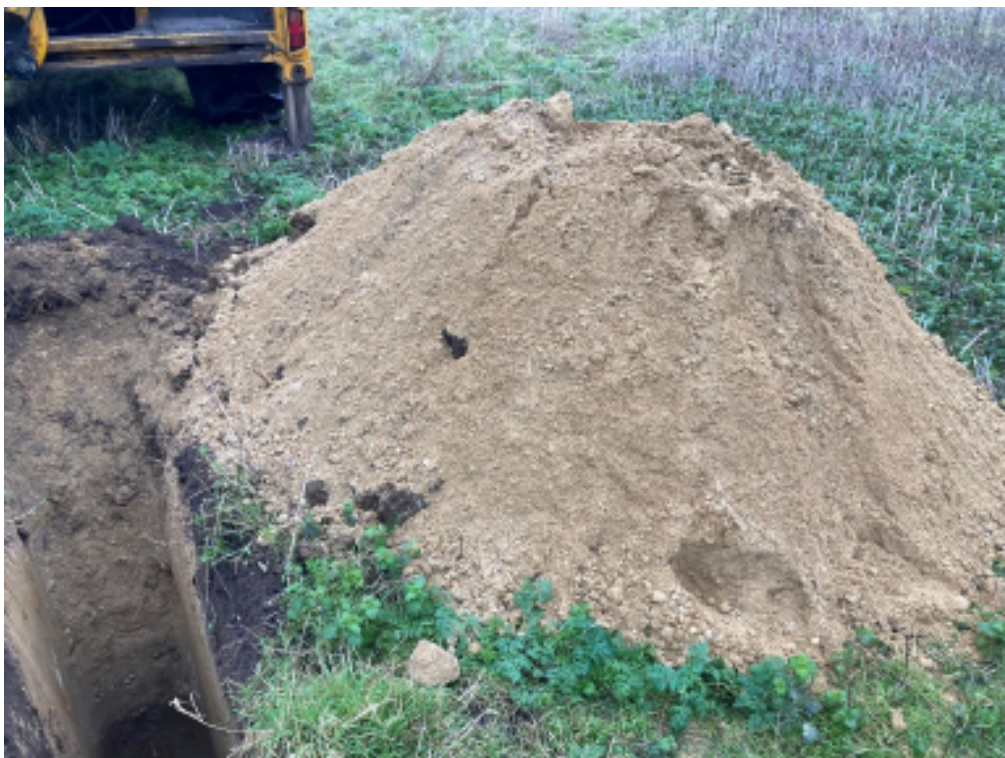
TP4 – Granular soil

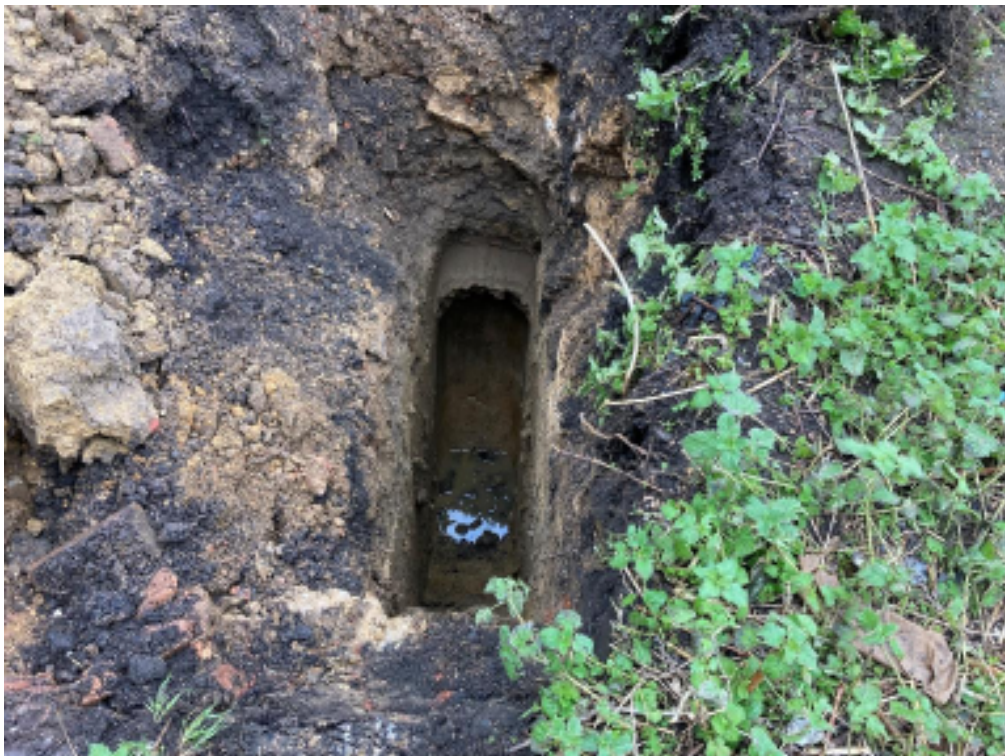
TP5 – Deepened Made Ground and water strike

Shallow foundations within the Glaciofluvial Deposit at a depth of 1.00m bgl or 0.20m into the stratum, whichever is the deeper (may be as deep as 2.00m bgl given the locally thick Made Ground soils) may be suitable. At this depth, an estimation of the net allowable bearing pressure is considered to be 70kPa which could be adopted for foundations not exceeding 1m in width. This allows for a factor of safety of three against shear failure and for settlements generally not to exceed 25mm taking place over a number of years.
