# **Arboricultural Impact Assessment**

The Court Yard, Ickleford, Hertfordshire

Report Reference: BG26.234

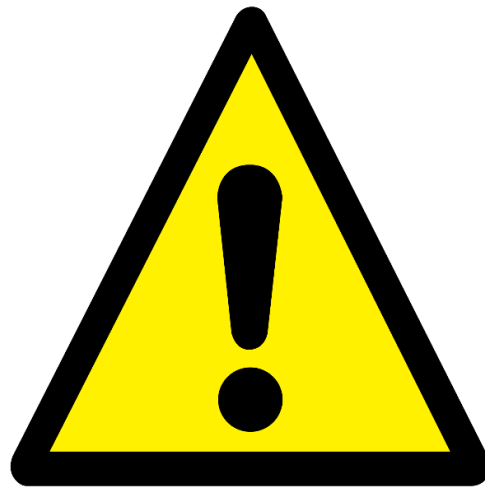
Figure 3: Tree protection fencing signage.

Tree protective fencing must have all-weather notices attached at regular intervals, such as those in Figure 3 and Figure 4. The notices must include wording such as 'CONSTRUCTION EXCLUSION ZONE – NO ACCESS' or 'TREE PROTECTION AREA – KEEP OUT'. The tree protective fencing must remain *in situ* and intact until completion of construction; they may be removed after agreement with the project arboriculturist and their removal discharged to the Local Planning Authority.

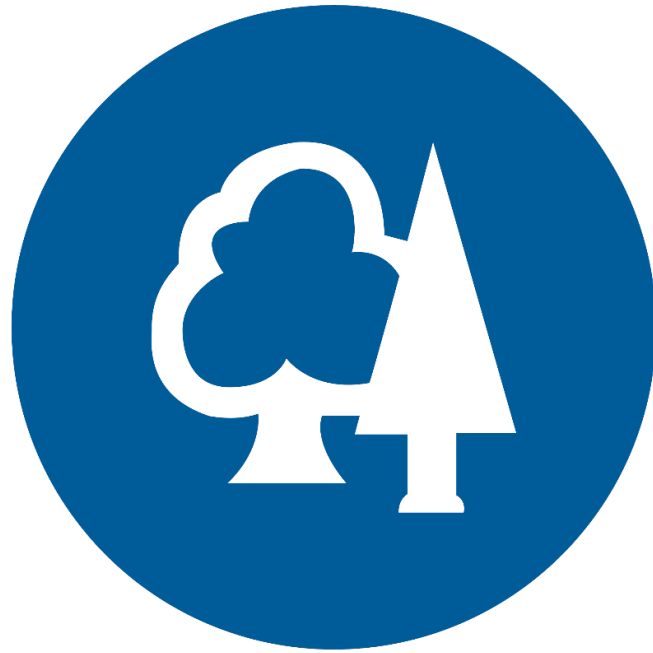
## **PROTECTIVE FENCING**

**Fencing must be maintained in accordance with the approved plans and drawings for this development**

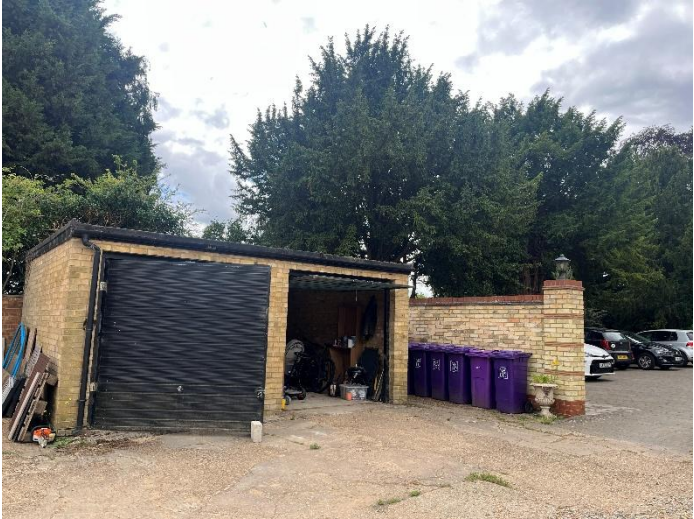
| Image | Description |
|---|---|
| | <p>Offsite tree T1 behind onsite garage.</p> |

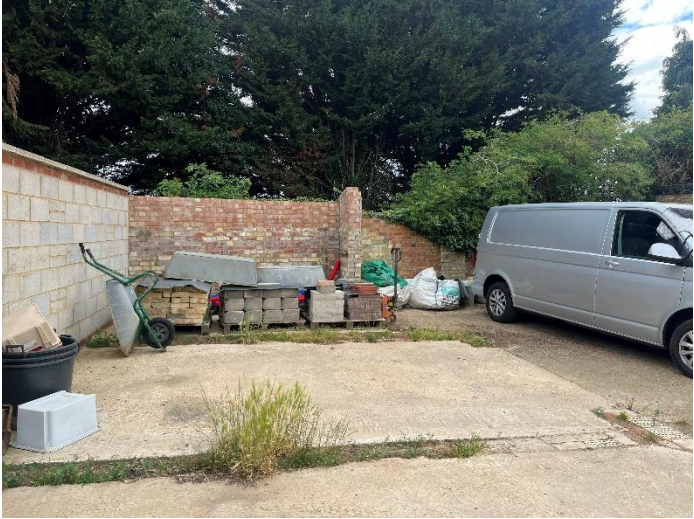
| Group ID | Species | BS 5837 Category | Description |
|---|---|---|---|
| G1 | Lawson Cypress | C2 | Average height 12m. Off site on other side of driveway. Mature. Stems plotted individually. Stems obscured by ivy. Bark inclusions at stem junctions. Slight overhang into site, with approximately 5m clearance along driveway. Average stem diameter 595mm. Fair condition. |
| H1 | Privet, Common Elder, Common Hawthorn | C1 | Fair condition with sparse foliage due to significant shading from overhead trees. Young. Considerable minor deadwood throughout. Average height 3.5m and width 1m. Off site. Fair condition. Beyond survey red boundary line, within client ownership. |

| Image | Description |
|---|---|
| | <p>Offsite G1 and H1.</p> |
