## Preliminary Roost Assessment

Old Manor, Shaftenhoe End, Barley, Royston, Hertfordshire, SG8 8LE

This report is prepared to inform a planning application for: Extension to the lodge, and internal renovations of the main house, to include skylights and reglazing of the western extension.

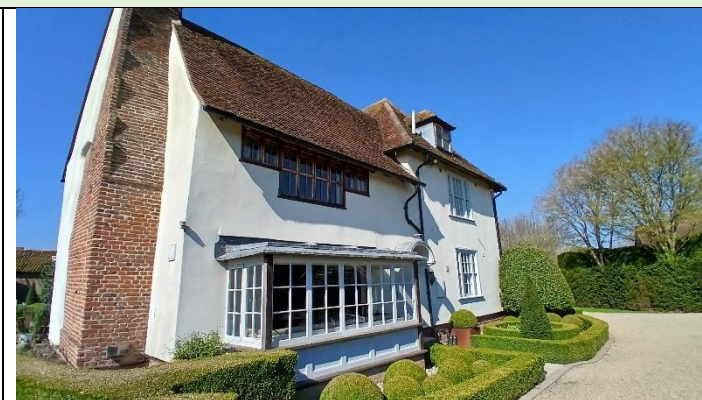
*Figure 1: B1*

B1 is a three-storey, listed, residential property. The building is brick-and-mortar in construction, with areas of rendering and wood cladding. The roof is complex in structure and constructed of overlapping clay tiles. There are a large number of raised field tiles, with some missing tiles interspersed. There are small gaps around the eaves where the original beams protrude through the wall, and gaps at the bargeboard. The void has been fully converted into a third storey, with a small void below the pitch that is inaccessible.

**The habitat value of B1 is moderate.**

| Recommendations | <p><b>Buildings</b></p> <p><i><b>B1</b> - Two bat emergence/re-entry survey are required on the <b>western extension of B1</b> during the active bat season (May – September) to confirm presence/likely-absence of bats roosting in or on the buildings. The survey visits should be completed during the optimal survey period mid-May to August inclusive. The survey effort should be supported by night vision aids (NVA).</i></p> <p><i><b>Two surveyors</b> are required to provide full coverage of the building's elevations. Infrared cameras should be used as an aid.</i></p> <p><i><b>B2</b> - Two bat emergence/re-entry survey is required on the western extension of B1 during the active bat season (May – September) to confirm presence/likely-absence of bats roosting in or on the buildings. The survey visits should be completed during the optimal survey period mid-May to August inclusive. The survey effort should be supported by night vision aids (NVA).</i></p> |

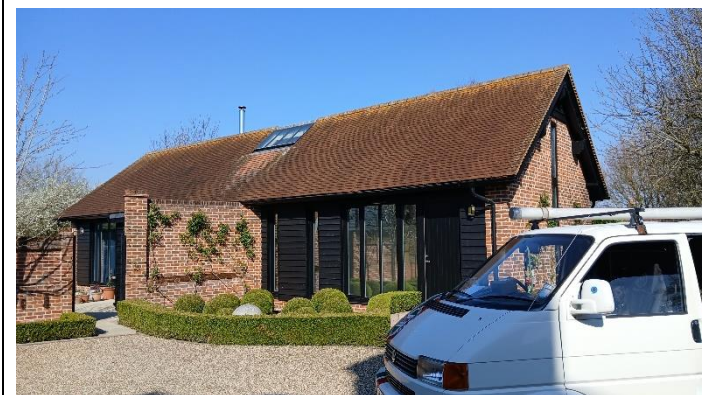
*Figure 2: B2*

B2 is a pitched and gabled residential property, with a roof comprised of overlapping clay tiles. The walls are constructed of brick and mortar, with areas of timber cladding. The roof has multiple lifted tiles particularly at the eaves, but no other external roosting features. Due to the construction of the building, there are two, small, inaccessible voids on the northern elevation.

**The habitat value of B2 is moderate.**

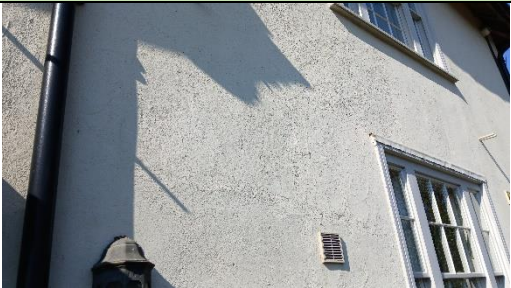
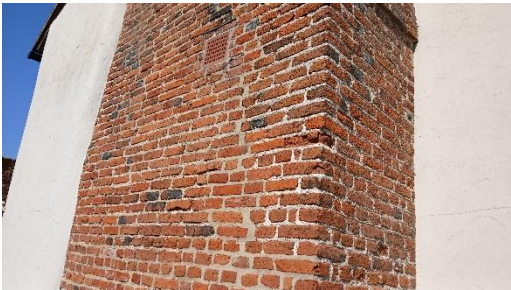
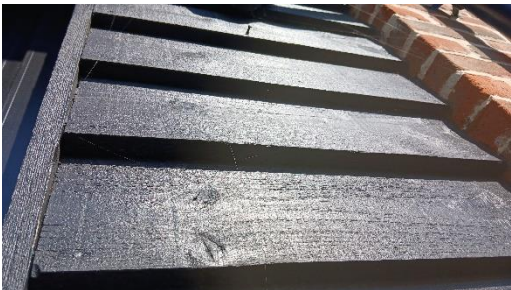
| B1 | | | | |
|---|---|---|---|---|
| Walls | Brick and mortar, with areas of rendering, and wood cladding. | The building is predominantly brick and mortar with rendering. There is wood cladding on the western most extension of the property. The brickwork and rendering is in good condition with no gaps or missing mortar. The areas of cladding are in good condition with no raised or warped areas that would create gaps. | The walls present no roosting opportunities for bats. | |

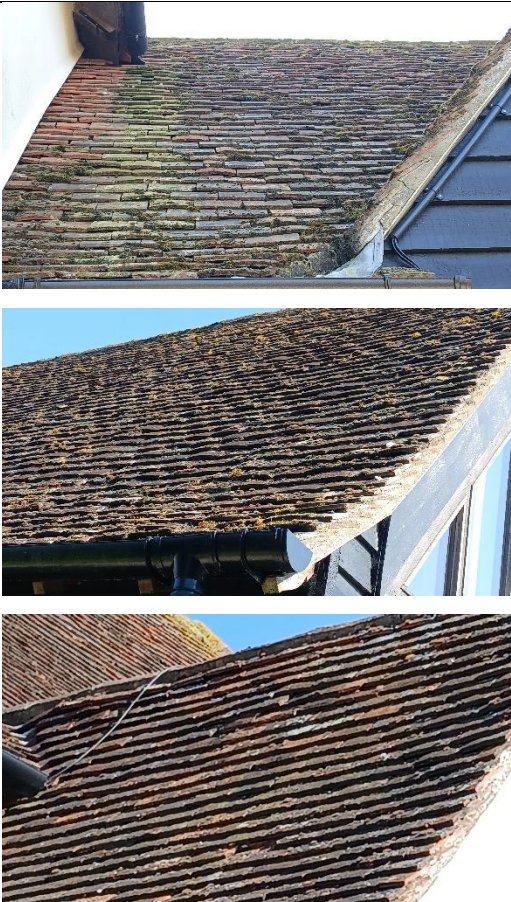
| Roof | <p>Complex roof structure.</p> <p>Pitched. Tiled with overlapping clay tiles.</p> | <p>The roof is complex in structure and covered in overlapping clay tiles. The majority (&gt;90%) of the tiles are raised, with a small number (&lt;5) of missing tiles interspersed.</p> | <p>The roof provides roosting opportunities for crevice dwelling species. Given the volume of raised tiles, the roof could support large numbers of bats.</p> | |

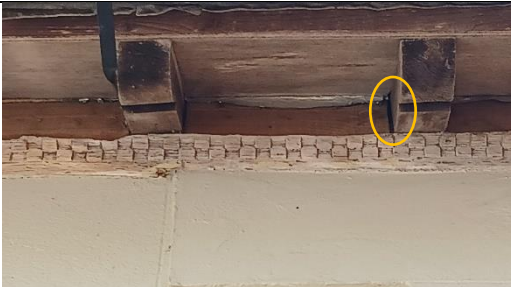
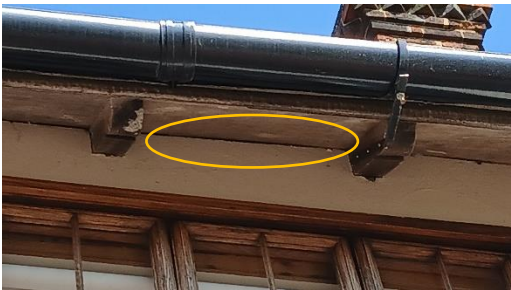
| Eaves | Closed.<br>Gutter lined. | Eaves are closed and lined with guttering. Guttering is in good condition with no damaged or missing areas. Original timbers protrude, opening up small gaps between brickwork and timbers. | The eaves present no roosting opportunities for bats. Protruding timbers will provide roosting opportunities for small numbers of crevice dwelling species. | |

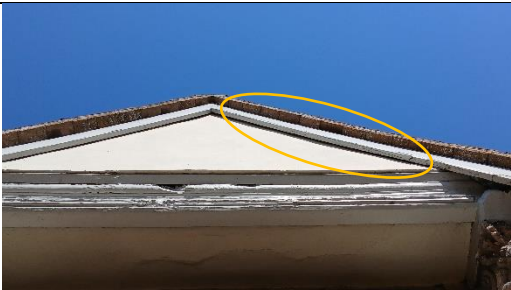
| Bargeboards | Timber bargeboards | Timber bargeboards on the southern elevation have gaps present between the bargeboard and the brickwork. | The bargeboards would provide roosting opportunities for a small number of crevice dwelling species. | |

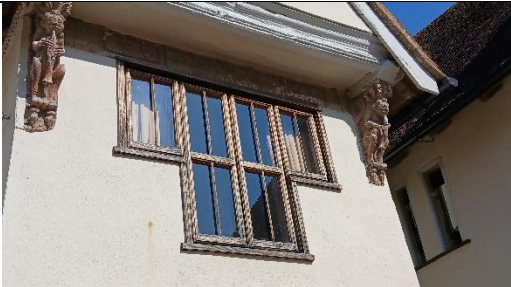
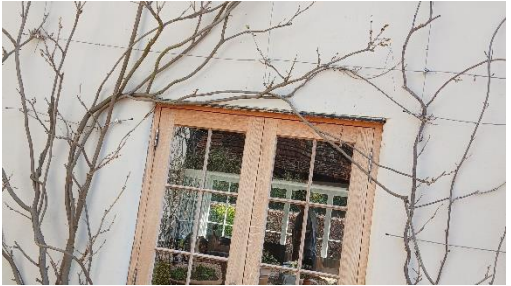
| Doors/<br>Windows | Timber | Doors and windows fit tight within the frames, and the frames sit tightly to the surrounding brickwork/ cladding. | Doors and windows present no roosting opportunities for bats. | |

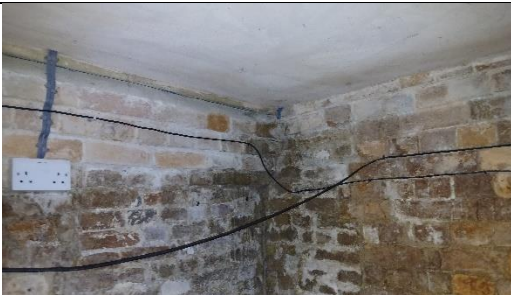
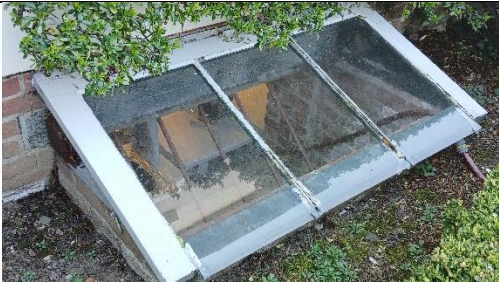
| Internal Void<br>- Cellar | Brick-and-mortar | The only void in the property is the cellar, which sits below the northwestern side of the property. The walls are comprised of brick and mortar. There is a small window which provides a good amount of light to the region. There are no ingress points for bats. | The void provides no roosting opportunities for bats. | |

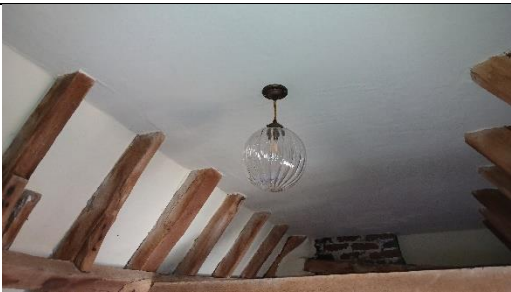
| Internal Void<br>- Roof | Unknown.<br><br>Likely to be original timbers. | The voids here have been converted into liveable spaces, with the exception of a small area above the conversion, where the rooms have been created with a flat ceiling, rather than pitched to the ridge. There is no access to the void. The area of remaining void is approximated to be <1m in pitch, and be comprised of original rafters. | The conversions provide no roosting opportunities for bats. There is likely access to the remaining void via tile gaps, and whilst a bat presence cannot be ruled out, the low pitch here is likely to make the area sub optimal for void dwelling species. | |

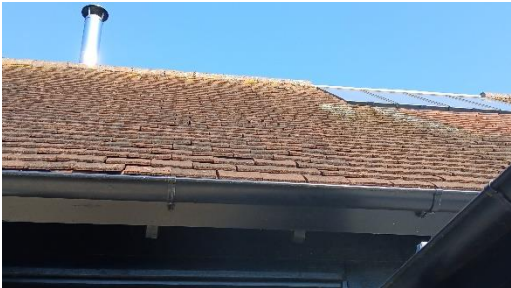
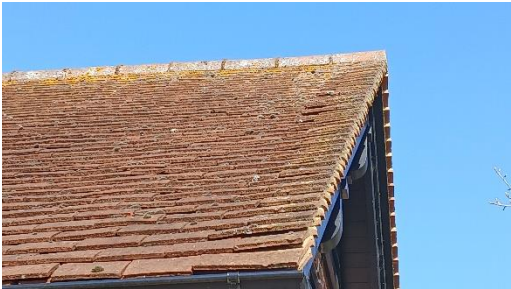
| B2 | | | | |
|---|---|---|---|---|
| Roof | Pitched and gabled. | The roof is pitched and gabled, with overlapping clay tile. The roof has multiple (~60%) raised field tiles throughout, particularly at the hips. There is a small flat-roofed porch on the southern elevation, with no lifts or damage to the felt. | The pitched roof could provide roosting opportunities to larger numbers of bats and could allow for ingress points internally. | |

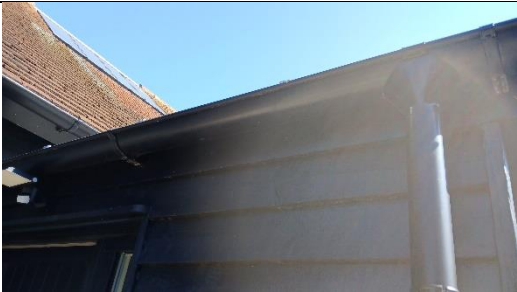
| Eaves | Closed.<br>Gutter lined. | Eaves are closed and lined with guttering. The guttering is in good condition with no missing or damaged areas. | The eaves present no roosting opportunities for bats. | |

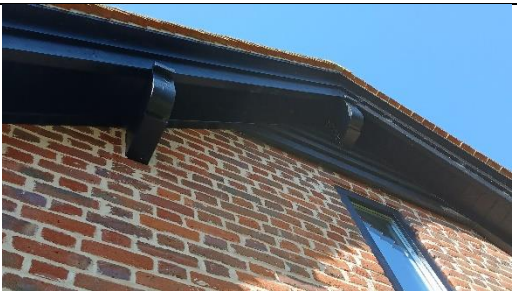
| Bargeboards | Timber | The bargeboards are in good condition and does not lift away from the brickwork. | Bargeboards present no roosting opportunities for bats. | |

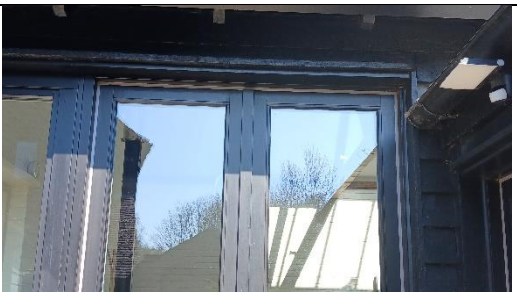
| Doors/<br>windows | uPVC | Doors and windows fit tight within the frames, and the frames sit tightly to the surrounding brickwork/ cladding. | Doors and windows present no roosting opportunities for bats. | |

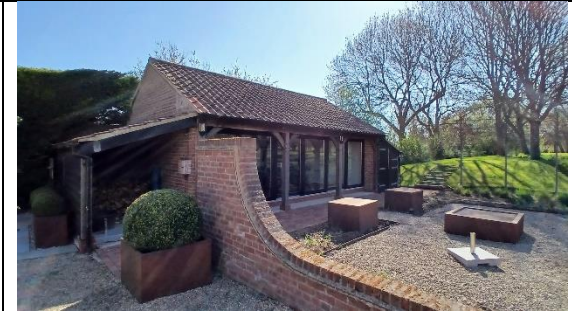
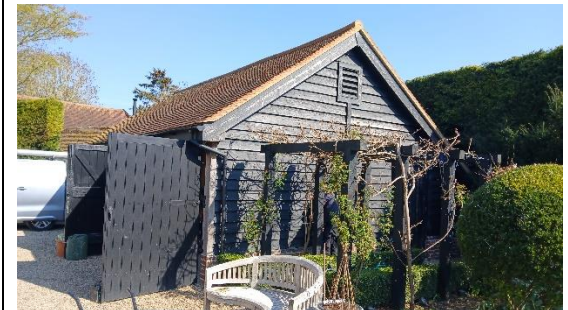
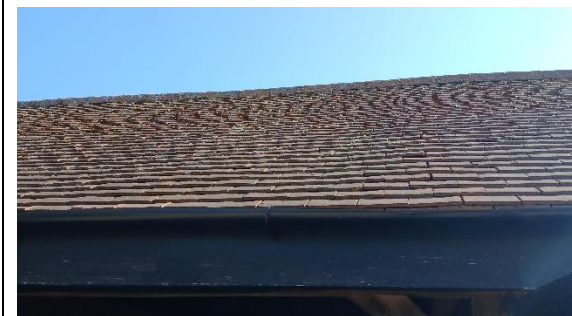
Within and immediately adjacent to the red line boundary are two additional buildings that form part of the wider site complex but are not included within the proposed development footprint. These buildings are identified on the Preliminary Roost Assessment (PRA) map. Neither structure contains internal voids, although both exhibit a small number of raised tiles that could provide limited roosting opportunities for crevice-dwelling bat species. Given the overall size of the site, the extent of surrounding gardens, and the limited nature of the proposed works, it is considered unlikely that there will be any direct or indirect impacts on these buildings.
