LEVEL MONITORING - RELATIVE SURVEY READINGS

Client: Crawford Client Ref: SU1703302

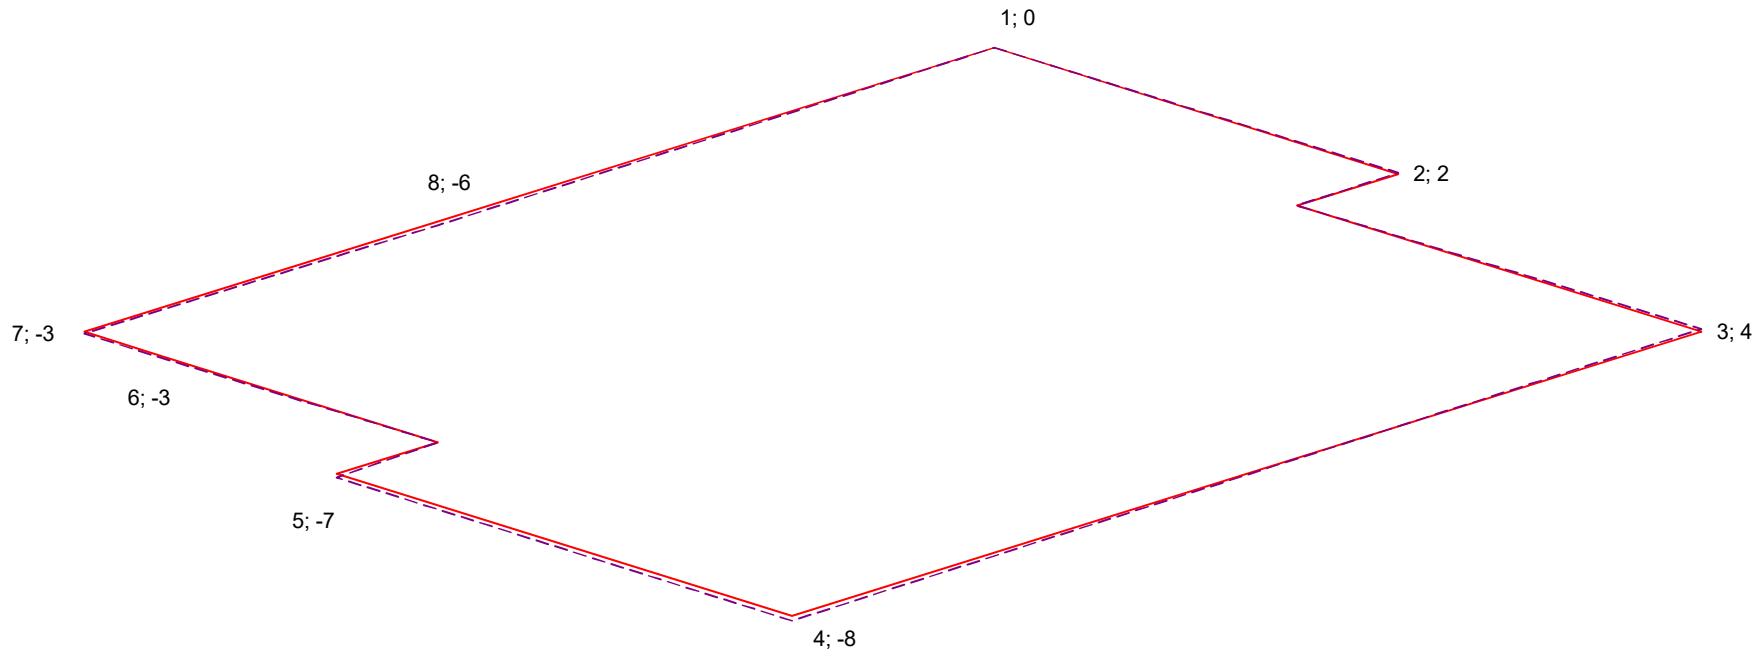
LEVEL MONITORING - RELATIVE MOVEMENT SKETCH

Point labels give level difference of last reading from original datum in mm.
