DEMOLITION ASBESTOS SURVEY

ROYAL BRITISH LEGION
PAYNE'S PARK
HITCHIN
SG5 1EH

NES /JC02/0013

ASBESTOS SURVEY REPORT

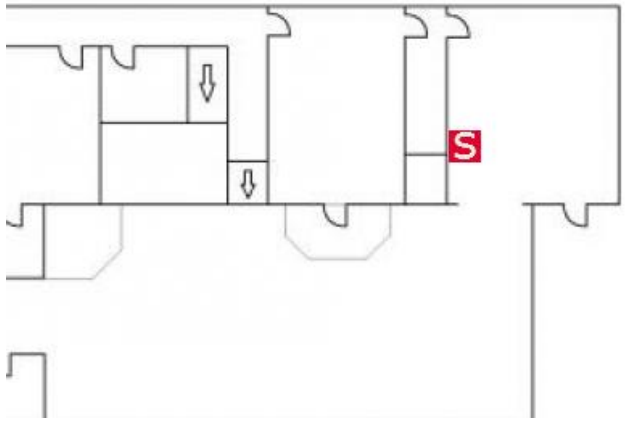
SAMPLE NUMBER	NES /JC02/0013/1	QUANTITY	4 lm	SCORE
CLIENT	IMN Properties Ltd	MATERIAL/PRODUCT	Under Cloaking	0
SURVEY LOCATION	Royal British Legion	DAMAGE	Good Condition	0
FLOOR	External	SURFACE TREATMENT	Enclosed Sprays	0
LOCATION	External Over Flat Roof	ASBESTOS TYPE	No Asbestos Detected	0
TYPE OF SURVEY	Demolition		RISK SCORE TOTAL	0
DATE OF SURVEY	23rd Nov 2017	IDENTIFICATION LEVEL	Identified By Analysis	
SURVEYOR	Jamie Cain	ACCESSIBILITY	N/A	
NEXT INSPECTION	N/A - SEE COMMENTS	MATERIAL HAZARD RATING	N/A	PRIORITY 0 No Action Required

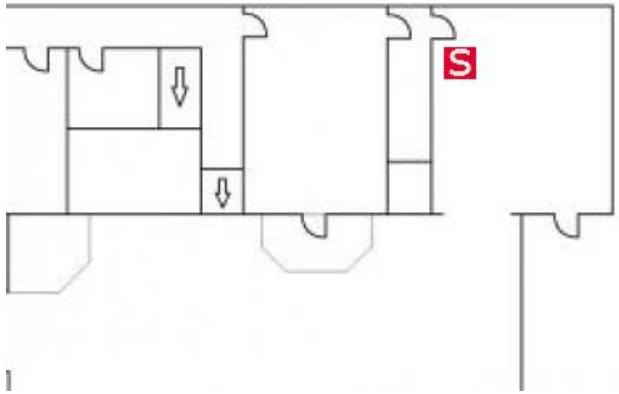
SAMPLE NUMBER	NES /JC02/0013/2	QUANTITY	2m²	SCORE
CLIENT	IMN Properties Ltd	MATERIAL/PRODUCT	Insulation Board	2
SURVEY LOCATION	Royal British Legion	DAMAGE	High	3
FLOOR	Ground Floor	SURFACE TREATMENT	Unsealed 1	2
LOCATION	Small Function Room	ASBESTOS TYPE	Grunerite & Chrysotile (Brown & White)	2
TYPE OF SURVEY	Demolition		RISK SCORE TOTAL	9
DATE OF SURVEY	23rd Nov 2017	IDENTIFICATION LEVEL	Identified By Analysis	
SURVEYOR	Jamie Cain	ACCESSIBILITY	High	
NEXT INSPECTION	N/A - SEE COMMENTS	MATERIAL HAZARD RATING	MEDIUM	PRIORITY 1 Remove

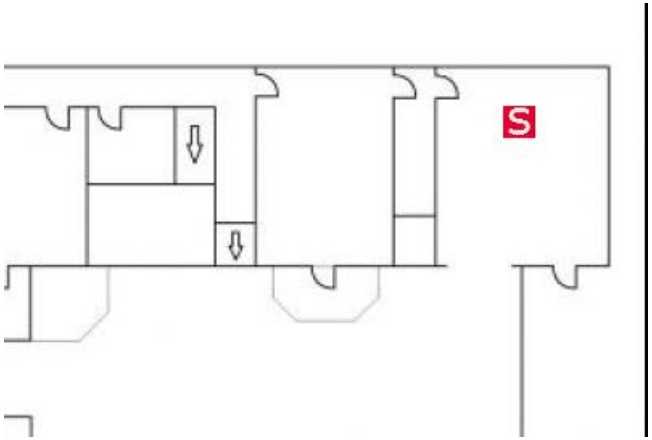
SAMPLE NUMBER	NES /JC02/0013/3	QUANTITY	40m²	SCORE
CLIENT	IMN Properties Ltd	MATERIAL/PRODUCT	Text Coating	1
SURVEY LOCATION	Royal British Legion	DAMAGE	High	3
FLOOR	Ground Floor	SURFACE TREATMENT	Composite Materials	0
LOCATION	Small Function Room	ASBESTOS TYPE	Chrysotile (White)	1
TYPE OF SURVEY	Demolition		RISK SCORE TOTAL	5
DATE OF SURVEY	23rd Nov 2017	IDENTIFICATION LEVEL	Identified By Analysis	
SURVEYOR	Jamie Cain	ACCESSIBILITY	High	
NEXT INSPECTION	N/A - SEE COMMENTS	MATERIAL HAZARD RATING	LOW	PRIORITY 1 Remove

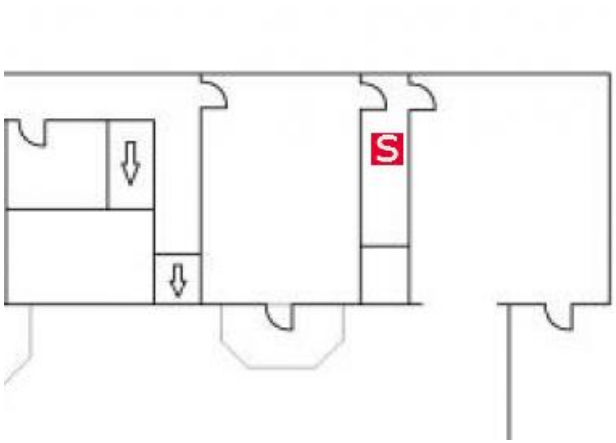
SAMPLE NUMBER	NES /JC02/0013/4	QUANTITY	8m²	SCORE
CLIENT	IMN Properties Ltd	MATERIAL/PRODUCT	Text Coating	1
SURVEY LOCATION	Royal British Legion	DAMAGE	Low	1
FLOOR	Ground Floor	SURFACE TREATMENT	Composite Materials	0
LOCATION	Small Store	ASBESTOS TYPE	Chrysotile (White)	1
TYPE OF SURVEY	Demolition		RISK SCORE TOTAL	3
DATE OF SURVEY	23rd Nov 2017	IDENTIFICATION LEVEL	Identified By Analysis	
SURVEYOR	Jamie Cain	ACCESSIBILITY	Low	
NEXT INSPECTION	N/A - SEE COMMENTS	MATERIAL HAZARD RATING	V.LOW	PRIORITY 1 Remove

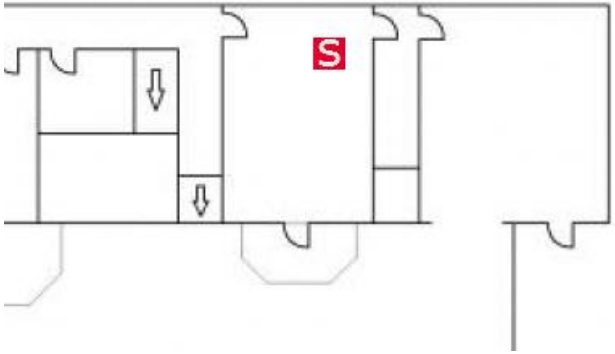
SAMPLE NUMBER	NES /JC02/0013/5	QUANTITY	30m²	SCORE
CLIENT	IMN Properties Ltd	MATERIAL/PRODUCT	Debris	3
SURVEY LOCATION	Royal British Legion	DAMAGE	High	3
FLOOR	Ground Floor	SURFACE TREATMENT	Unsealed 1	2
LOCATION	Cellar	ASBESTOS TYPE	Grunerite & Chrysotile (Brown & White)	2
TYPE OF SURVEY	Demolition		RISK SCORE TOTAL	10
DATE OF SURVEY	23rd Nov 2017	IDENTIFICATION LEVEL	Identified By Analysis	
SURVEYOR	Jamie Cain	ACCESSIBILITY	High	
NEXT INSPECTION	N/A - SEE COMMENTS	MATERIAL HAZARD RATING	HIGH	PRIORITY 1 Remove

A sample was taken from the Insulation Board Debris that was found on the floor.
The Debris is believed to have come from the damaged door lining in the small function room.

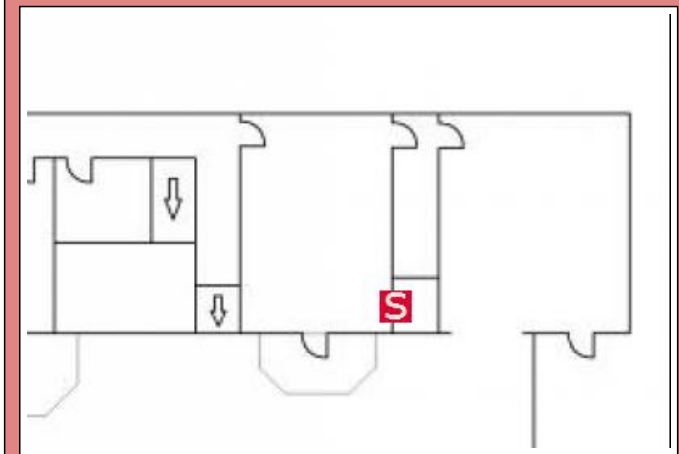
SAMPLE NUMBER	NES /JC02/0013/6	QUANTITY	30m²	SCORE
CLIENT	IMN Properties Ltd	MATERIAL/PRODUCT	Text Coating	1
SURVEY LOCATION	Royal British Legion	DAMAGE	Low	1
FLOOR	Ground Floor	SURFACE TREATMENT	Composite Materials	0
LOCATION	Cellar	ASBESTOS TYPE	Chrysotile (White)	1
TYPE OF SURVEY	Demolition		RISK SCORE TOTAL	3
DATE OF SURVEY	23rd Nov 2017	IDENTIFICATION LEVEL	Identified By Analysis	
SURVEYOR	Jamie Cain	ACCESSIBILITY	Low	
NEXT INSPECTION	N/A - SEE COMMENTS	MATERIAL HAZARD RATING	V.LOW	PRIORITY 1 Remove

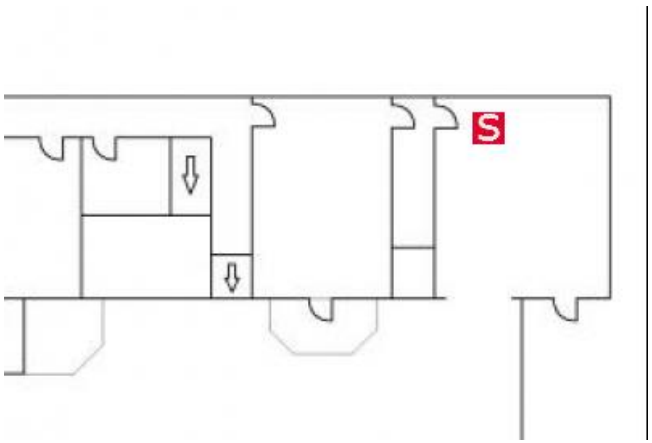
SAMPLE NUMBER	NES /JC02/0013/7	QUANTITY	50m²	SCORE
CLIENT	IMN Properties Ltd	MATERIAL/PRODUCT	Insulation Board	2
SURVEY LOCATION	Royal British Legion	DAMAGE	High	3
FLOOR	Ground Floor	SURFACE TREATMENT	Unsealed 1	2
LOCATION	Small Function Room	ASBESTOS TYPE	Grunerite & Chrysotile (Brown & White)	2
TYPE OF SURVEY	Demolition		RISK SCORE TOTAL	9
DATE OF SURVEY	23rd Nov 2017	IDENTIFICATION LEVEL	Identified By Analysis	
SURVEYOR	Jamie Cain	ACCESSIBILITY	Low	
NEXT INSPECTION	N/A - SEE COMMENTS	MATERIAL HAZARD RATING	MEDIUM	PRIORITY 1 Remove

A sample was taken from the Insulation Board Debris that was found on the floor.
The Debris is believed to have come from the damaged door lining in the small function room.

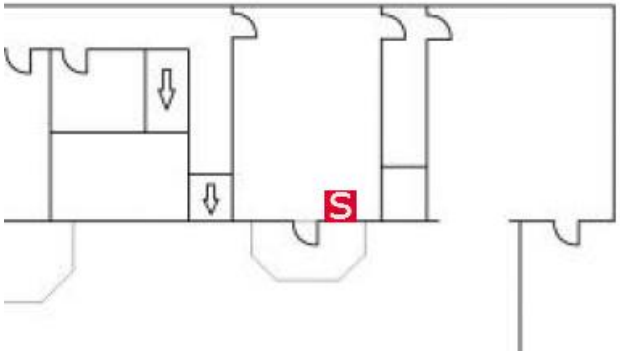
SAMPLE NUMBER	NES /JC02/0013/8	QUANTITY	2 units	SCORE
CLIENT	IMN Properties Ltd	MATERIAL/PRODUCT	Bitumen Sink Pads	1
SURVEY LOCATION	Royal British Legion	DAMAGE	Low	1
FLOOR	Ground Floor	SURFACE TREATMENT	Composite Materials	0
LOCATION	Cellar	ASBESTOS TYPE	Chrysotile (White)	1
TYPE OF SURVEY	Demolition		RISK SCORE TOTAL	3
DATE OF SURVEY	23rd Nov 2017	IDENTIFICATION LEVEL	Identified By Analysis	
SURVEYOR	Jamie Cain	ACCESSIBILITY	Low	
NEXT INSPECTION	N/A - SEE COMMENTS	MATERIAL HAZARD RATING	V.LOW	PRIORITY 1 Remove

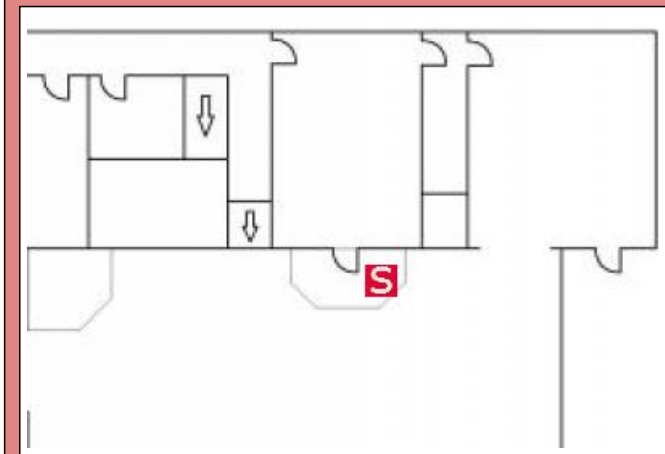
SAMPLE NUMBER	NES /JC02/0013/9	QUANTITY	2 units	SCORE
CLIENT	IMN Properties Ltd	MATERIAL/PRODUCT	Bitumen Sink Pads	0
SURVEY LOCATION	Royal British Legion	DAMAGE	Good Condition	0
FLOOR	Ground Floor	SURFACE TREATMENT	Composite Materials	0
LOCATION	Main Bar	ASBESTOS TYPE	No Asbestos Detected	0
TYPE OF SURVEY	Demolition		RISK SCORE TOTAL	0
DATE OF SURVEY	23rd Nov 2017	IDENTIFICATION LEVEL	Identified By Analysis	
SURVEYOR	Jamie Cain	ACCESSIBILITY	Low	
NEXT INSPECTION	N/A - SEE COMMENTS	MATERIAL HAZARD RATING	N/A	PRIORITY 0 No Action Required

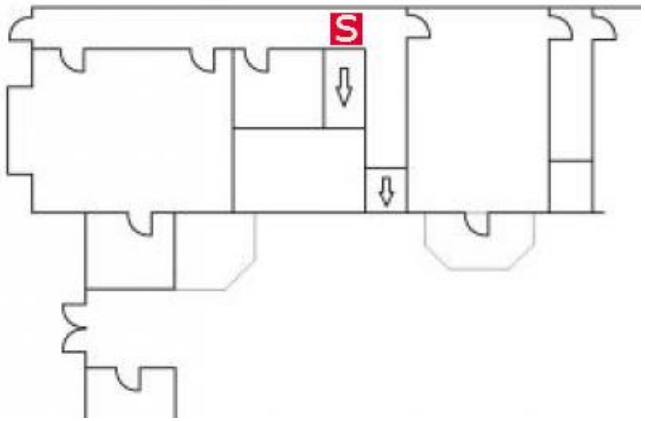
SAMPLE NUMBER	NES /JC02/0013/10	QUANTITY	40m²	SCORE
CLIENT	IMN Properties Ltd	MATERIAL/PRODUCT	Insulation Board	2
SURVEY LOCATION	Royal British Legion	DAMAGE	High	3
FLOOR	Ground Floor	SURFACE TREATMENT	Unsealed 1	2
LOCATION	Rear Corridor	ASBESTOS TYPE	Grunerite & Chrysotile (Brown & White)	2
TYPE OF SURVEY	Demolition		RISK SCORE TOTAL	9
DATE OF SURVEY	23rd Nov 2017	IDENTIFICATION LEVEL	Identified By Analysis	
SURVEYOR	Jamie Cain	ACCESSIBILITY	High	
NEXT INSPECTION	N/A - SEE COMMENTS	MATERIAL HAZARD RATING	MEDIUM	PRIORITY 1 Remove

A sample was taken from the Insulation Board Debris that was found on the floor.
The Debris is believed to have come from the damaged door lining in the small function room.

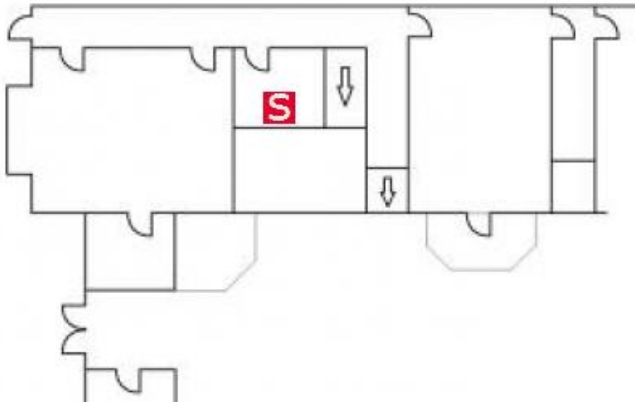
SAMPLE NUMBER	NES /JC02/0013/11	QUANTITY	10m²	SCORE
CLIENT	IMN Properties Ltd	MATERIAL/PRODUCT	Text Coating	1
SURVEY LOCATION	Royal British Legion	DAMAGE	Low	1
FLOOR	Ground Floor	SURFACE TREATMENT	Composite Materials	0
LOCATION	Female WC	ASBESTOS TYPE	Chrysotile (White)	1
TYPE OF SURVEY	Demolition		RISK SCORE TOTAL	3
DATE OF SURVEY	23rd Nov 2017	IDENTIFICATION LEVEL	Identified By Analysis	
SURVEYOR	Jamie Cain	ACCESSIBILITY	Low	
NEXT INSPECTION	N/A - SEE COMMENTS	MATERIAL HAZARD RATING	V.LOW	PRIORITY 1 Remove

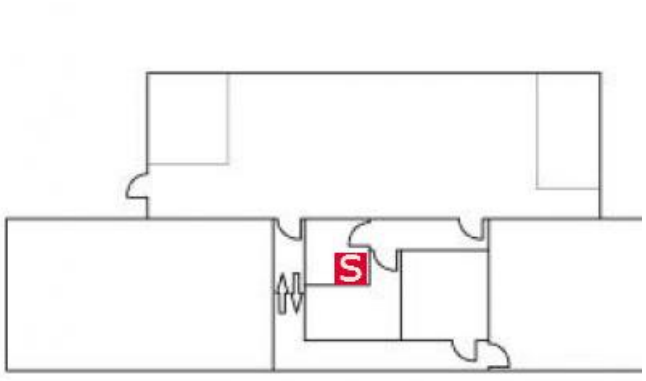
SAMPLE NUMBER	NES /JC02/0013/12	QUANTITY	2 units	SCORE
CLIENT	IMN Properties Ltd	MATERIAL/PRODUCT	Bitumen Sink Pads	0
SURVEY LOCATION	Royal British Legion	DAMAGE	Low	0
FLOOR	First Floor	SURFACE TREATMENT	Composite Materials	0
LOCATION	Kitchen	ASBESTOS TYPE	No Asbestos Detected	0
TYPE OF SURVEY	Demolition		RISK SCORE TOTAL	0
DATE OF SURVEY	23rd Nov 2017	IDENTIFICATION LEVEL	Identified By Analysis	
SURVEYOR	Jamie Cain	ACCESSIBILITY	Low	
NEXT INSPECTION	N/A - SEE COMMENTS	MATERIAL HAZARD RATING	N/A	PRIORITY 0 No Action Required

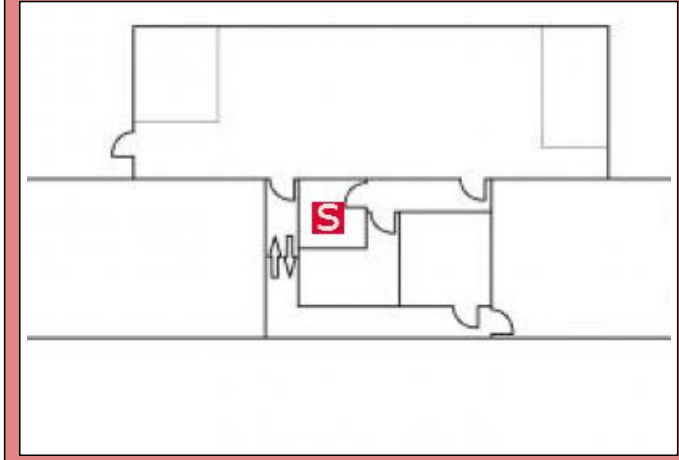
SAMPLE NUMBER	NES /JC02/0013/13	QUANTITY	10m²	SCORE
CLIENT	IMN Properties Ltd	MATERIAL/PRODUCT	Text Coating	1
SURVEY LOCATION	Royal British Legion	DAMAGE	Low	1
FLOOR	First Floor	SURFACE TREATMENT	Enclosed Sprays	1
LOCATION	Male WC	ASBESTOS TYPE	Chrysotile (White)	1
TYPE OF SURVEY	Demolition		RISK SCORE TOTAL	4
DATE OF SURVEY	23rd Nov 2017	IDENTIFICATION LEVEL	Identified By Analysis	
SURVEYOR	Jamie Cain	ACCESSIBILITY	Low	
NEXT INSPECTION	N/A - SEE COMMENTS	MATERIAL HAZARD RATING	V.LOW	PRIORITY 1 Remove

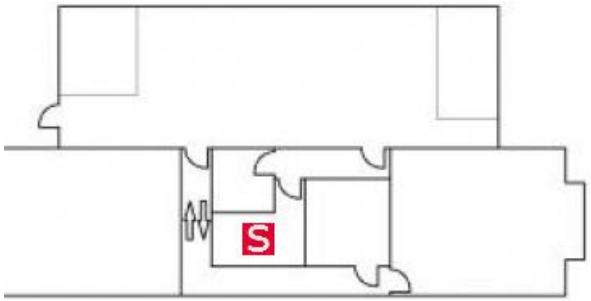
SAMPLE NUMBER	NES /JC02/0013/14	QUANTITY	10m²	SCORE
CLIENT	IMN Properties Ltd	MATERIAL/PRODUCT	Text Coating	1
SURVEY LOCATION	Royal British Legion	DAMAGE	Low	1
FLOOR	First Floor	SURFACE TREATMENT	Composite Materials	0
LOCATION	Female WC	ASBESTOS TYPE	Chrysotile (White)	1
TYPE OF SURVEY	Demolition		RISK SCORE TOTAL	3
DATE OF SURVEY	23rd Nov 2017	IDENTIFICATION LEVEL	Identified By Analysis	
SURVEYOR	Jamie Cain	ACCESSIBILITY	Low	
NEXT INSPECTION	N/A - SEE COMMENTS	MATERIAL HAZARD RATING	V.LOW	PRIORITY 1 Remove

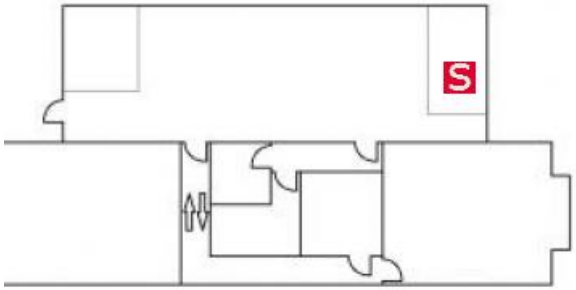
SAMPLE NUMBER	NES /JC02/0013/15	QUANTITY	10m²	SCORE
CLIENT	IMN Properties Ltd	MATERIAL/PRODUCT	Text Coating	1
SURVEY LOCATION	Royal British Legion	DAMAGE	Low	1
FLOOR	First Floor	SURFACE TREATMENT	Composite Materials	0
LOCATION	Lounge & Small Service Bar	ASBESTOS TYPE	Chrysotile (White)	1
TYPE OF SURVEY	Demolition		RISK SCORE TOTAL	3
DATE OF SURVEY	23rd Nov 2017	IDENTIFICATION LEVEL	Identified By Analysis	
SURVEYOR	Jamie Cain	ACCESSIBILITY	Low	
NEXT INSPECTION	N/A - SEE COMMENTS	MATERIAL HAZARD RATING	V.LOW	PRIORITY 1 Remove
