**21/00434/HYA**

ARBORICULTURAL IMPACT ASSESSMENT AND METHOD STATEMENT REPORT

Land North Pound farm, London Road, St Ippolyts, Herts, SG4 7NE

**OUR REF: SHA 1874**

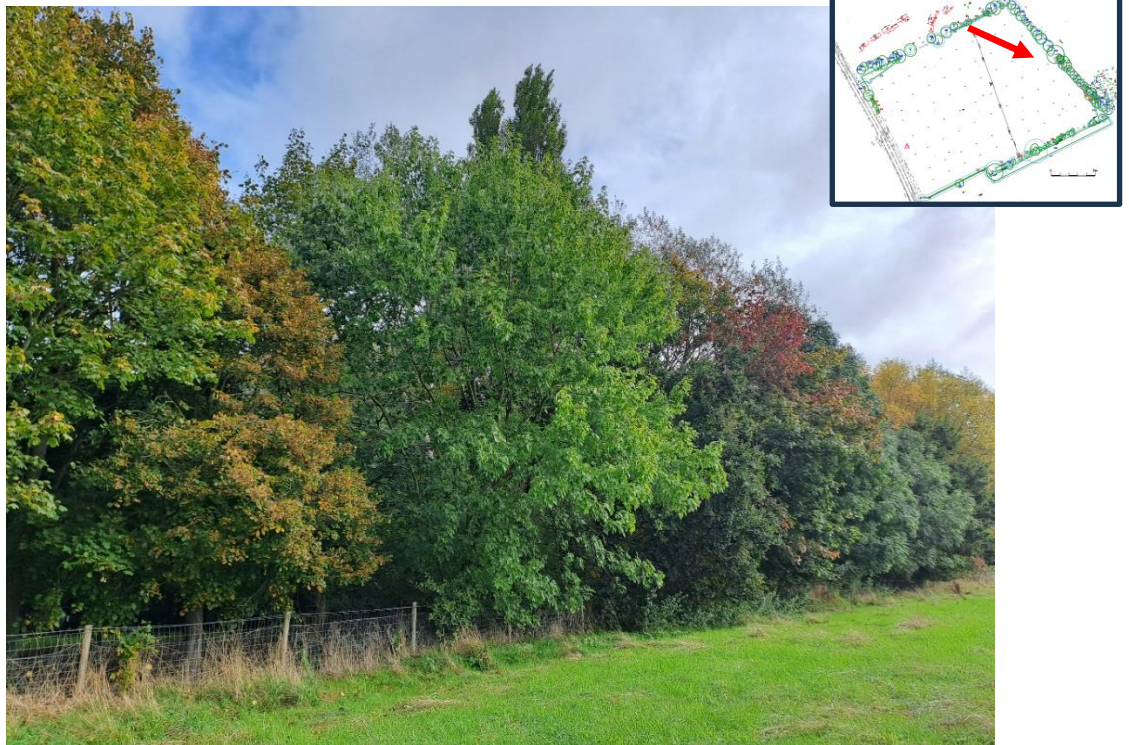
The line of trees included in the tree survey is the closest to the boundary in an offsite linear woodland which forms public open space. The trees are similar in age and character for the northern 2 thirds of this group and more informal and wooded in the southern third. The northern two thirds comprise Norway maple, ash, lime, silver maple and oak. There is a large multi stemmed crack willow (T13) which has the potential for stems to collapse, a large white poplar (T16), with further willows, ash, hazel to the south.

*Photo 1 – typical view on the eastern boundary looking south*

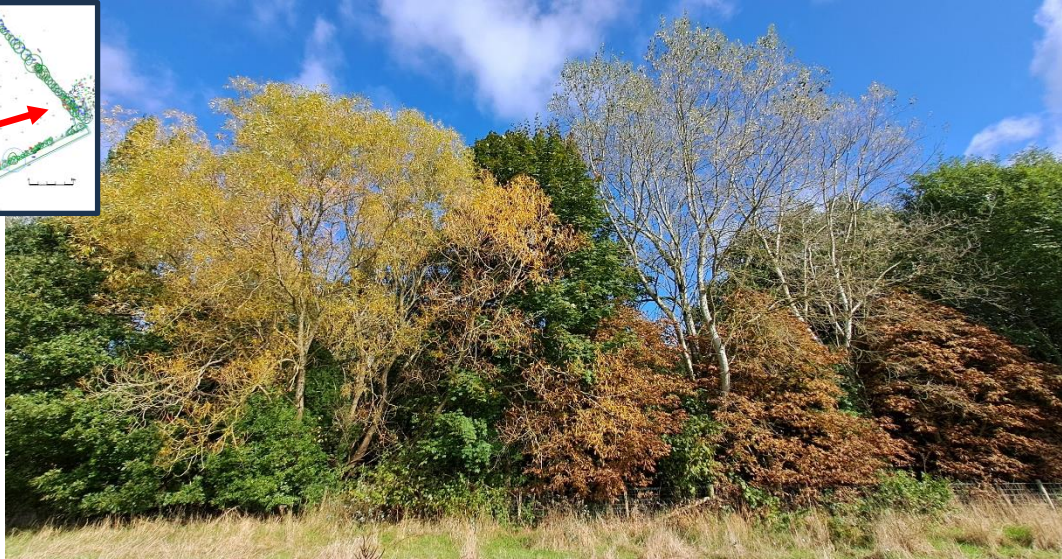
*Photo 2 – typical view on the eastern boundary looking east showing the willow and poplars*

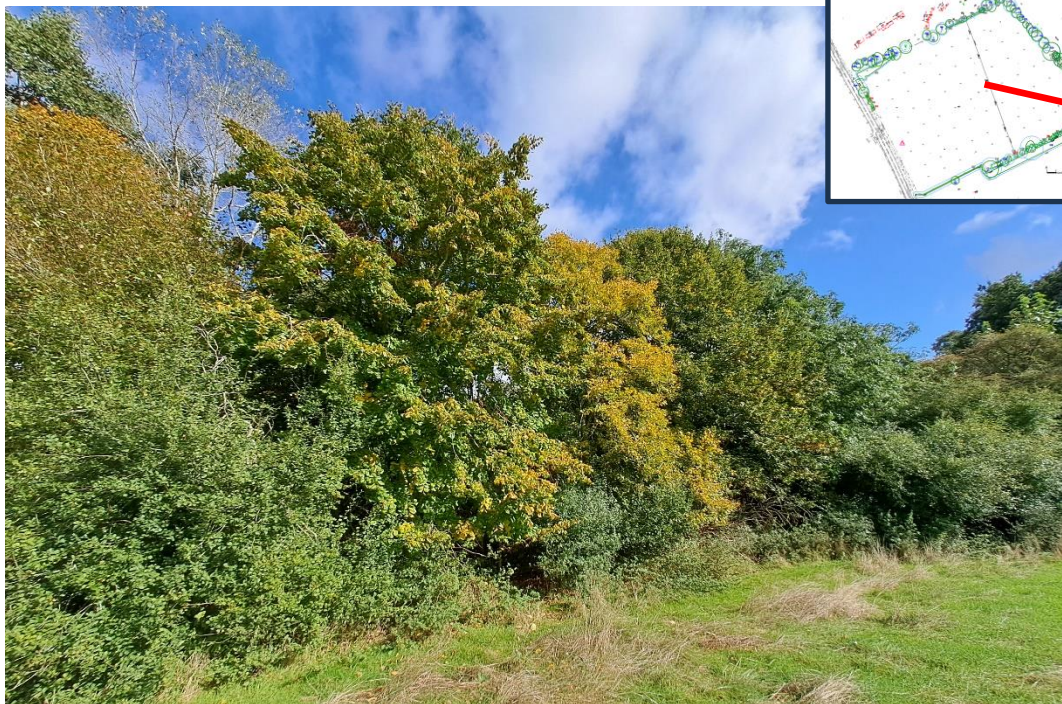
*Photo 3 – typical view on the south – eastern boundary corner*

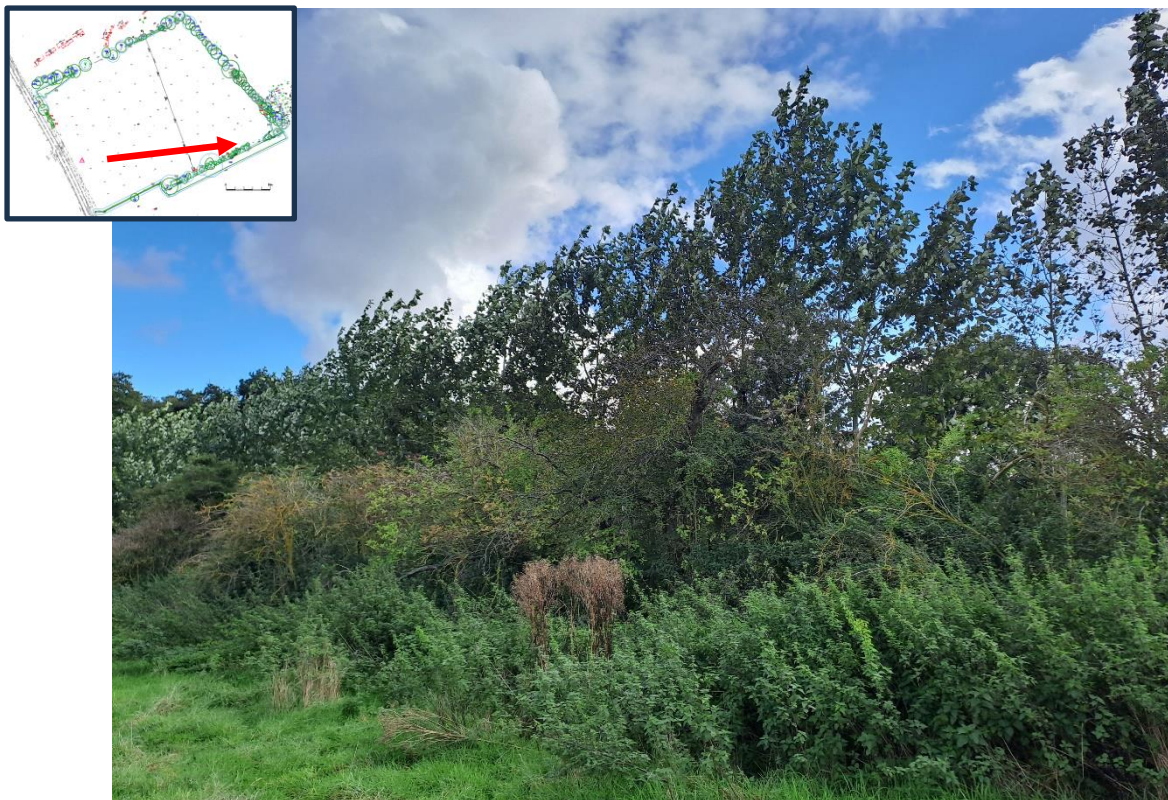
There is group of suckering blackthorn and elder amongst ruderal vegetation in the south-eastern corner. A line of semi-mature poplars (G37) is offsite to the south, fronted by offsite hawthorns and elders in a reasonable/poor condition. There are two large, characterful trees with structural defects with decay; T41 oak which is retrenching with 40% live crown, and T47 ash which has fungal brackets, (*Inonotus hispidus*), which is associated with failure of branches. Both trees are recommended for further investigation, but this is a matter for the landowner. Both trees have landscape, and ecological value, but there is a risk of dead/defective branches falling into the site. To the west of the southern boundary is a conifer hedge with a prominent spruce to the rear.

*Photo 4 of G37 offsite poplars fronted by hawthorns and elders looking south-east*

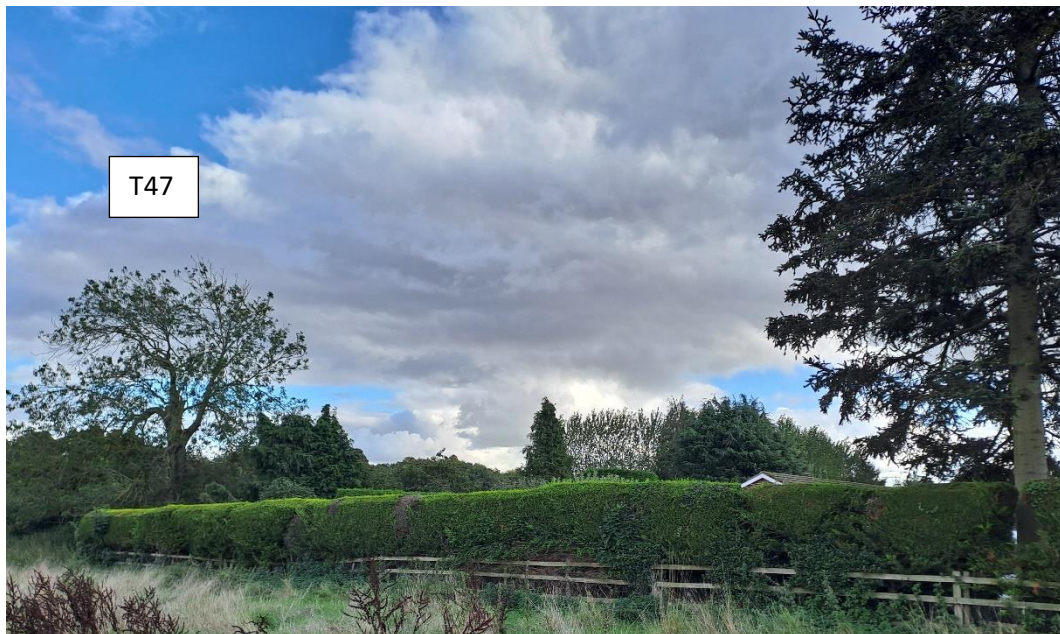
*Photo 8 of the offsite hedge H80 and spruce T81 with T47 ash in the background*

- 8.12. That the landowner is made aware of the condition of the oak T41 and ash T47.

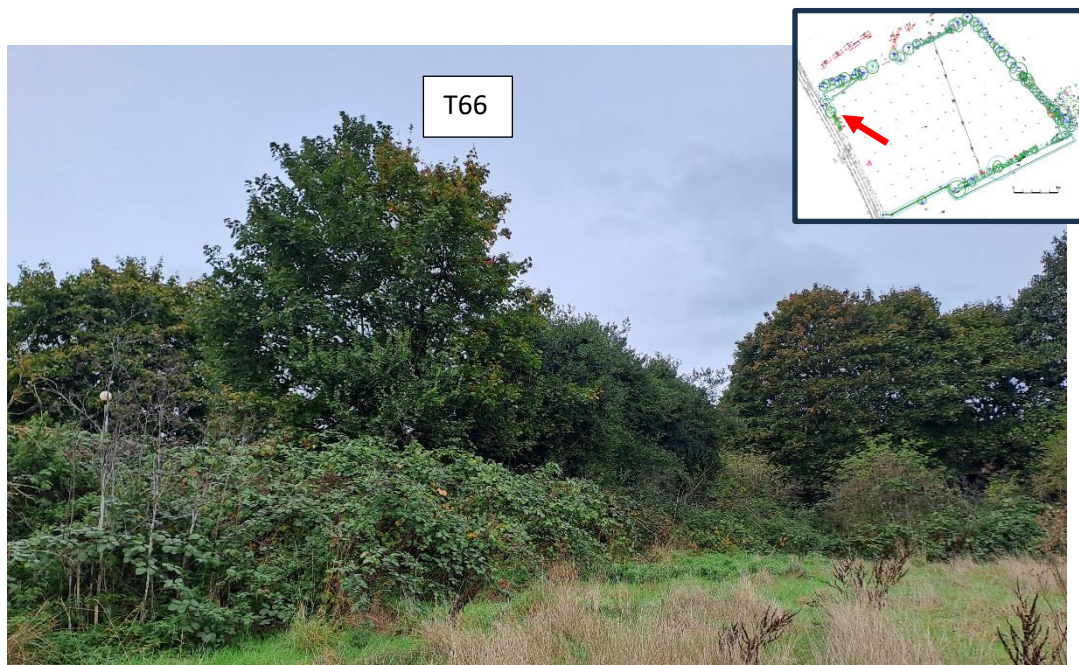
The vegetation on the roadside is very patchy, with the prominent tree being T68 Norway maple. A group of dense early mature hollies (G67) is on the south-western corner. There are a few dead and dying elms (S64) which pose a risk to the road.

*Photo 9 of the north – western corner*
