## **Julians Park, Rushden, Buntingford, Herts. SG9 0TD.**

Historic building recording and analysis of the Outbuildings. Recorded 08 05 2024.

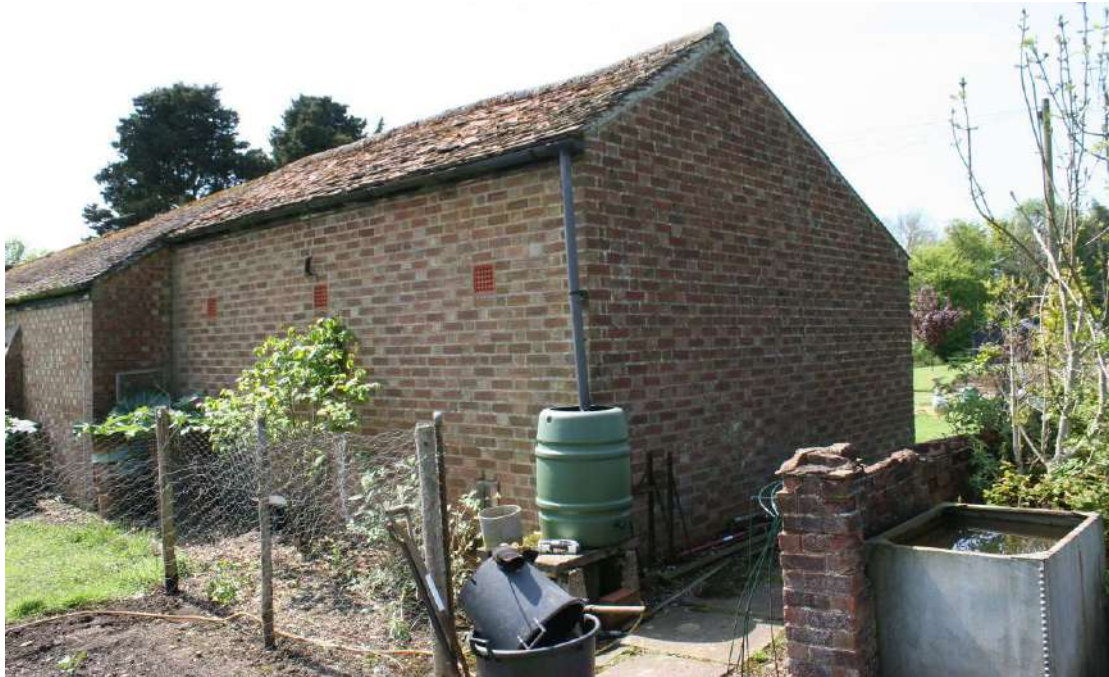
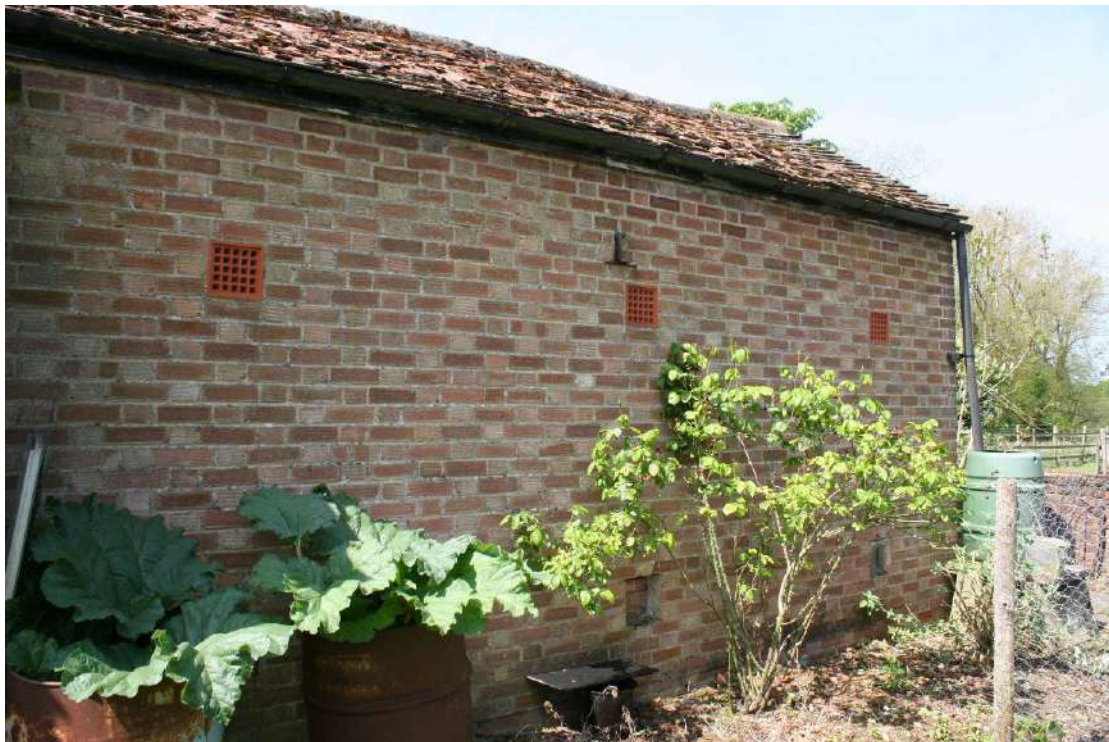
The NW and NE Elevations of the Stables.

The NE elevations of the Stables.

The Stables is made from textured Flettons set in grey cement. There are three ceramic air grates and three lower ones bricked up. The Stable roof facing the House has been clad with nibbed tiles that have been storm damaged and many are loose.

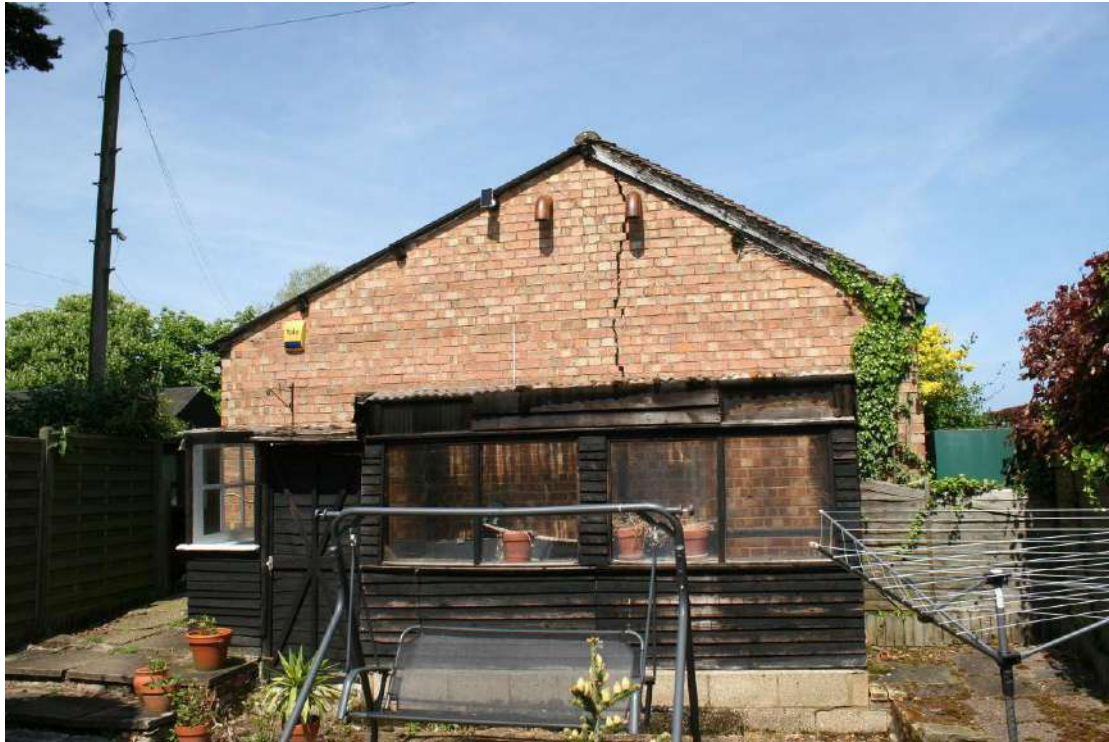
The SE elevation of the Workshop.

The SE elevation faces the cottage and a potting shed has been built against it. The wall has serious structural cracks and the roof has shifted. The air vents are sewer pipes.

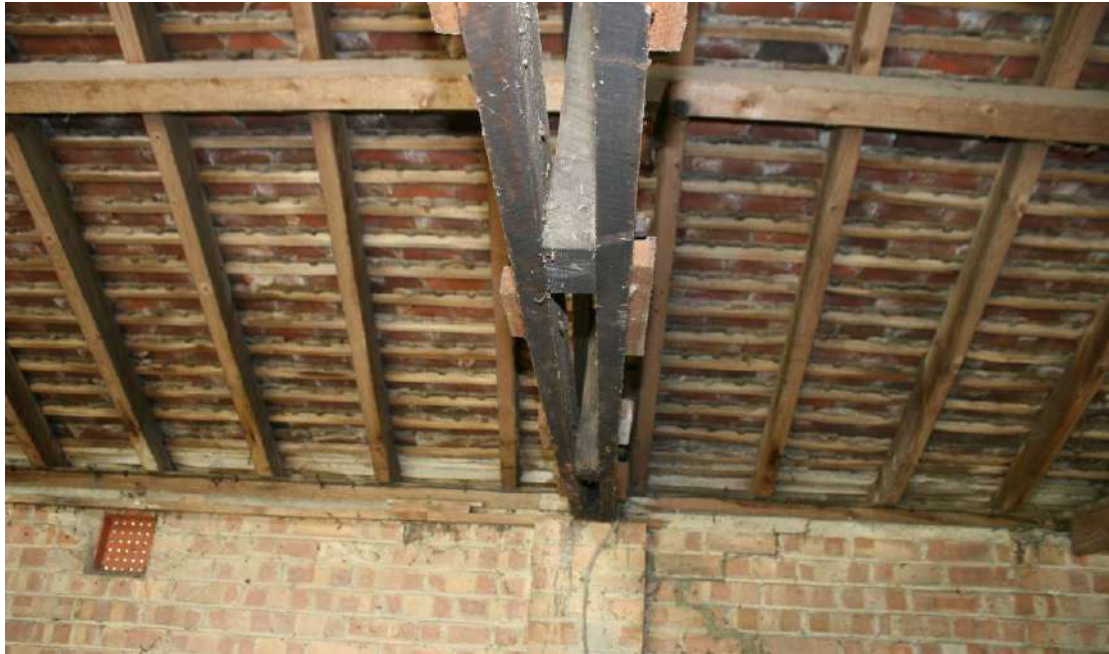
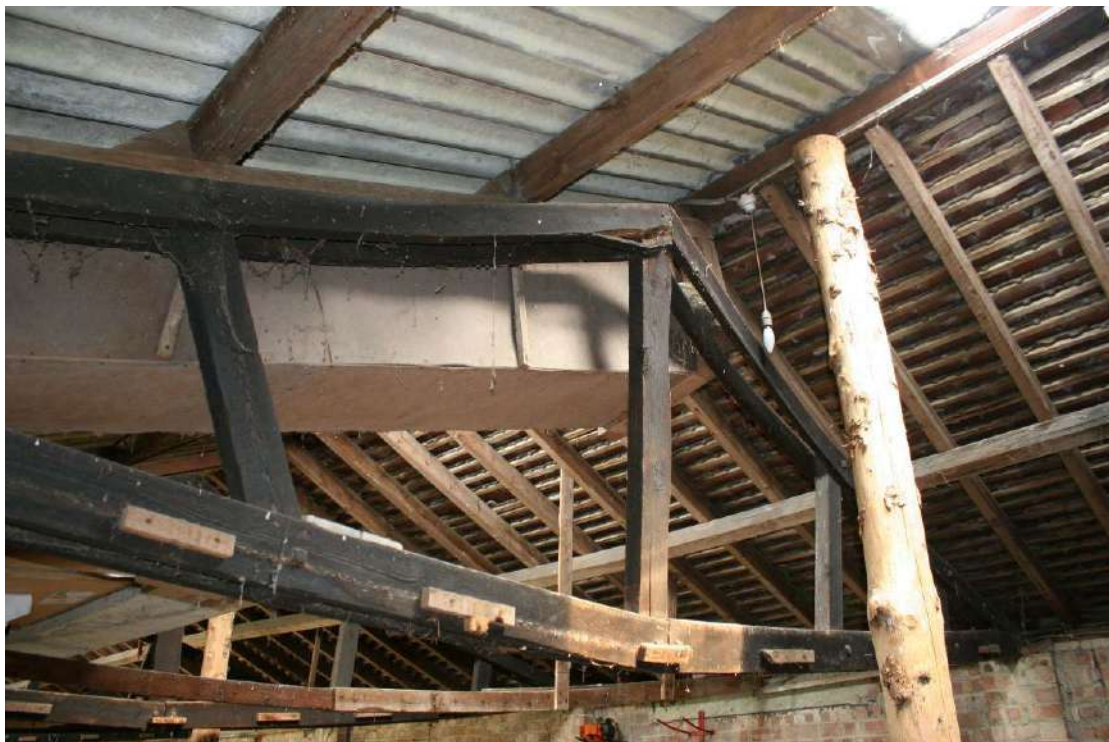
Detail of one of the composite trusses and the NE side of the roof with nibbed tiles.

The SW side of the roof has a corrugated cement board roof covering.

The NE side of the roof is clad with nibbed tiles set on battens and machined softwood rafters. The SW side has a corrugated cement board roof supported on purlins. The roof pitch has been altered and does not match the trusses and additional ashlar posts have been inserted to bear the NE side. The disparity in weight has contorted the trusses and is causing them to fail. Tree trunks have been added to support the ridgepiece.

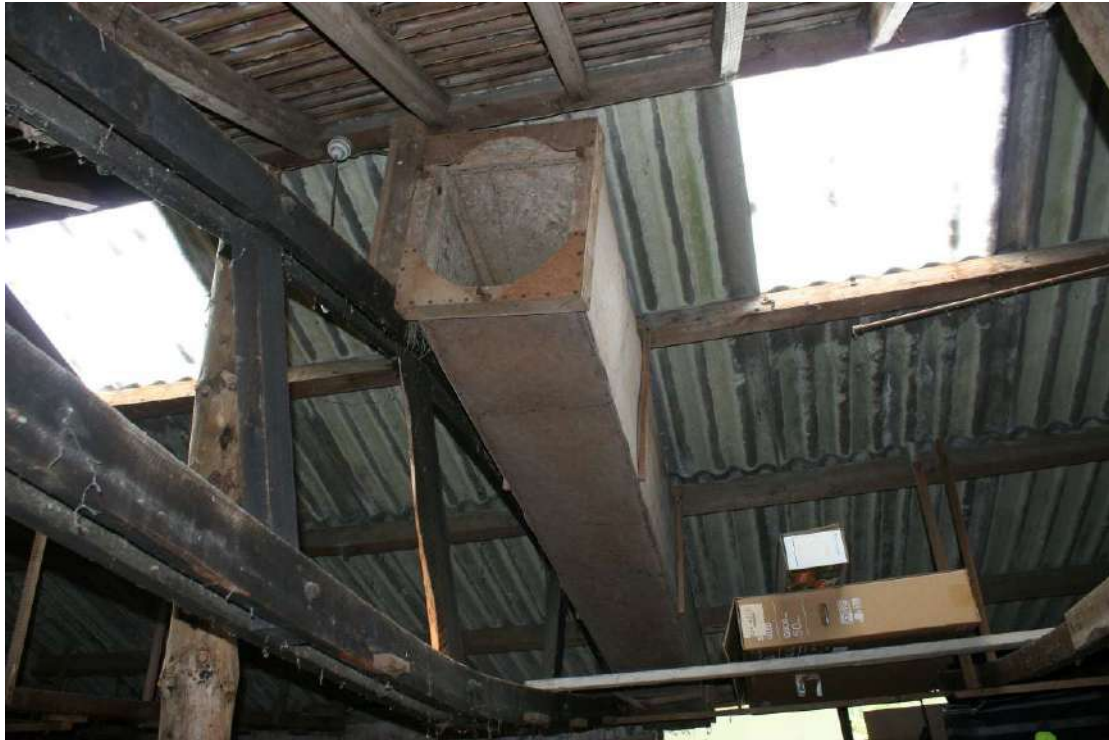
There is a timber duct fitted in the roof.

There is evidence that the building may have been used to dry and store produce. There is large wooden air duct and sewer pipes have been inserted to provide high level ventilation. Unfortunately, this has caused serious structural cracks in the SE wall.

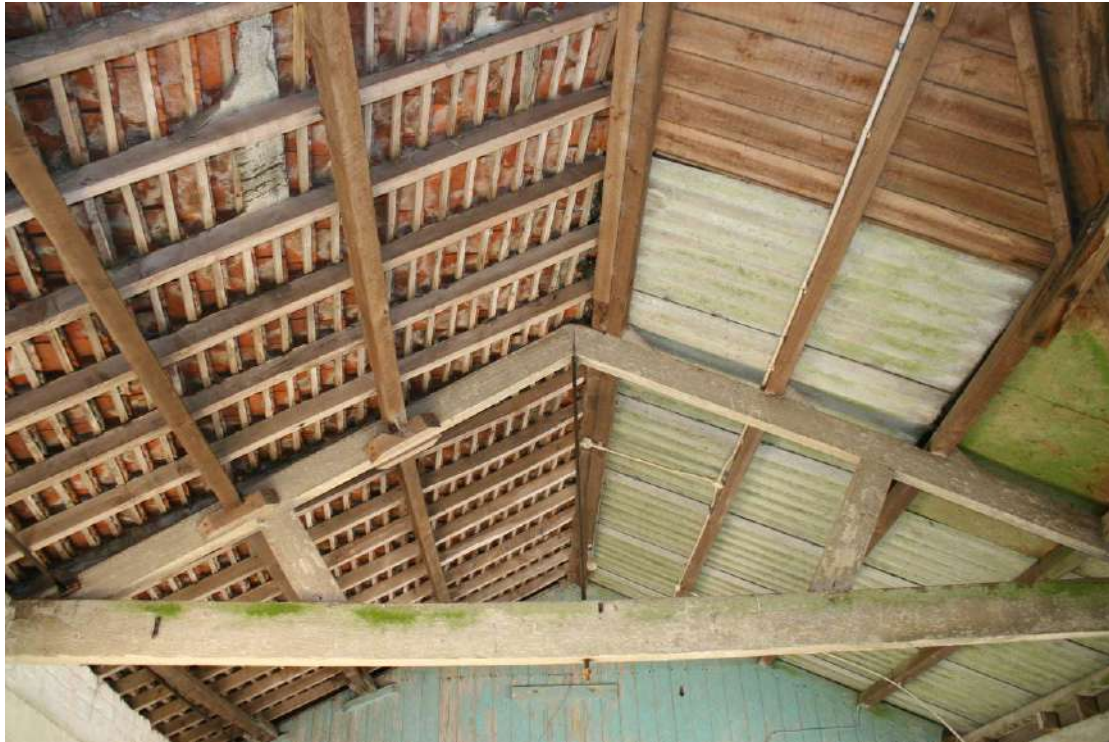
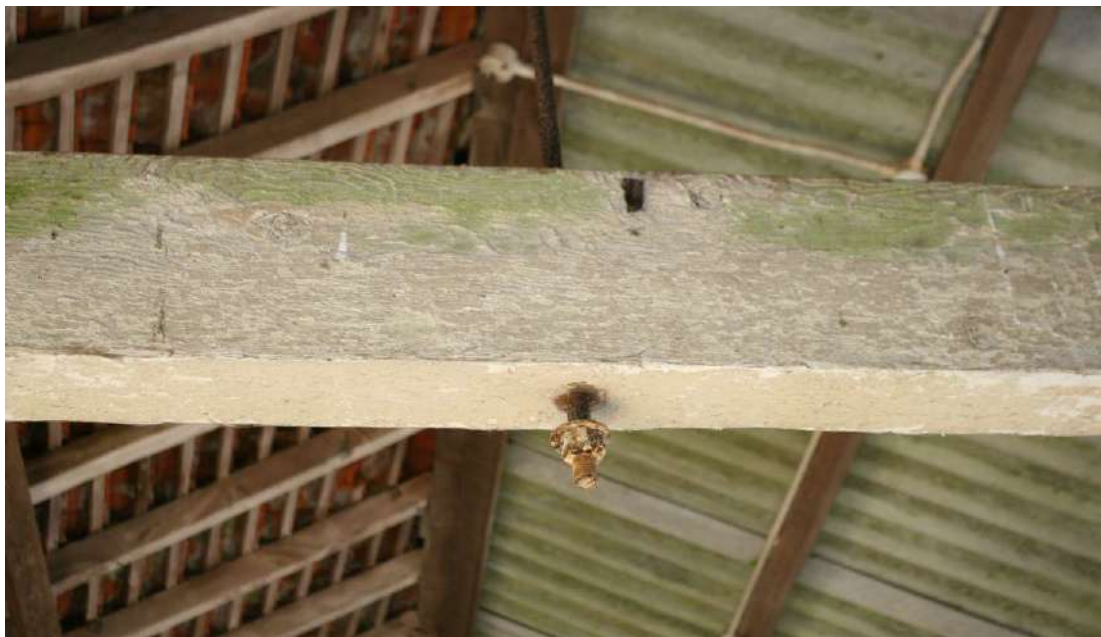
The roof over the carriage arch. Looking SW.

Detail of the king bolt showing the sag of the roof.

The roof over the Garage bay, the carriage arch and the rest of the Long Garage is of a consistent design dating to the 1939 improvements. The roof has a set of king bolt trusses which have been adapted for the present roof covering. The NW side has side purlins supported on cleats set on top of the principal rafters to support corrugated cement boards. The SE side has butt purlins set between the principal rafters and supported on nailed on clamps to support machined softwood rafters, battens and nibbed tiles.

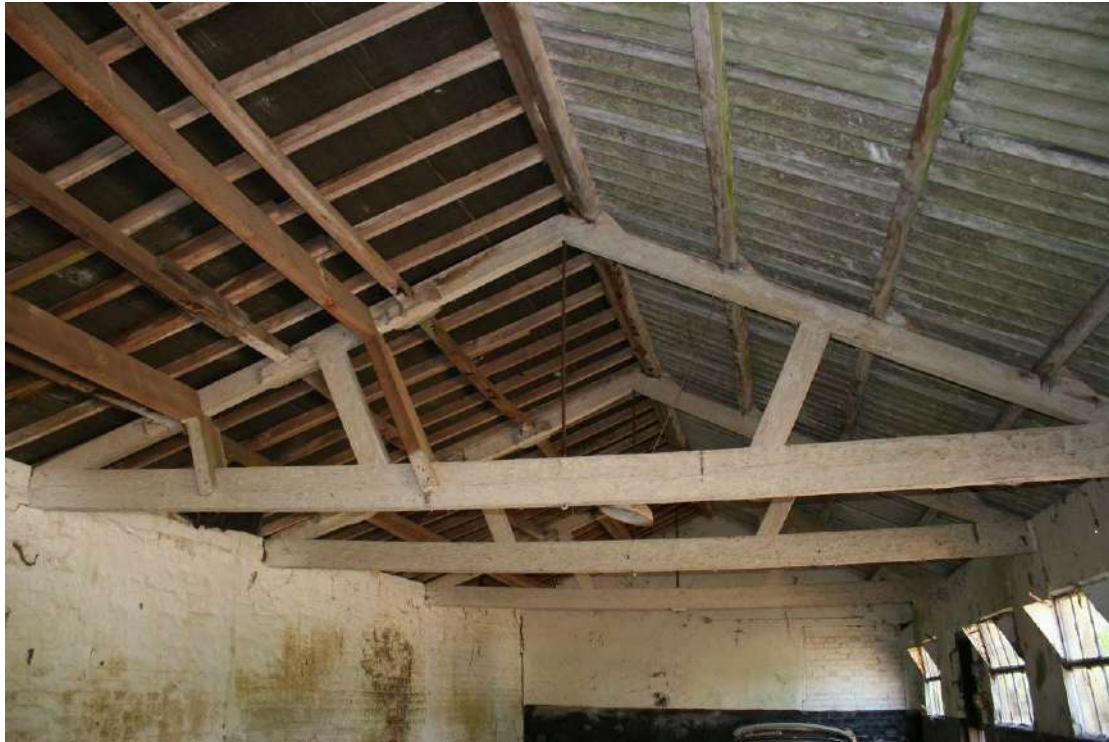
Detail of the roof structure looking SW.

The SE side of the roof has an asphalt membrane which would indicate the roof has been re-battened between 1965 and 1985. The type of membrane with a cotton mesh would indicate early in this period. The membrane has failed and there has been considerable water damage to one of the trusses which has been reinforced with steel fish plates.

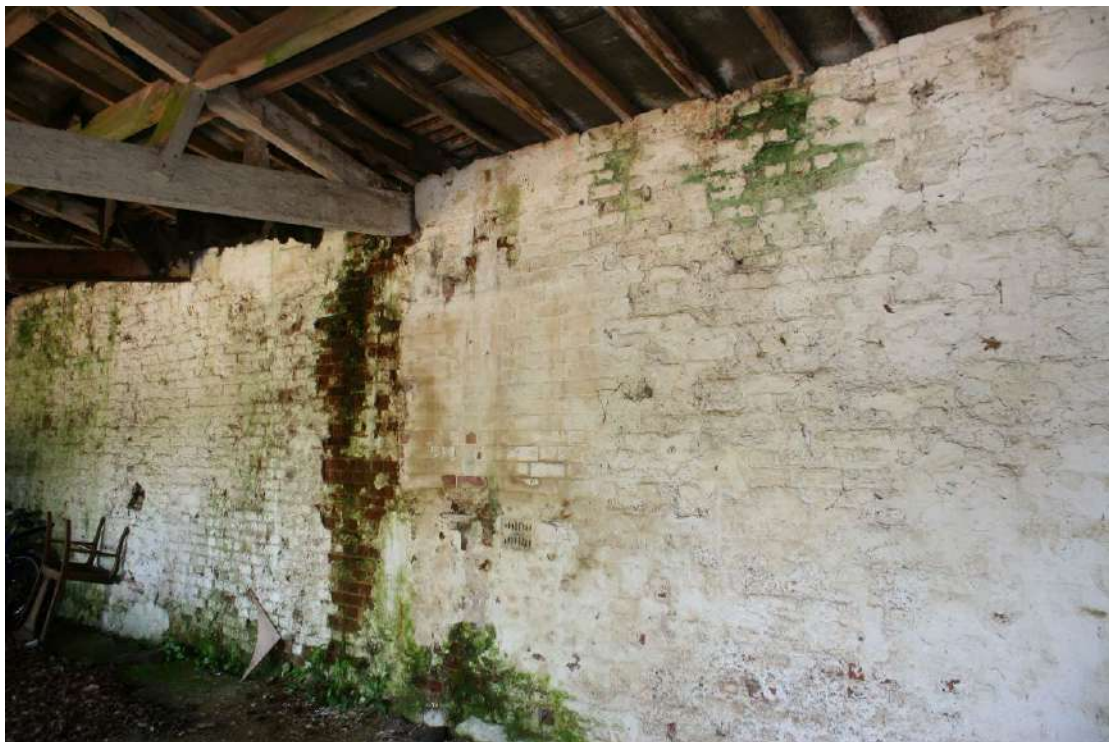
Bricked up window in the SE wall.

The building has been built off an earlier 13in thick perimeter wall made of 55-60x105x210mm red bricks with creased faces and soft arrises set in beige sandy mortar and mostly in English bond. There are sections near the carriage arch which are H-S-H-H-S-H-H-H-S bond which approximates to Flemish Garden Wall bond. The wall has shifted away from its added buttresses. Mapping might indicate a wall here from between 1777 and 1806.

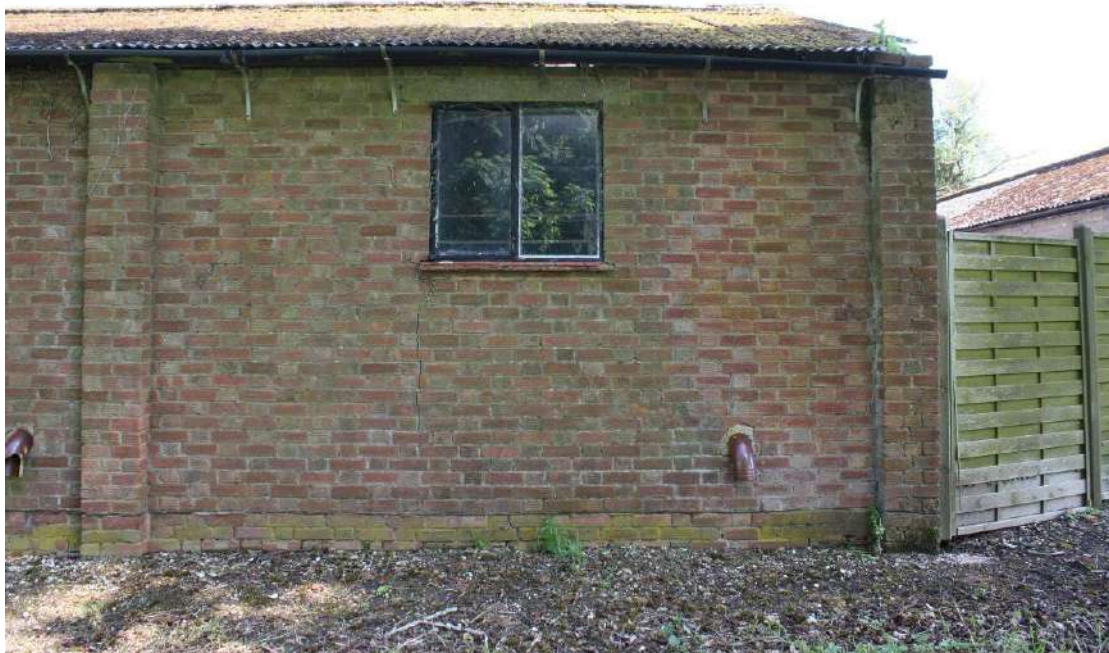
Detail of the southernmost bay.

The brickwork is set in grey cement joints and the windows have queen closer bricks (which are lacking on the quoins). The windows have steel reinforced concrete lintels and have internal steel bars which might suggest that animals were kept inside and the windows needed protection. There is also some serious cracking near the windows.

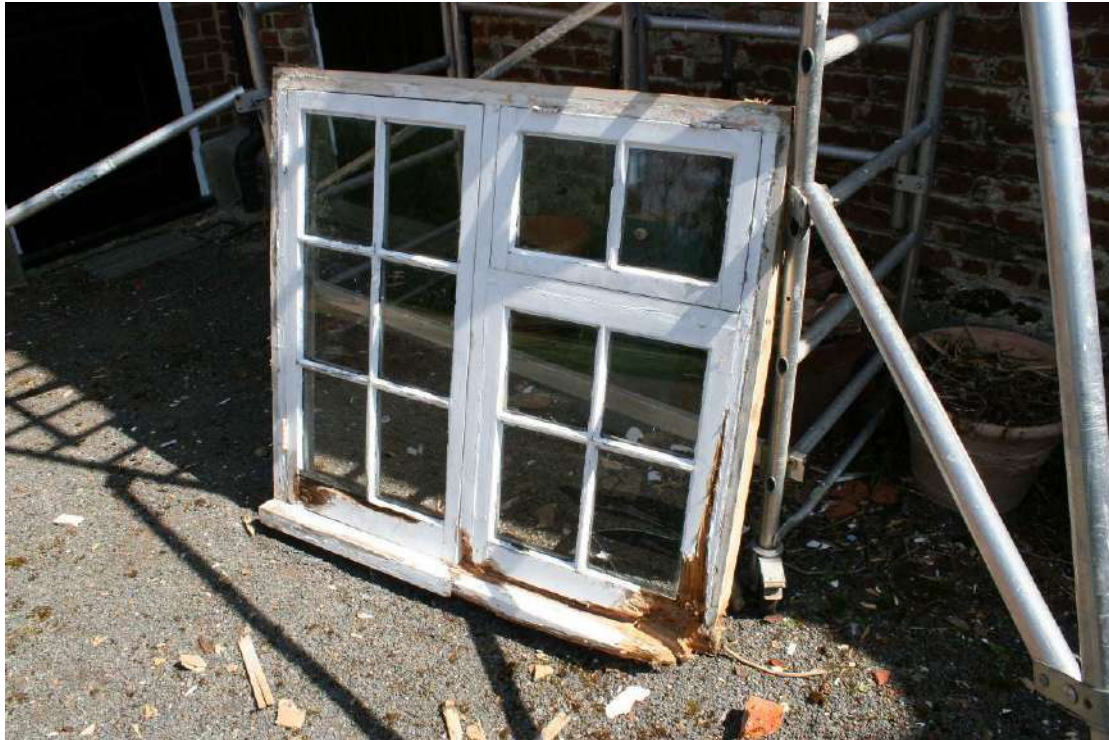
1930's casement window under restoration.

At the time of the survey the attic window had been removed for repair and could be seen that it was a 1930's product with machined softwood components, routed astragals and rat-tail catches and stays.

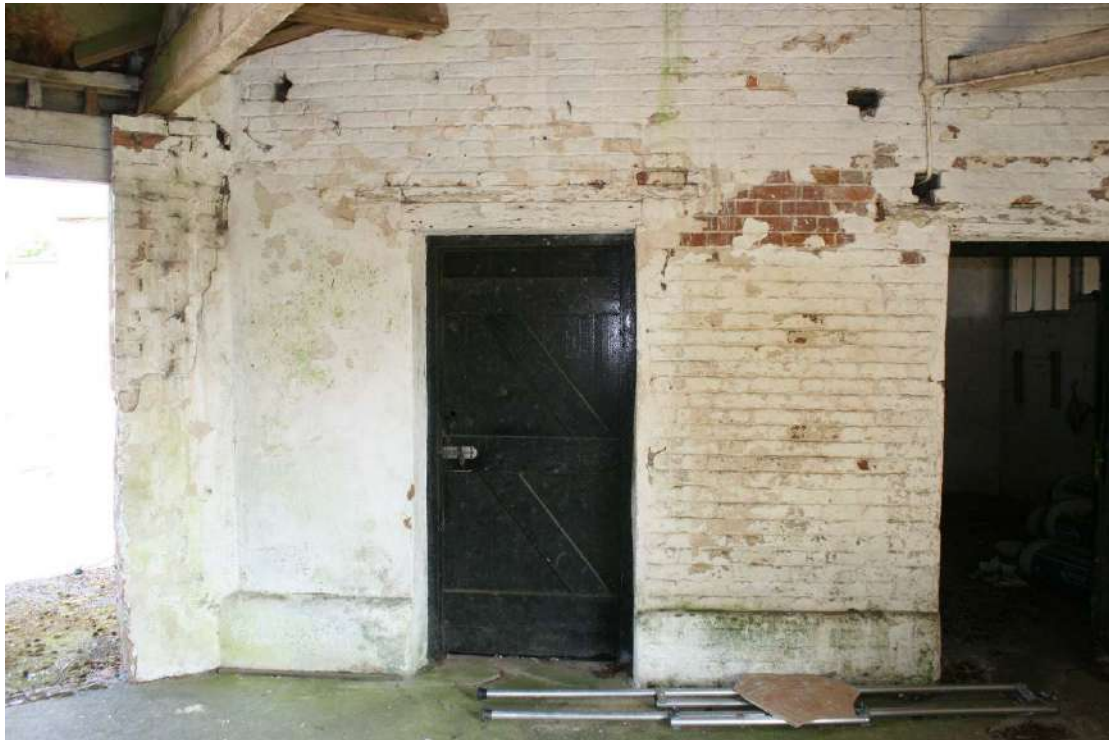
Door into the Storeroom. Note it is hung backwards.
