## Julians Park, Rushden, Buntingford, Herts. SG9 0TD.

Historic building recording and analysis of the Kitchen. Recorded 26 05 2023.

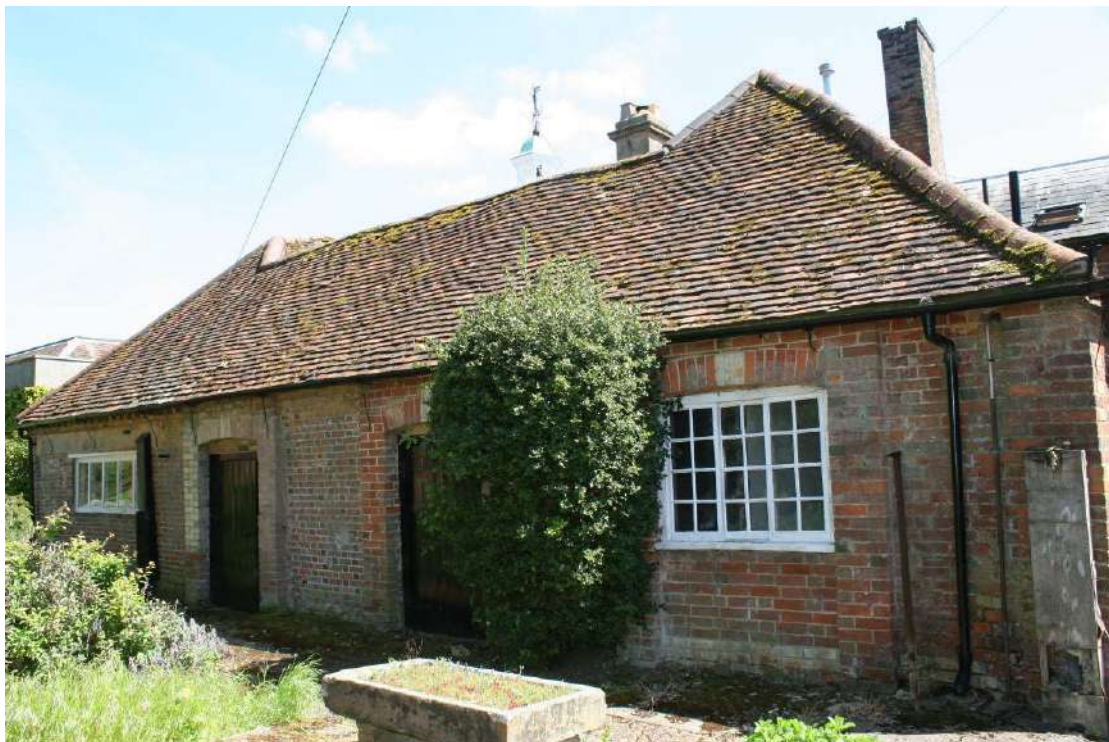
The north elevation of the Kitchen with MC20th doors and windows.

The north elevation shows a single storey range behind the two storey front elevation with a hipped roof concealing a lightwell in the centre. Inside the roof structure is more than 80 percent modern from the 1939 works and later repairs. Some older timbers have been retained.

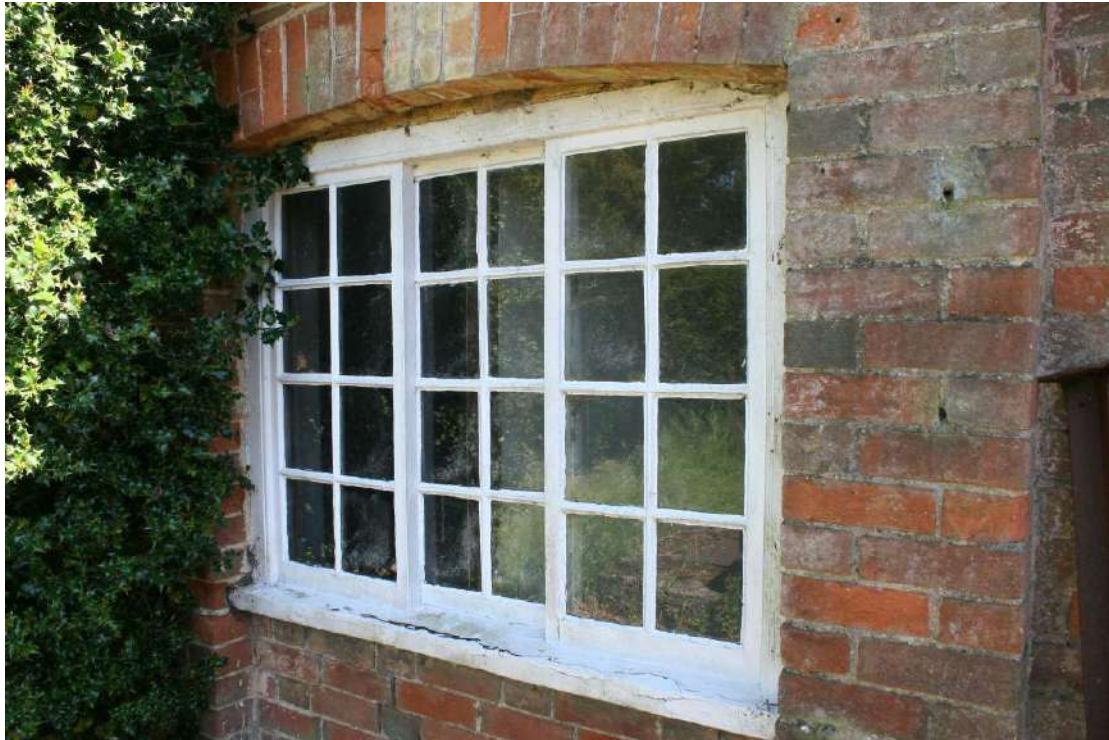
Detail of the replica horizontal sliding sash window and brickwork.

The brickwork has been laid to resemble that of the main House with some overfired headers to create a loose chequerwork. However, the pointing is consistent throughout and most of the features can be ascribed to the 1939 works. There is a horizontal sliding sash window with three lights that has machine routed astragals and is a LC20th replica.

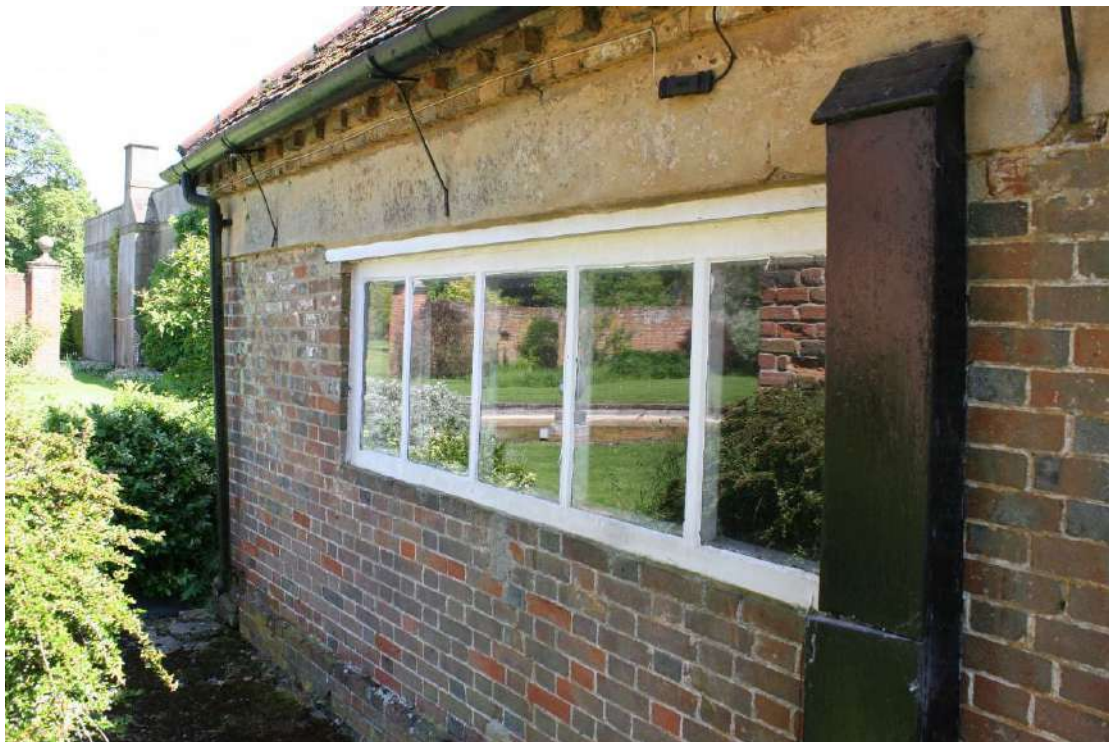
Detail of the 5 light window. Note the modillion cornice.

There are some hints that some of the brickwork is older than 1939. At the NE corner there is a modillion cornice that carries around to the east elevation. Below this is a 5 light large pane window from the 1939 works. The brickwork above is rendered over probably to conceal a concrete lintel.

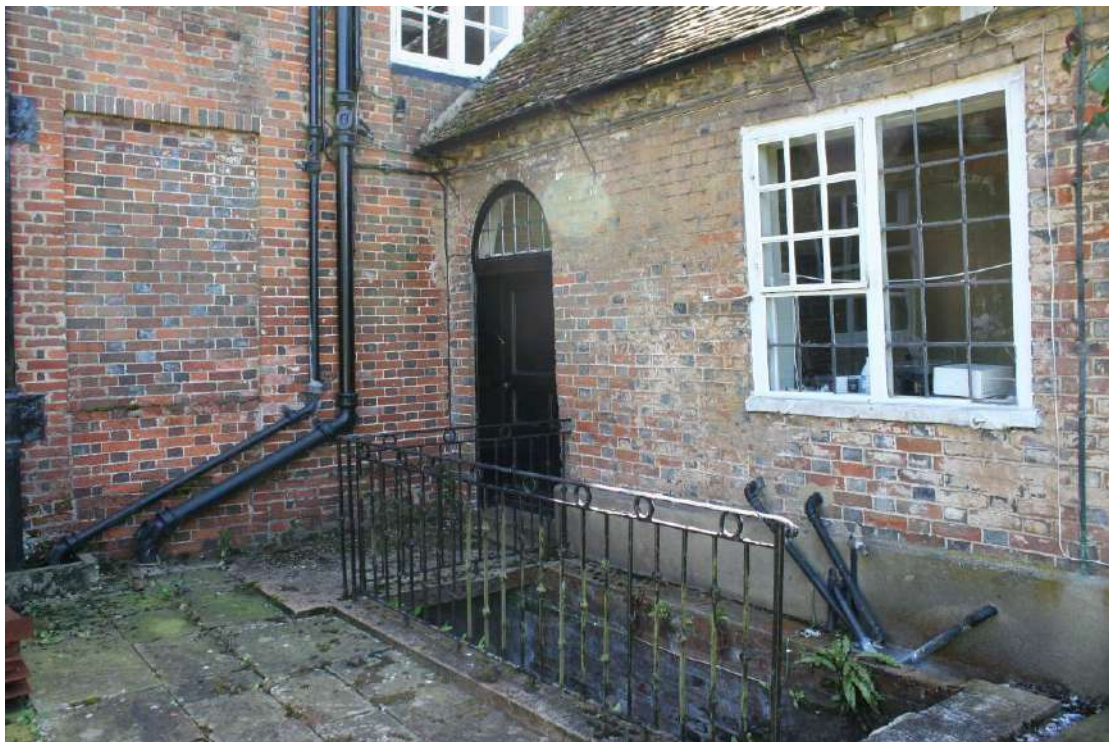
External entrance to the Cellar and doorway to the servant's corridor.

There is a wide panelled door with an arched light above leading to the servant's corridor. The doorway and the door itself are part of the C18th improvements. The door is hung on pintle hinges and has been over-panelled on the outside to appear more modern. There is a flight of steps down to the Cellar with set of MC20th railings.

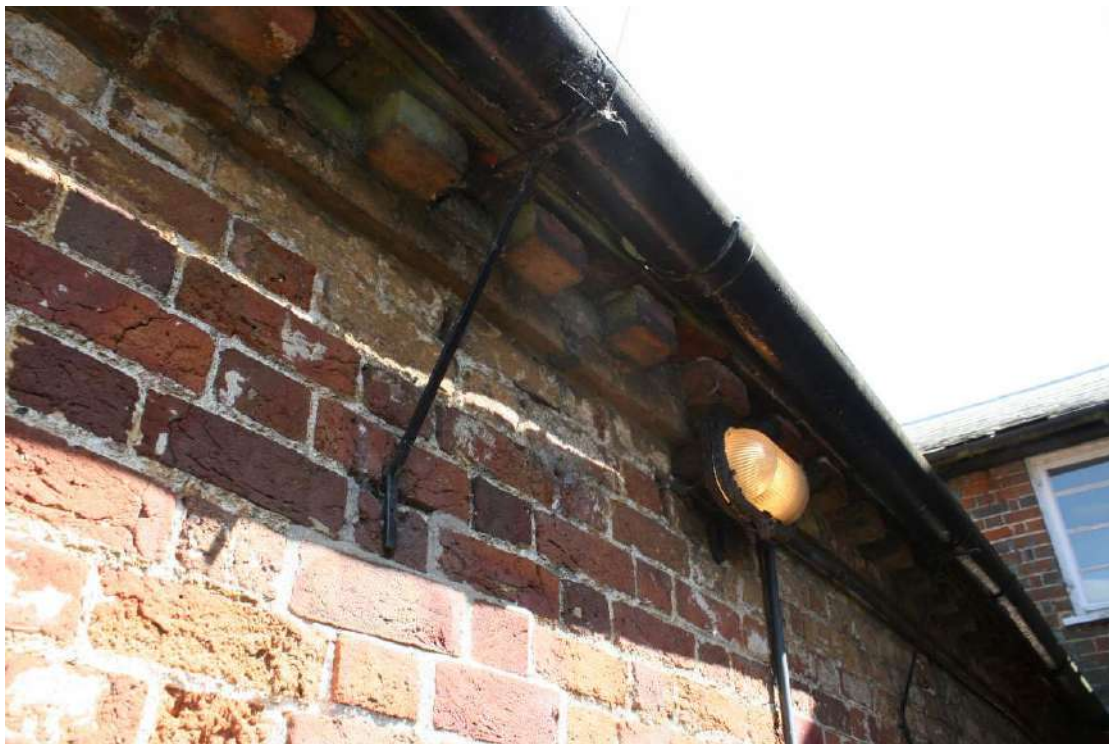
Detail of the brickwork and modillion cornice.

The western elevation presents a blank brick wall along the service passage with at least one blocked window opening. The junction with the north elevation has been rebuilt with a buttressed quoin decorated with yellow bricks. There is a modillion cornice but here the bricks are sharp and unworn. The pointing matches the front range and the brickwork must be part of the 1939 works.

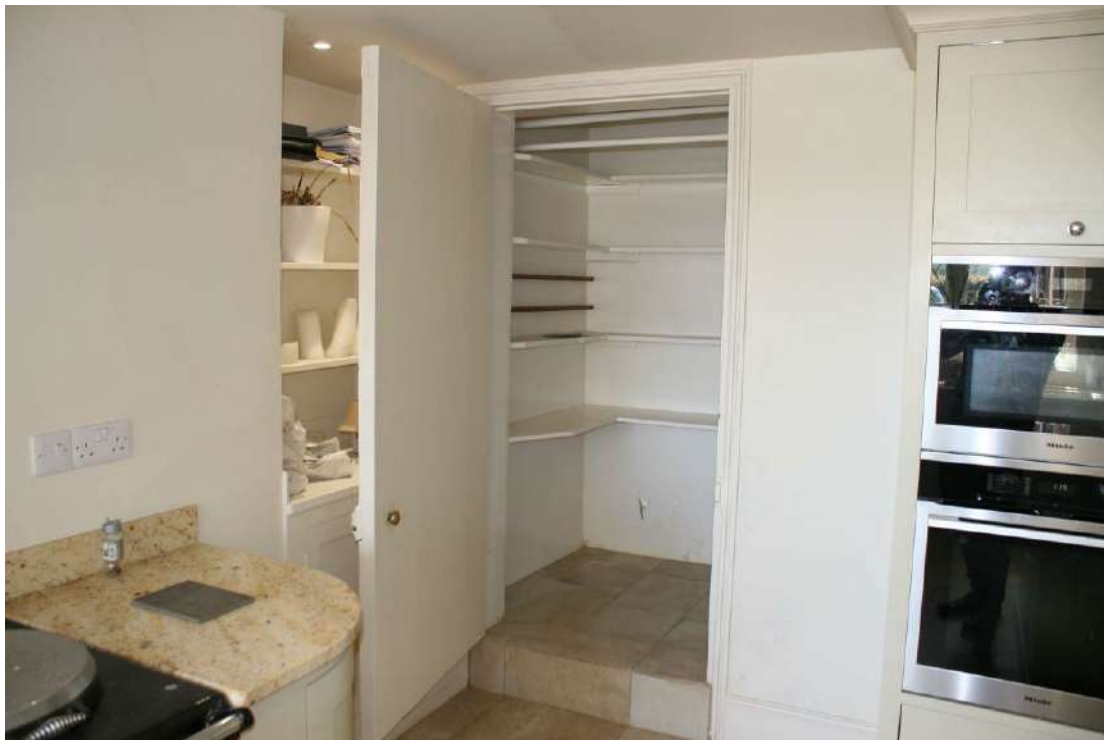
Door to the food cupboard.

The door to the food cupboard is a sawn down Georgian style 6 panel door that has been clad with plywood and used in the 1939 works. The applied mouldings and pressed steel lock box would indicate it is a MC20th replica. The cupboard retains some M-LC20th shelves but the structure itself cannot be older than the 1939 works and its volume has been taken out of the Boiler Room.

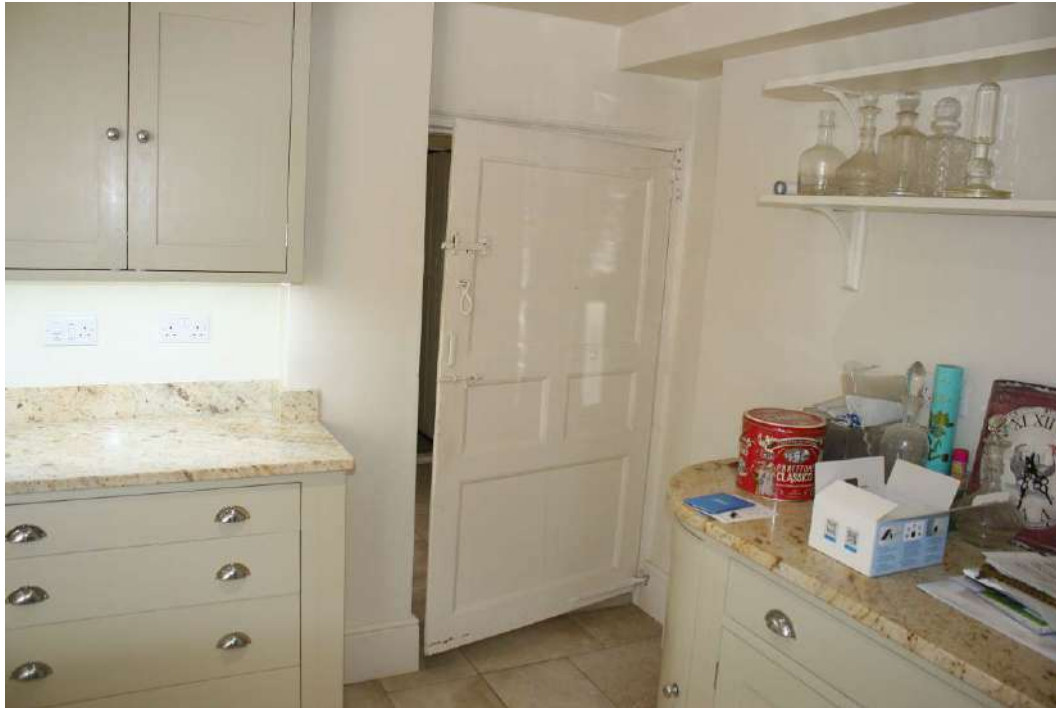
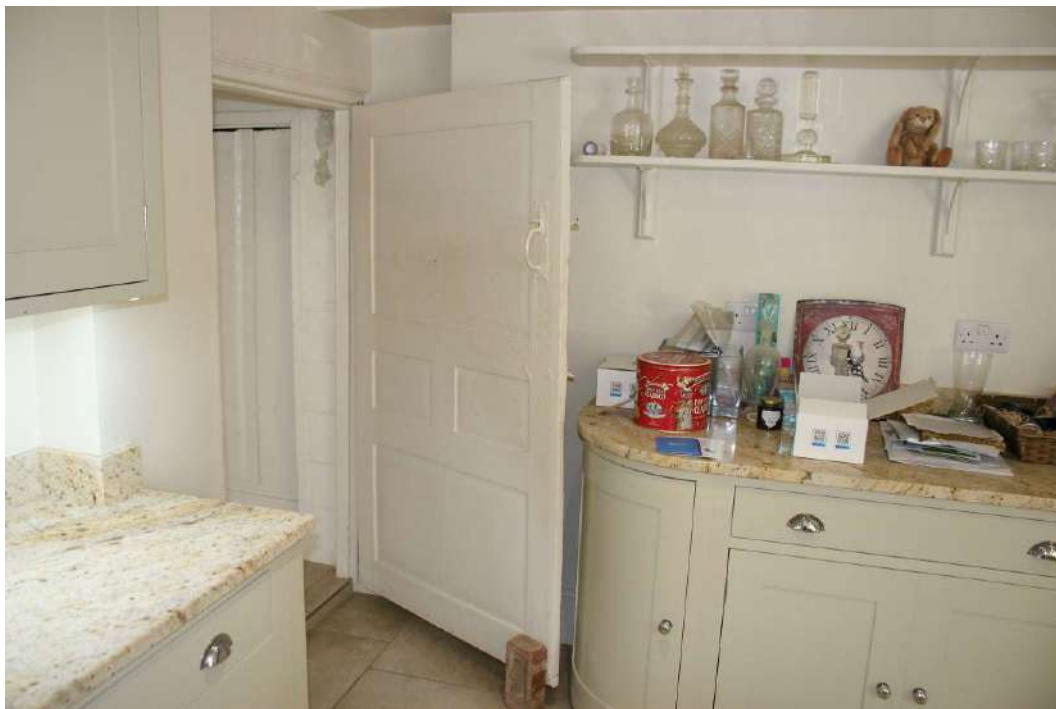
Looking NE in the Kitchen at the door to the corridor.

Looking NE in the Kitchen at the door to corridor. Obverse side.

The door to the service corridor appears to be an original Georgian style 6 panel door and is hung on a T-strap hinge and a pintle hinge. It has an EC19th style bolt and figure of eight loop for a hasp and padlock. There is a replacement C20th Suffolk Latch as well as a keeper for an earlier one. There is also a metal wear plate for a self-closer. It is evident this door has had a long life.

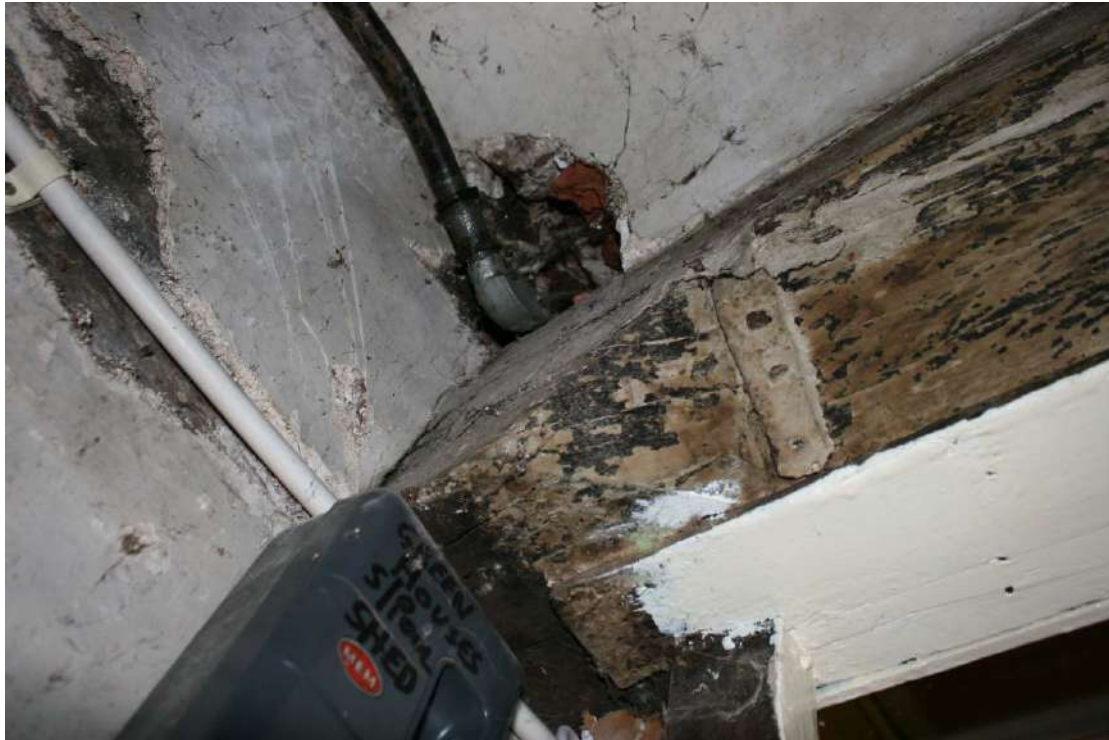
The cupboards that are built into Butler's Pantry Corridor conceal a very large fireplace with a heavy oak bressummer. The cupboard doors are fixed with nailed on butterfly hinges and are likely EC18th but must be resited as part of the 1939 works as the owner has a photograph of a C17th overmantle that has been removed. The corridor walls are panelled and have small shelves. There is a roughly formed arch in the ceiling which is probably a flue for a copper or small stove.

The end of the fireplace bressummer in the westernmost cupboard.

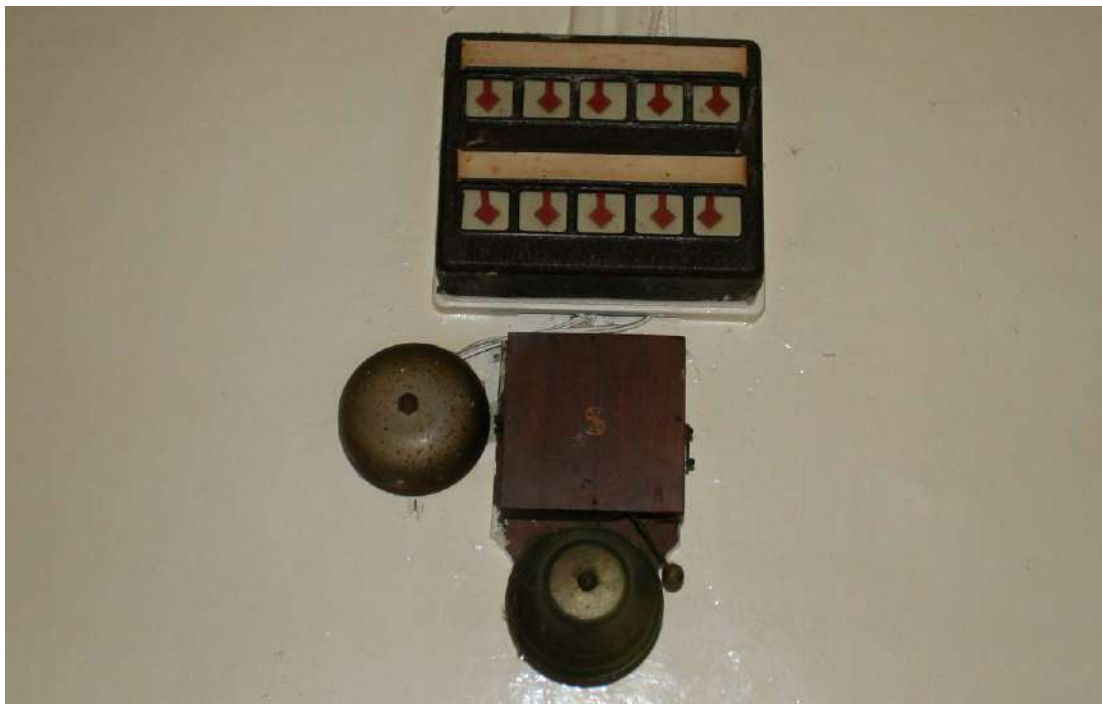
MC20th electric service board and doorbells.

The cupboards now hide the electrical power boards and switches for the greenhouse, swimming pool and sheds. Of interest is a MC20th electric service board and doorbells. Unfortunately, most of the room names have been bleached out but there is a label for Office and Blue Room written in Biro. (Invented in 1938).

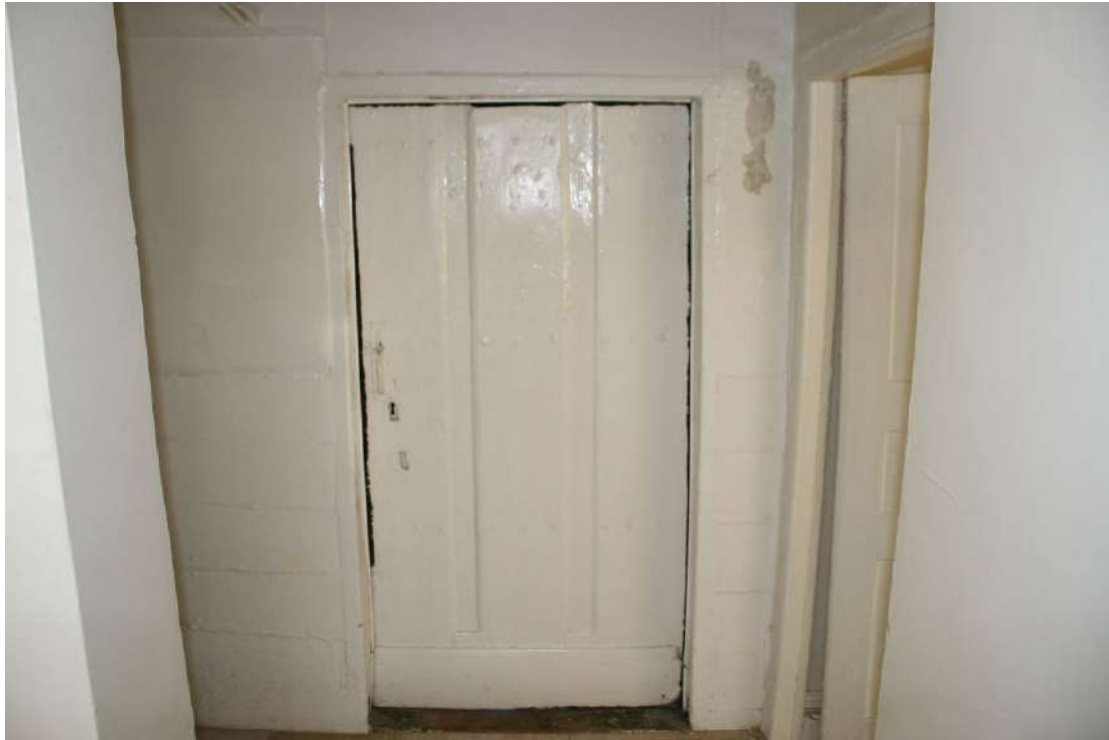
The door to the Larder looking E.

There are historic game hooks and a suspension chain with no obvious use. In the floor there is a drain for a sink that has been removed. The door is a C17th style vertically boarded, filleted and plank door with hobnails and has two repair plates. The wooden box lock has been let in and the Suffolk Latch and automatic door closer are MC20th. The door is rehung on mild steel T-strap hinges with slot headed screws and later Phillips head screws as repairs. This was originally an external door.

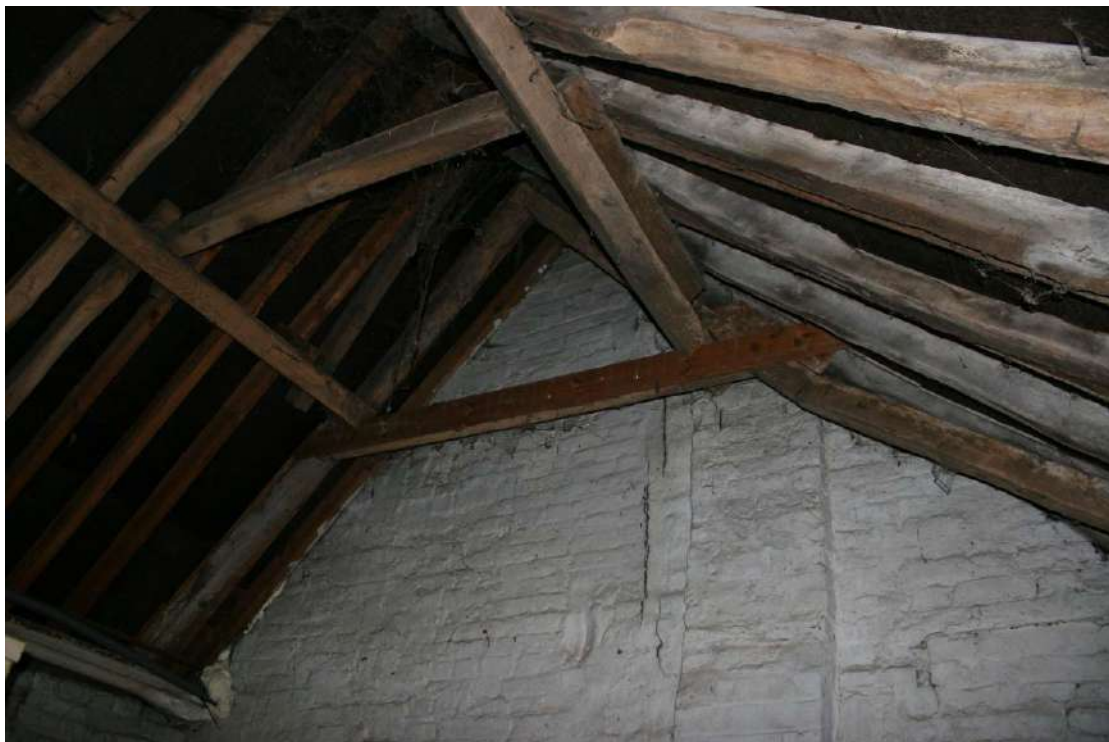
The roof above the wood store.

The roof above the Store is a simple clasped side purlin roof that has been rebuilt as part of the 1939 works but also has been retiled between 1965 and 1985 when it was common to use asphalt membranes. The purlins are lodged in a full height brick wall that also incorporated a chimney that has since been removed.

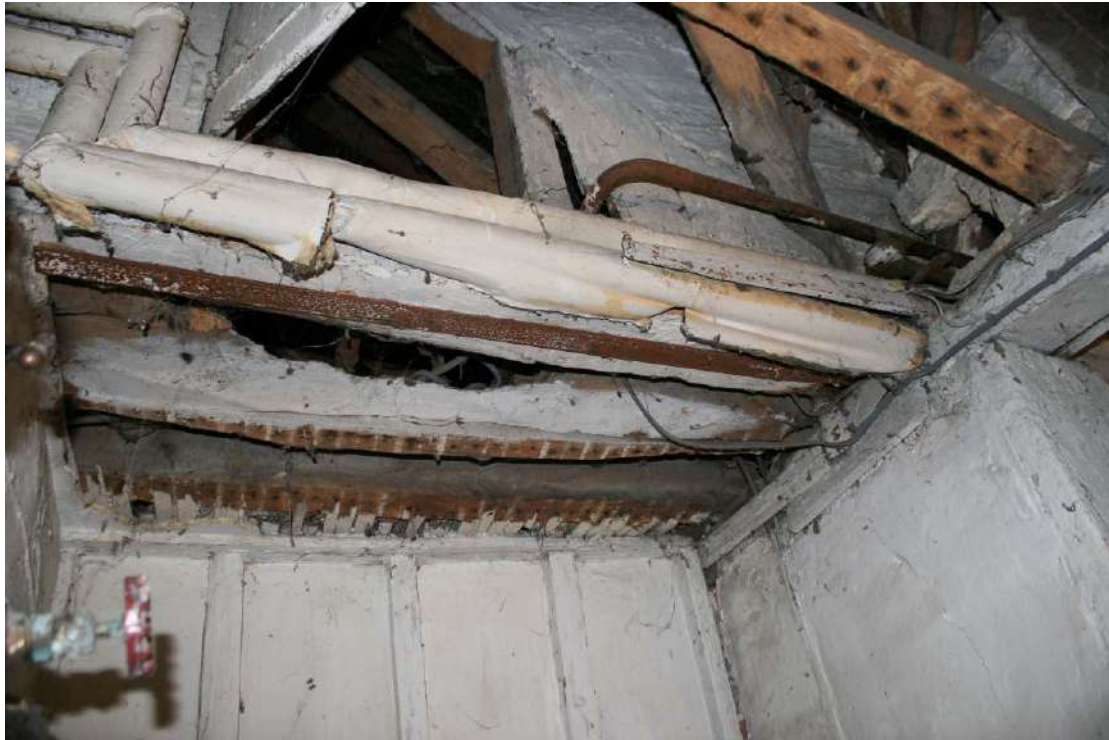
Access door above the Kitchen door. The frame is reinforced with a steel beam.

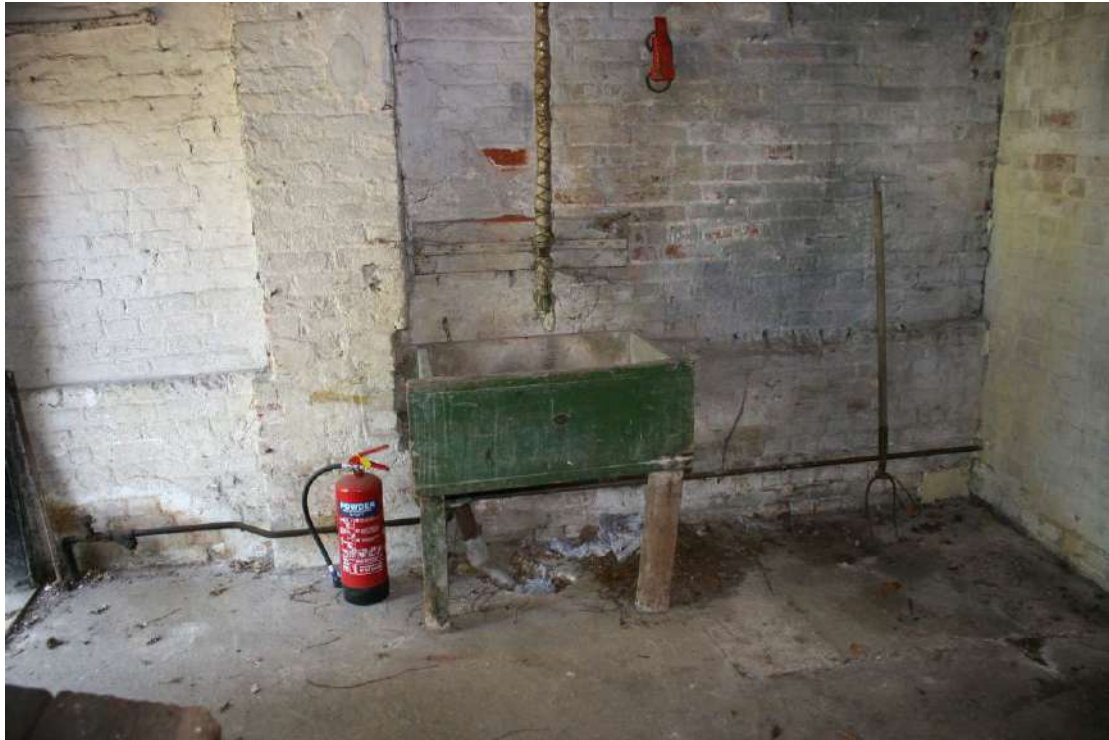
A wooden sink set against the west wall in the Boiler Room.

A wooden sink (for washing glasses without breaking them) is in place under a tap but it occupies where a fireplace has been removed. The wall has been remade as the 1939 plan shows the fireplace. The sink has a brass badge with Staines Establishment Everlast and must be MC20th. The floor is covered in cement screed that levels a brick pavior floor of which a small section is still visible under a workbench.

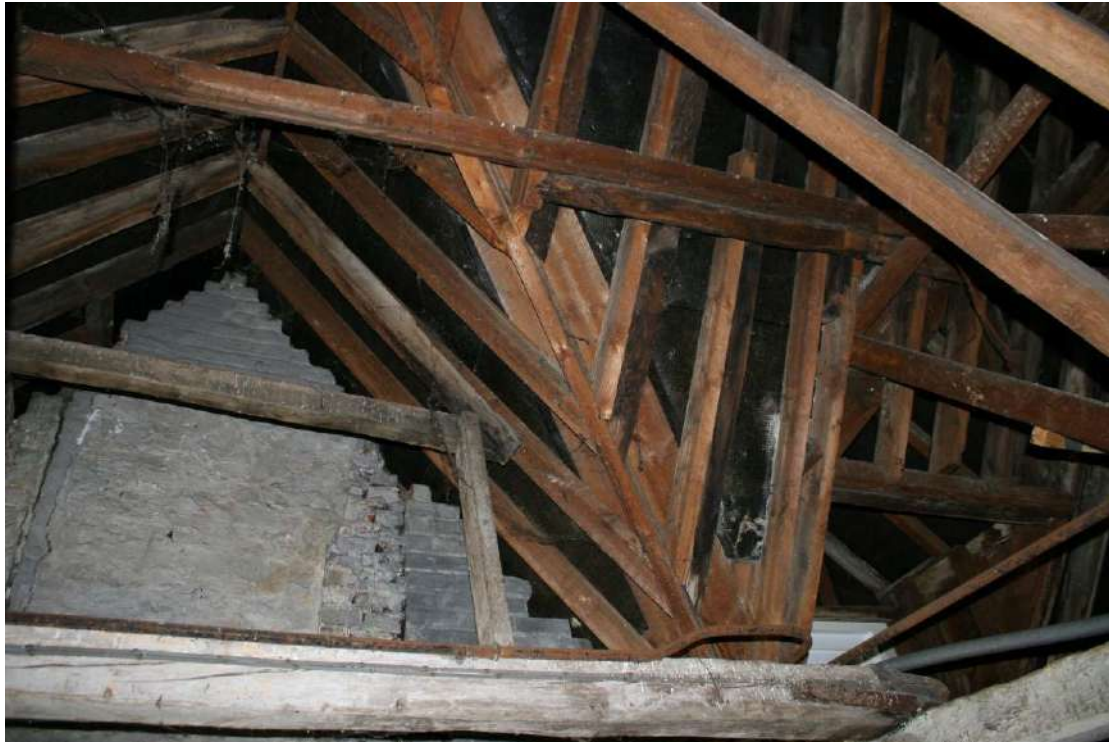
The roof over the wooden sink.

The roof is largely made from machined softwood as part of the 1939 works and again has been retiled between 1965 and 1985 with an added asphalt membrane. The partition wall has been removed and now the support beam has deflected.

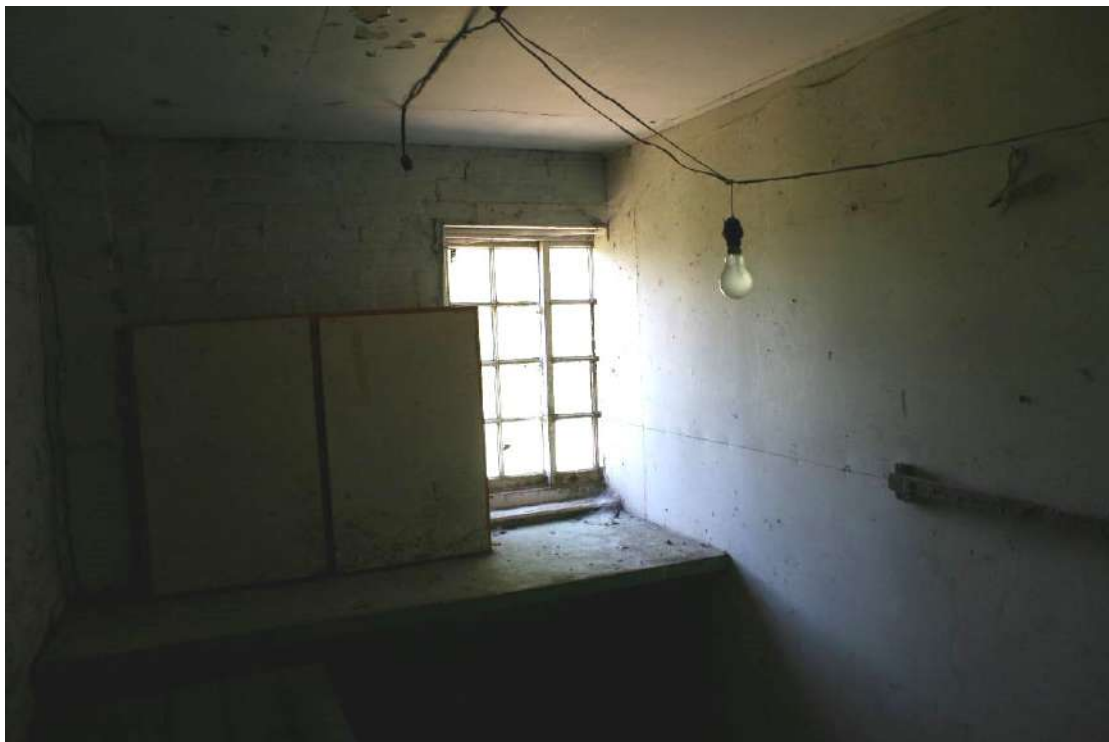
Looking N in the workshop. The partition wall meets the centre of the window.

There is a small workshop with a narrow workbench and poorly strung electric light fitting that has been inserted into the volume of the Boiler Room and was most likely a secure store for tools. The partition wall meets the centre of the window and is made of lightweight studwork and hardboard panels. It is not shown on the 1939 plan.

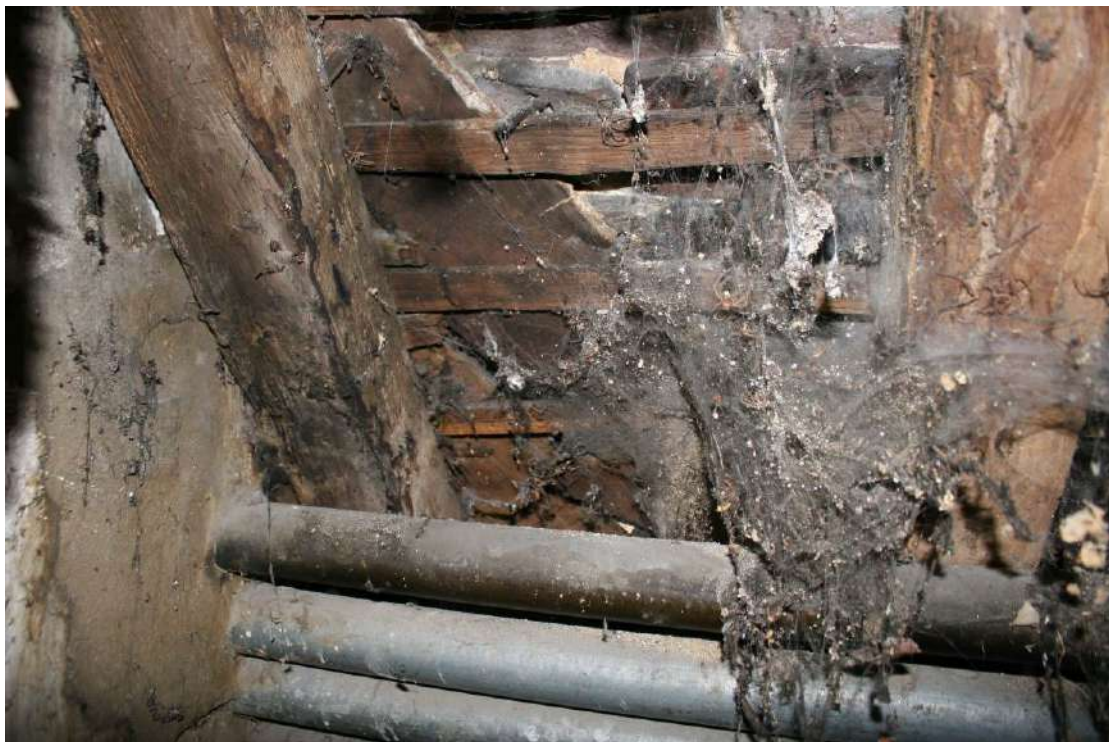
A section of 1939 original roof tiling with narrow laths.

In a second closet a section of hardboard panelling has been pulled back to get at the pipes and this reveals the roof as it was tiled in 1939 with narrow riven laths and peg tiles hung on galvanised nails. Older rafters have been reused.

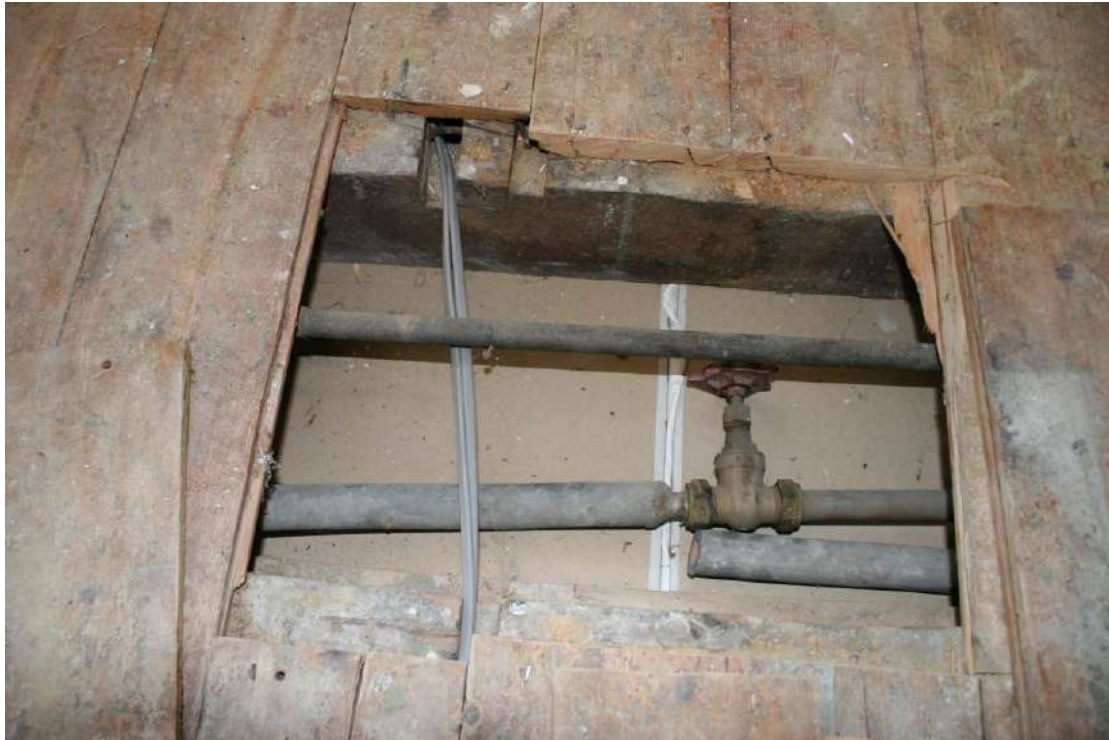
Lifted boards in the WC show the lead pipes and the plasterboard ceiling below.
