## **Condition Survey**

**Threshing Barn at  
Highover Farm  
Highover Way  
Hitchin  
SG4 0RQ**

**Gill-Hudson Homes Limited**

**16<sup>th</sup> June 2025**

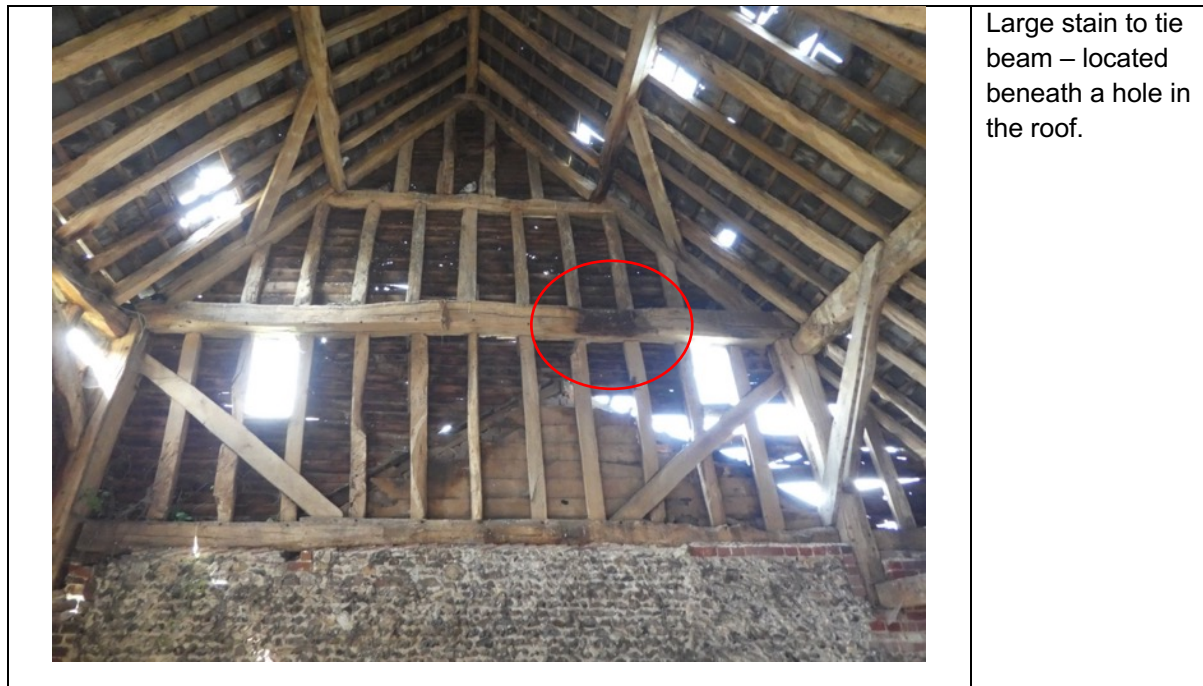
The timber frame to this elevation appears to be in reasonable order, with no areas of significant decay noted. However, a large stain was observed on the tie beam at the south-west corner. This is located directly beneath an area of missing slates on the roof, and it is likely that water ingress is occurring at this location. Due to the height, it was not possible to confirm the condition of the timber from ground level. The extent of any decay to the tie beam could not be determined, particularly to its upper surface, which was not visible. Further inspection will be required once safe access is available via scaffolding.

Aside from this area, no major issues were noted with the frame to this elevation.

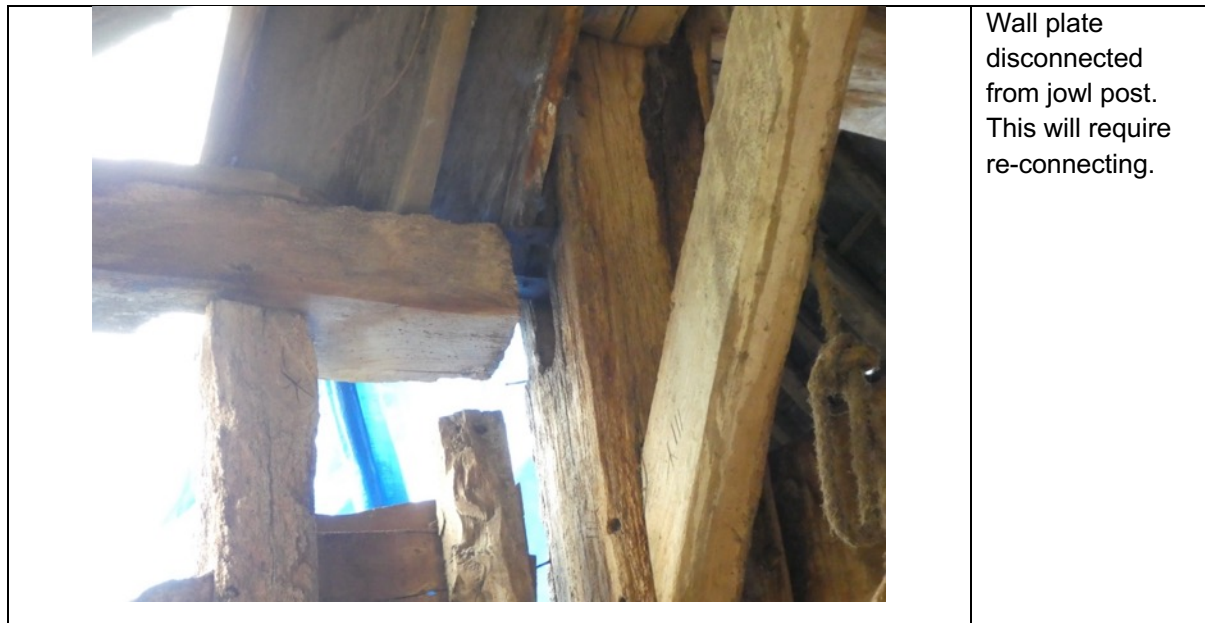
The soleplate appears largely free of decay when viewed from the interior. However, a large amount of mortar has been applied to the base of the plate, possibly to fill voids. It will be necessary to remove this mortar to inspect the condition of the timber underneath and determine whether repairs are required. The soleplate was noted to be wet in multiple areas due to roof leaks, and while some decay is present, it did not appear to be extensive.

As noted, the base of the diagonal brace is decayed. Additionally, the jowl post at the south-east corner is split, and it is recommended that the gap be filled with timber inserts to restore proper integrity at this joint.

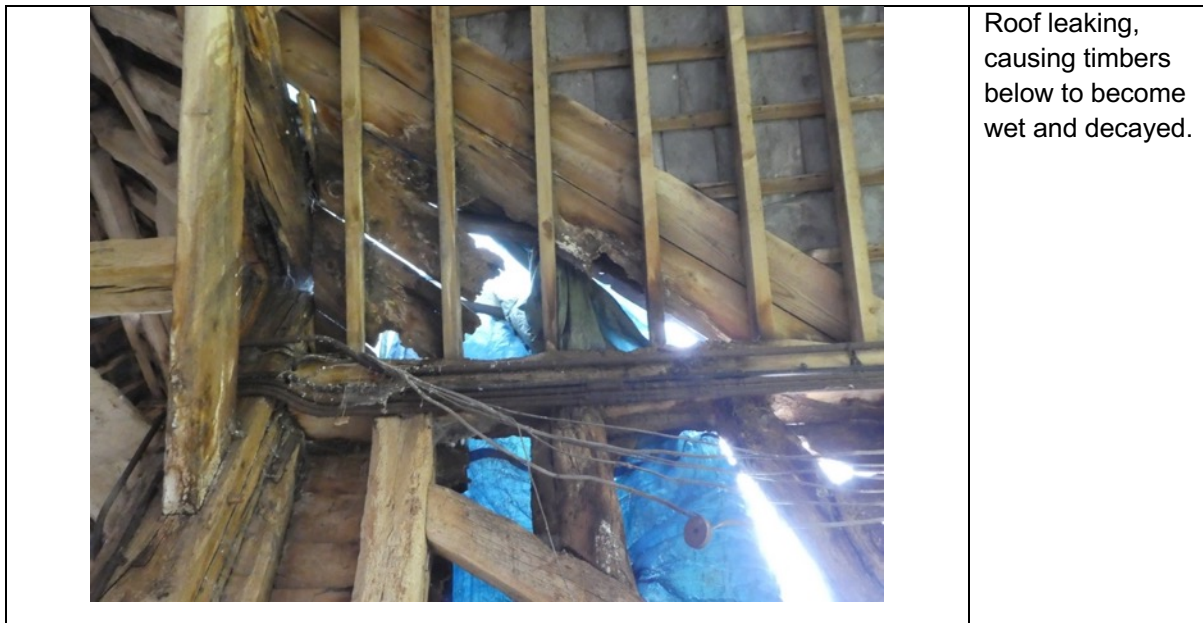
There is localised decay to the inner face of the soleplate, as well as decay to the sides and outer faces of four studs. Decay is also present to the diagonal brace, and the top of the wall plate appears to be heavily decayed in one area.

All of this deterioration is attributed to ongoing water ingress from the roof above.

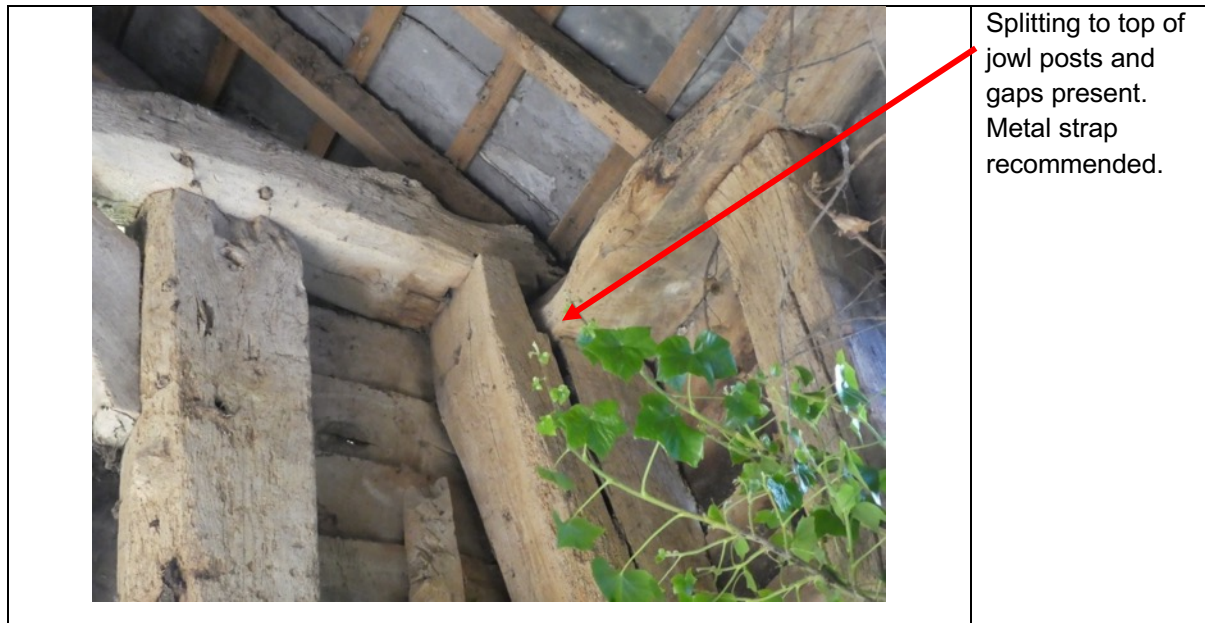
The framing to this elevation is in reasonable condition, though it was noted that there is a split to the top of the jowl post adjacent to the south door. There is also gaps between the top of the jowl post and the tie beam and adjacent wall plate. As a precaution it is suggested that a metal strap be installed which laps onto all three components, providing additional restraint.
