**MILL BARNS, CHARLTON , HITCHIN**

**PRELIMINARY STRUCTURAL REPORT**

**MILL-BUR-ZZ-ZZ-RP-S-0001 – S2 – P01**

**DECEMBER 2023**

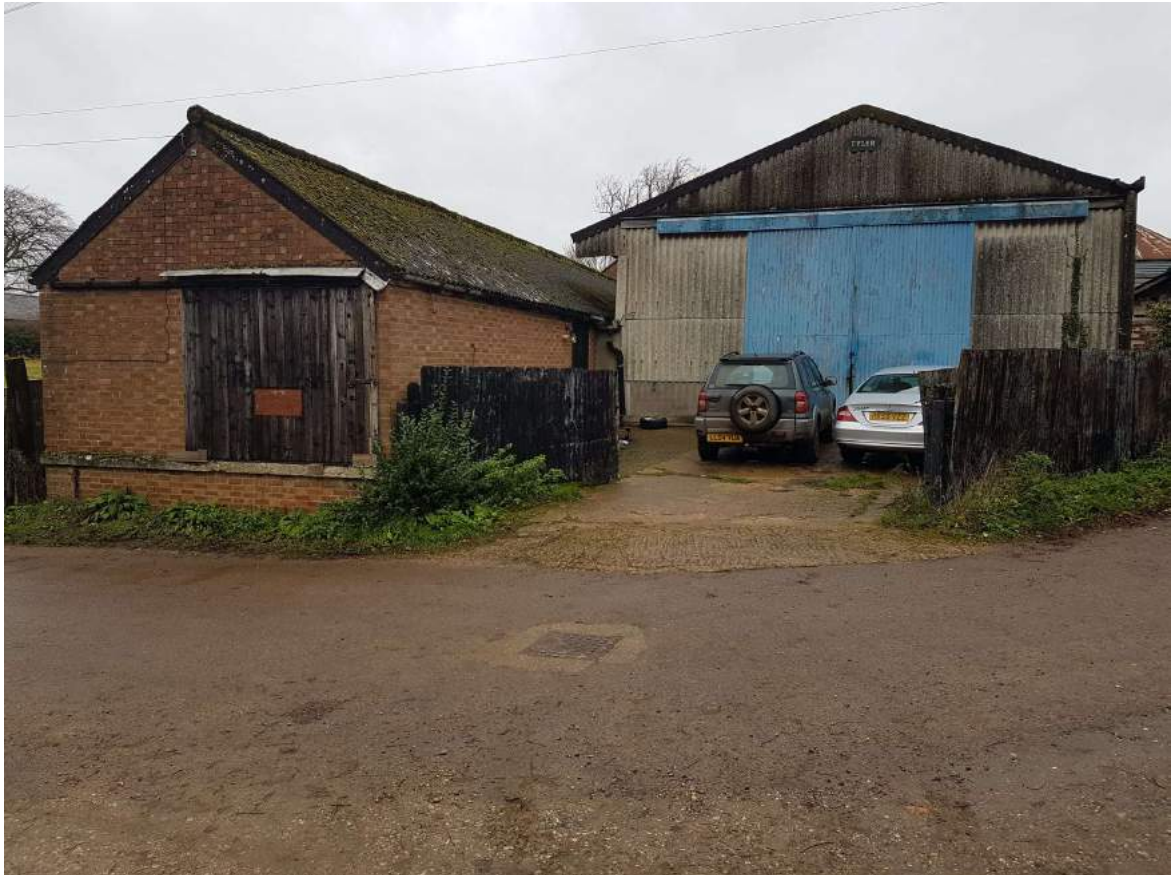
There is a small lean-to structure housing a service trench to the Western side of the barn with a more recently constructed concrete portal frame shed to the East of the barn. The small lean-to roof has failed and needs replacing while the guttering detail between the portal frame shed and Barn A has led to water ingress and weathering of an area of masonry.

*Photograph 3 – Barn A and adjacent portal frame shed on Eastern Elevation*

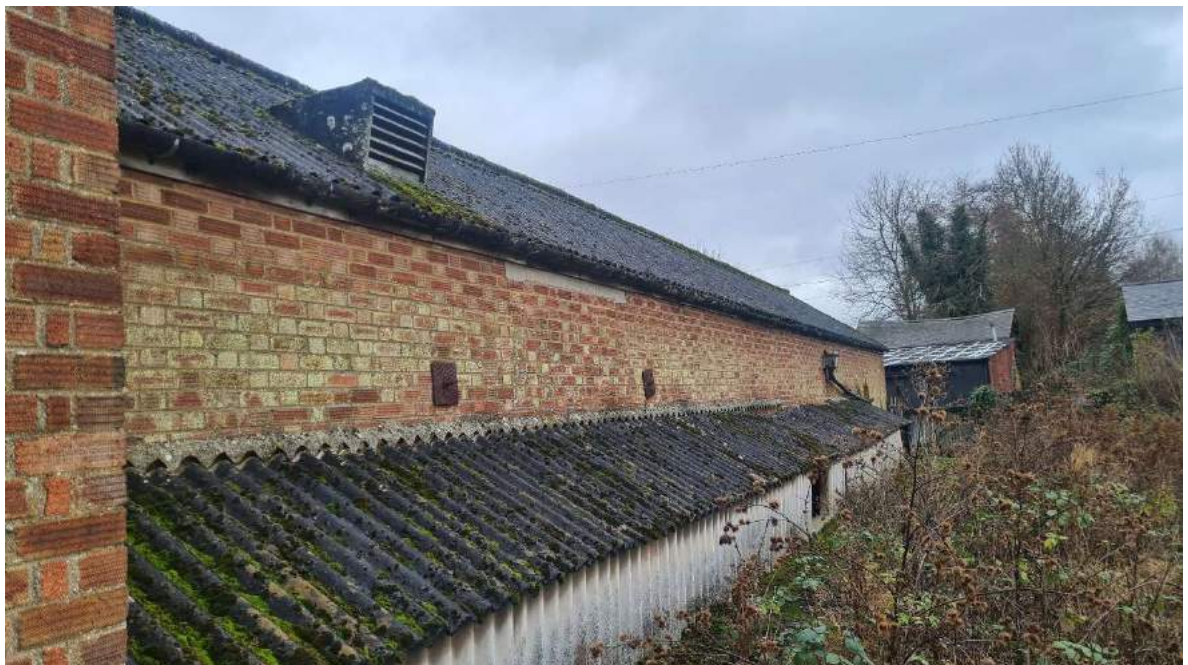
*Photograph 4 – Barn A Service Trench lean to on Western Elevation*

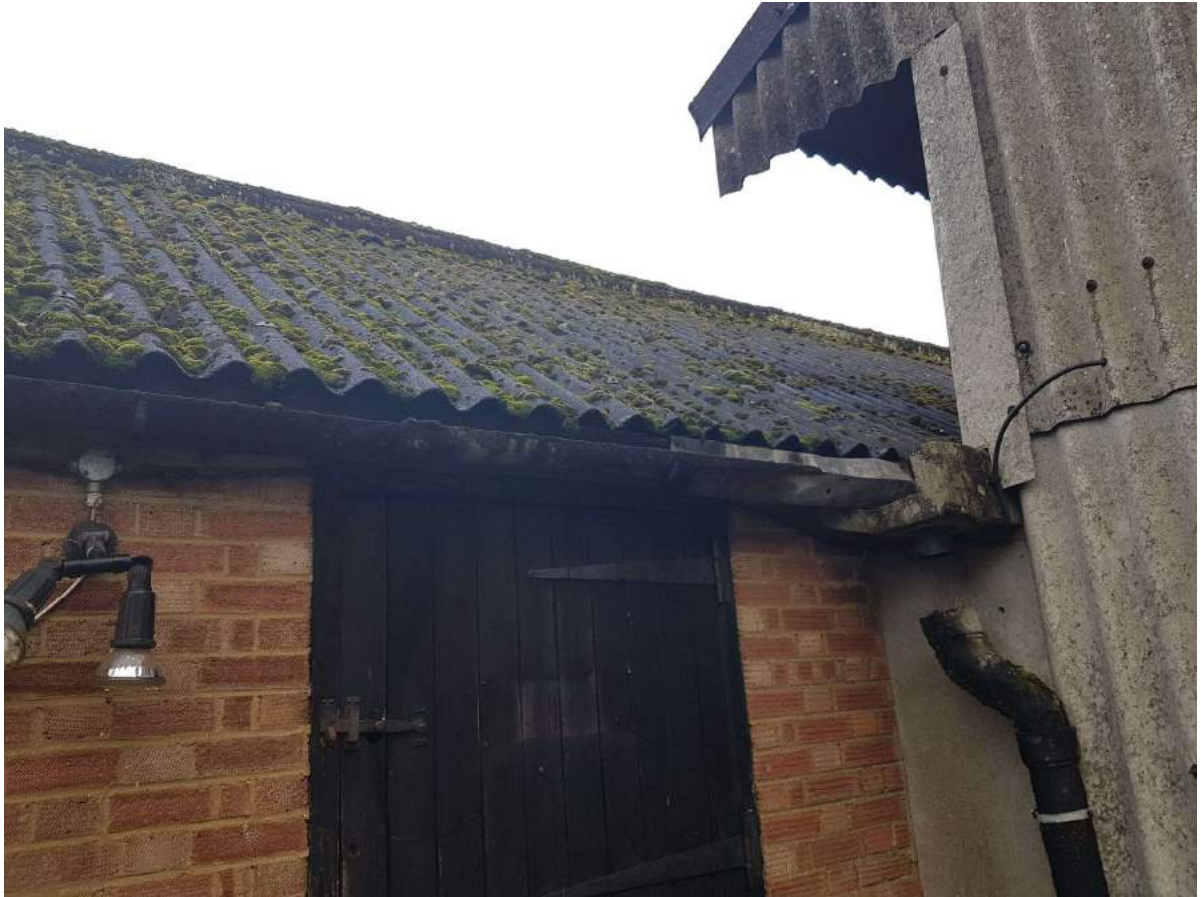
*Photograph 9 – Junction between Barn A and concrete portal frame shed*

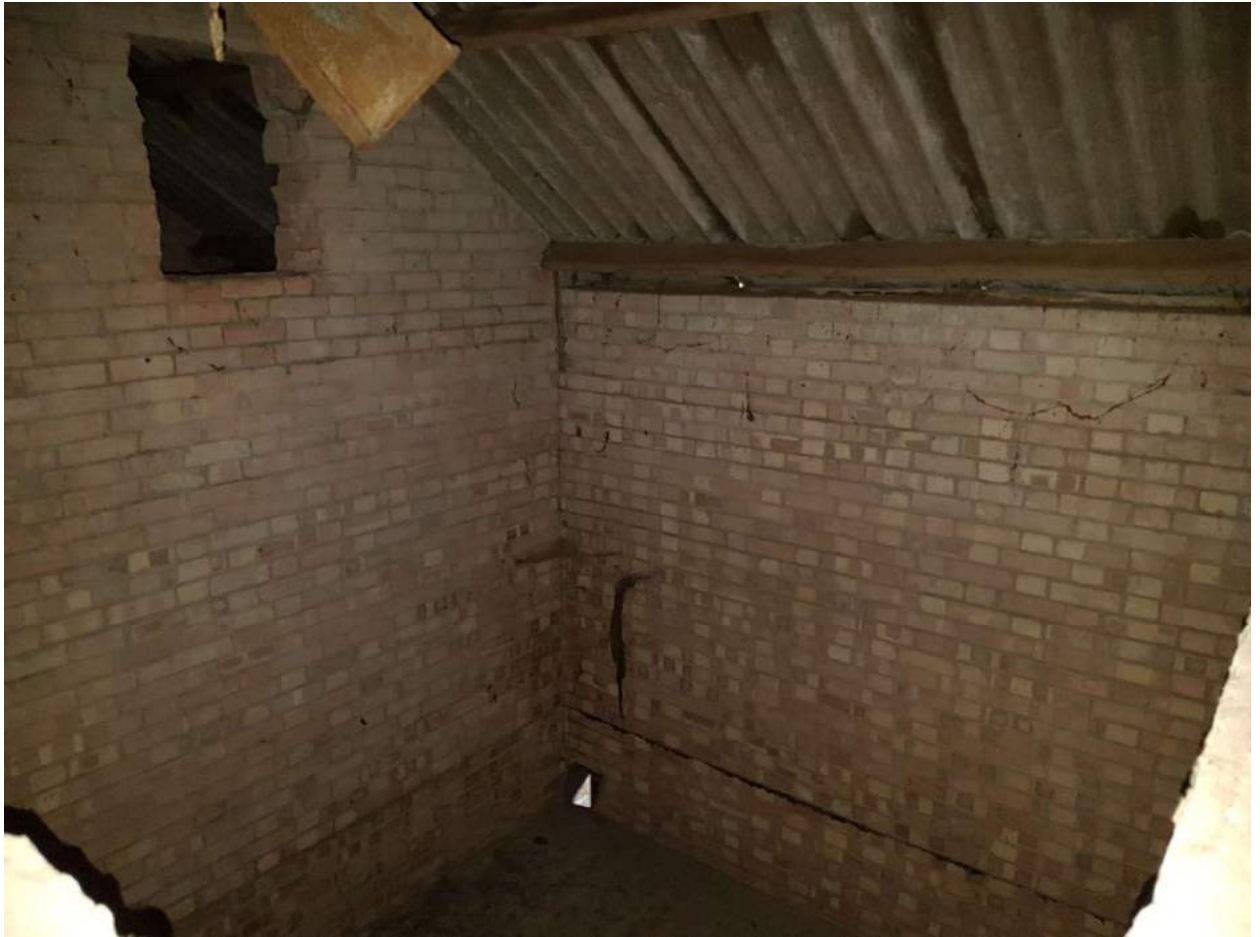
Two instances of historical cracking were observed within the same bay and have been remediated with steel ties and wall anchors. There were no visible signs of lateral bowing of the walls. The cracks were at high level only and assumed to be associated with historical storage of the the bay. As part of any new development the cracks would be stitched and cross walls tied into the external frame to ensure stability. The current layout offers significant lateral stability to the barn through the 5No. cross walls.

*Photograph 15 – Internal cross wall in Barn A*

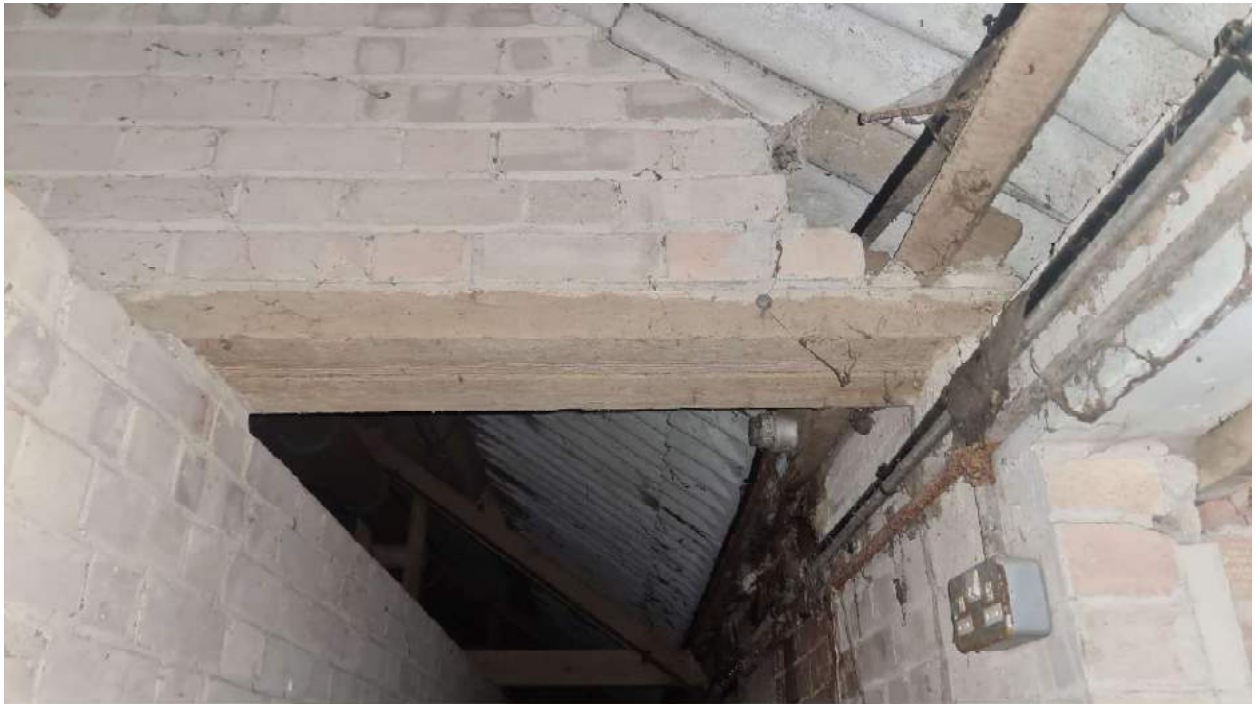
*Photograph 17 – Timber lintel in Barn A*

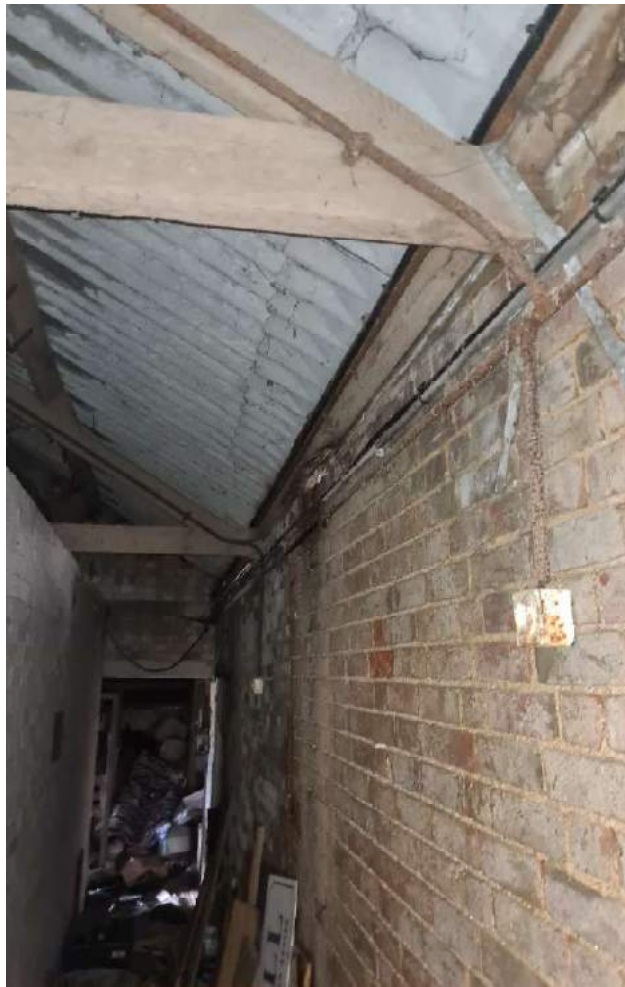
Barn A is a single storey long barn with a corrugated cement-based sheeting roof. The walls are of masonry construction and the roof is formed from timber trusses with timber purlins spanning between them. The roof trusses are in good condition but may need to be strengthened to accommodate the additional roof loads due to insulation/ ceiling installation.

*Photograph 20 – Timber Truss support in Barn A*

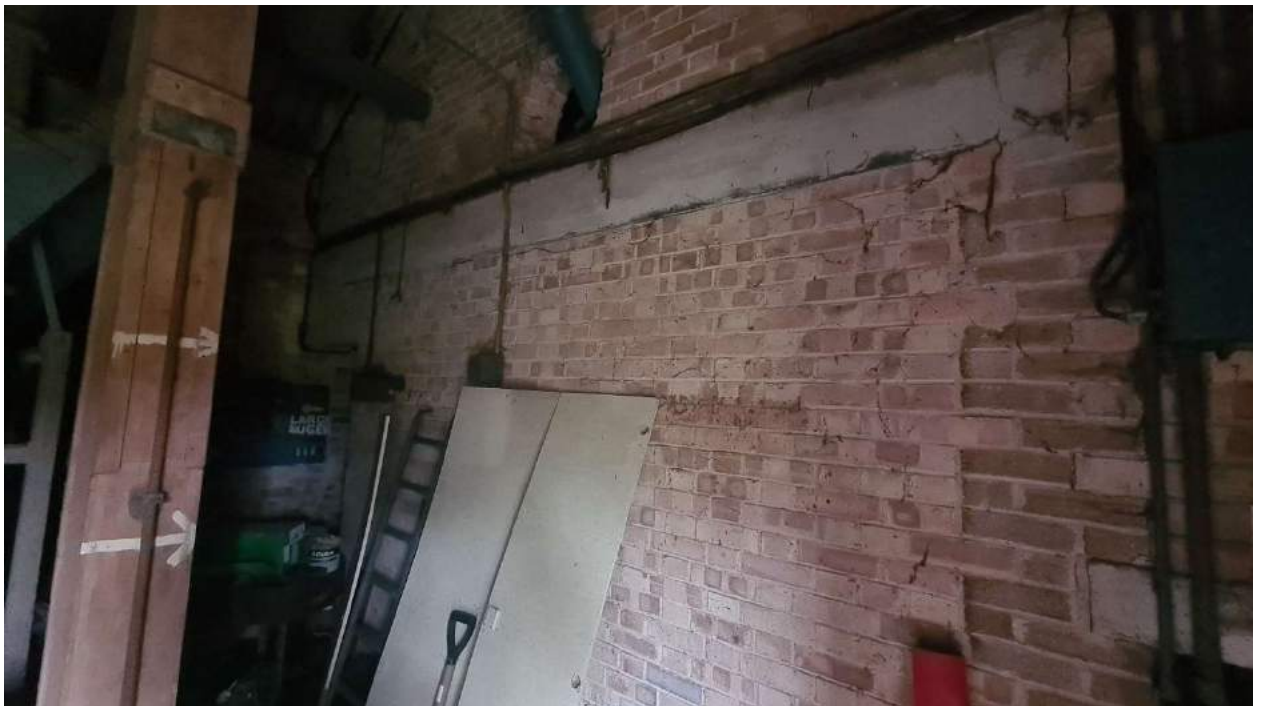
*Photograph 25 – Infilled opening between Barns A & B*

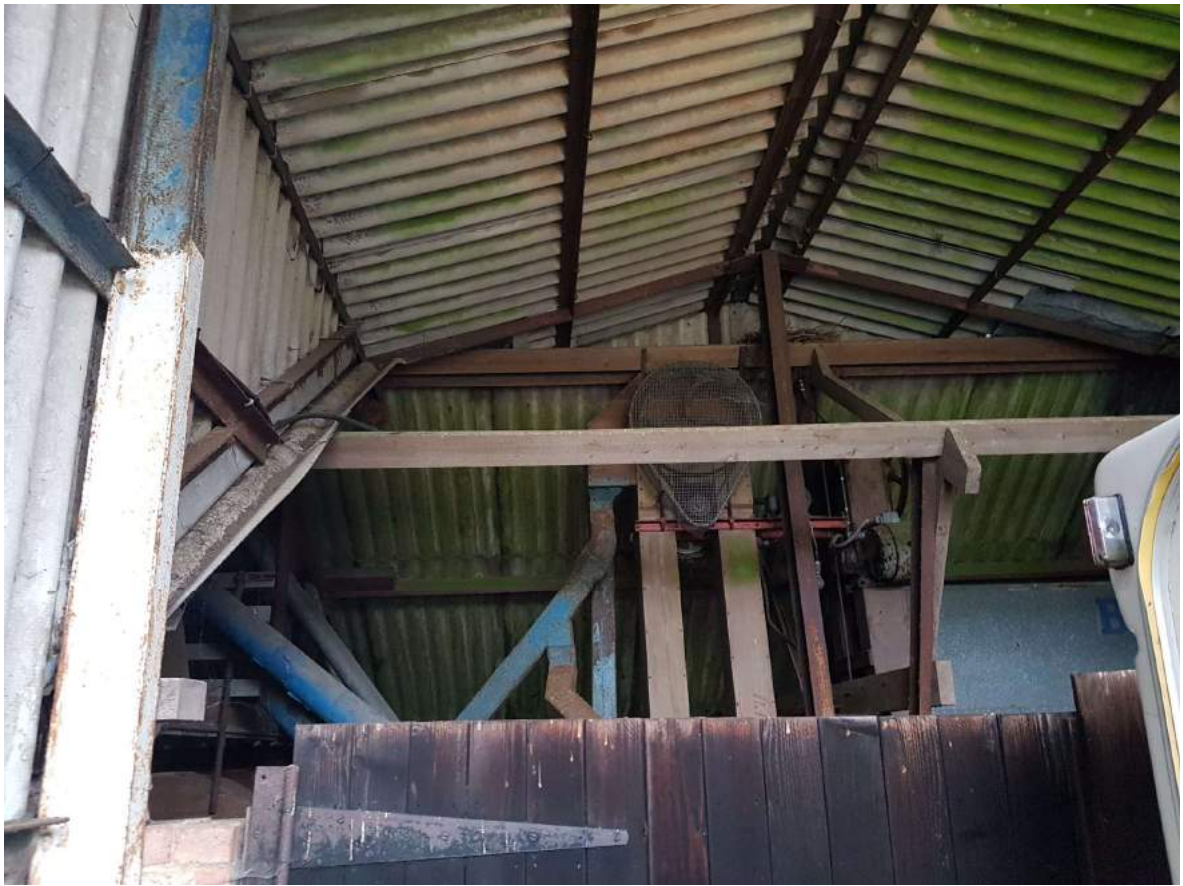
Barn B is of masonry construction and is rectangular in plan with an open front lean to structure to the Eastern side of the barn. Both Barn A & B would have been constructed at the same time. The roof is supported on timber trusses and intermediate purlins with the area over a floor hopper supported by a central post.

*Photograph 26 – Barn Roof Structure with central post*

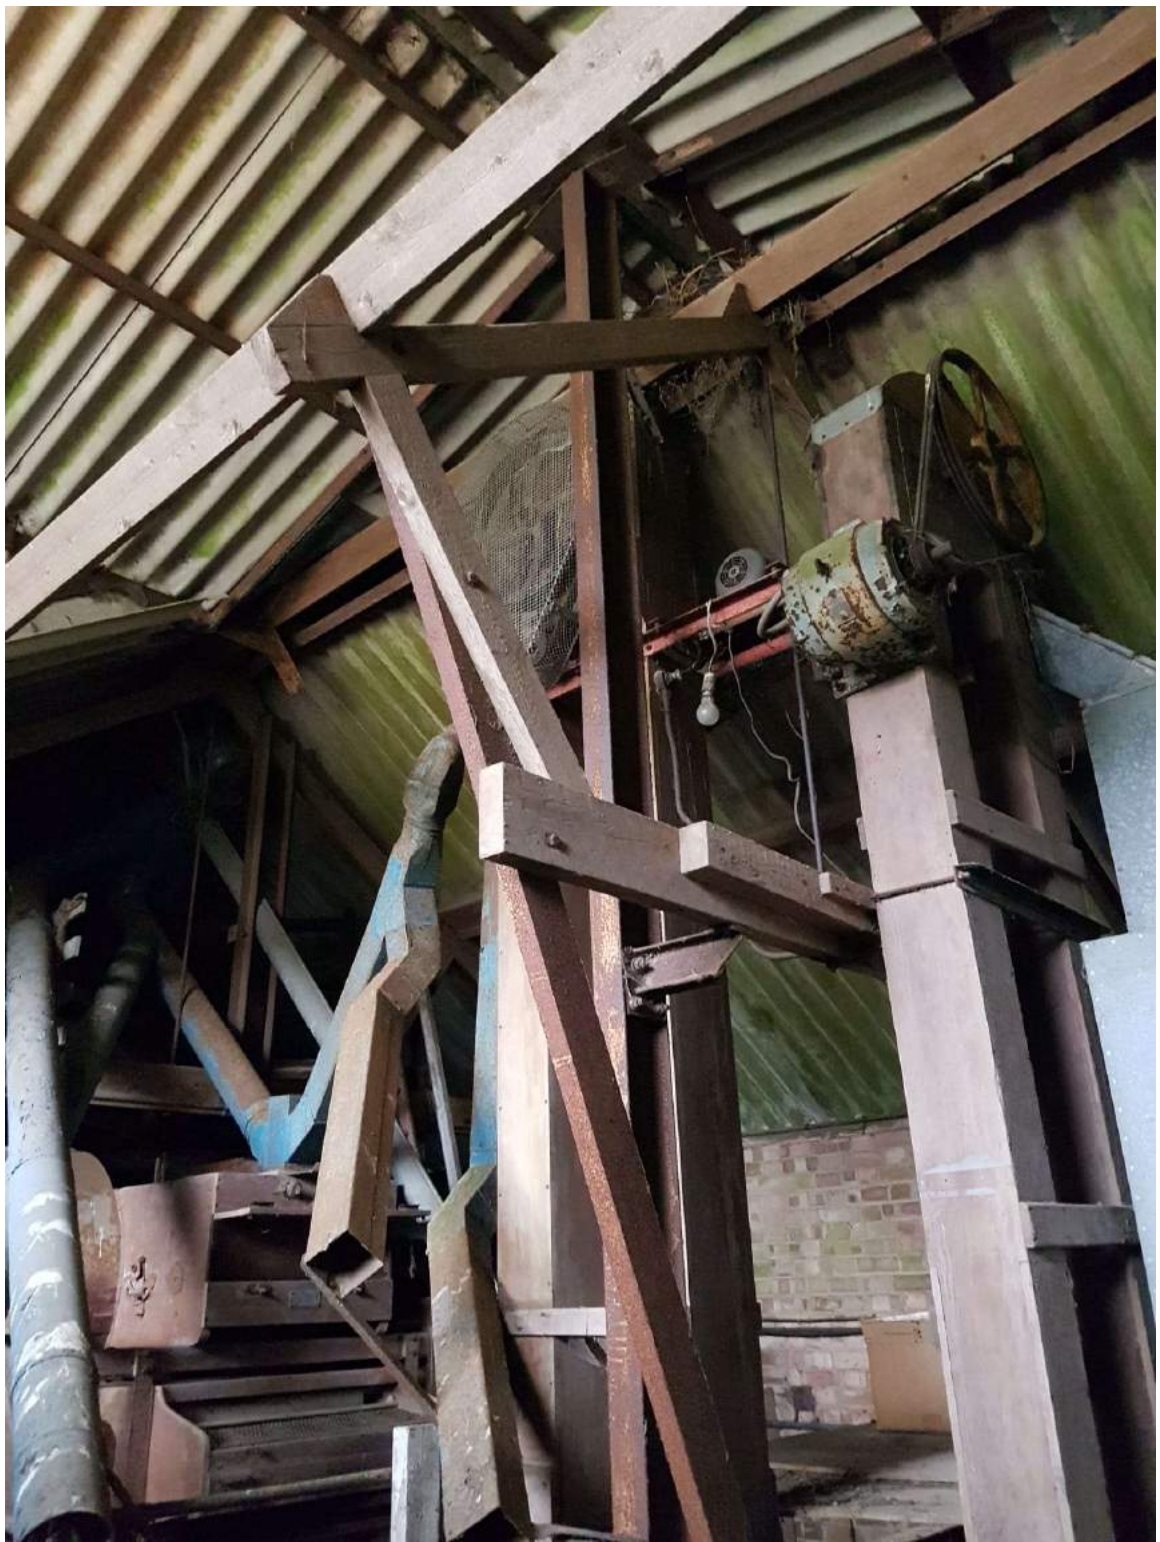
The underside of ridge height is approximately 2.0m higher than Barn A at 5.95m from slab level. The internal layout is occupied with disused agricultural plant but the area has the potential to be open plan.

*Photograph 28 – Disused Agri-plant and roof support in Barn B*

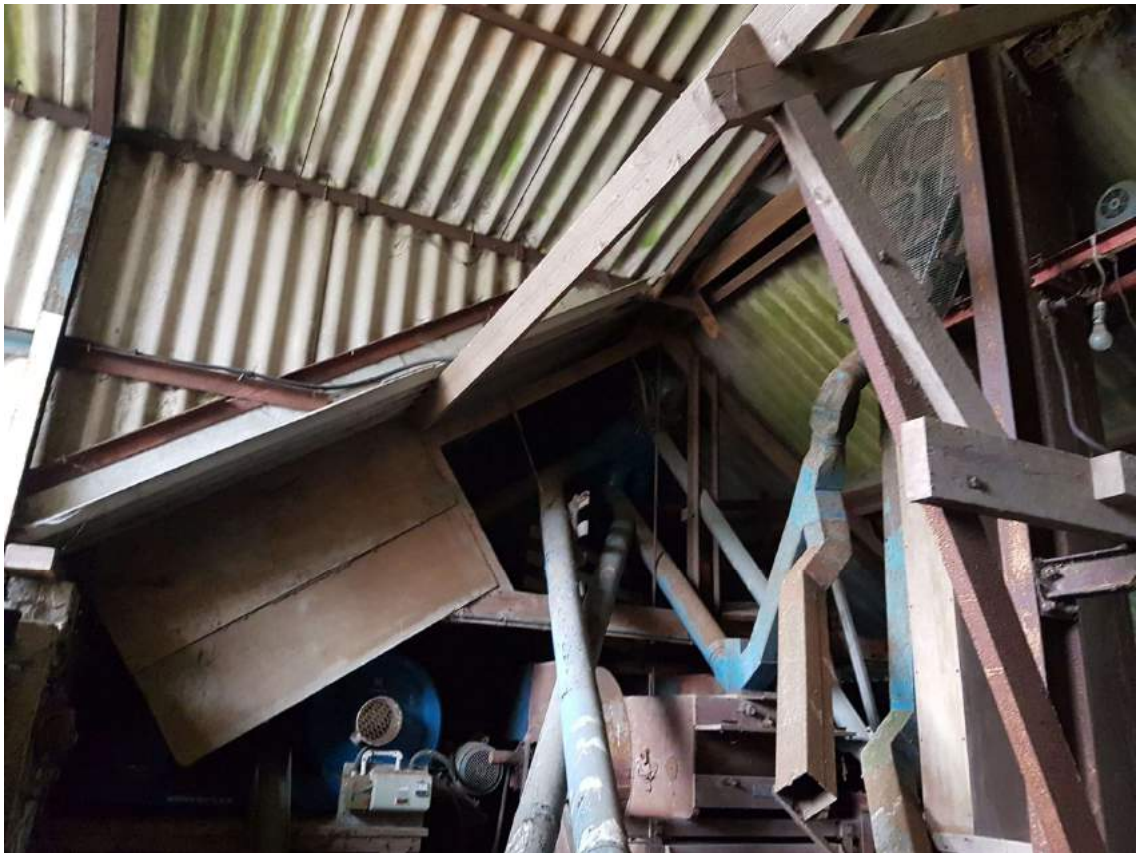
*Photograph 29 – Disused Agri-plant and roof structure to Barn B*

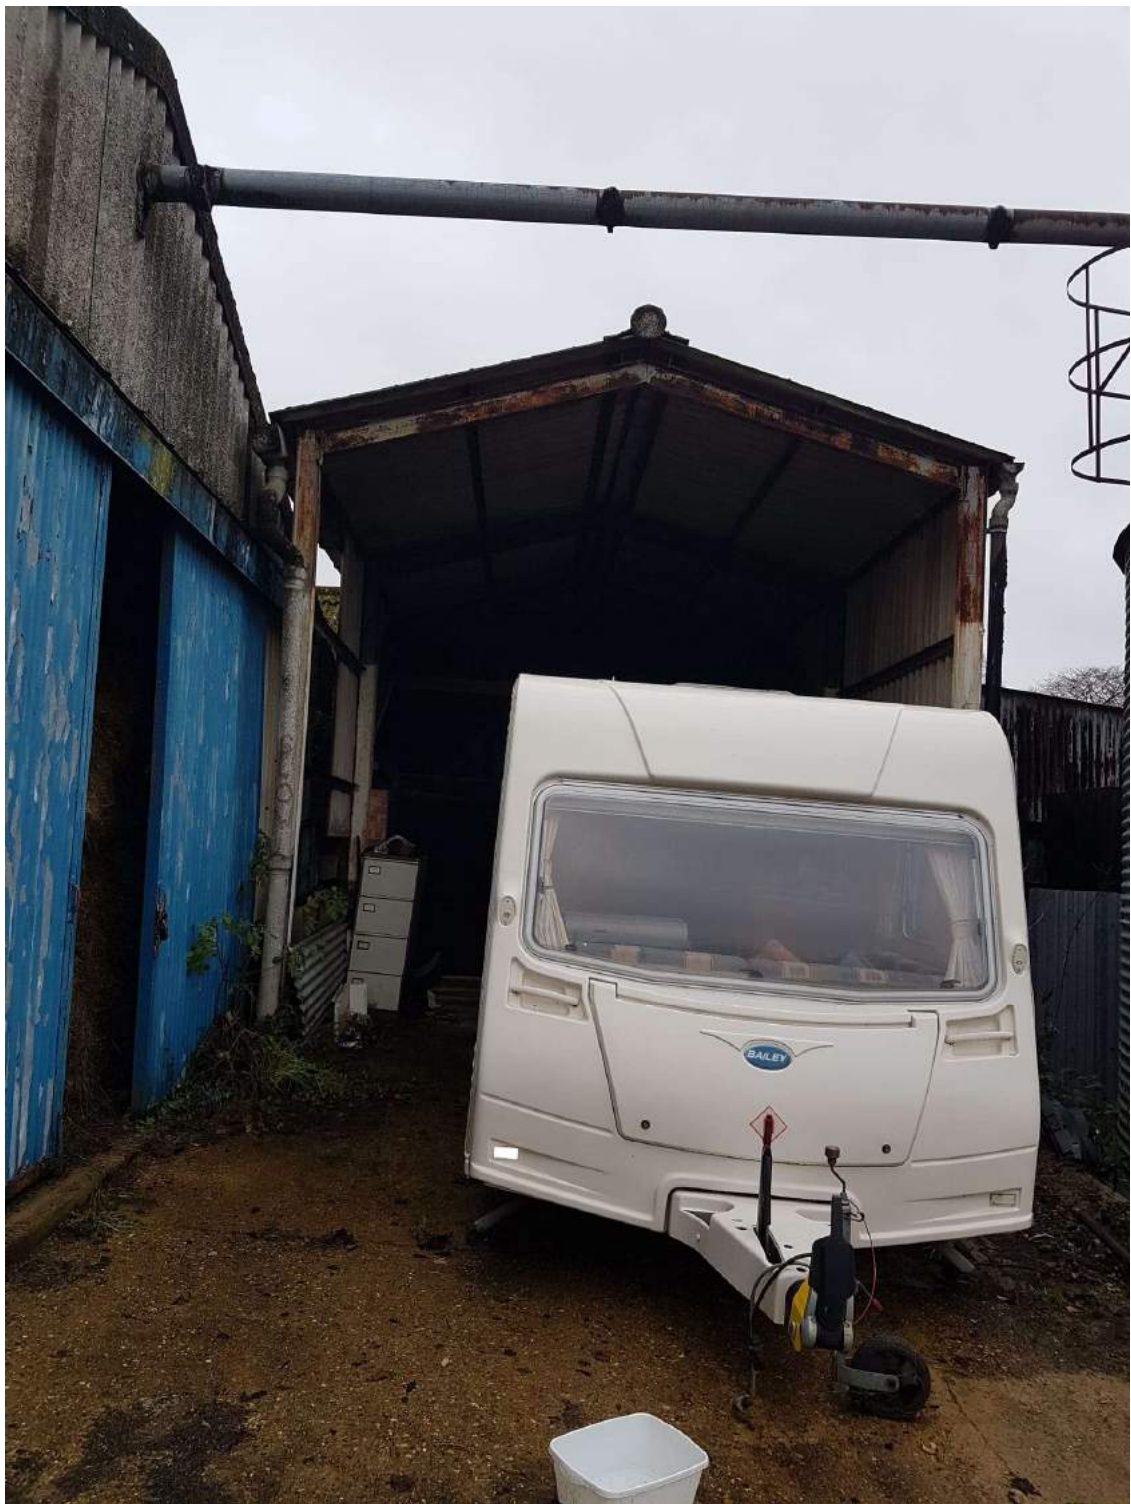
The lean to area comprises a steel frame with corrugated tin sheeting to the walls and roof. The steelwork frame and sheeting are in fair condition with visible rusting and will need replacing as part of any new development.

*Photograph 31 – Open front lean-to Barn B Eastern elevation*

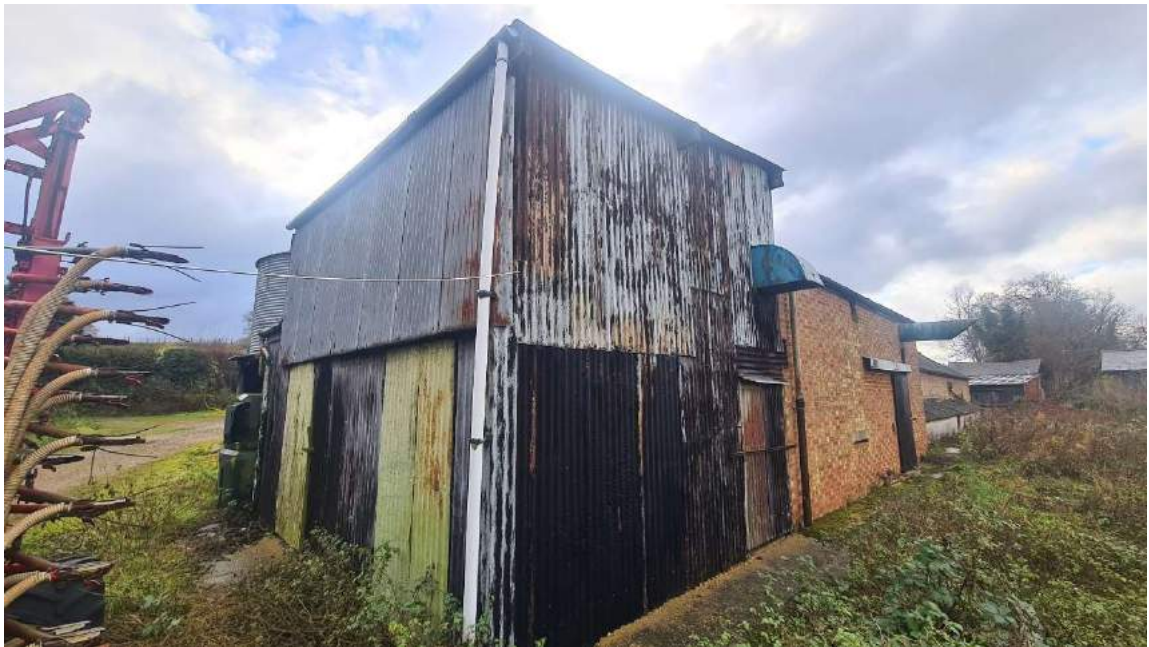
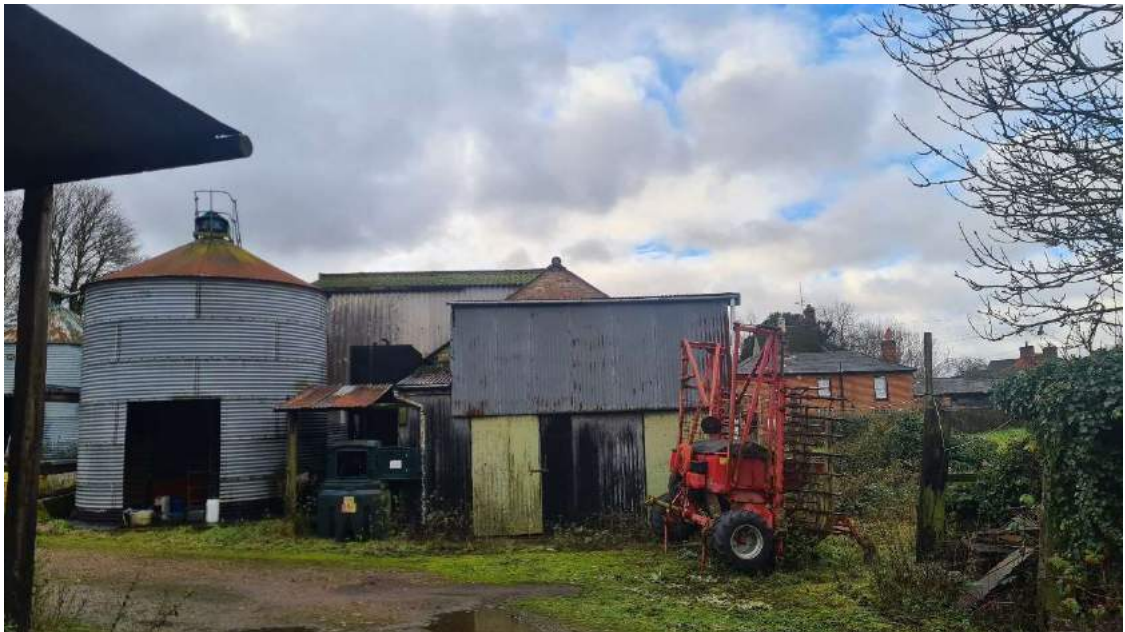
Barn C is of single storey construction formed from lightweight steel framing and corrugated tin sheeting to the external walls and roof, typical of agricultural storage sheds.

The structure is in fair condition and it is anticipated that this barn will be insulated and reclad in timber cladding with a new roof covering. We therefore recommend that the wall construction consist of 12mm plywood fixed to the existing frame (to provide stability) with insulation and cladding over. The roof should be replaced with lightweight artificial slates over plywood cladding and insulation.

*Photograph 33 – Barn C North elevation*

*Photograph 34 – Barn C*

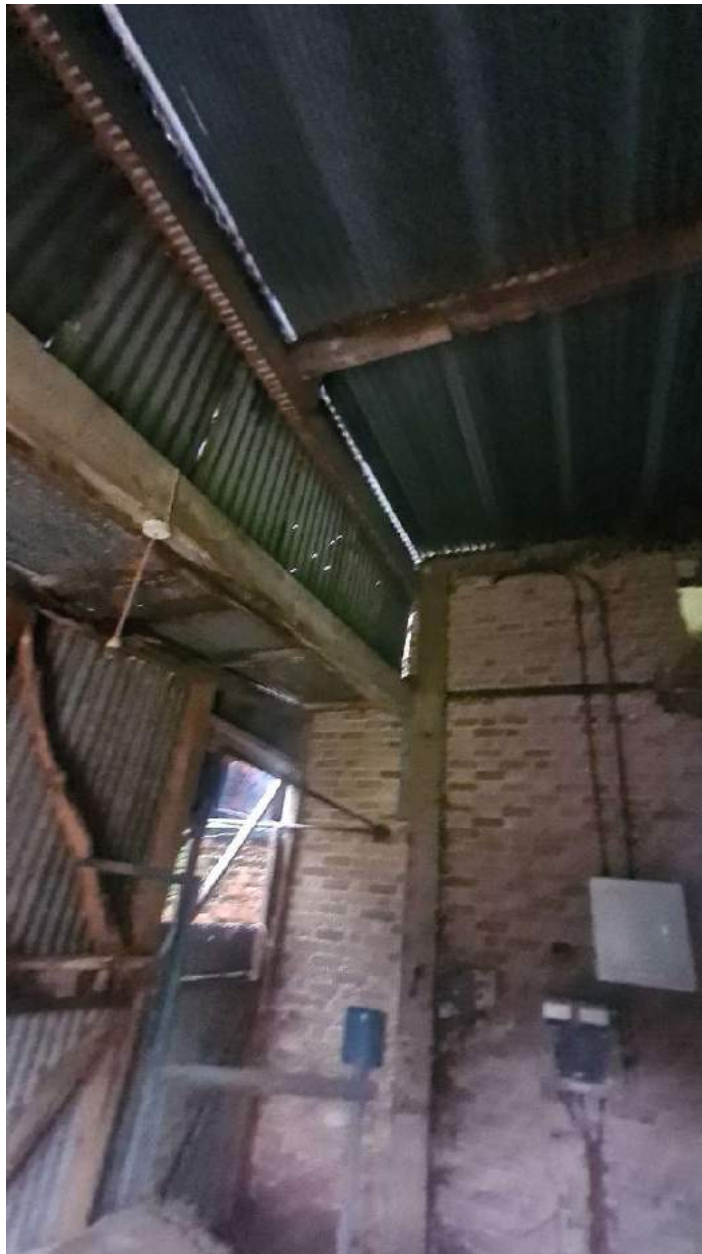
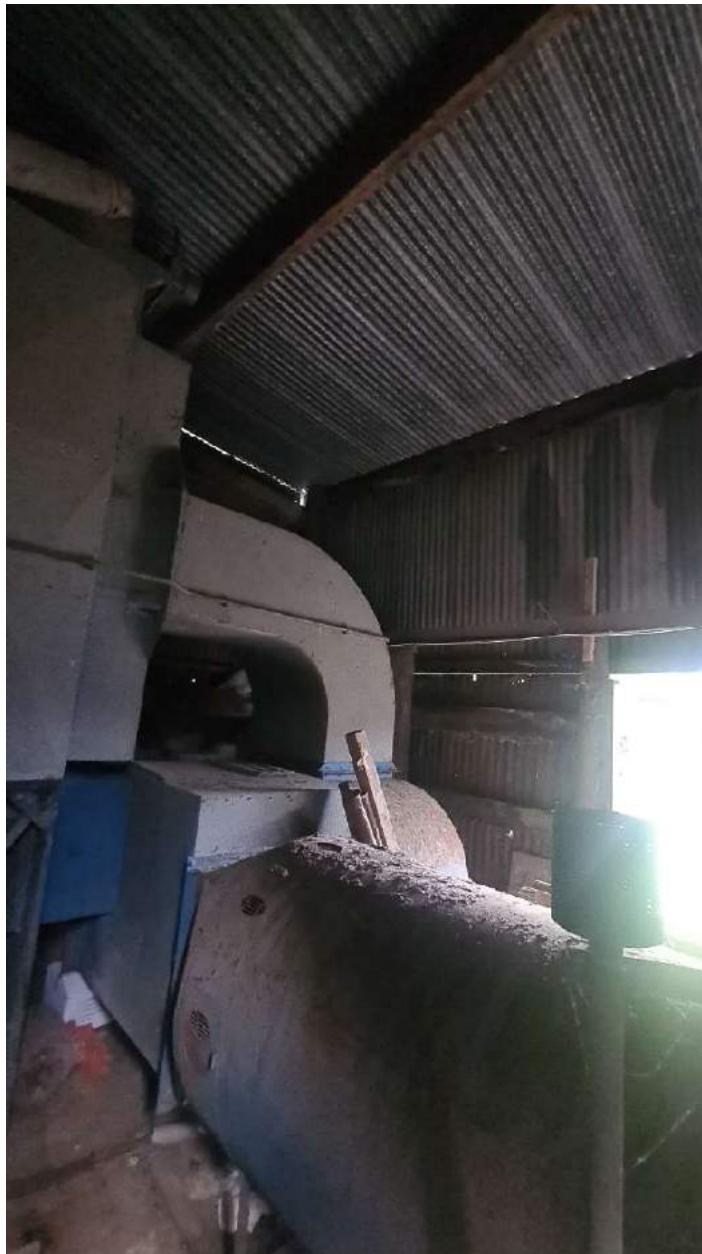
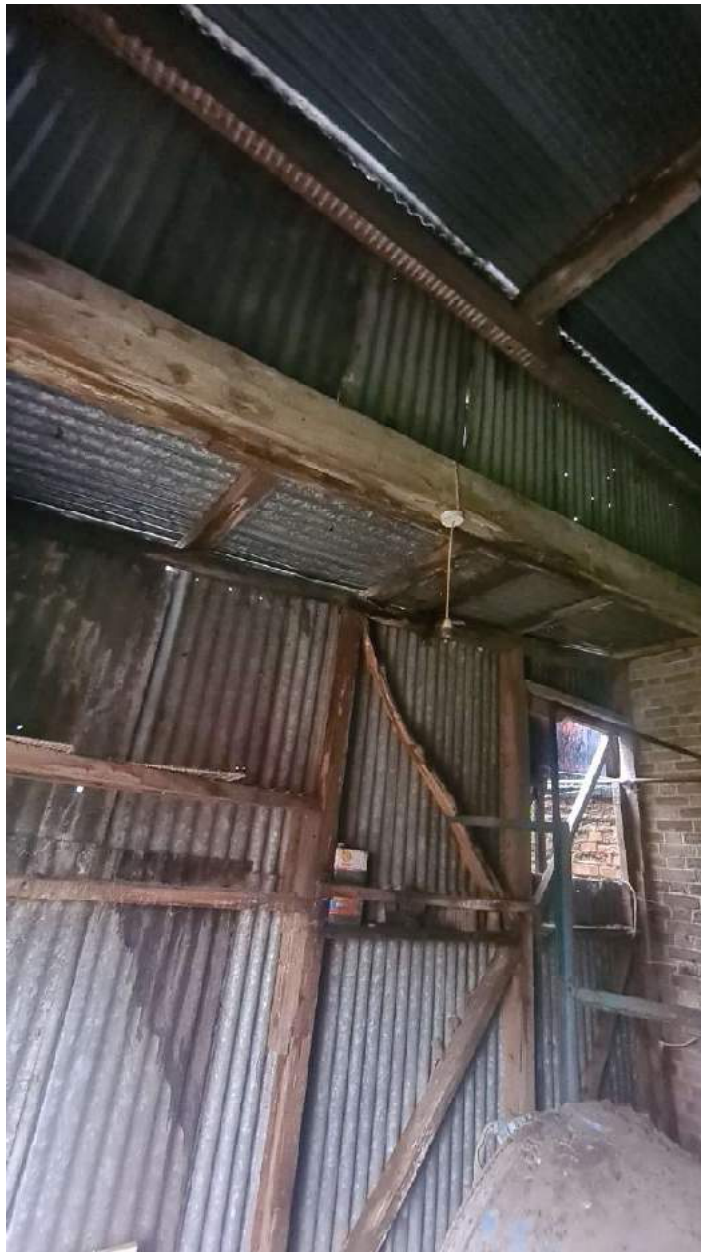
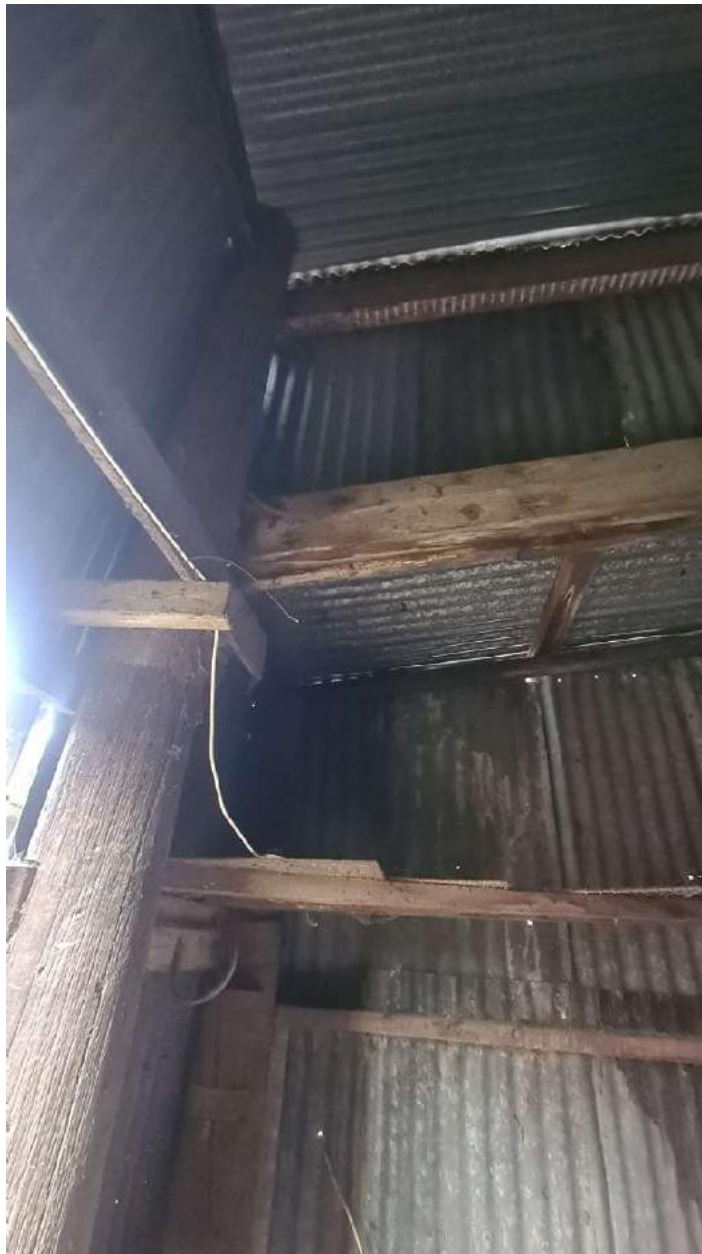
*Photograph 35 – Barn C roof structure*

*Photograph 36 – Barn C roof and wall structure*

*Photograph 37 – Barn C interior roof and wall structure*

*Photograph 38 – Barn C interior roof and wall structure*
