# Decay Detection Investigation

Old Rectory

Hodwell, Ashwell

260786-TMA-XX-RP-AR-1600

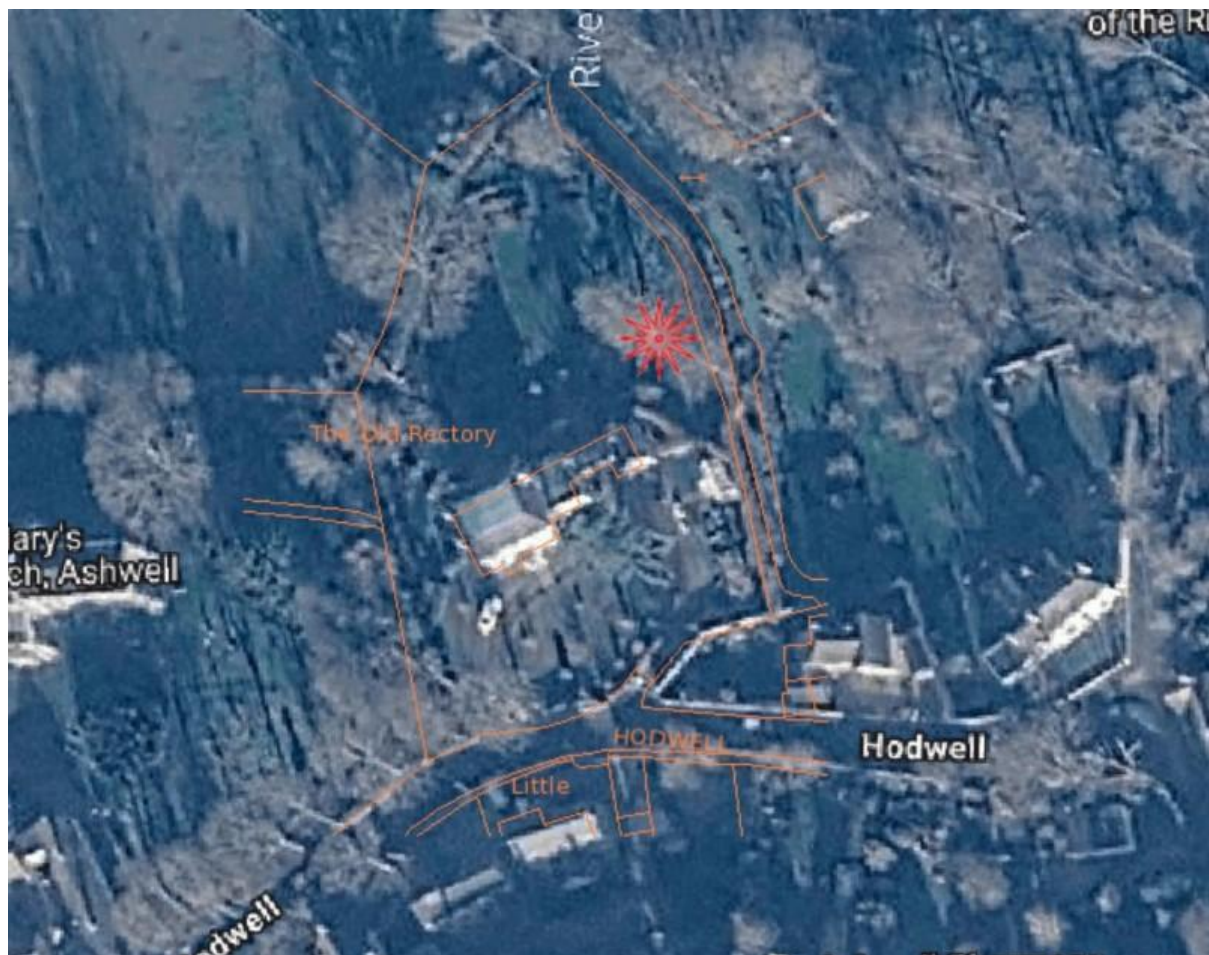
- 4.1 An early mature Norway spruce (*Picea abies*), with pronounced root buttressing, in poor physiological condition, and exhibiting low vitality. The tree is located within the rear garden, and is surrounded by plant beds and lawns, constituting permeable ground. The tree is within falling distance of the house and the neighbouring property boundary.

*T1 Norway spruce: MyTrees map with Google Maps overlay, showing the tree highlighted in red*
