Our Ref: 17446/JAE/KL

24 November 2023

**Kimpton Players Playhouse by the Memorial Hall, Hall Lane, Kimpton, CG4 8RD**  
**Structural Inspection**

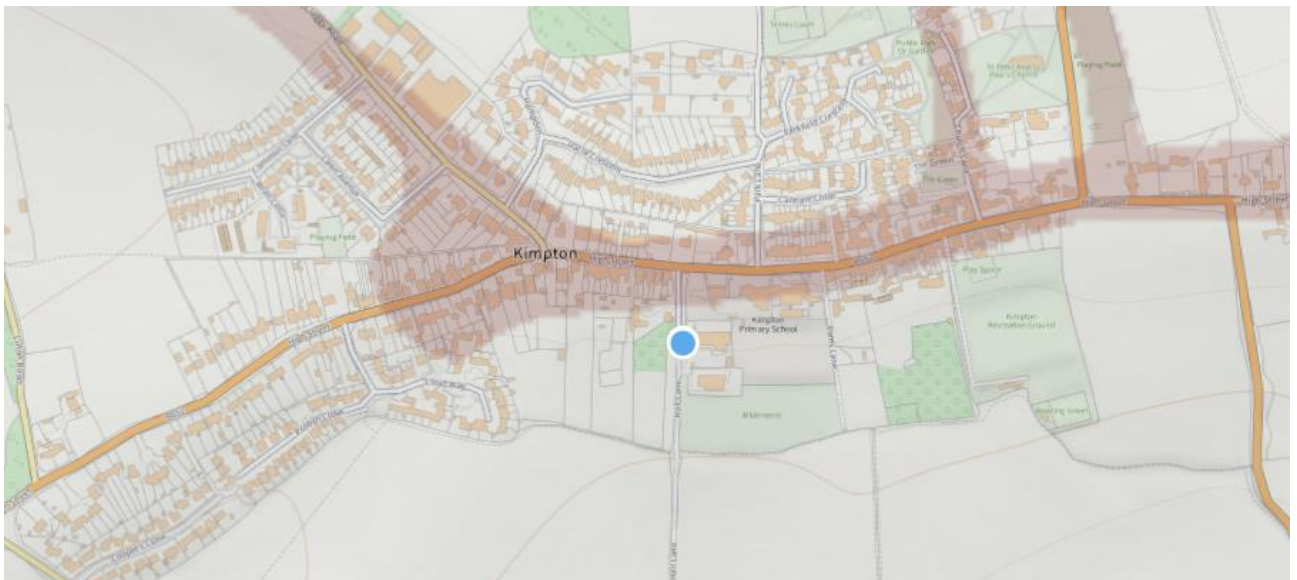
22. The British Geological Survey suggests the most likely 'bedrock' is expected to be:  
*Chalk Rock Member - Chalk. Sedimentary bedrock formed between 93.9 and 89.8 million years ago during the Cretaceous period.*

*Lewes Nodular Chalk Formation and Seaford Chalk Formation - Chalk. Sedimentary bedrock formed between 93.9 and 83.6 million years ago during the Cretaceous period.*

There are no superficial deposits expected at this location.

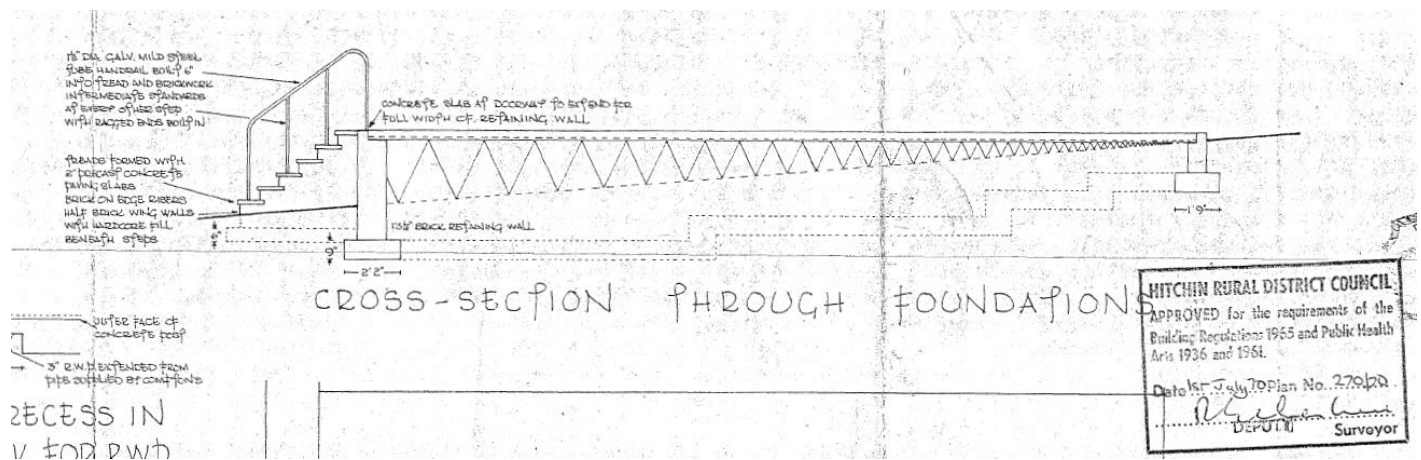
28. From the information provided, the foundations are about 2'0" deep (600mm), stepping up to follow the slope of the ground.
29. The wall by the steps is 325 thick with the other walls 215 thick.
