**Supporting Information for Listed Building Consent  
Application  
Survey and Method Statement**

Doc ID: ING/YNG/LBC/002

Youngloves Farm, Southern Green, Hertfordshire, SG9 0SP

Date: 10<sup>th</sup> April 2025

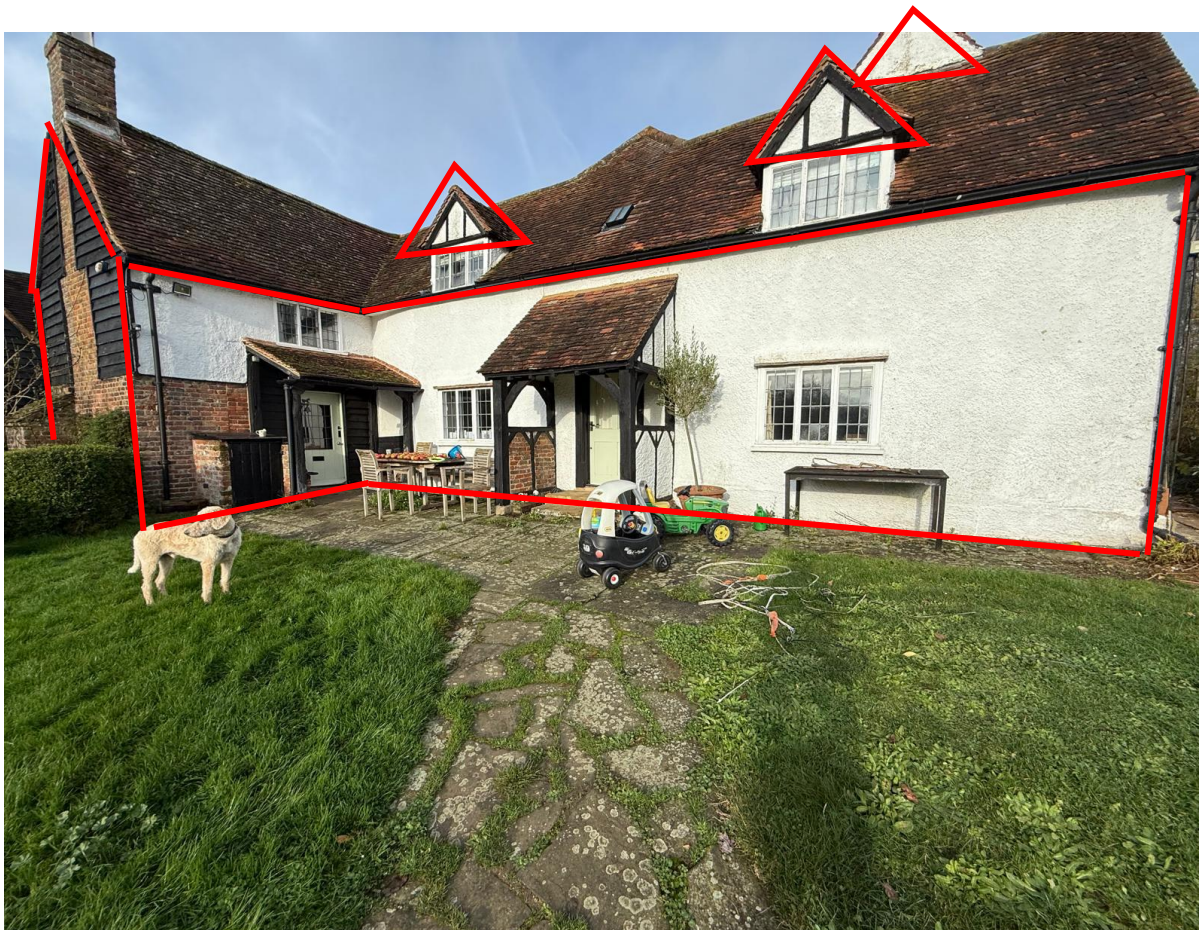
Figure 1 - Existing House - South Elevation

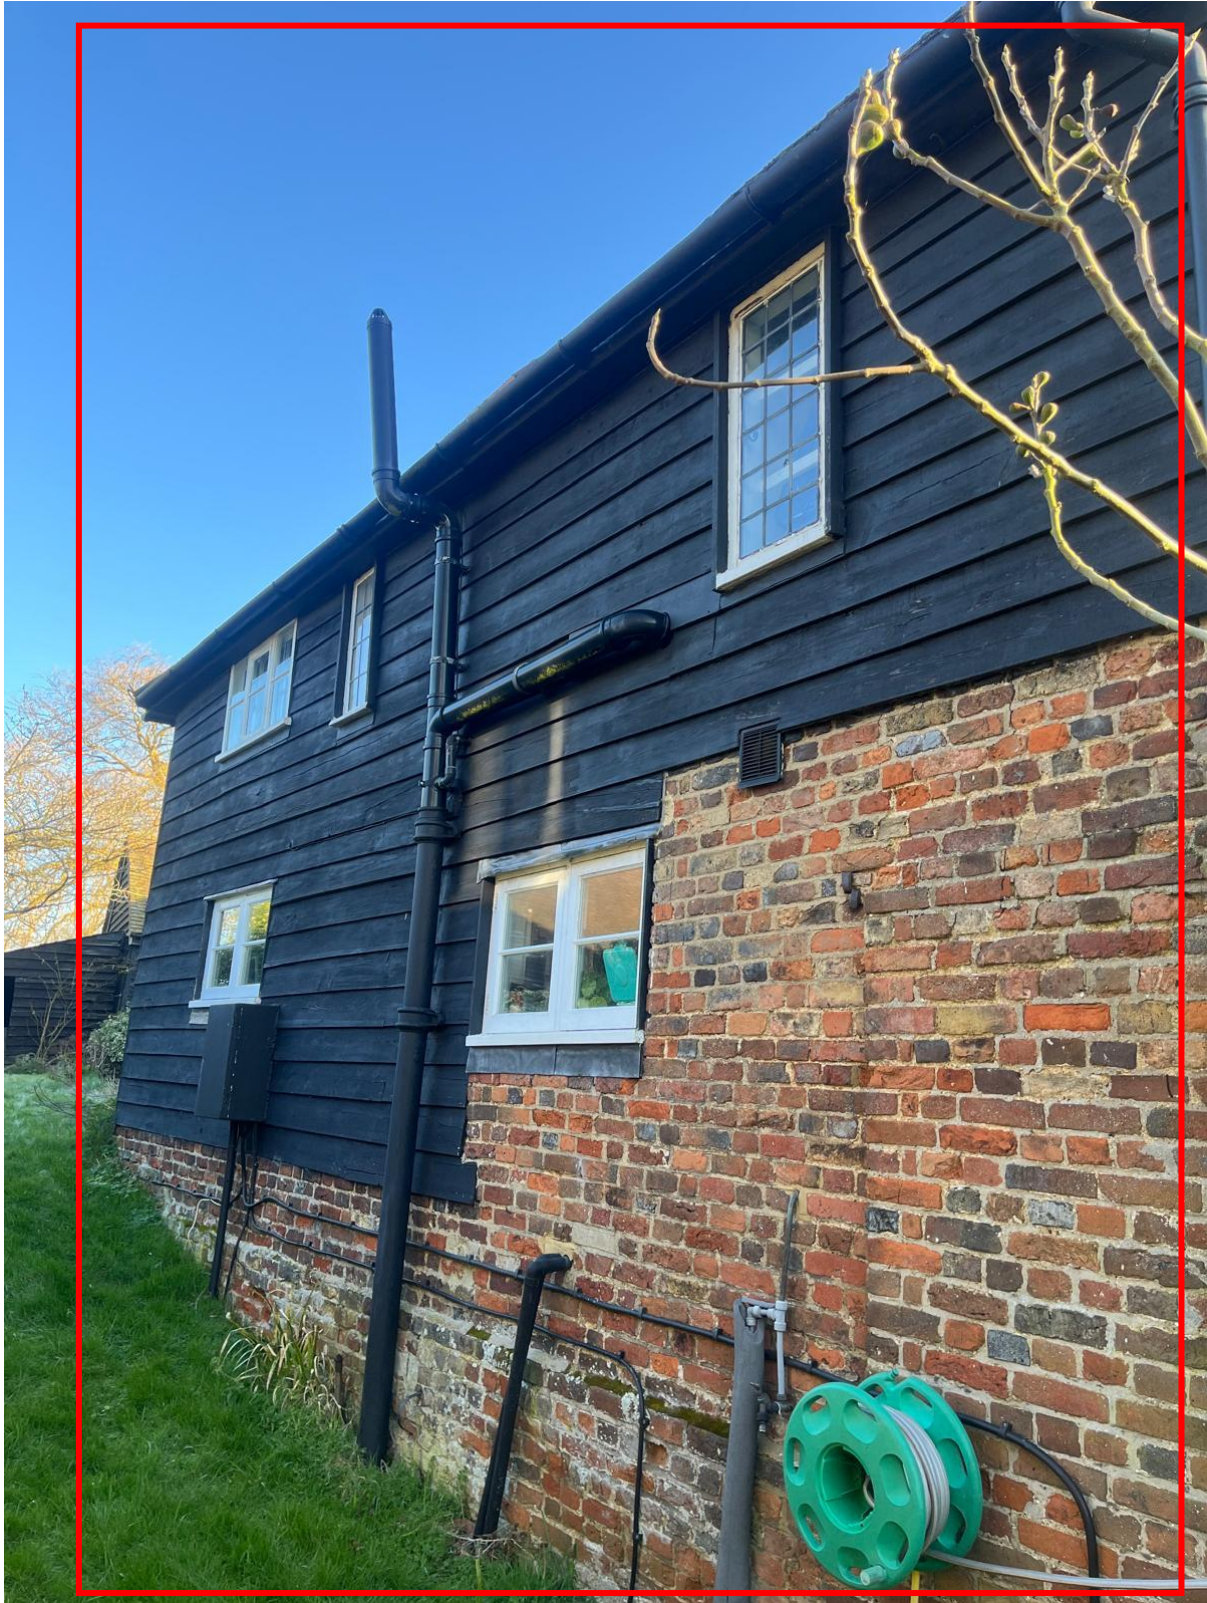
Figure 2 - Existing House - West Elevation

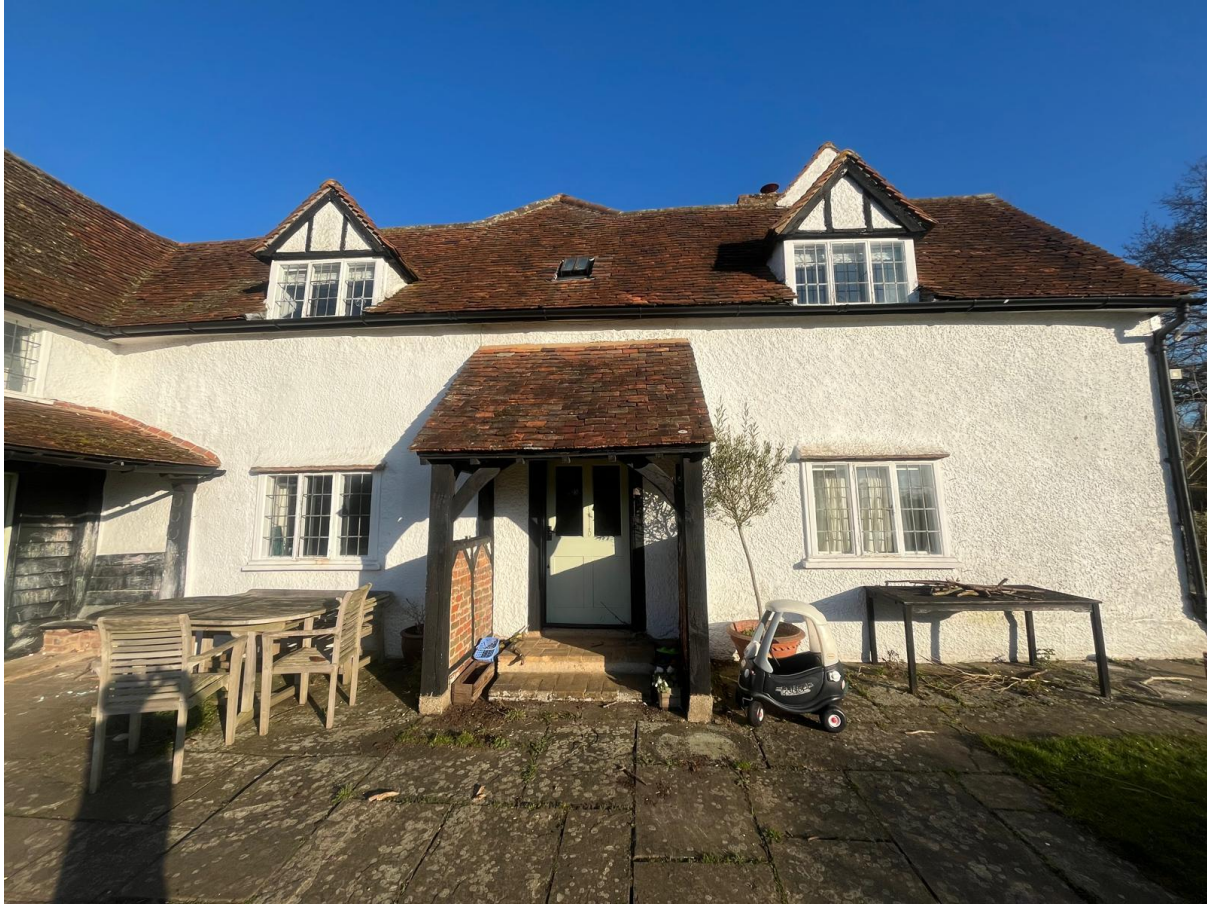
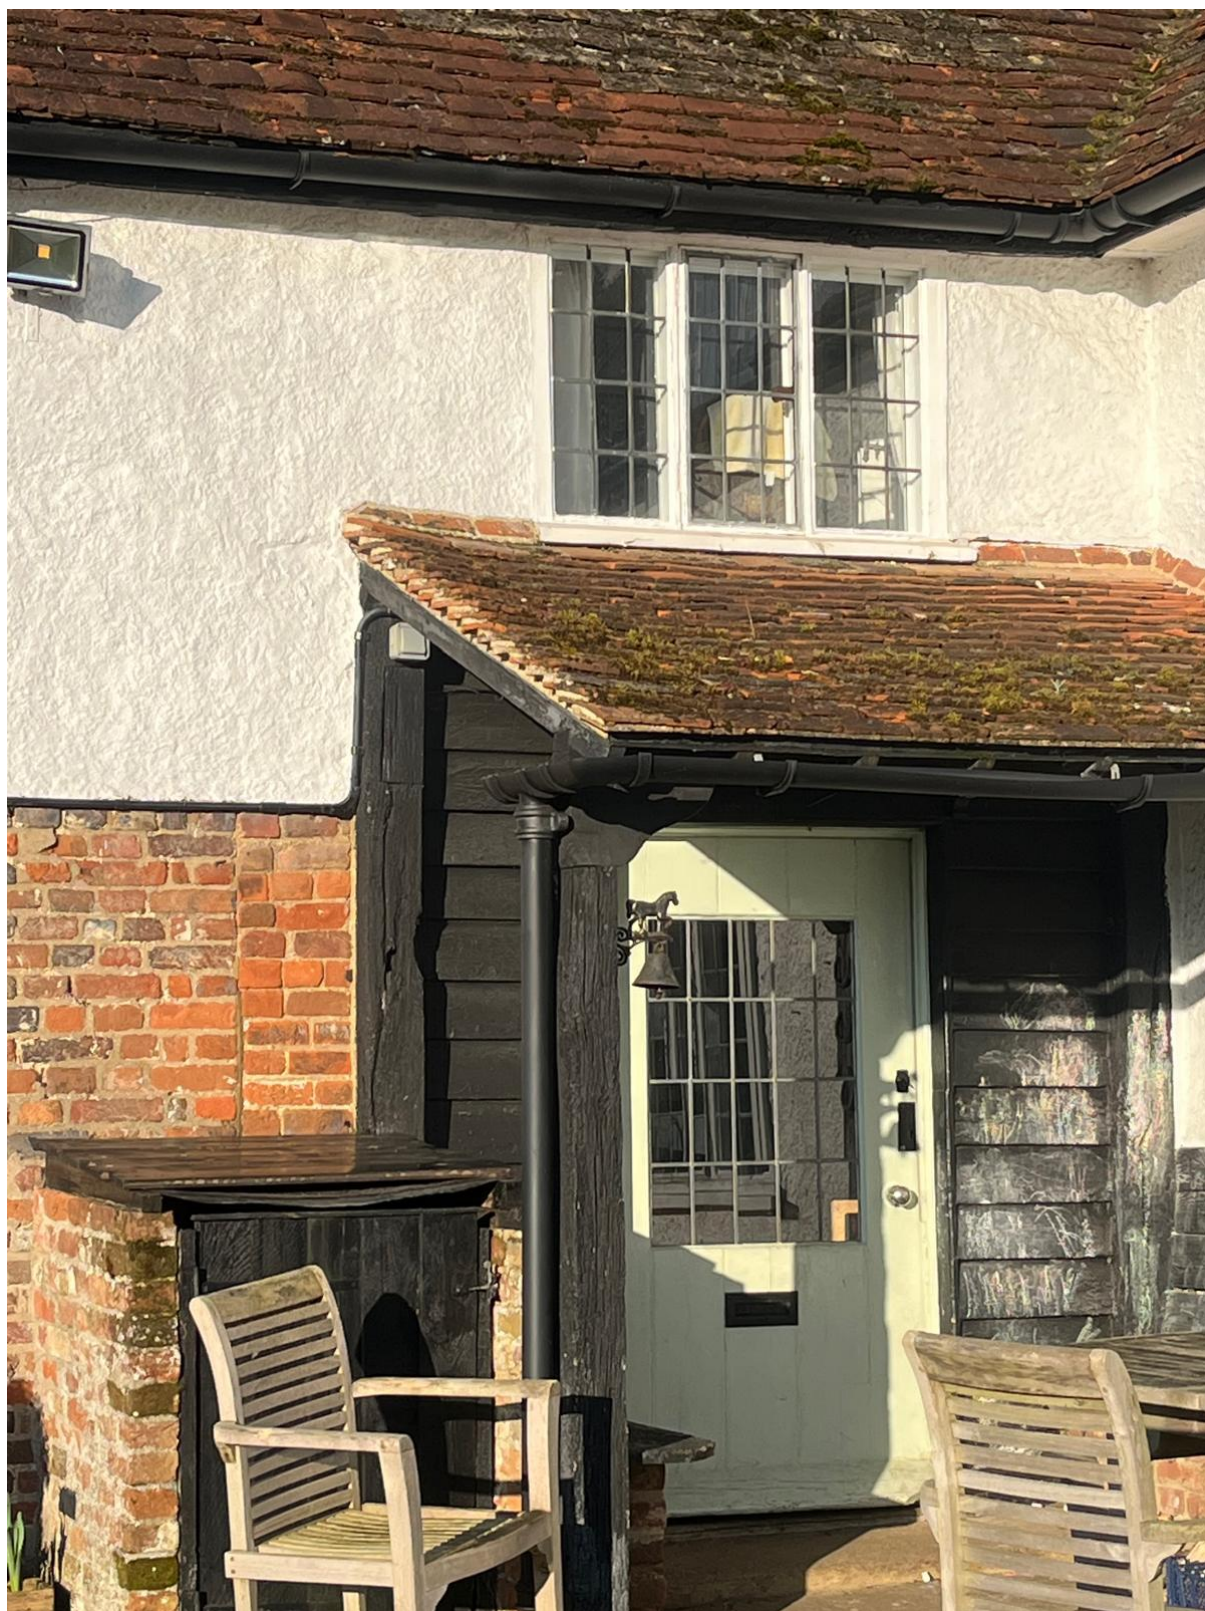
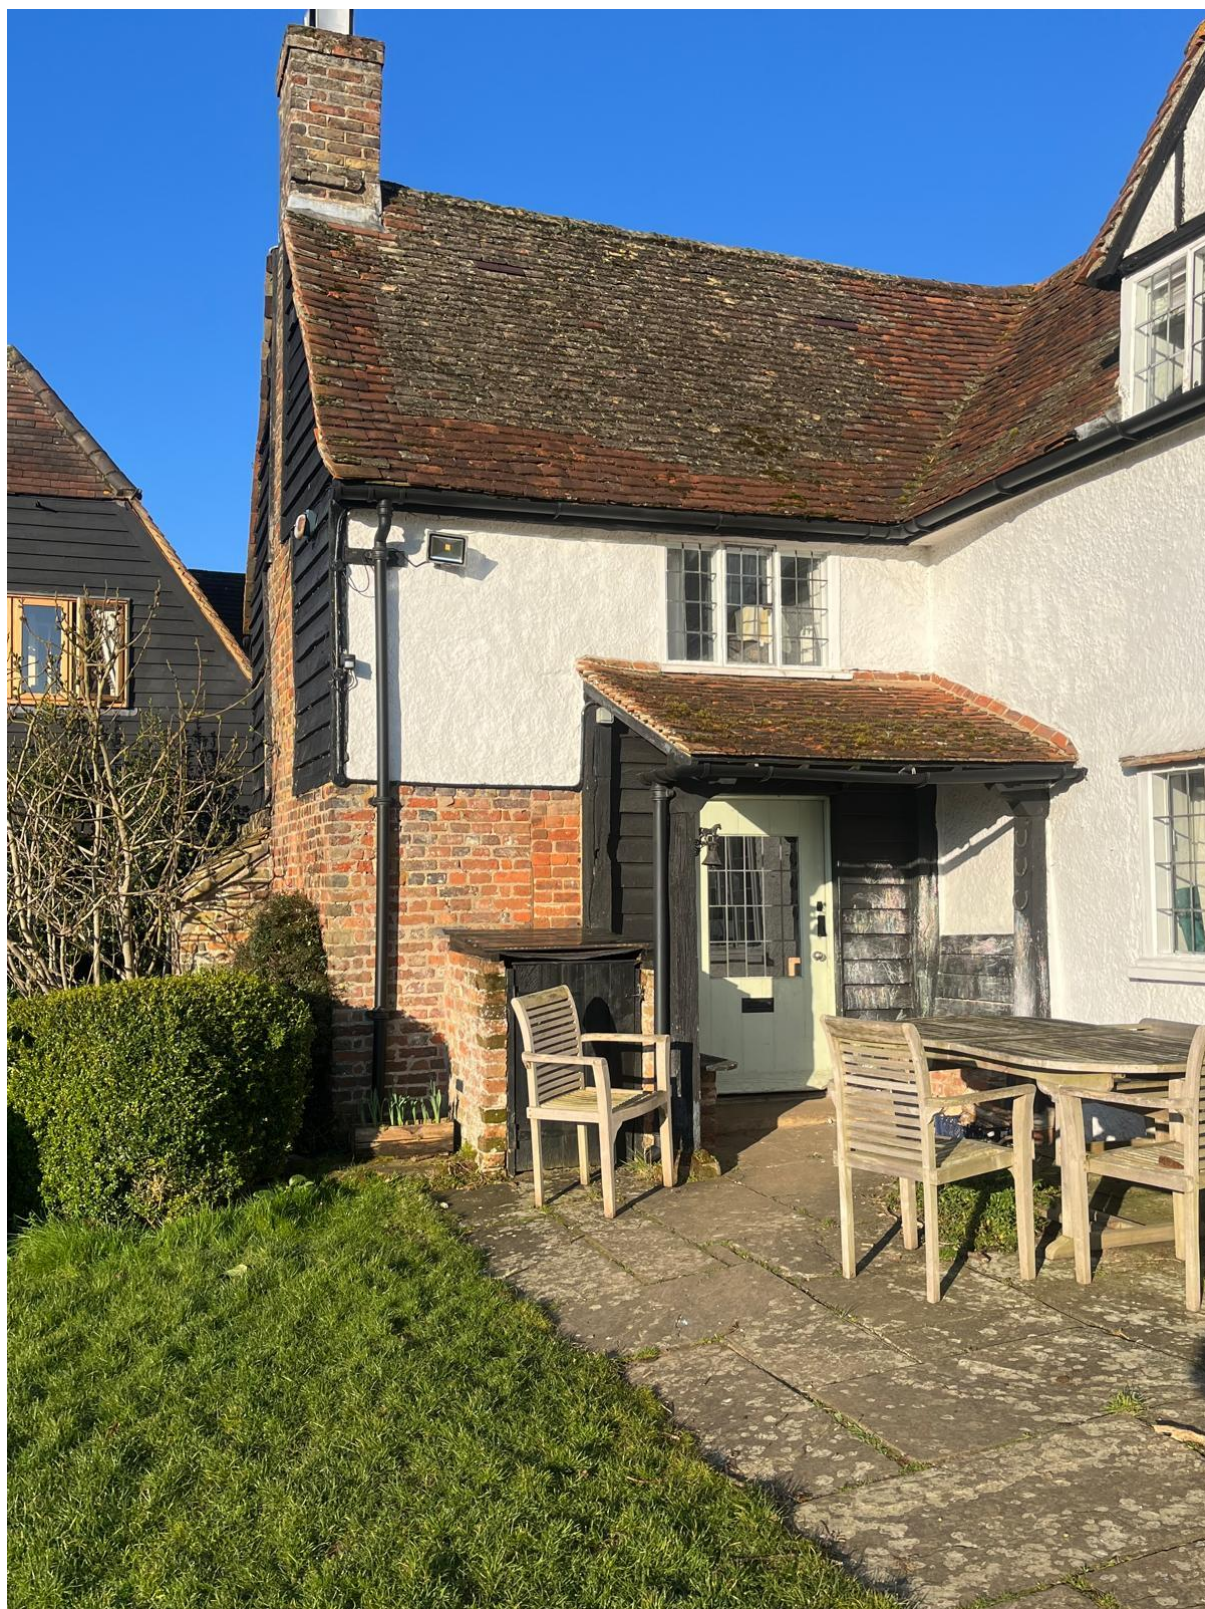
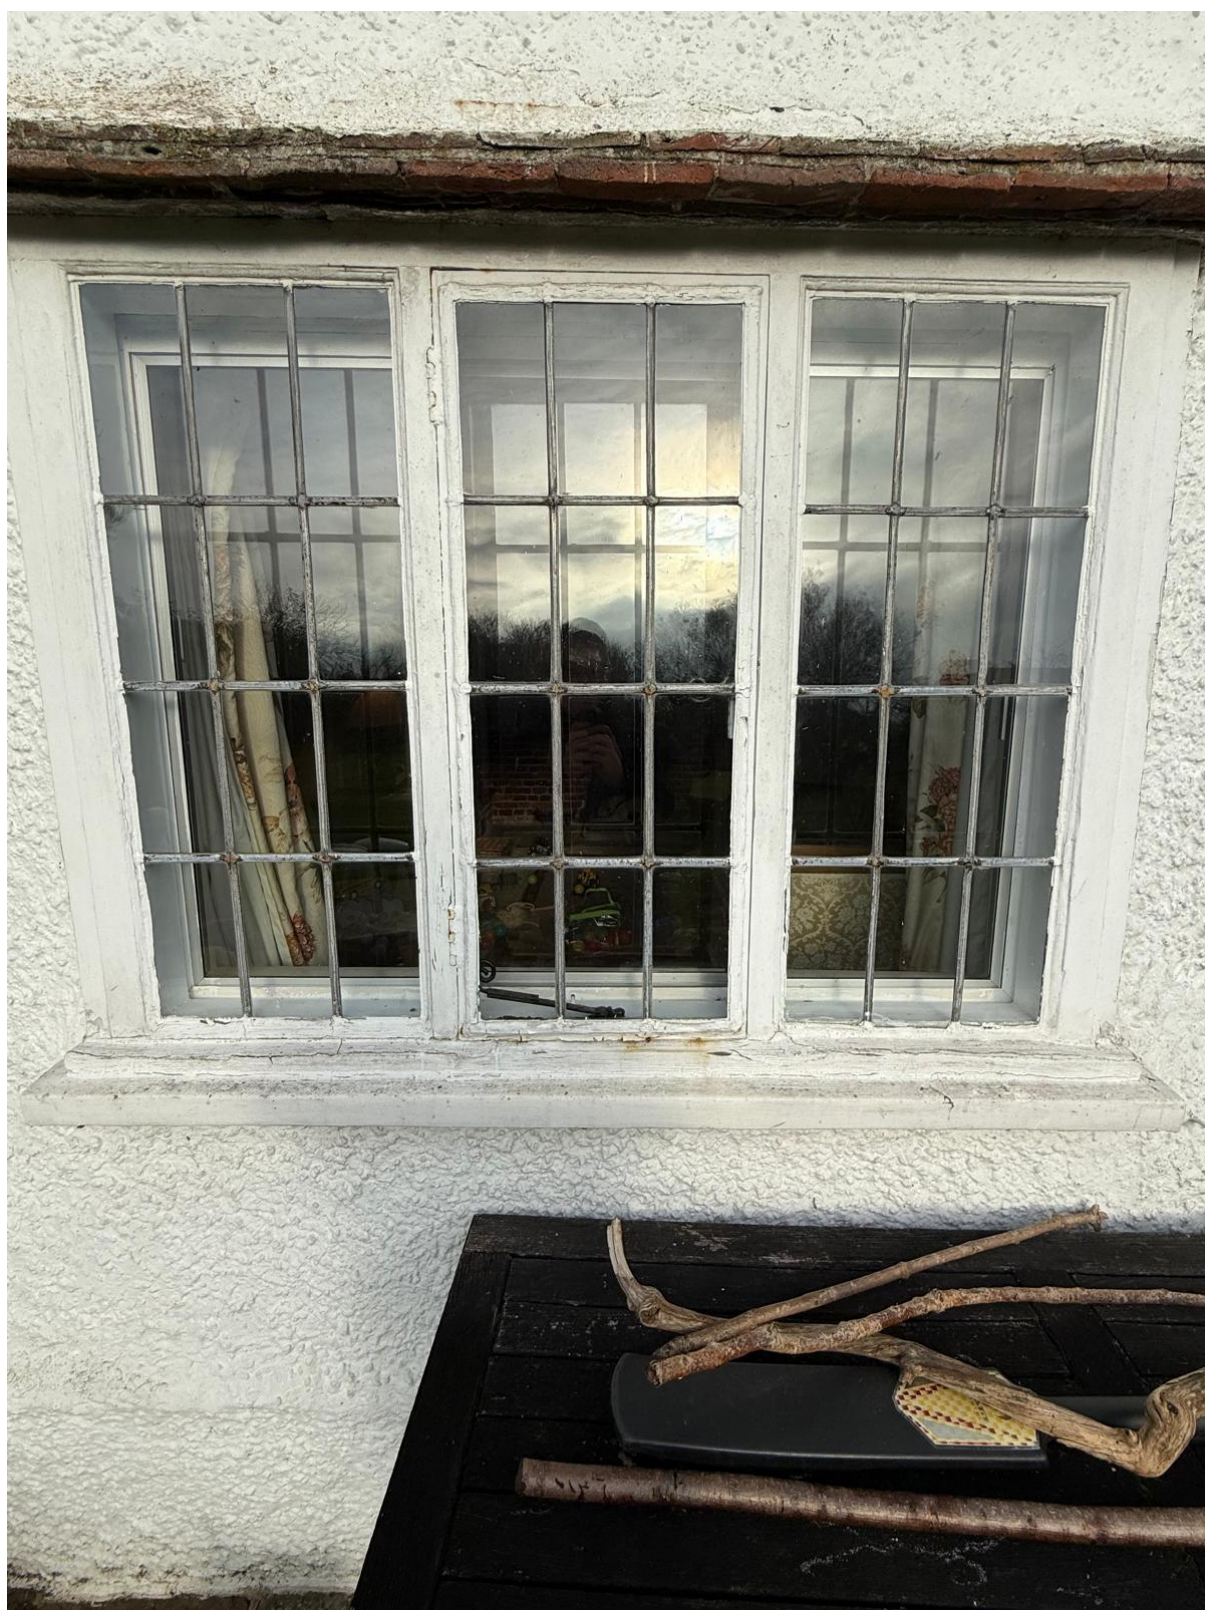
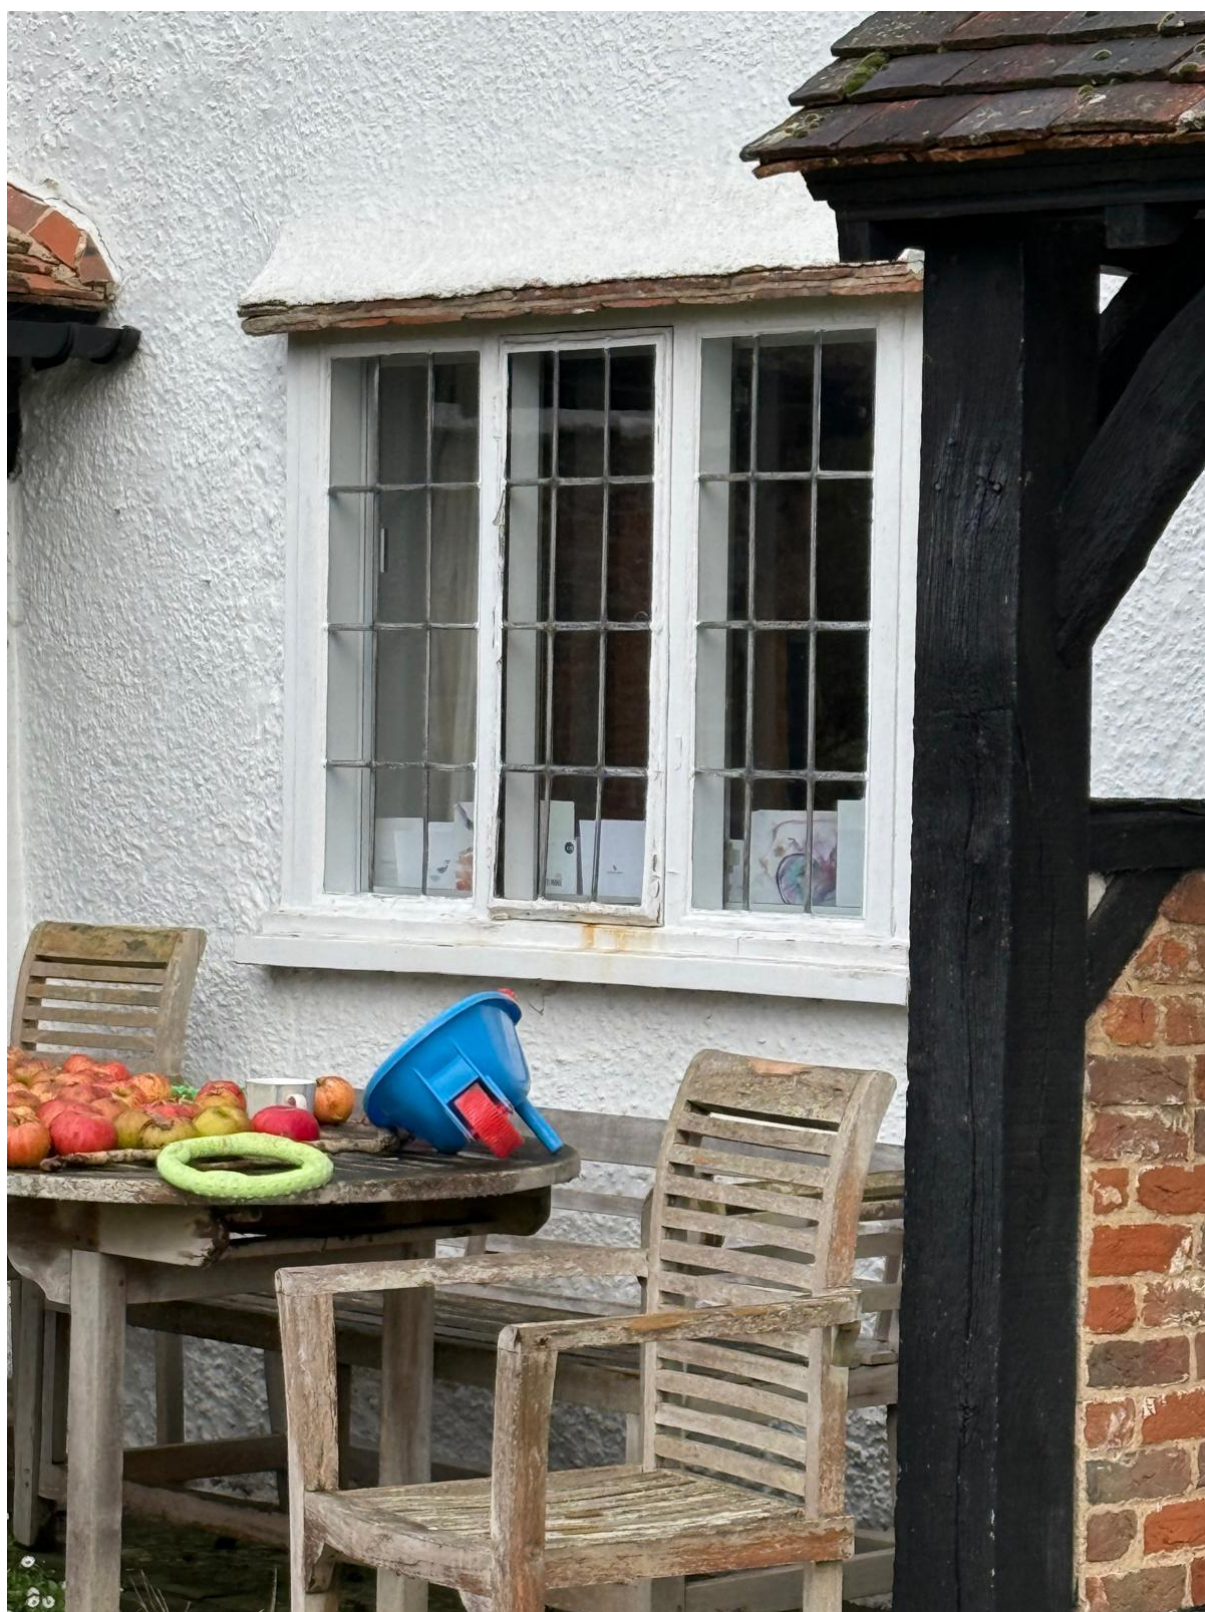
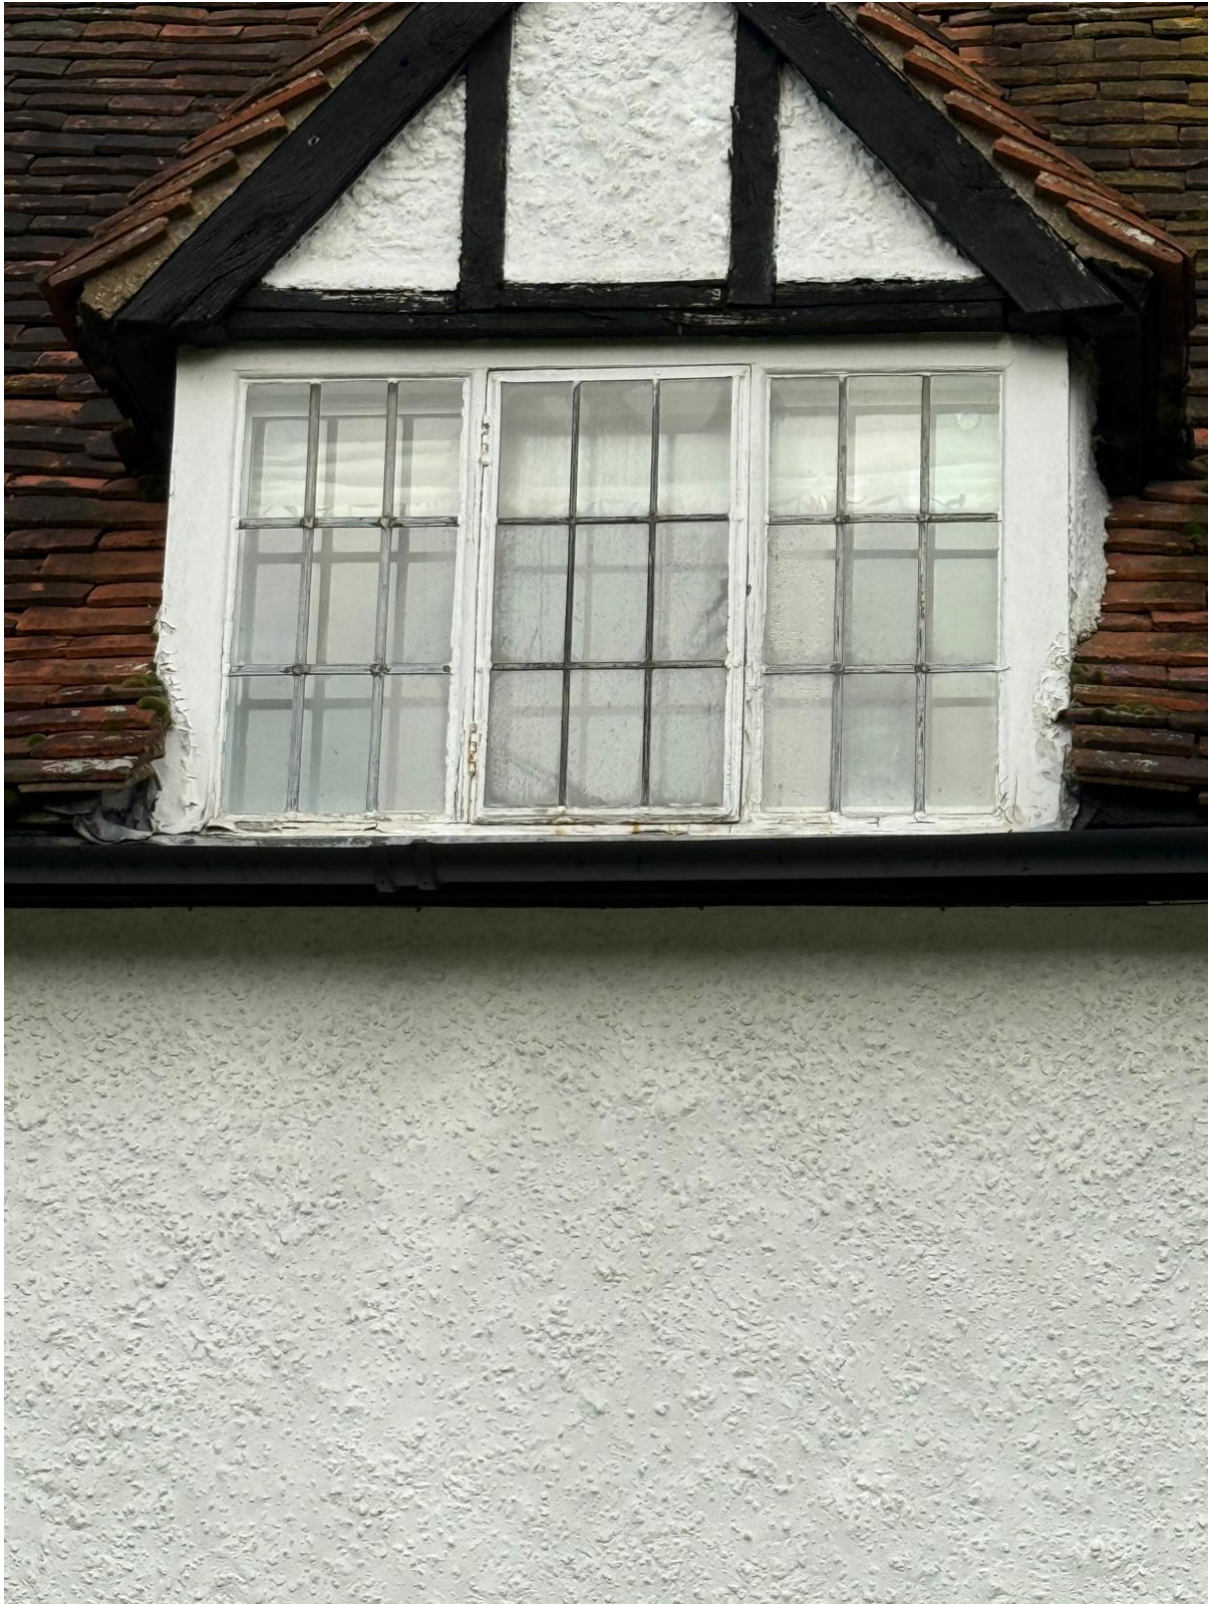
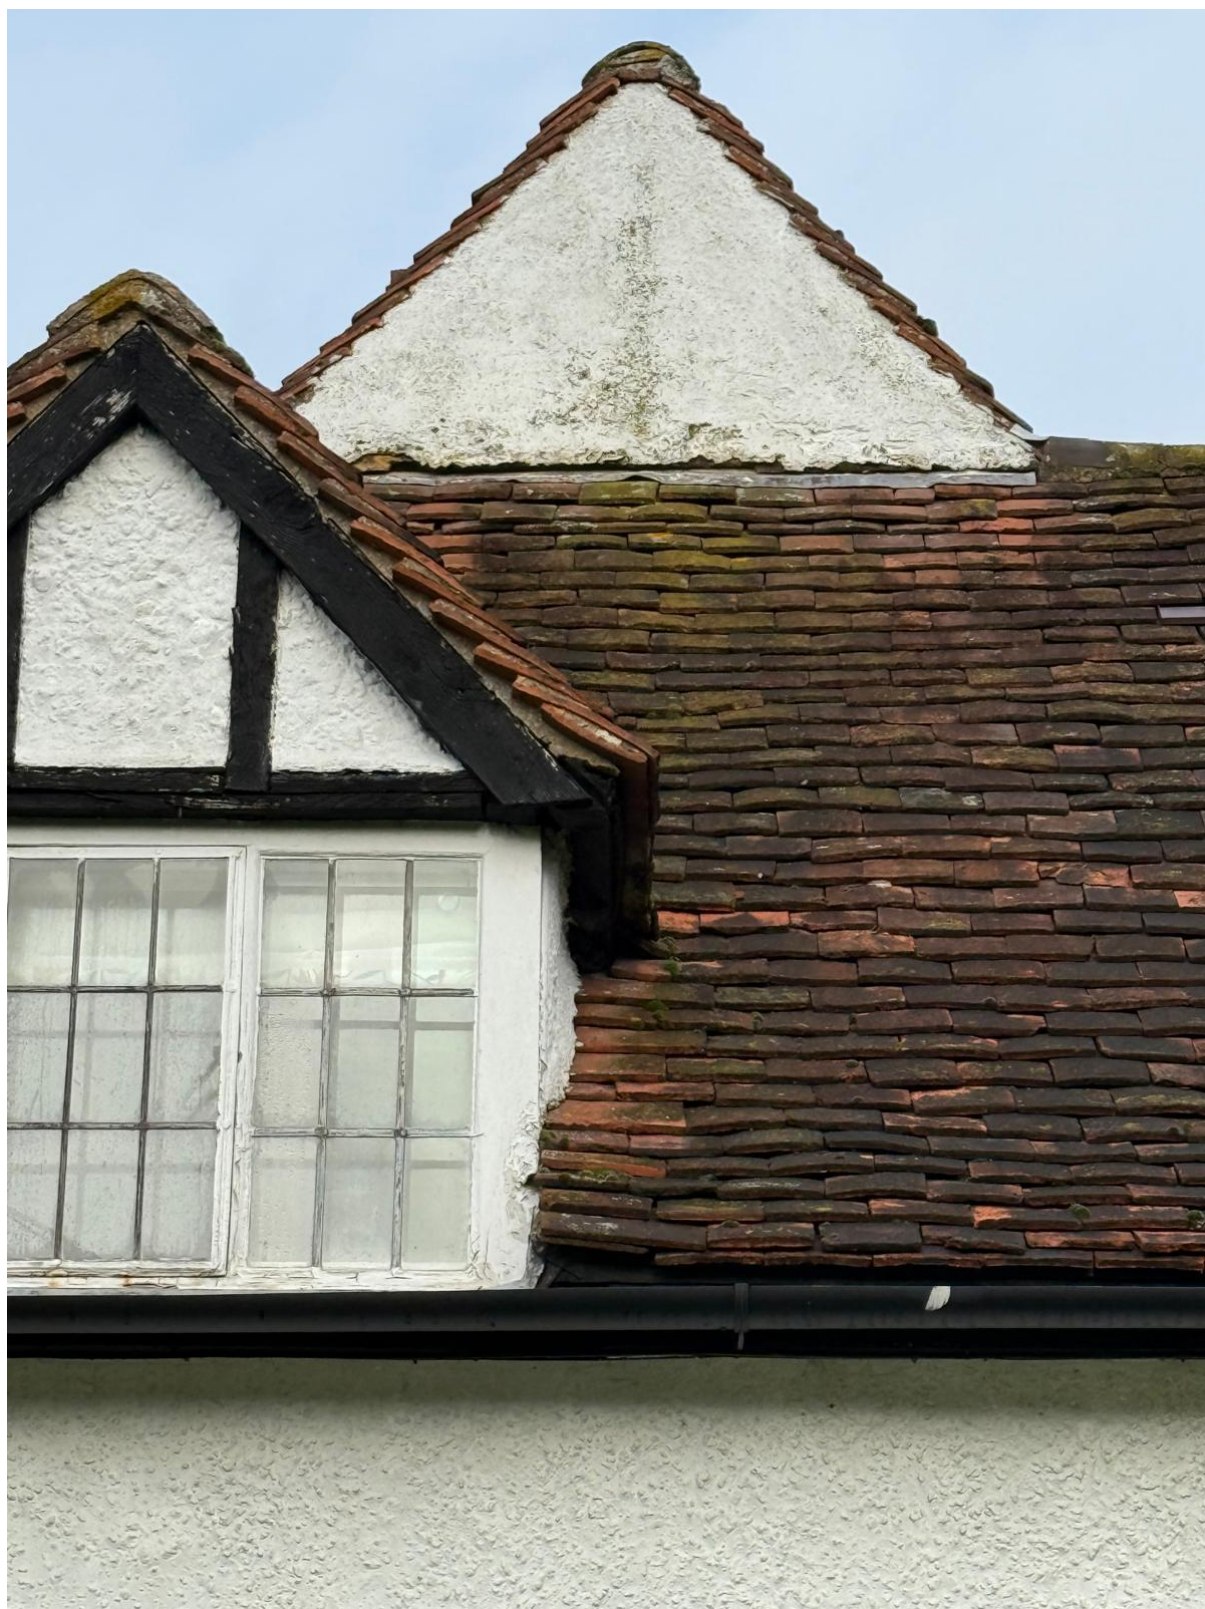
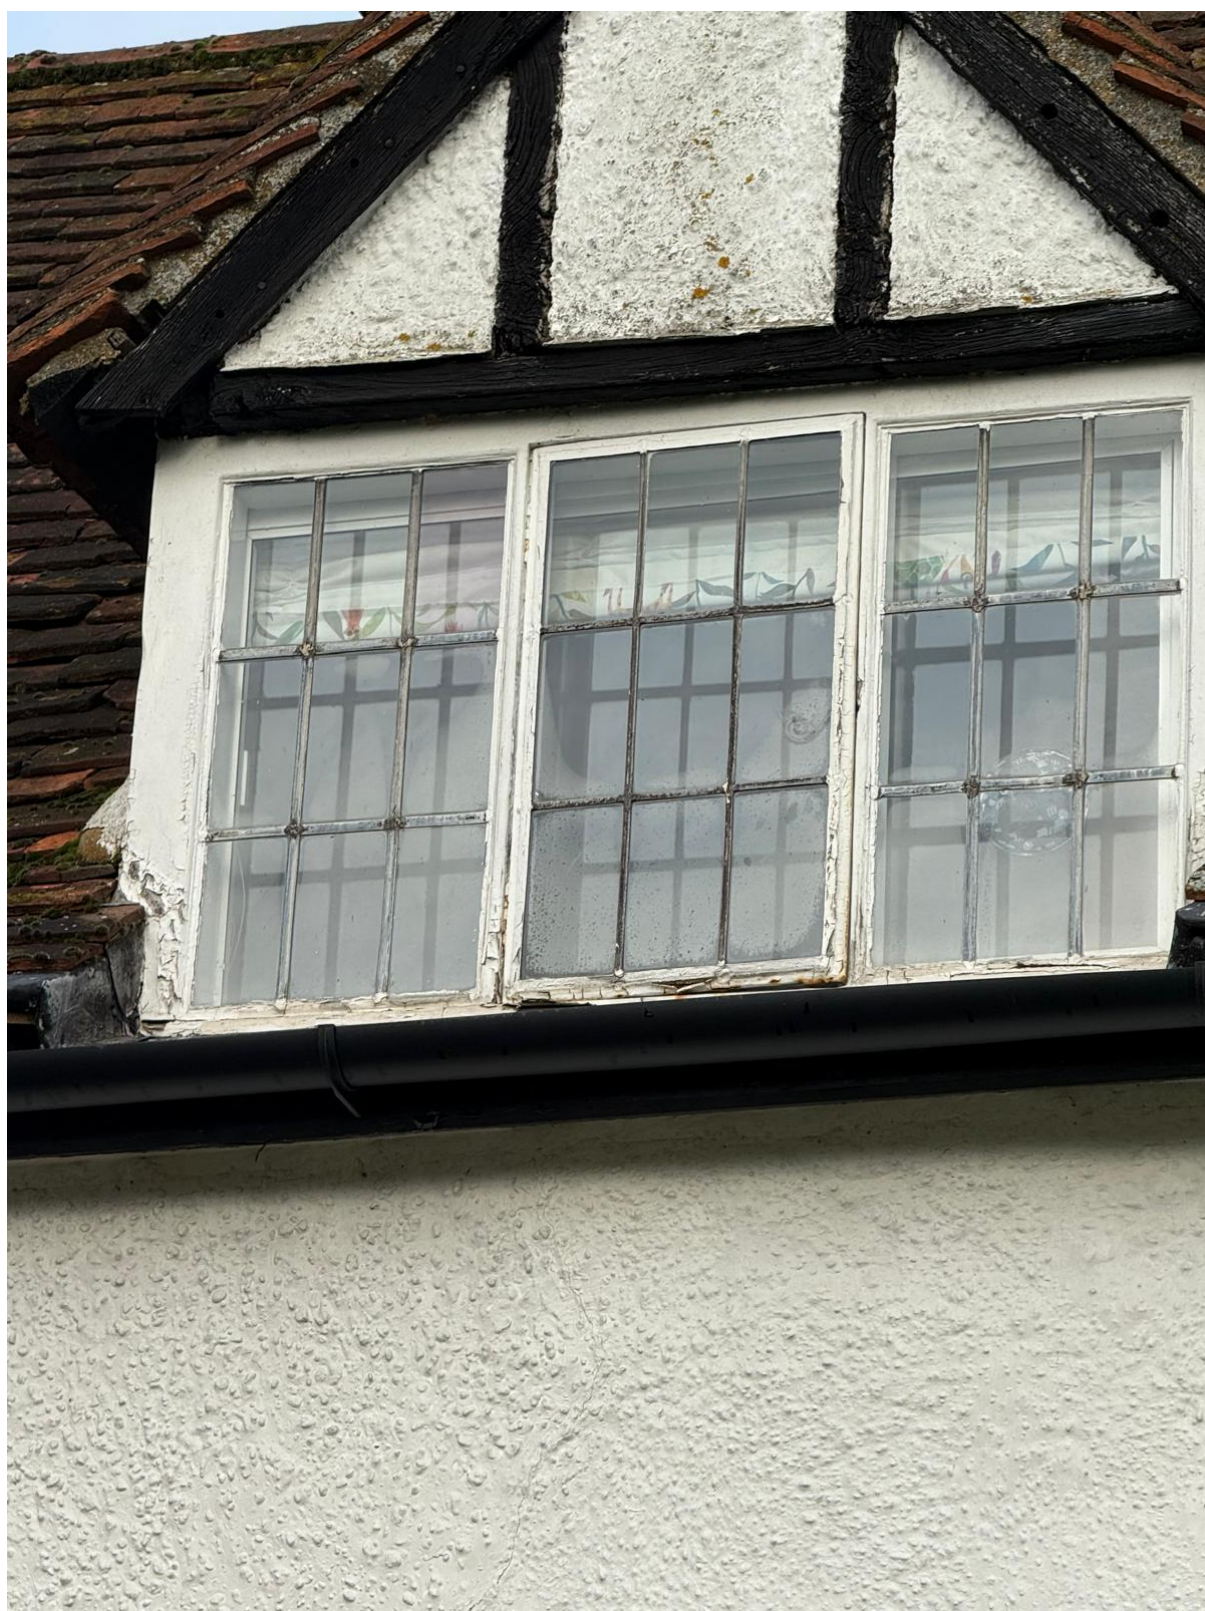
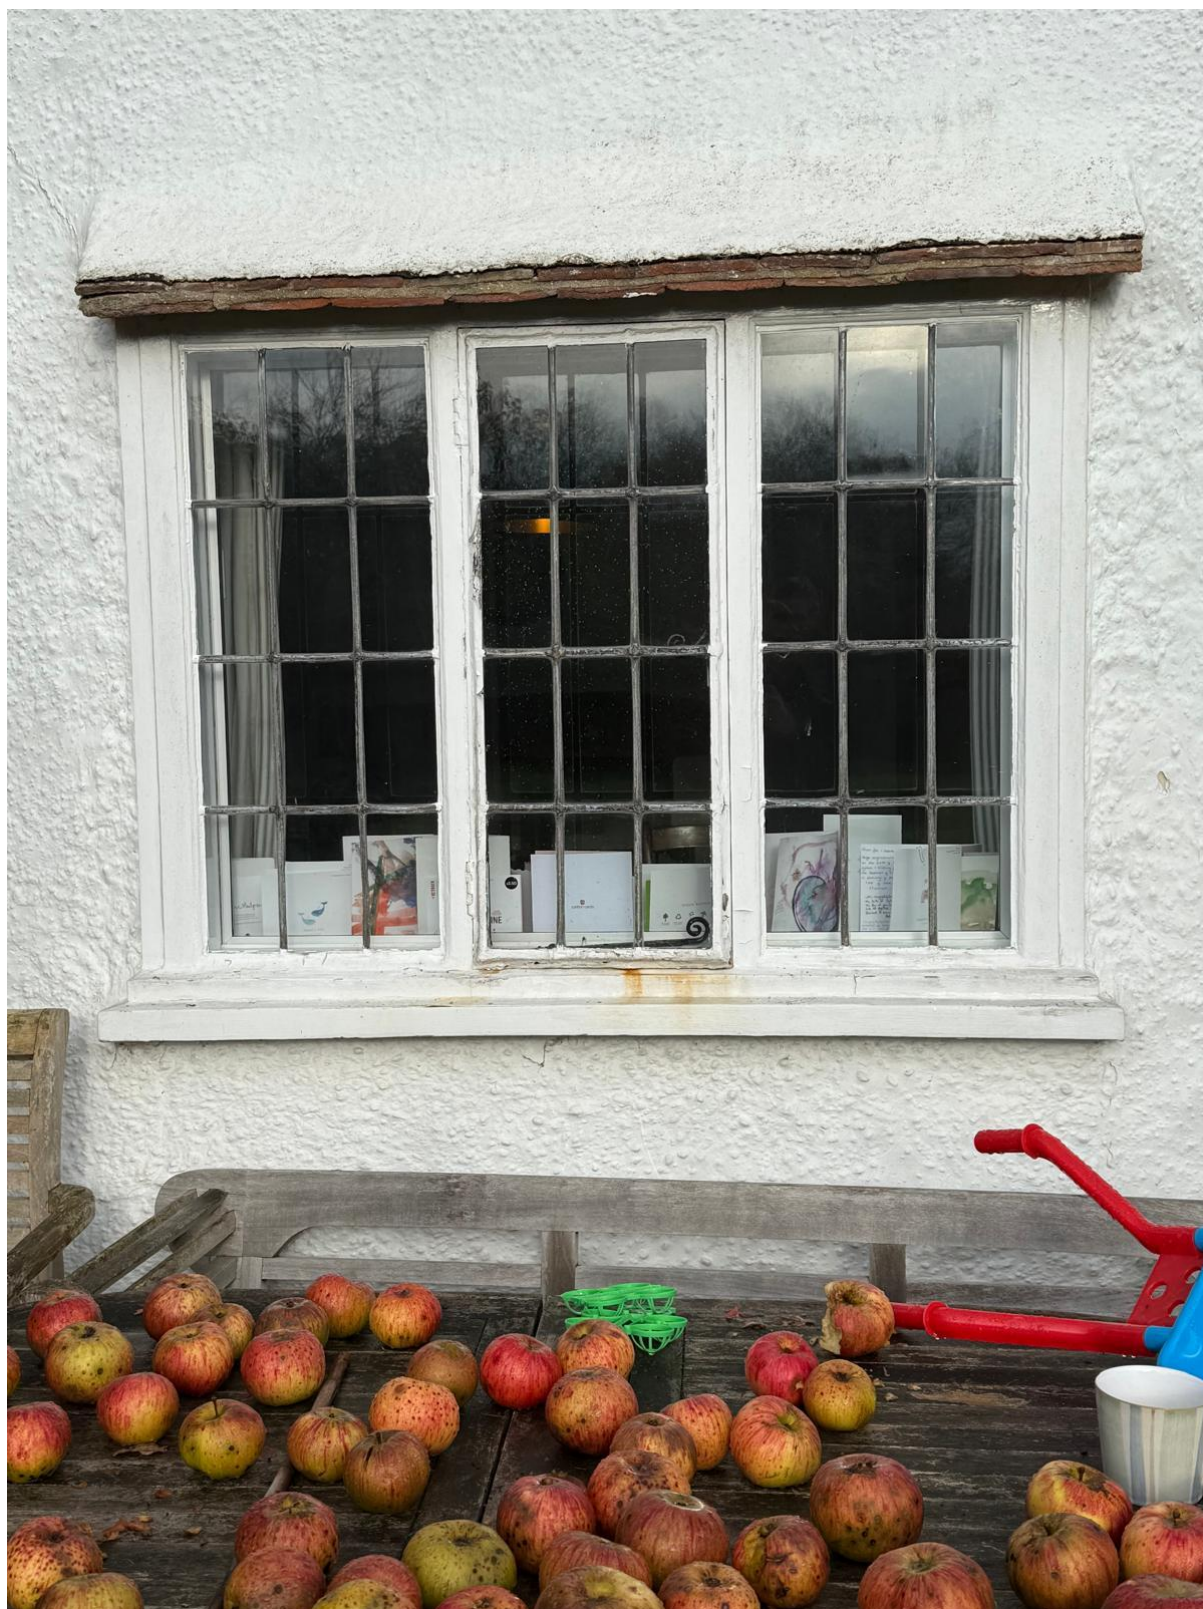
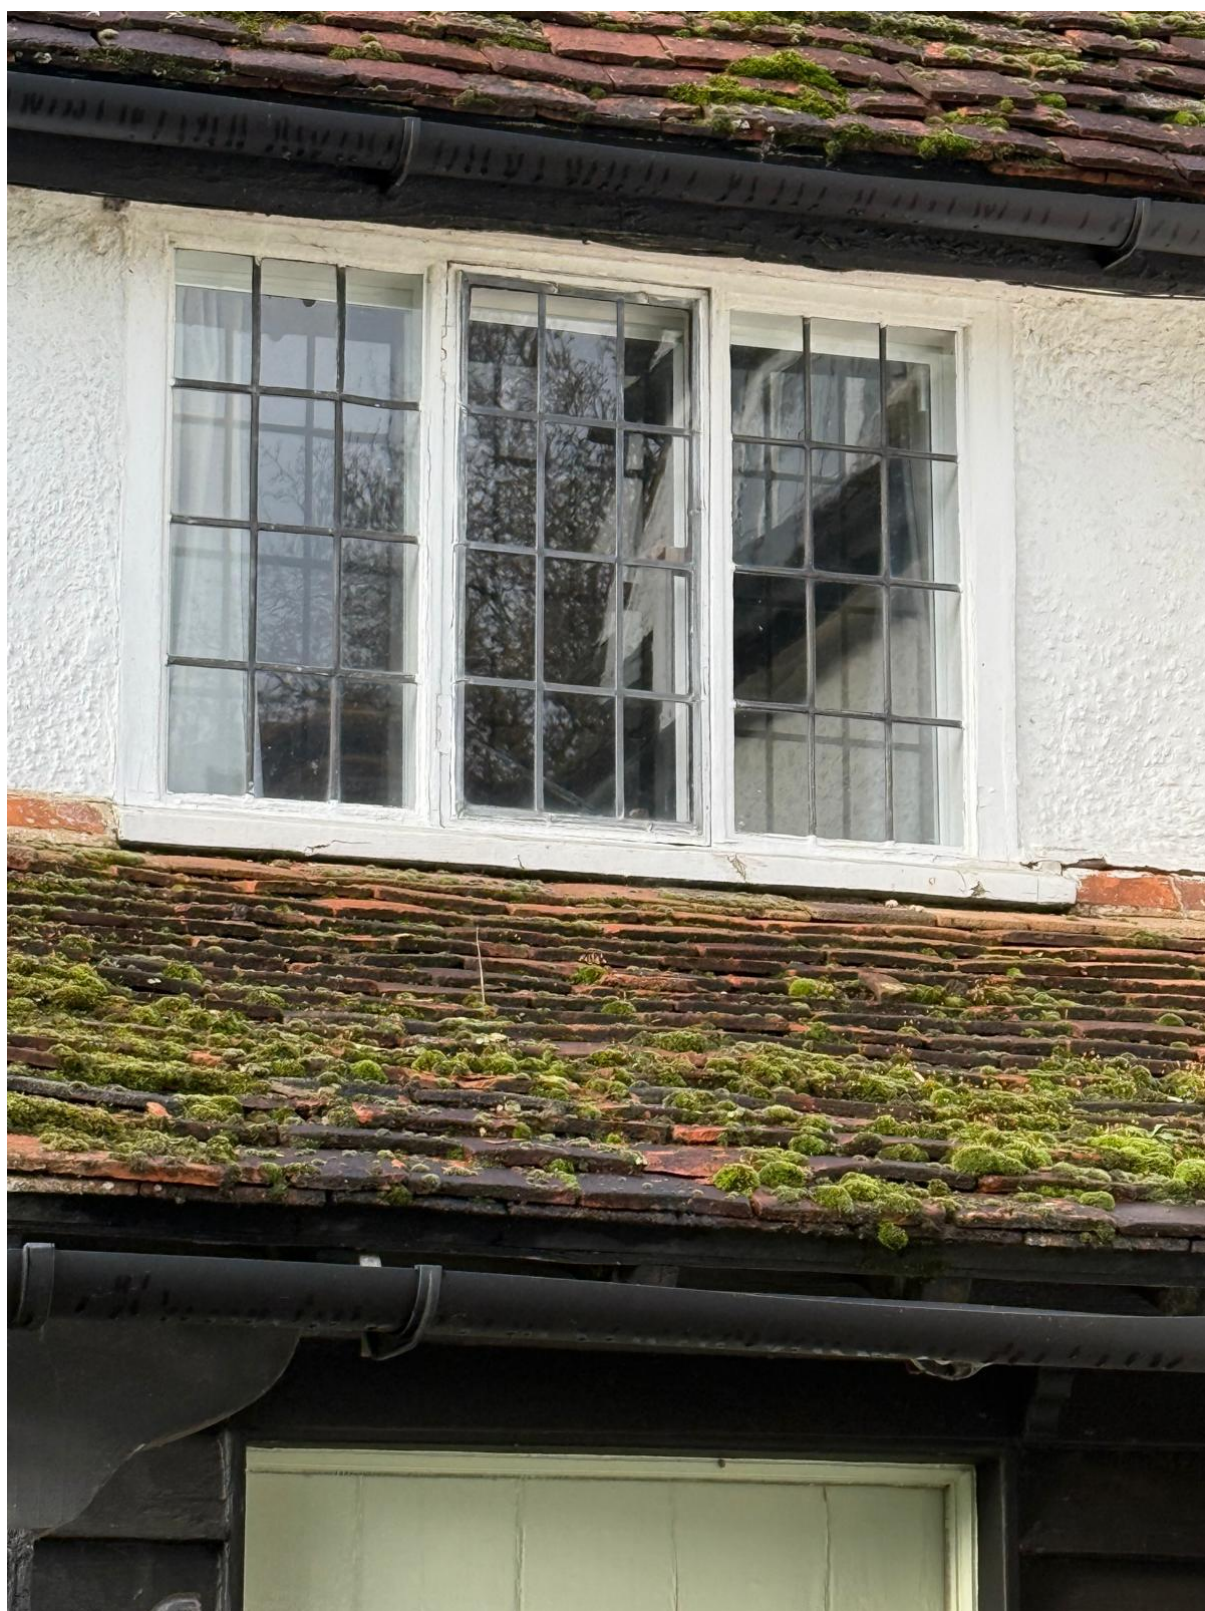
### 2.8.1. South Elevation

- a. A survey appears to show significant decay in the sole plate.
- b. Other timbers cannot be inspected until the concrete render has been removed.
- c. Weatherboard on the West Elevation is decayed and requires replacement

- a. The South Elevation is completely finished in a concrete render; the client wants to restore this to a permeable and breathable lime based finish.

- a. The South and West elevation both have several areas where the brick faces are significantly damaged or decayed.
- b. In addition, Concrete Mortar has been used for historic repairs.

| No | Step | Responsible Party | Supporting Notes |
|---|---|---|---|
| 1 | Strip Concrete Rendor | Cook & Sons | |
| 2 | Inspect Timbers | InGeni | Looking for rot and damage |
| 5 | Replace Damaged or decayed timbers | InGeni | Using appropriate methods shown in section 4, replace or repair oak timber with new green oak. |
| 6 | Build brick plinth to underside of sole plate | InGeni | Build the brick plinth in accordance with Structural Engineer scheme.<br><br>See Section 7 - Structural Engineering Scheme |
| 7 | Re-Point | InGeni | Carefully remove concrete mortar and repoint in traditional lime mortar mix using appropriate aggregate. |
| 9 | Apply new Lime Render System | Cook & Sons | Install 40mm Steico Protect Dry<br>Apply 8 – 10mm Best of Lime Warmcote with embedded mesh<br>Apply 6 – 8mm Best of Lime Limecote and Trowel finish<br>Decorate in two coats of Keim Soldalit (White Tie 2002) |
