**Supporting Information for Listed Building Consent  
Application  
Survey and Method Statement**

Doc ID: ING/YNG/LBC/002

Youngloves Farm, Southern Green, Hertfordshire, SG9 0SP

Date: 10<sup>th</sup> April 2025

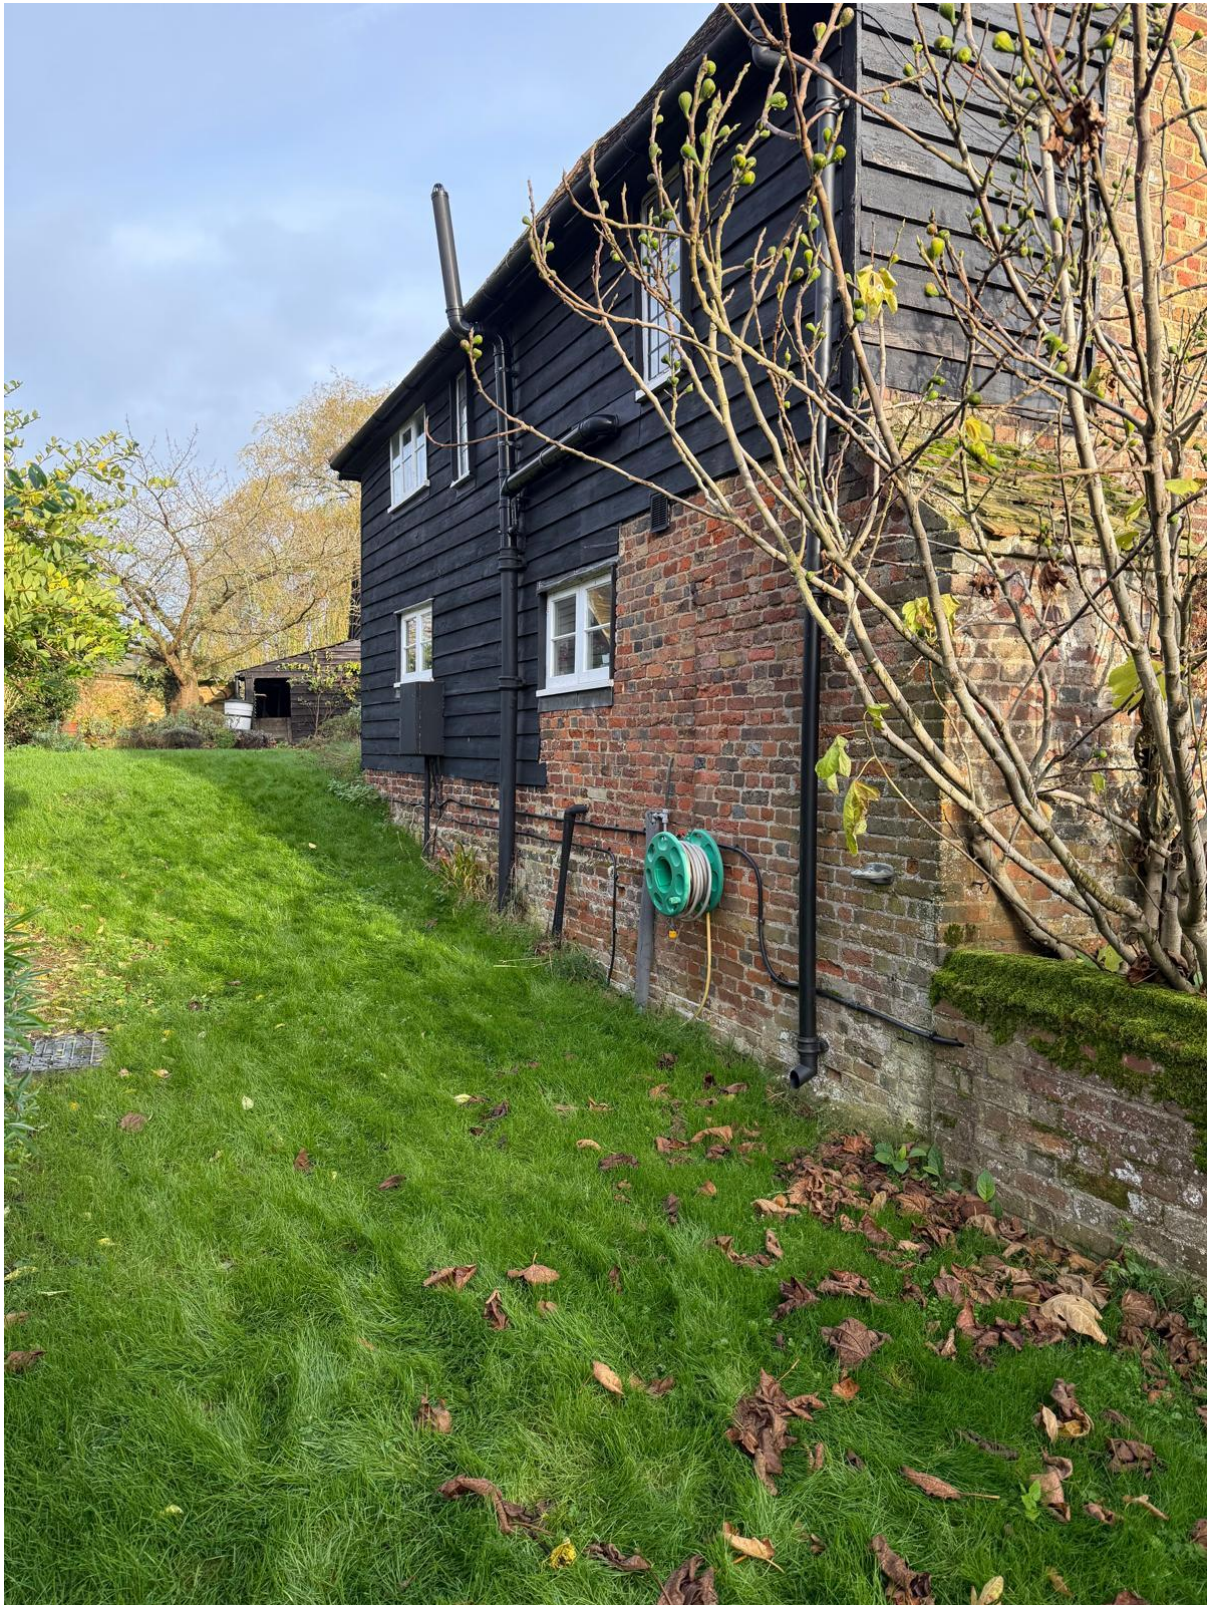
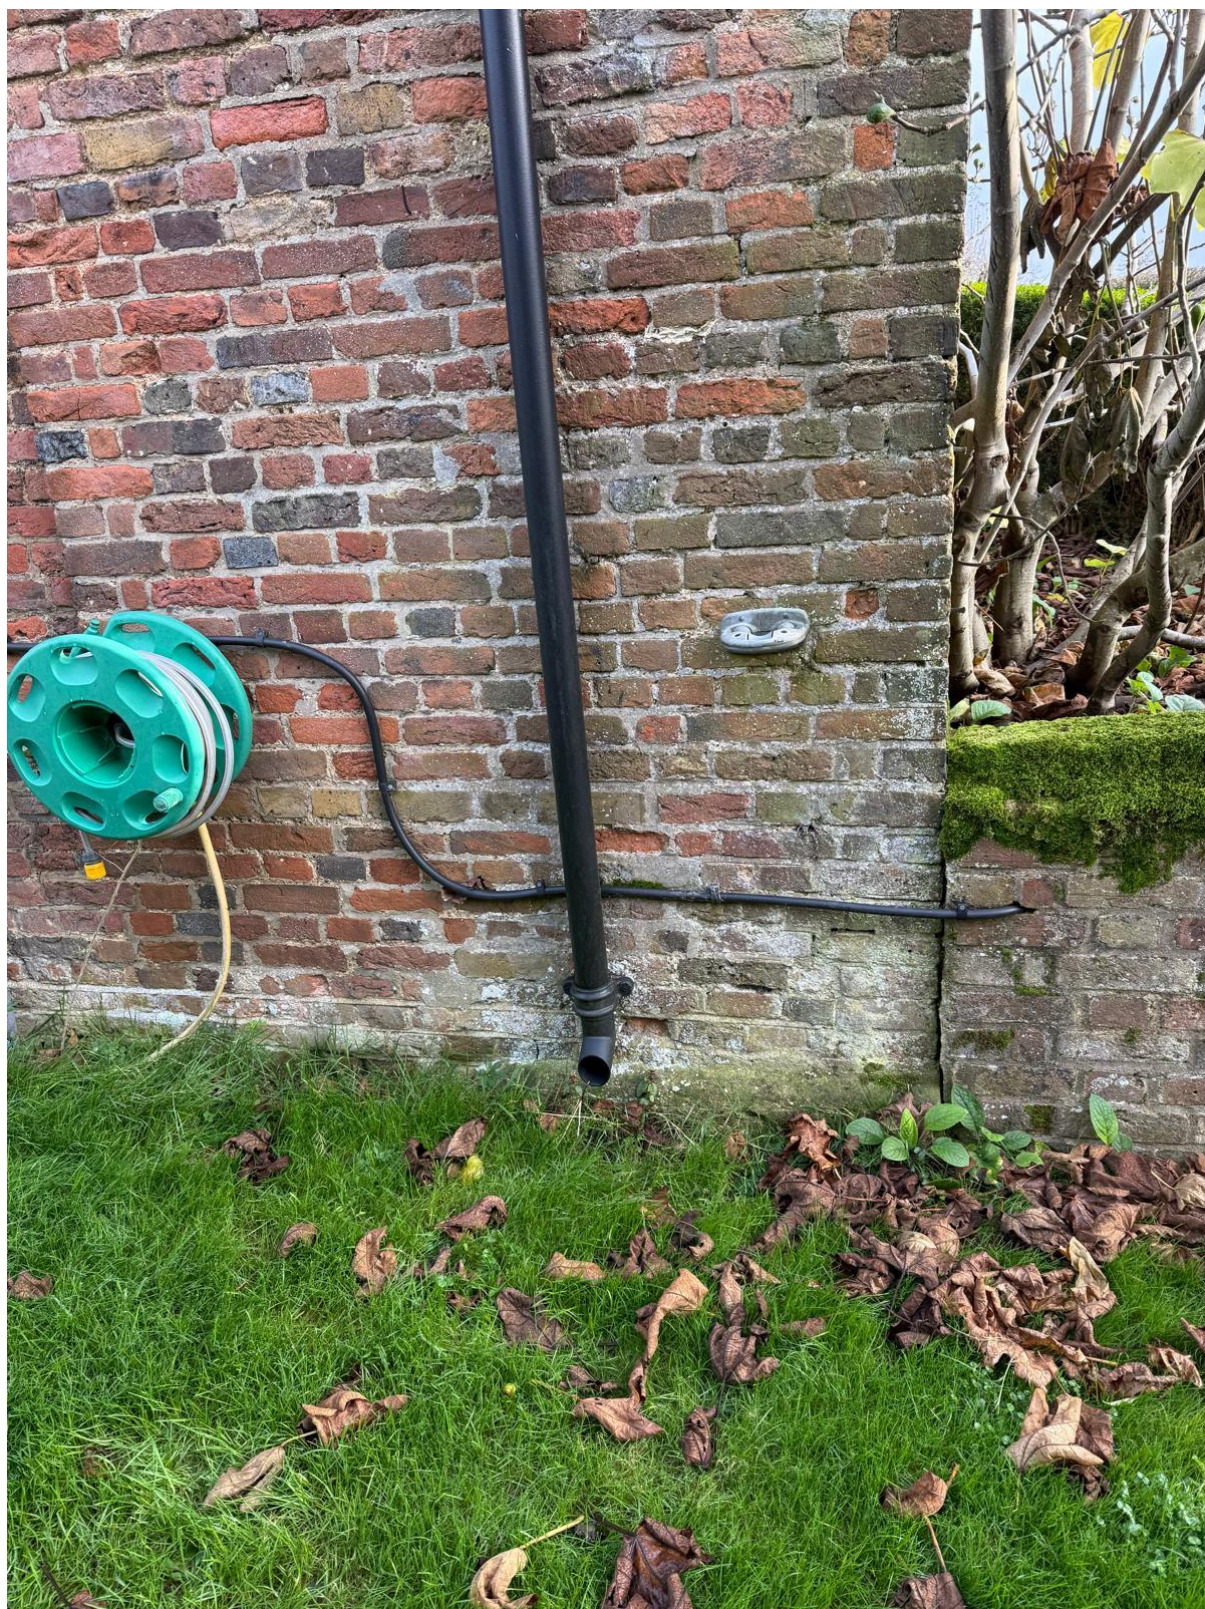
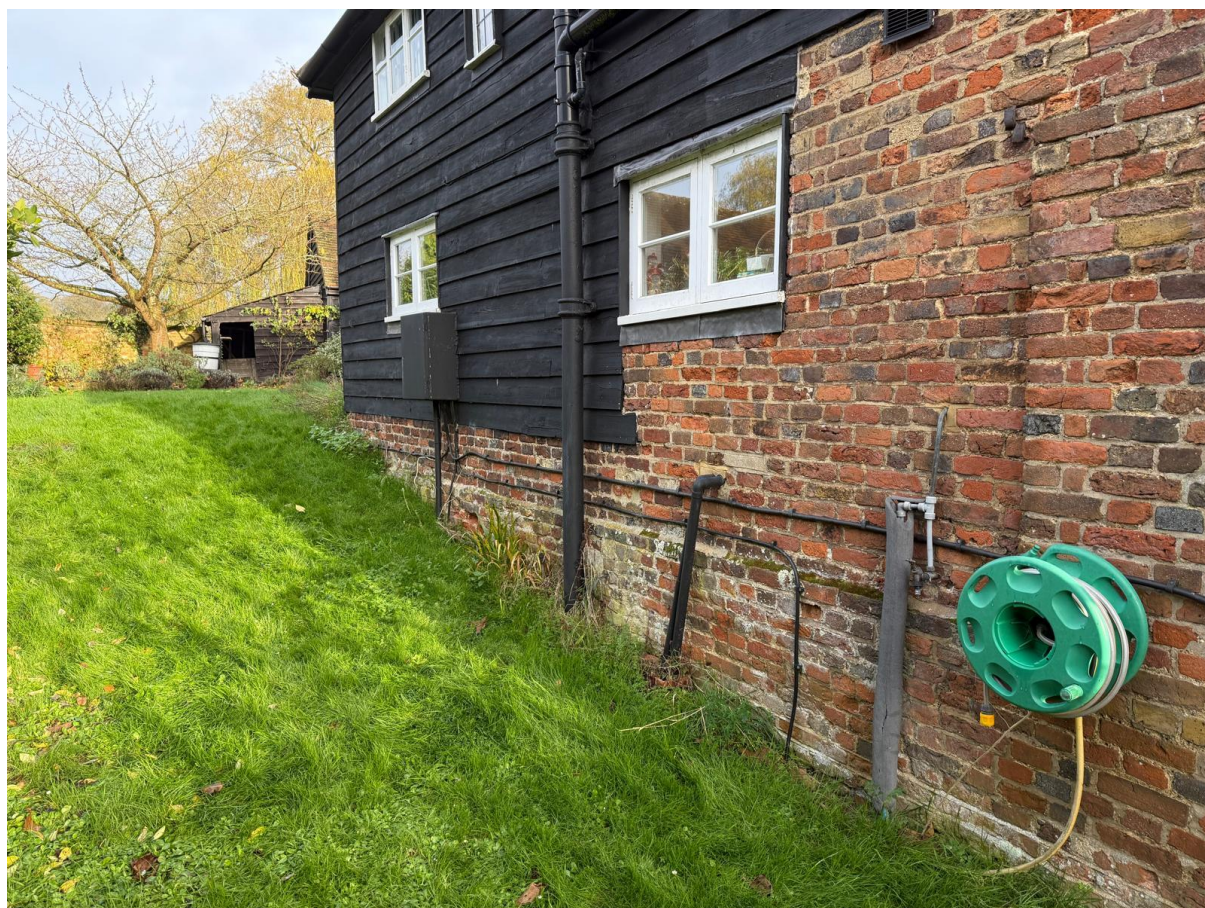
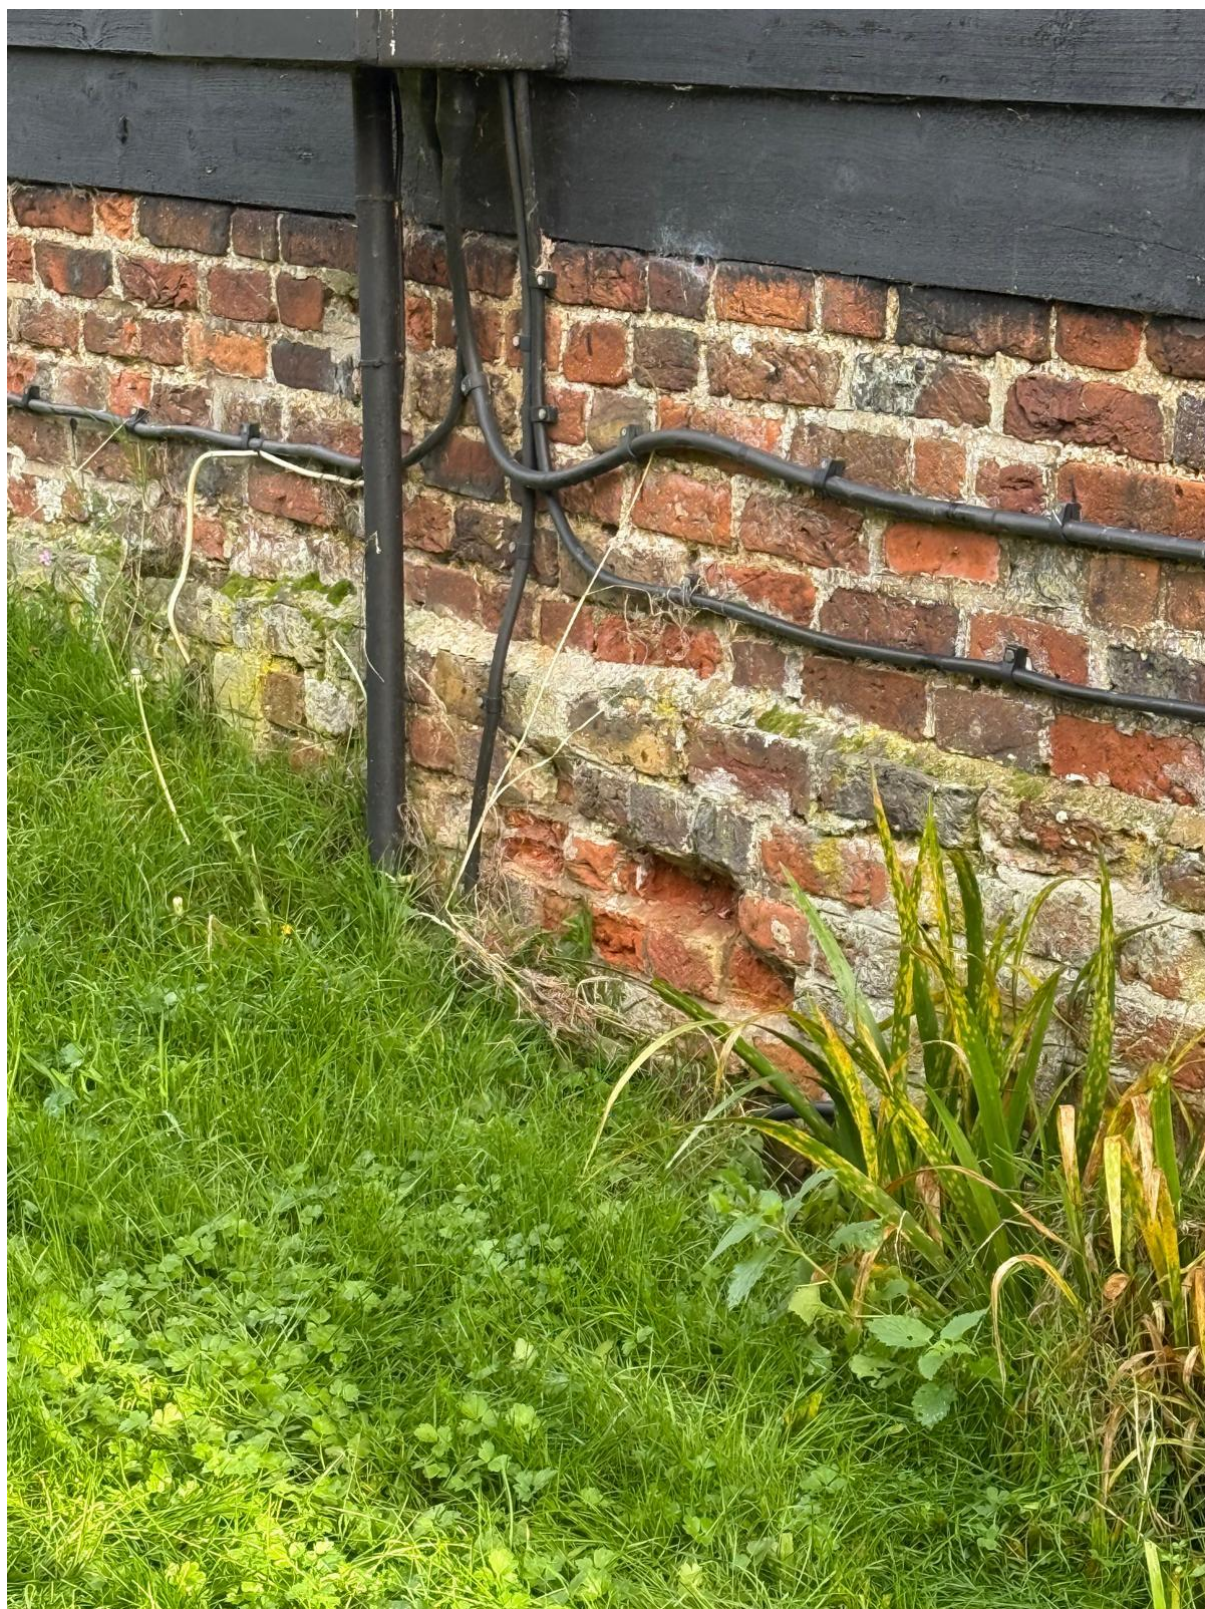
## 2.8.2. West Elevation

- a. A survey appears to show significant decay in the sole plate.
- b. Other timbers cannot be inspected until the concrete render has been removed.
- c. Weatherboard on the West Elevation is decayed and requires replacement

- a. Several Windows on both elevations are in need of repair, timber frame replacement and leaded light refurbishment.

- a. The South and West elevation both have several areas where the brick faces are significantly damaged or decayed.
- b. In addition, Concrete Mortar has been used for historic repairs.

| No | Step | Responsible Party | Supporting Notes |
|---|---|---|---|
| 3 | Replace Damaged or decayed timbers | InGeni | Using appropriate methods shown in section 4, replace or repair any timbers with new green oak. |
| 6 | Replace Weatherboard | InGeni | Replace using pre painted softwood and top coat with Bedec Black Barn Paint. |
| 7 | Inspect and Repair windows as required | InGeni | Timber repairs of frame and if required leaded lights. |
