# Conservation Repair Methodology Statement

Grade II Listed Ice House at Land off Waterdell Lane, St Ippolyts,  
Hertfordshire

**794-PLN-HER-02331**

## Structural Inspection Report

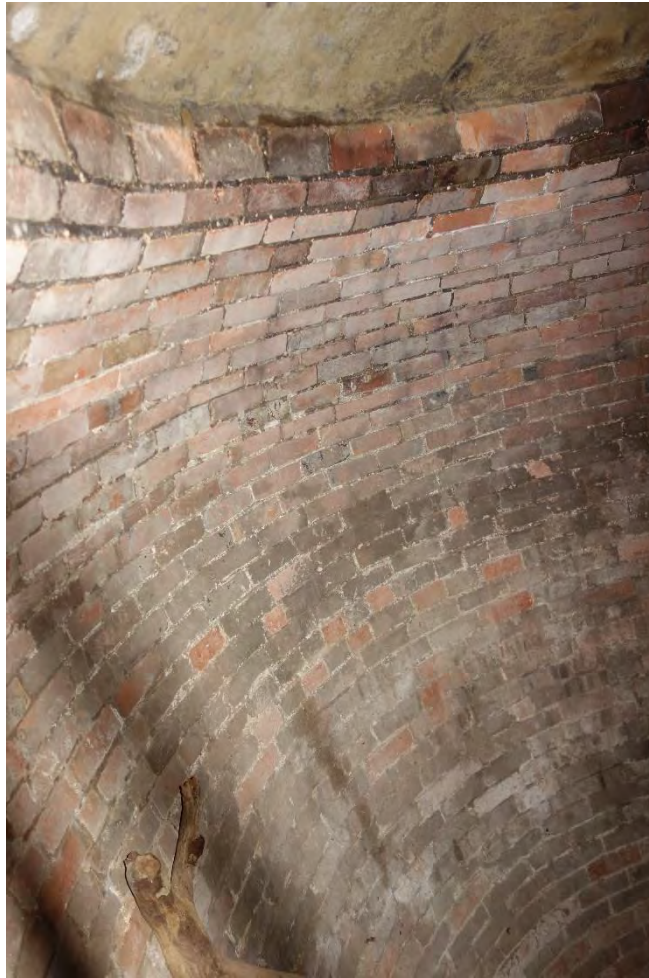
- 3.2.1 This larger structure comprises a tapering brickwork shaft with a maximum width of around 3.4 metres. A layer of debris is present at the base which prevents definitive confirmation of the overall depth/height, however it is in excess of 5 metres from the apex of the roof dome to the debris level. The walls return inwards to form a shallow dome. The inner part of the dome has render finish at the soffit (Photographs 7 & 8).

**Photograph 7: General view of the chamber showing inward taper at lower level with the dome brickwork returning inwards.**

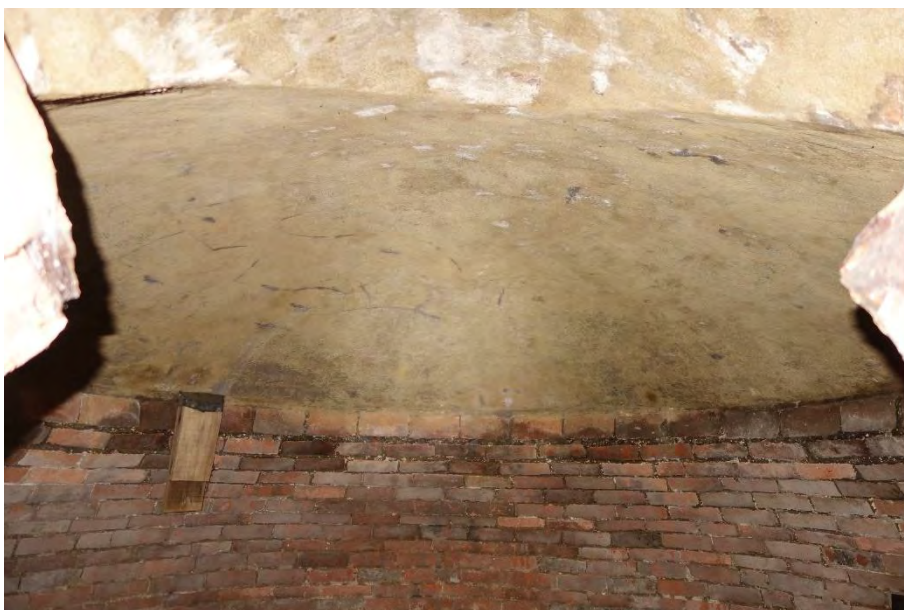
**Photograph 8: General view of the dome**
