**Structural Inspection at  
The Old Manor,  
Shaftenhoe End**

**Structural  
Engineers**  
Cambridge Ltd

**Project 24-722 for  
Mr & Mrs Noblet**

**Roof Inspection, June 2025: Bedroom 51-12**

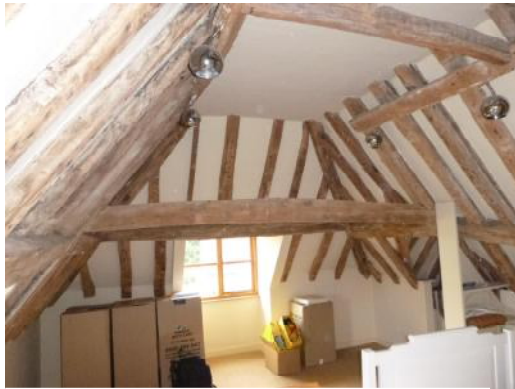
East attic bedroom, looking east

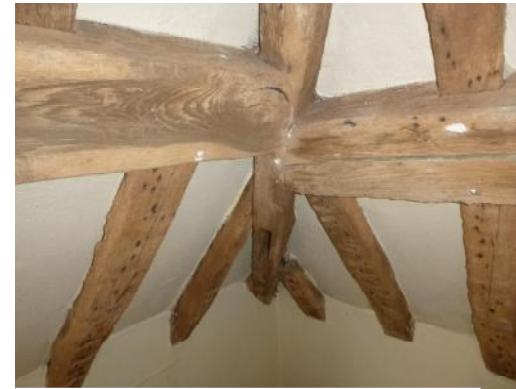
Empty mortise on hip beam (17)

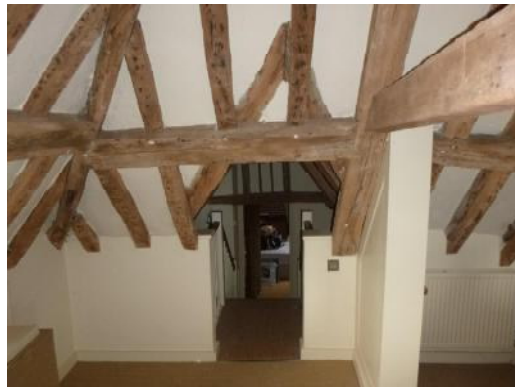
Looking into stairwell to SE wing (18)

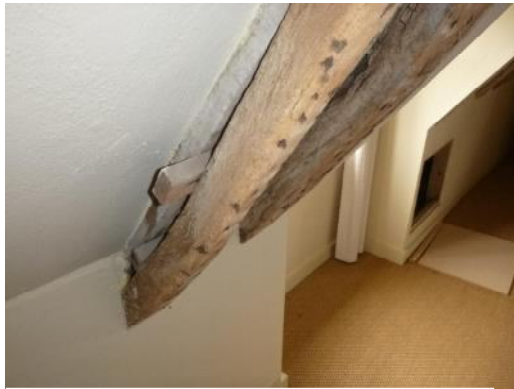
Sagging rafters packed out (13)

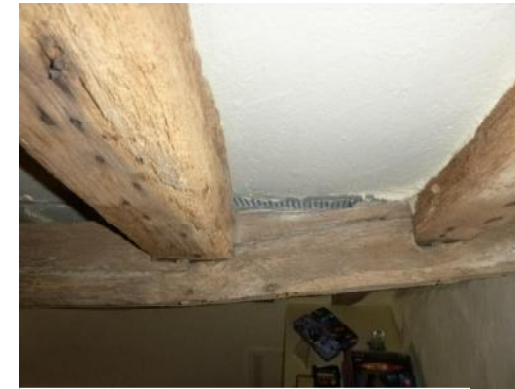
Gap between purlin and ceiling, judged historic with no sign of recent movement (13)

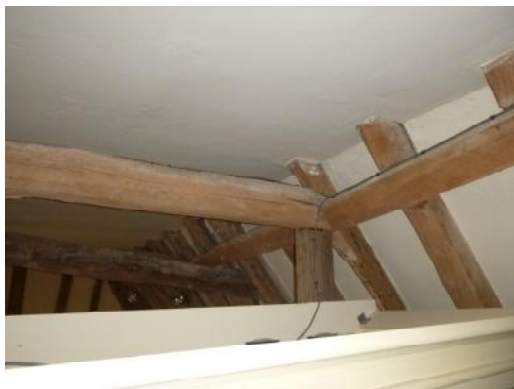
Framing above wardrobe/ partition (11)

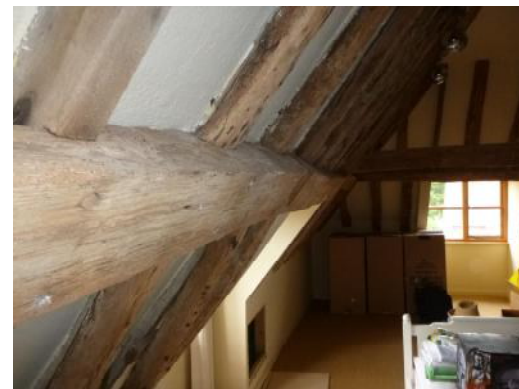
View along front (south) purlin (13)

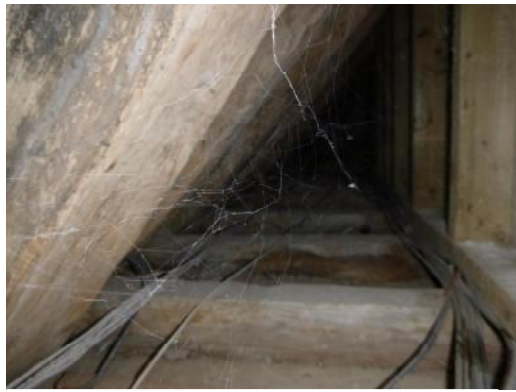
Front eaves, showing eaves wall (non-structural) supported on attic floor joists

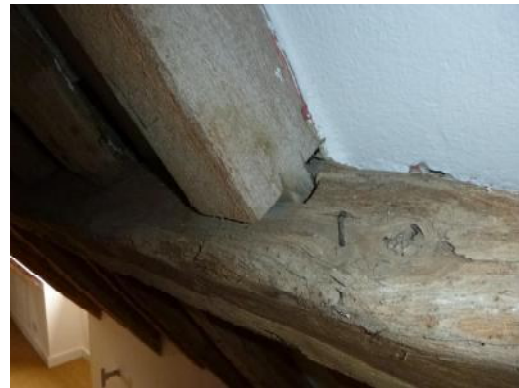
Rafters tenoned into purlin, with wrought iron repair strap below - historic (5)

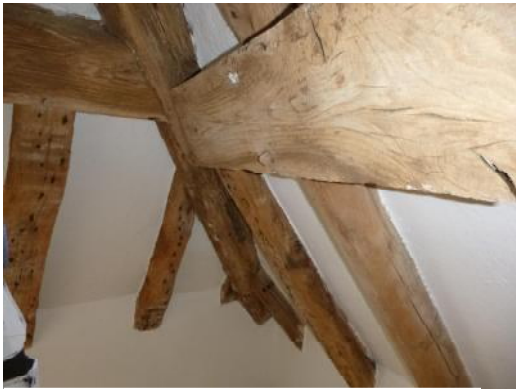
Empty mortises suggest previous alterations to roof (1)

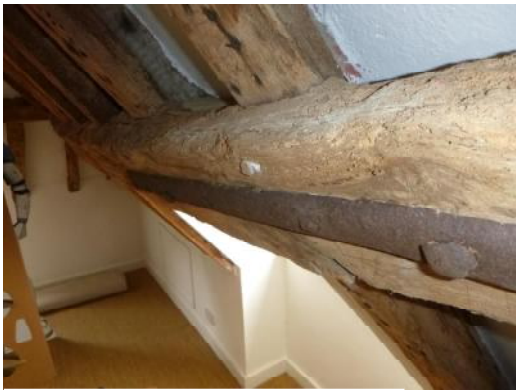
Wrought iron repair strap to front purlin (5)

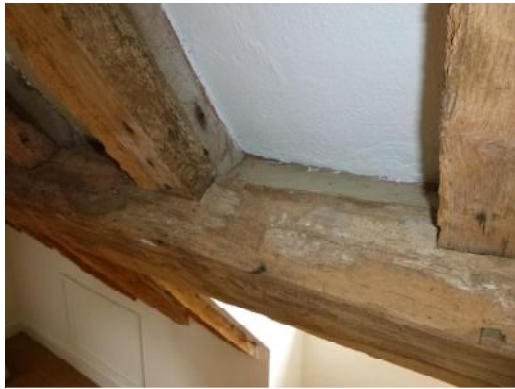
50mm gap between purlin and ceiling - no sign of recent movement (7)

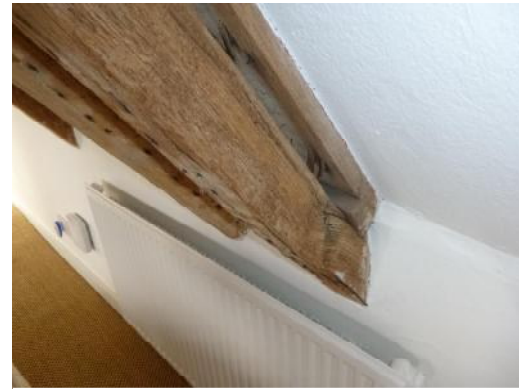
Gap between rafters and ceiling, with packing (7)

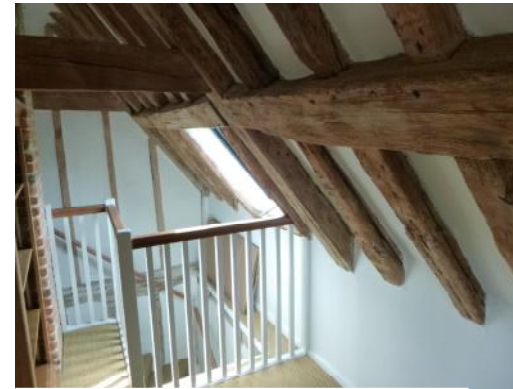
View towards stairwell, with collar above (4)

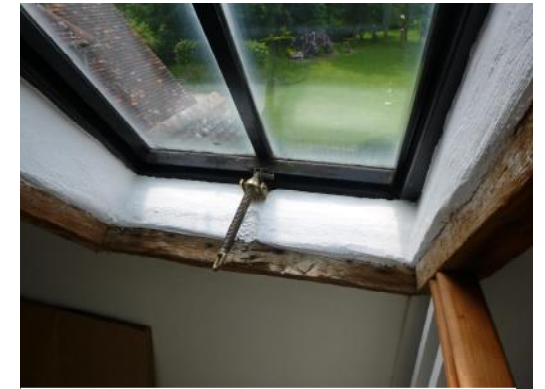
Roof window, with some signs of condensation

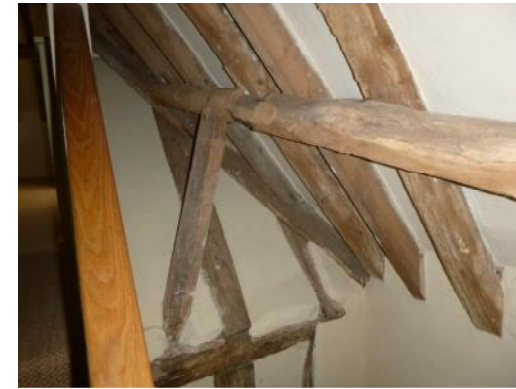
East purlin to link roof, propped from south wall of main house (19)

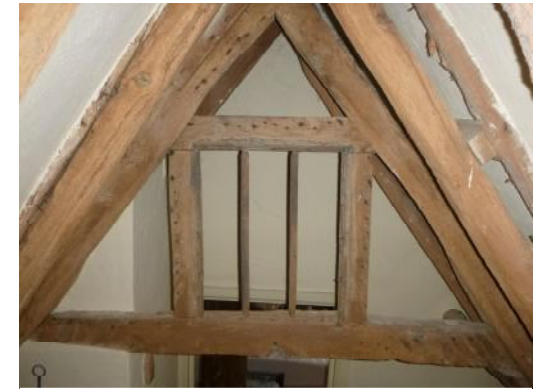
Historic gable framing and window of SE wing left in place above stairwell (20)

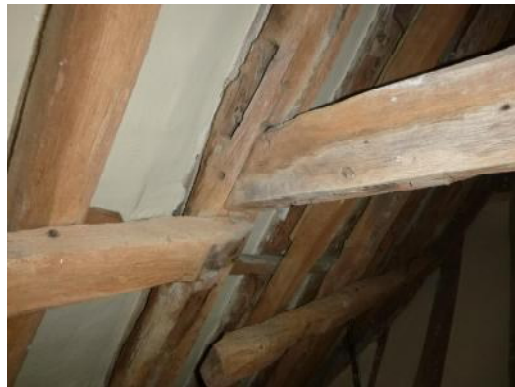
Gable frame with empty mortise and detached purlin (22)

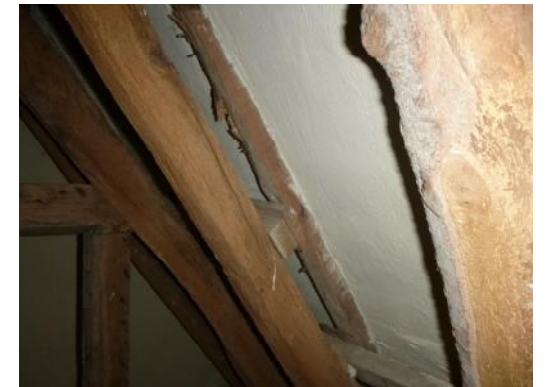
Sagging rafters packed out to restore roof profile - judged historic

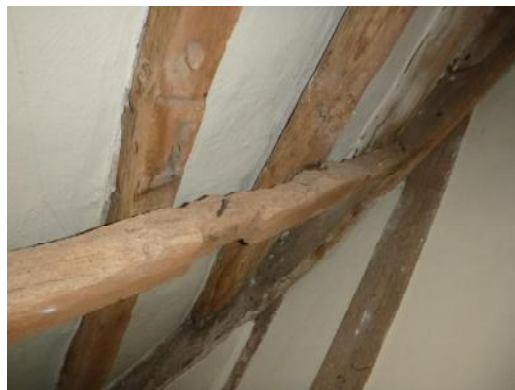
Inward sag of purlin (22)

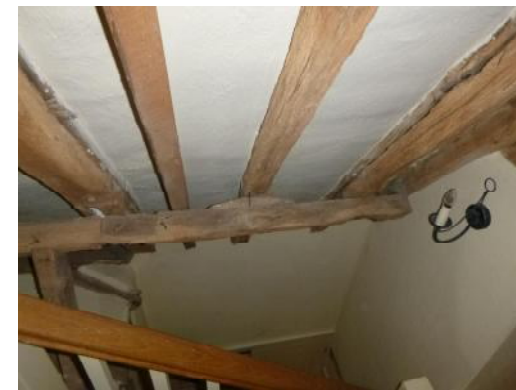
Unsupported end of east purlin, which cantilevers towards wall of SE wing. Supported by strut from house wall (19)

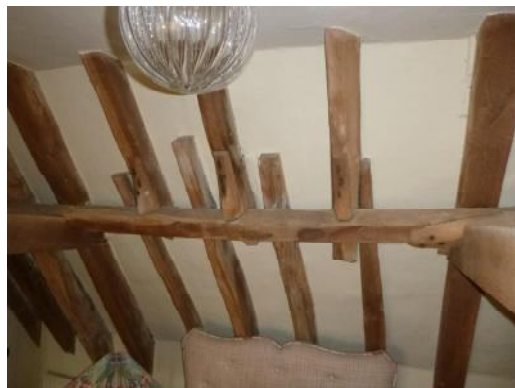
Purlin with rafters jointed over, suggesting position of former dormer

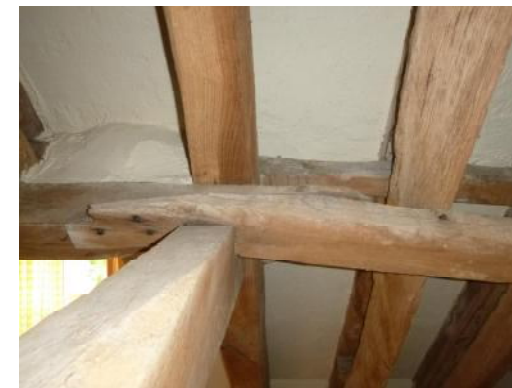
Collar in bedroom, with scarf joint in supported purlin

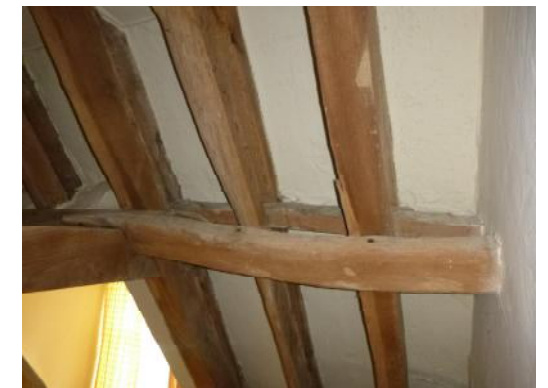
Historic distortion of purlin adjacent to collar and dormer

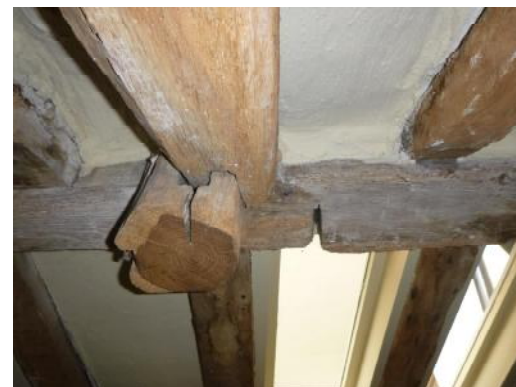
Stub of rail from former gable, severed when stairwell link was constructed

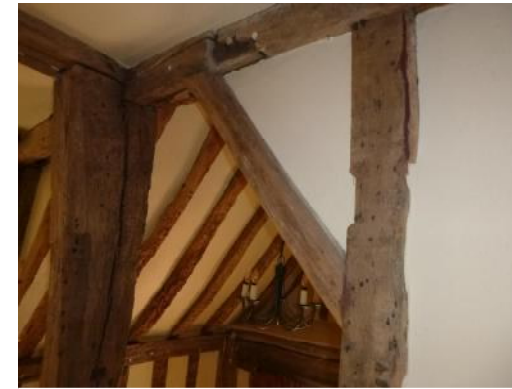
Framing to stairwell (4)

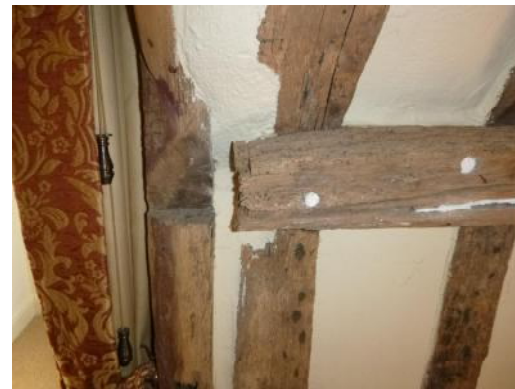
Detail of eaves rail - no intervention required (5)

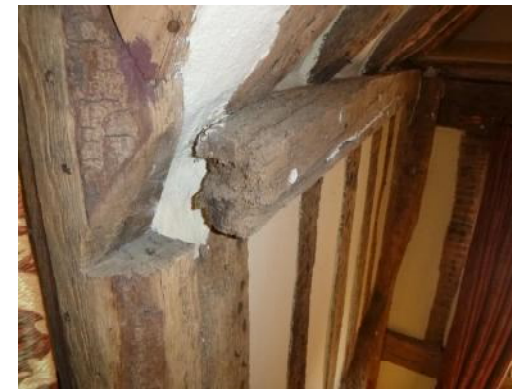
Detail of eaves rail - no sign of recent movement (5)

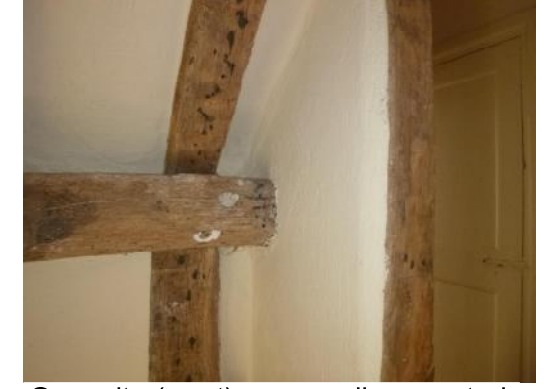
Opposite (west) eaves rail supported at stud in landing wall

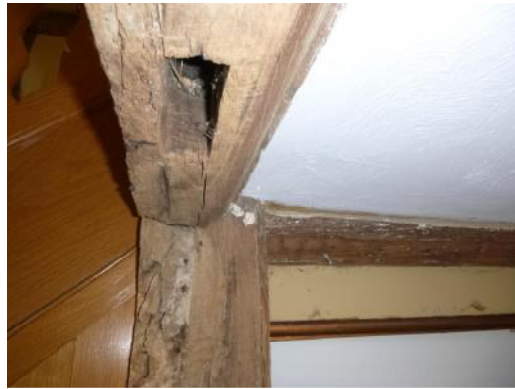
Empty mortise in headrail (4)

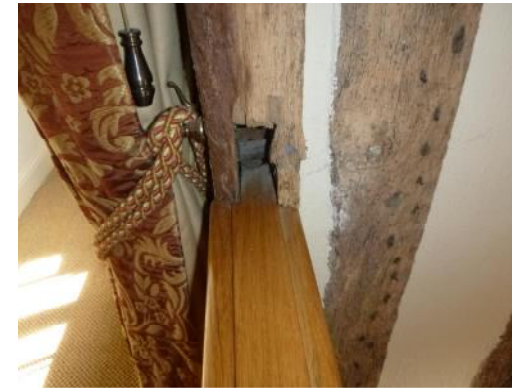
Handrail fitted into empty mortise

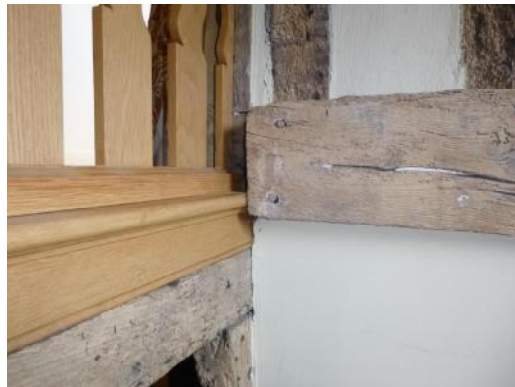
Side rail of stairwell tower meets landing at slightly higher level

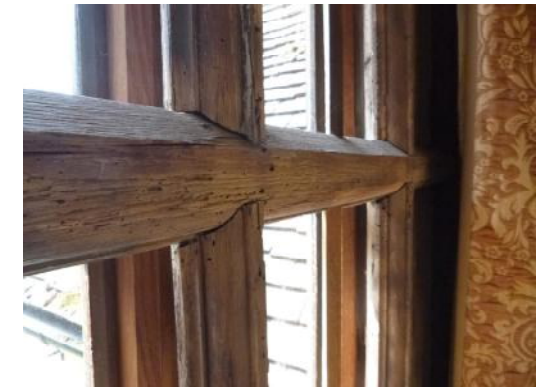
Transom of older window to west of stairwell

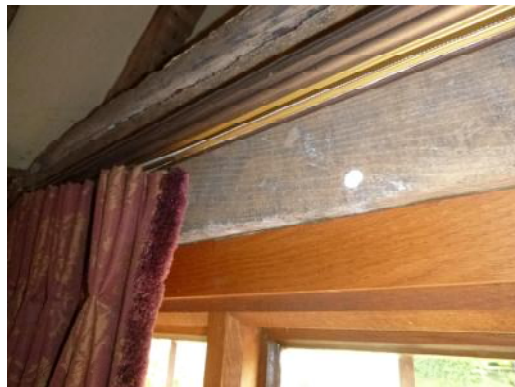
Head of replacement window to east of stairwell

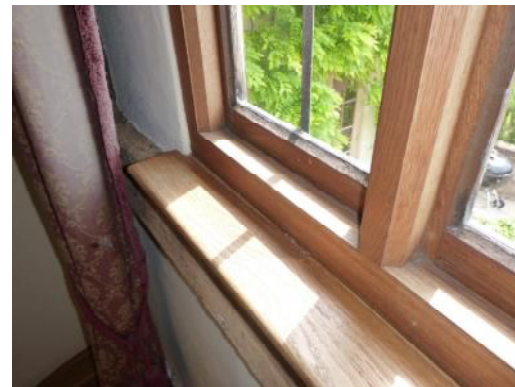
Replacement window to east of stairwell

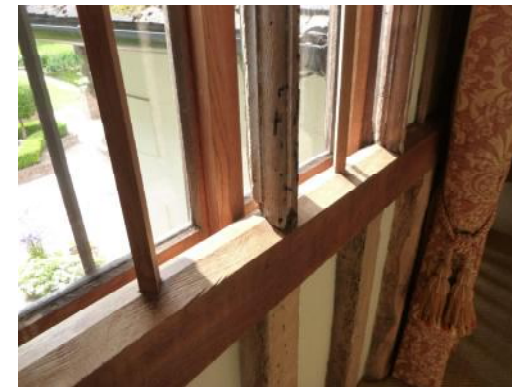
Repaired sill of older window to west of stairwell

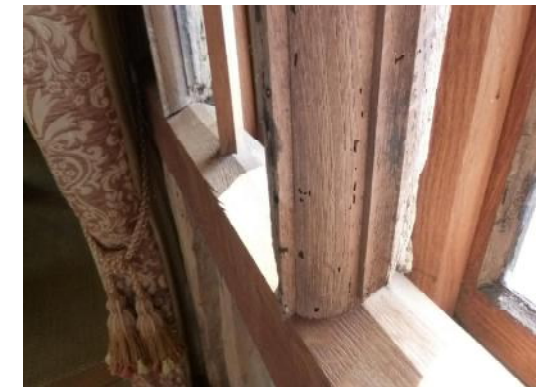
Repaired sill of older window to west of stairwell

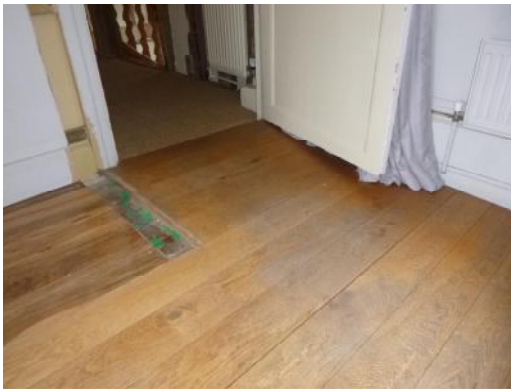
Entrance to bedroom - floor slopes away from here (2)

- 1) Previous repair - no intervention required.
- 2) See architect's specification. No removal of historic fabric involved.
- 3) Judged historic - no intervention required
- 4) Suggests Bressummer was a later introduction, and/or the chimney piece has been rebuilt.
- 5) Repair is structurally ineffective. Consider improvement.
- 6) Previous repair - no intervention required.
- 7) Repair detail required.
- 8) Refer timber specialist report.
- 9) Refer SE Cambridge file 18-042
- 10) Judged historic - structurally inadequate but not suffering movement at present. Monitor.
- 11) Requires Conservation Officer opinion on removal of modern fabric.

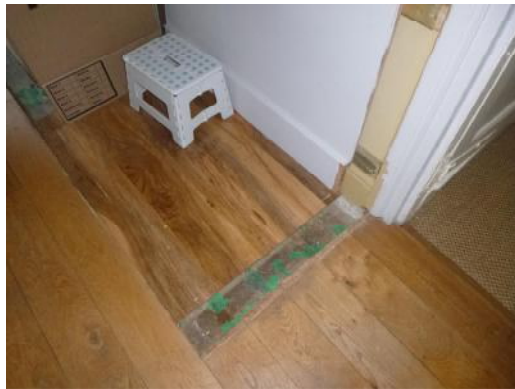
Repaired floor in first-floor bedroom

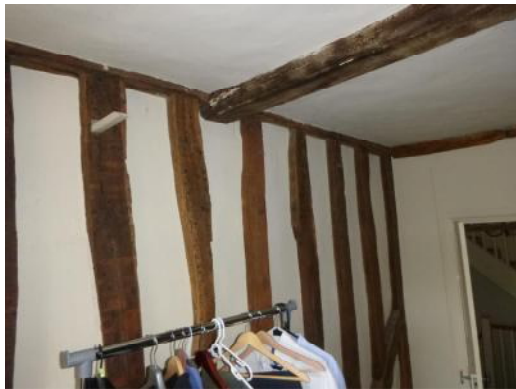
Spine beam over bedroom, meets wall not in line with studs. Considered OK, relying on tenon joint to head rail.

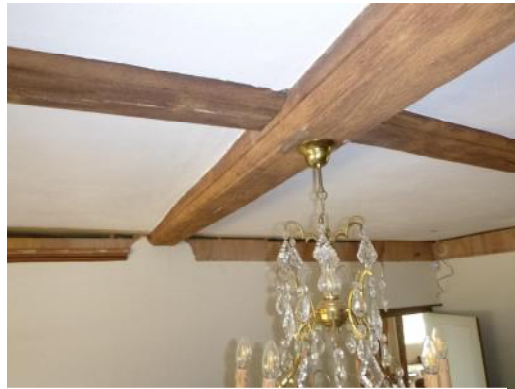
Beams at first floor level - no problems reported

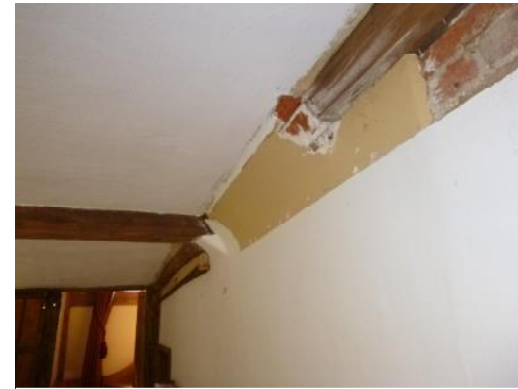
Repair at chimney end - possible related to removal of hearth at first floor level

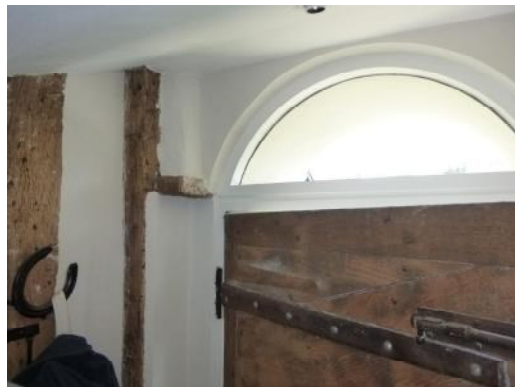
Arched fanlight above front door, with timber header cut out to make way

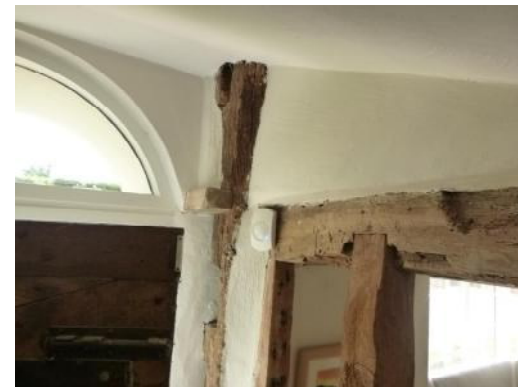
Timber header cut out at door head

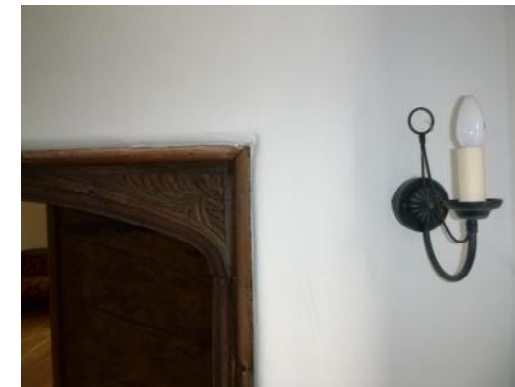
Gothic head of internal doorway, possibly relocated

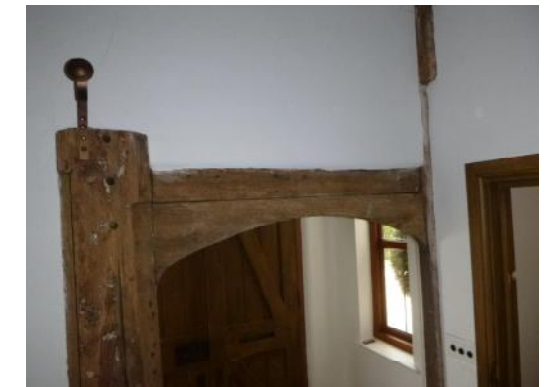
Truncated post used as jamb of internal doorway, possibly relocated

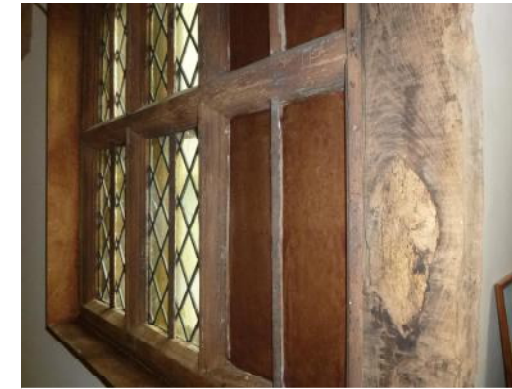
Window boarded up

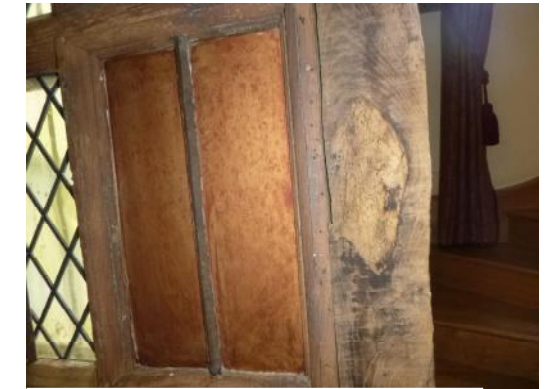
Rear window boarded up

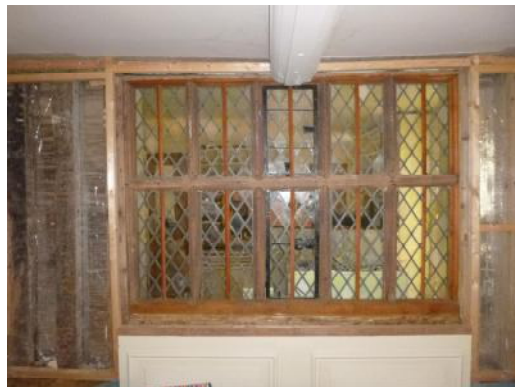
Window in west wall, with spine beam bearing on window head

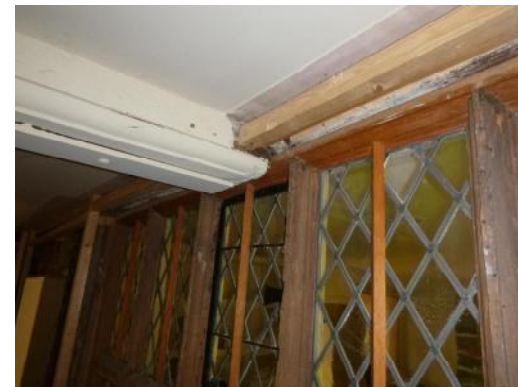
Spine beam bearing on window head is structurally illogical, but not unique

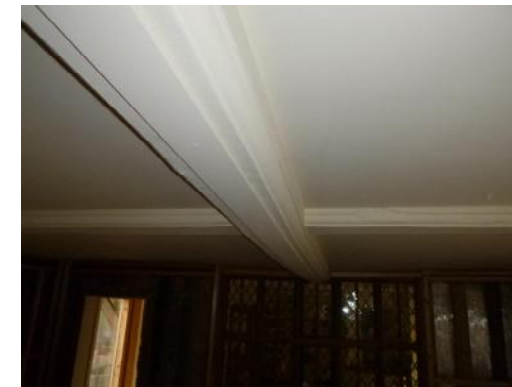
Beam at living room ceiling sags in line with sloping and sagging floor above (5)

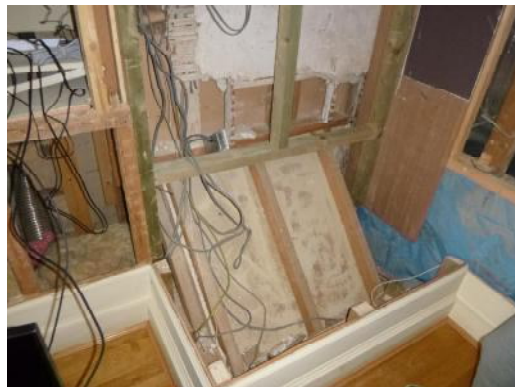
Framing of stairwell down to cellar. (The cellar was not inspected.)

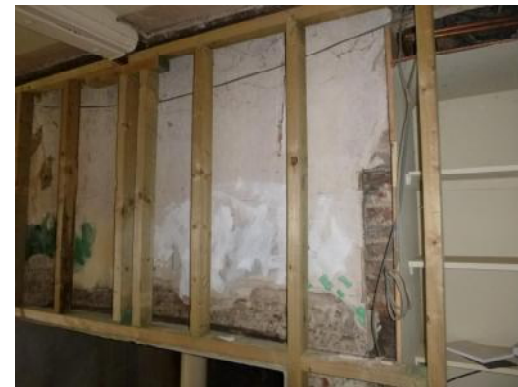
Modern softwood battens covering older fabric

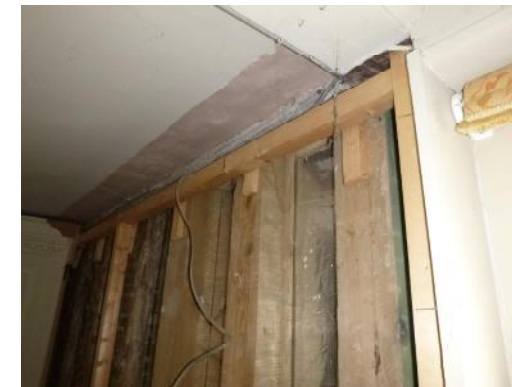
Replacement wall studs covered by modern softwood battens (2)

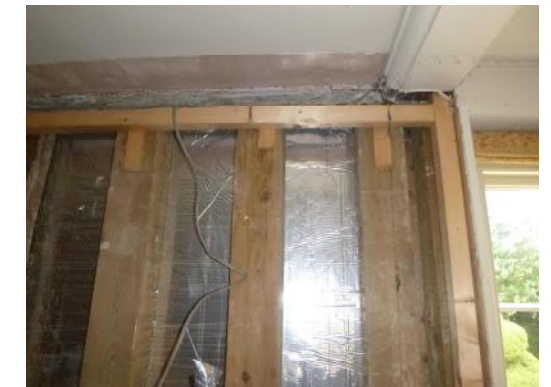
Replacement studs with foil-faced insulation and lined with softwood battens (2)

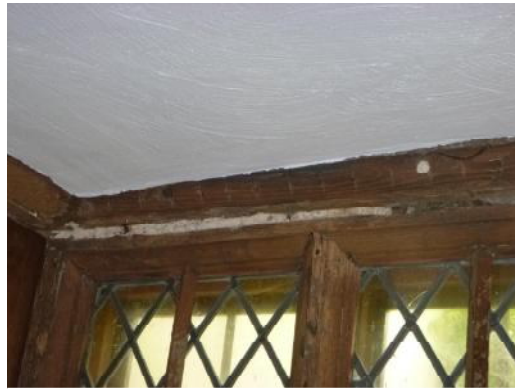
Mortar filler to gap above window head

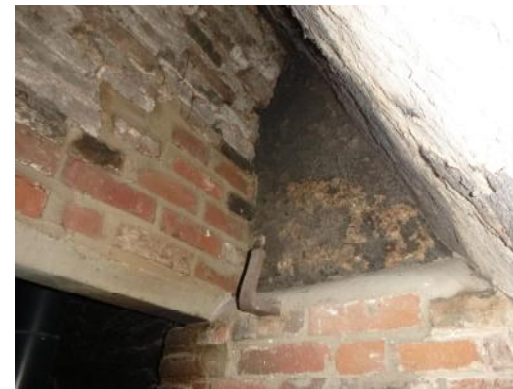
View from inside fireplace, showing concrete lintel supporting withy

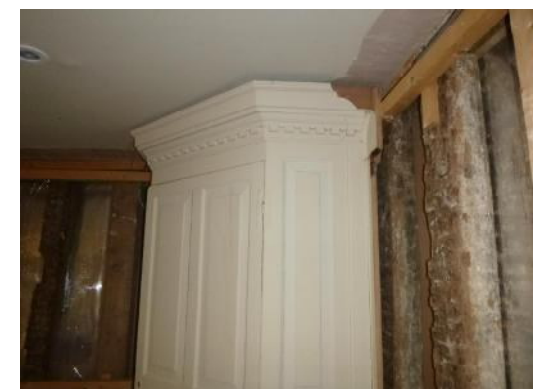
Cupboard in corner has been relocated and is mounted on an OSB backing

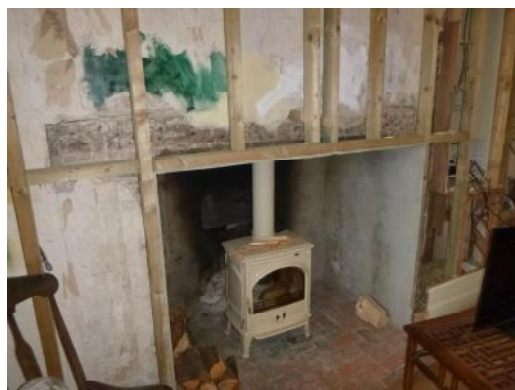
Chimney faced with softwood battens, with stove in fireplace

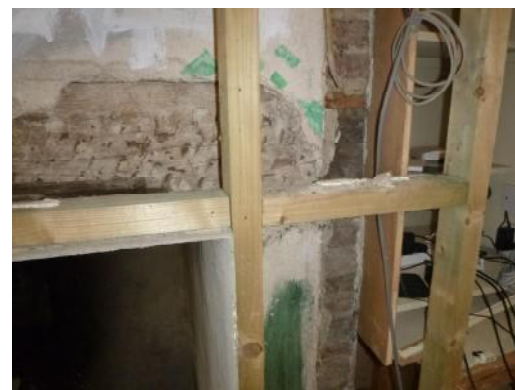
Softwood battens concealing adze-hewn bressumer

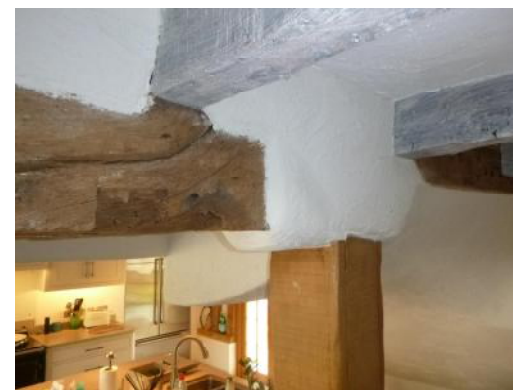
Support post and beam in kitchen (9)

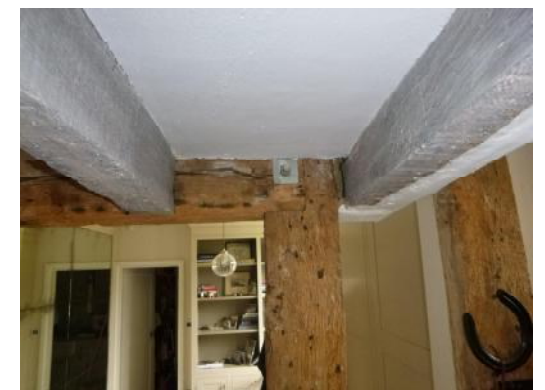
Stud-framed wall in east lobby near kitchen (9)
