# SHIRE TREES LIMITED

## TREE HEALTH & SAFETY SURVEY & ARBORICULTURAL REPORT

Site at:  
Barley C of E First School  
Church End  
Barley  
Royston  
Hertfordshire  
SG8 8JW

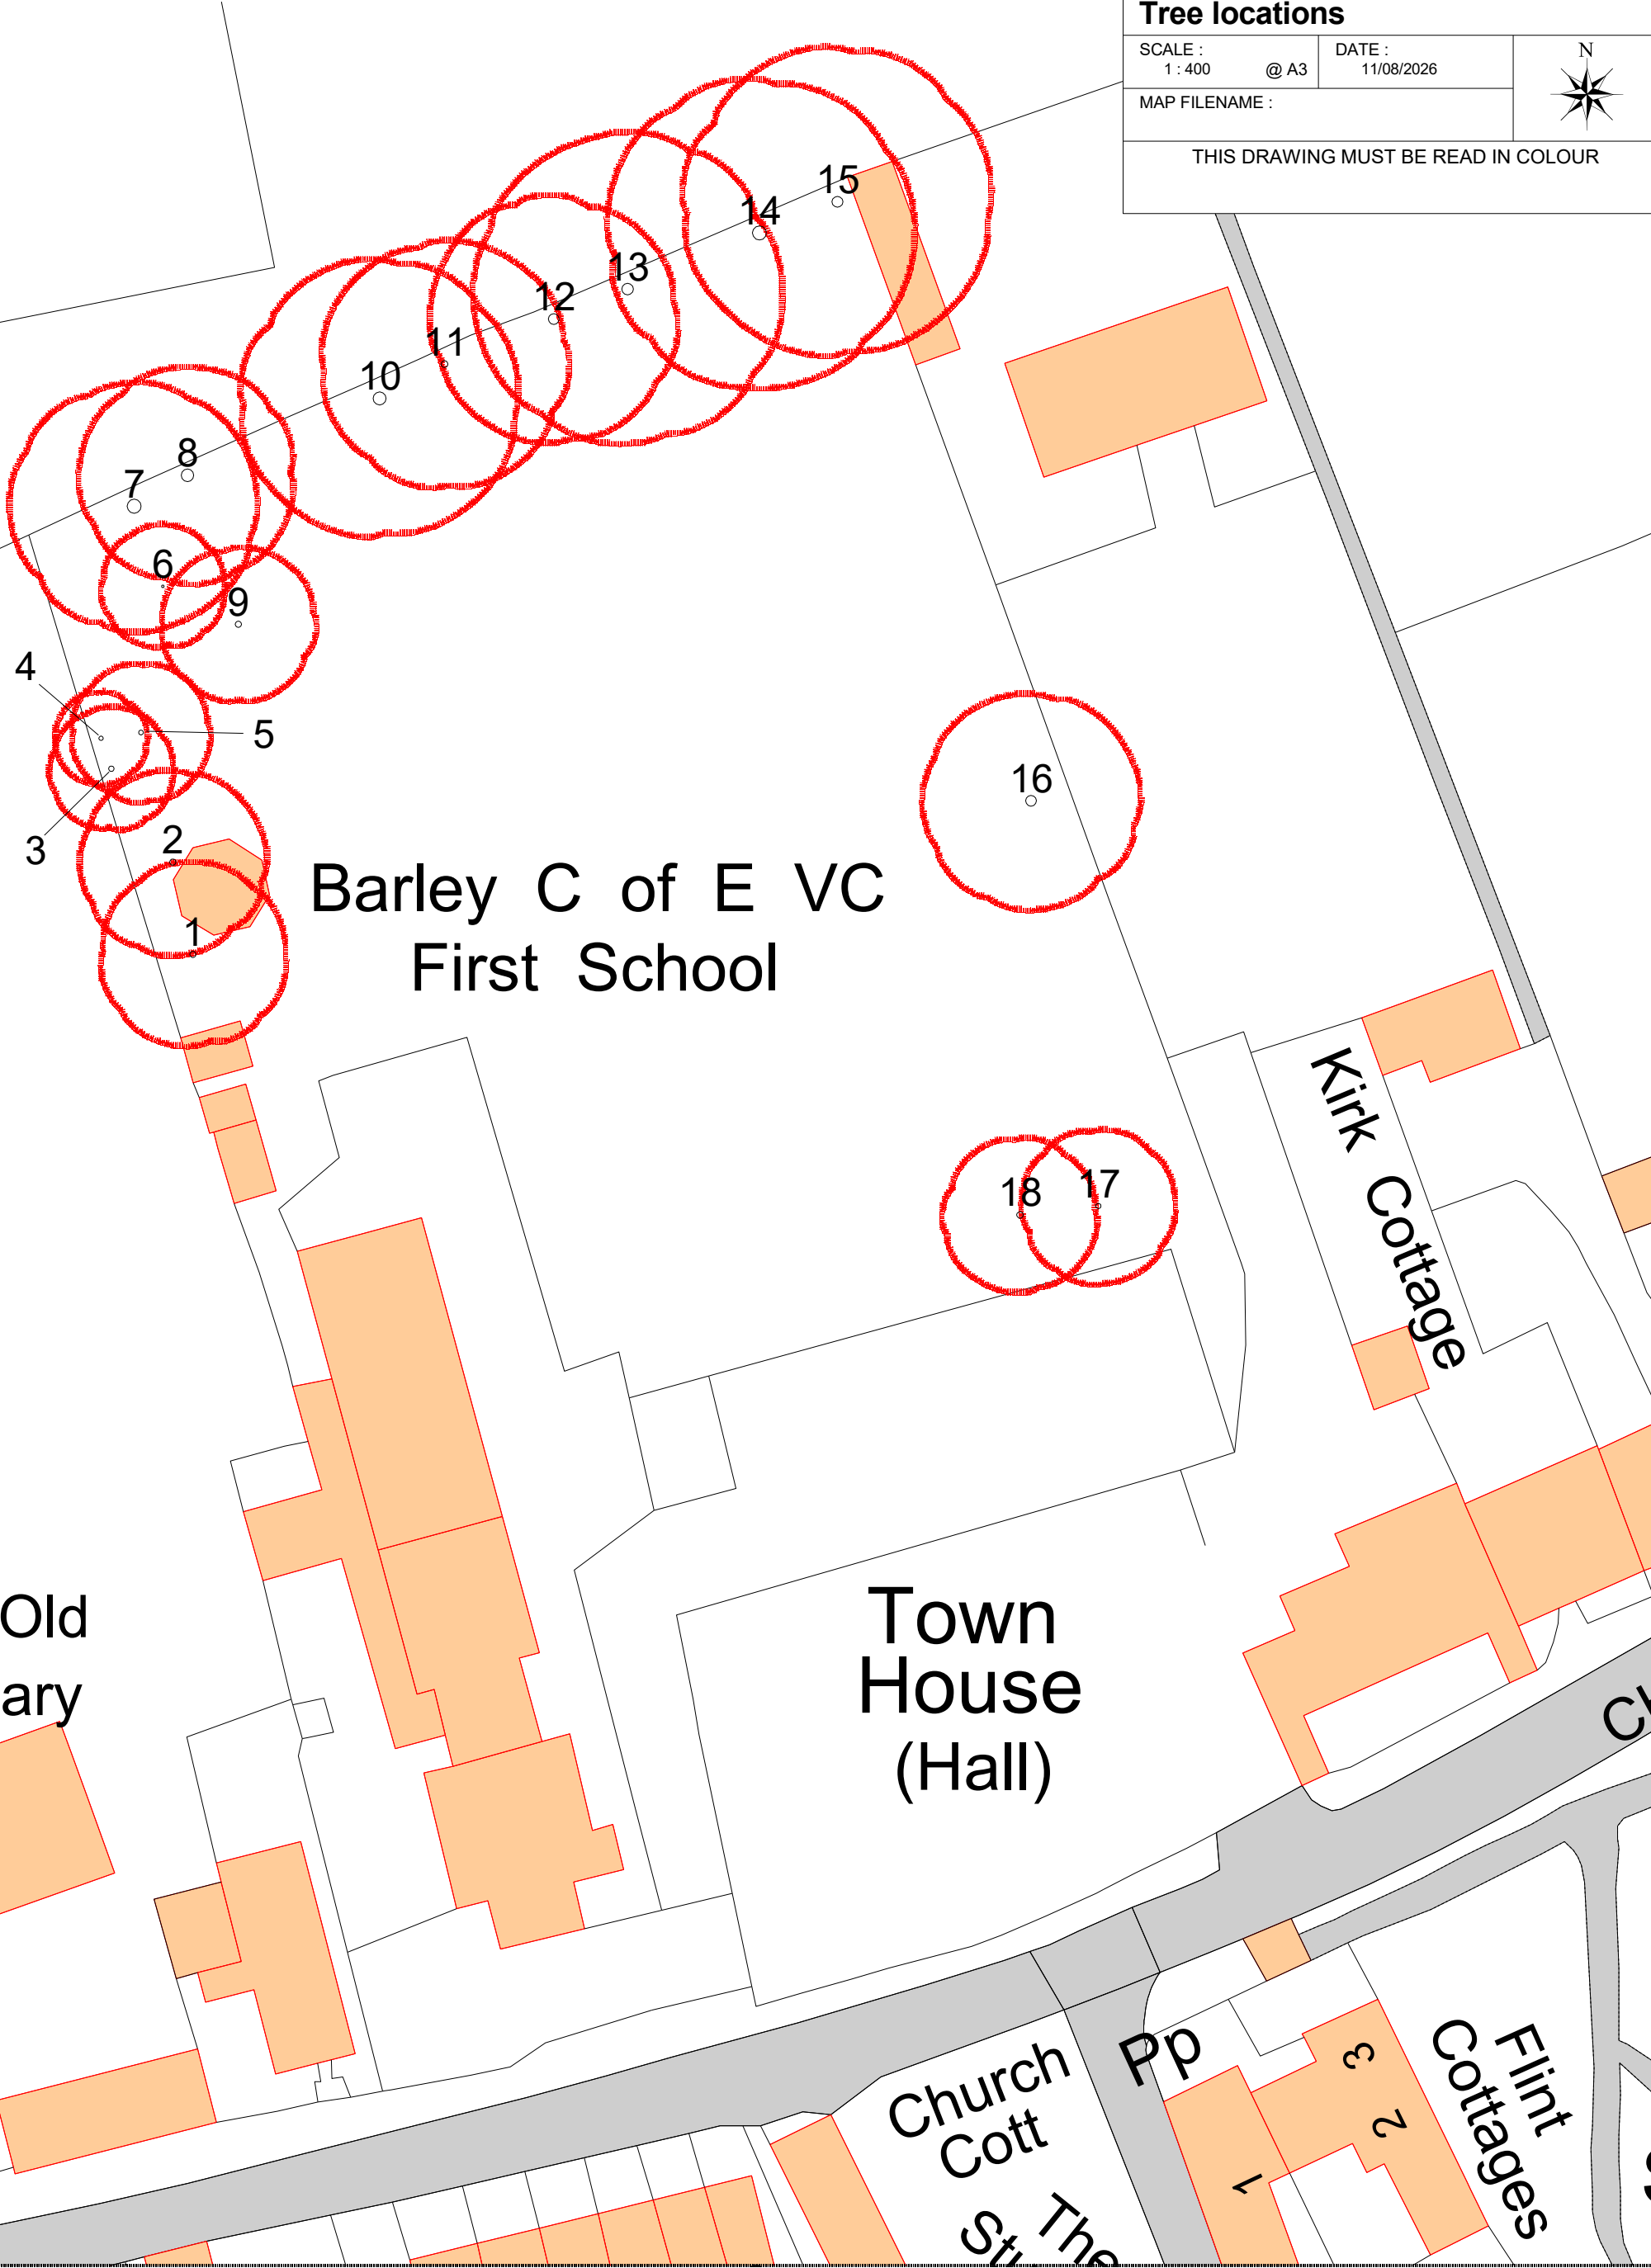
Barley First School  
Tree locations

- 3.1 18 trees were recorded. 5 trees require attention. Out of these, 3 trees require removal. The tree survey schedule provides the specifications.
- 3.2 **URGENT** felling (or otherwise making safe) is required for Norway Maple trees 10 and 11. This work must be completed within 6 weeks of the date of the tree survey. These trees are in such a condition that they may shed very substantial parts at any time.

- 3.3 Tree 1 (Norway Maple) has numerous structural defects in the form of three bark included unions that on Maple especially are prone to spontaneous failure.

- 3.6 It is recommended that the remaining trees be professionally reinspected within 2 years of the date of this report (no later than August 2028).
