This report has been prepared for our client in accordance with the terms and conditions of our appointment for 3-5 Bucklersbury, Hitchin. Mason Navarro Pledge Ltd cannot accept any responsibility for any use of or reliance on the contents of this report by any third party.

## 1.0 Introduction

### 3-5 Bucklersbury, Hitchin

Langham Mansions Properties Ltd

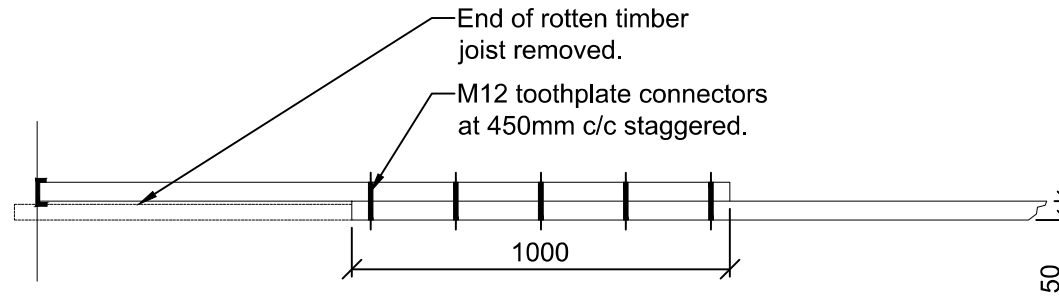
## Joist End Splice Repair Detail - Plan

| | A | B | C | D | E | F | G | H |
|---|---|---|---|---|---|---|---|---|
| 13 | Bay 1 | Rear | B1R -04 | Eaves Beam | Deep Decay - structurally significant | Structural Repair required. Splice Detail | Remove end 500mm (approx) and splice new timber section below truss. | Same |
| 17 | Truss 2 | Rear | T2R -01 | Tie Beam | Deep Decay - structurally significant | Structural Repair required. Splice Detail | Remove end 500mm (approx) and splice new timber section below truss. | Same |

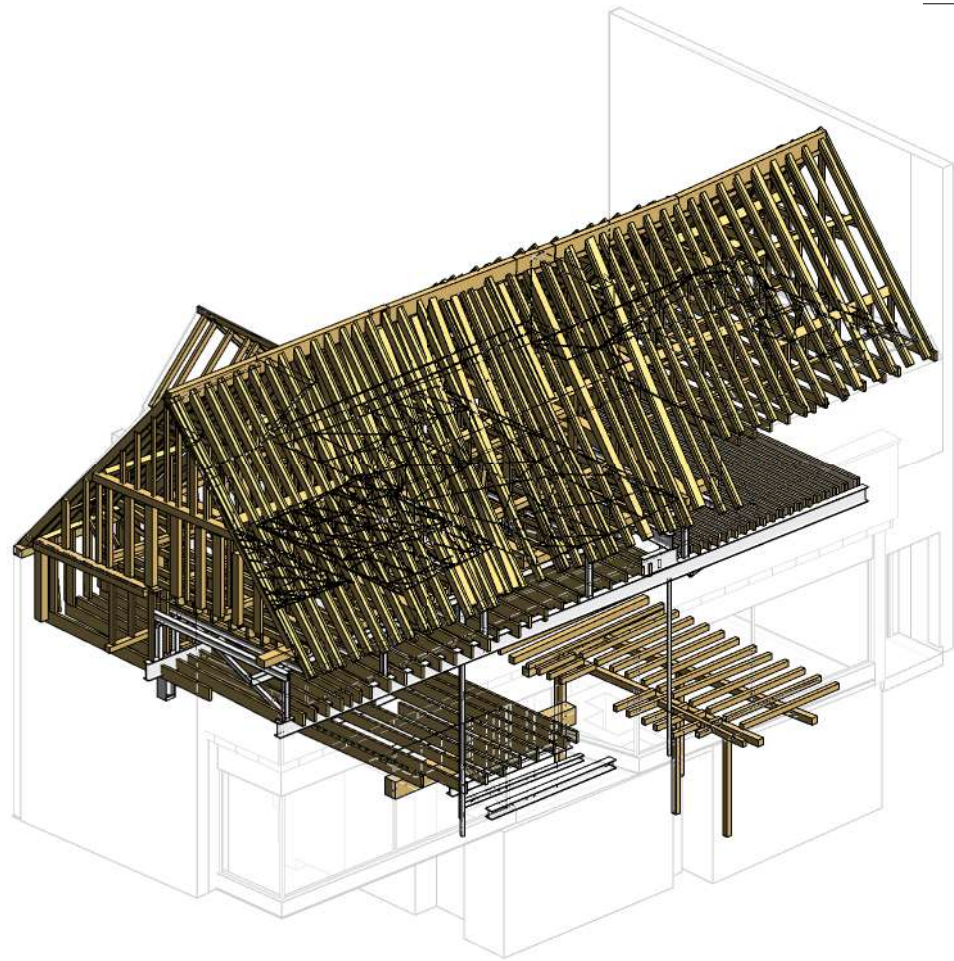
Modern structure, whilst not compliant with agreed proposal from MNP in 2020, appears to adequately strengthen existing medieval structure

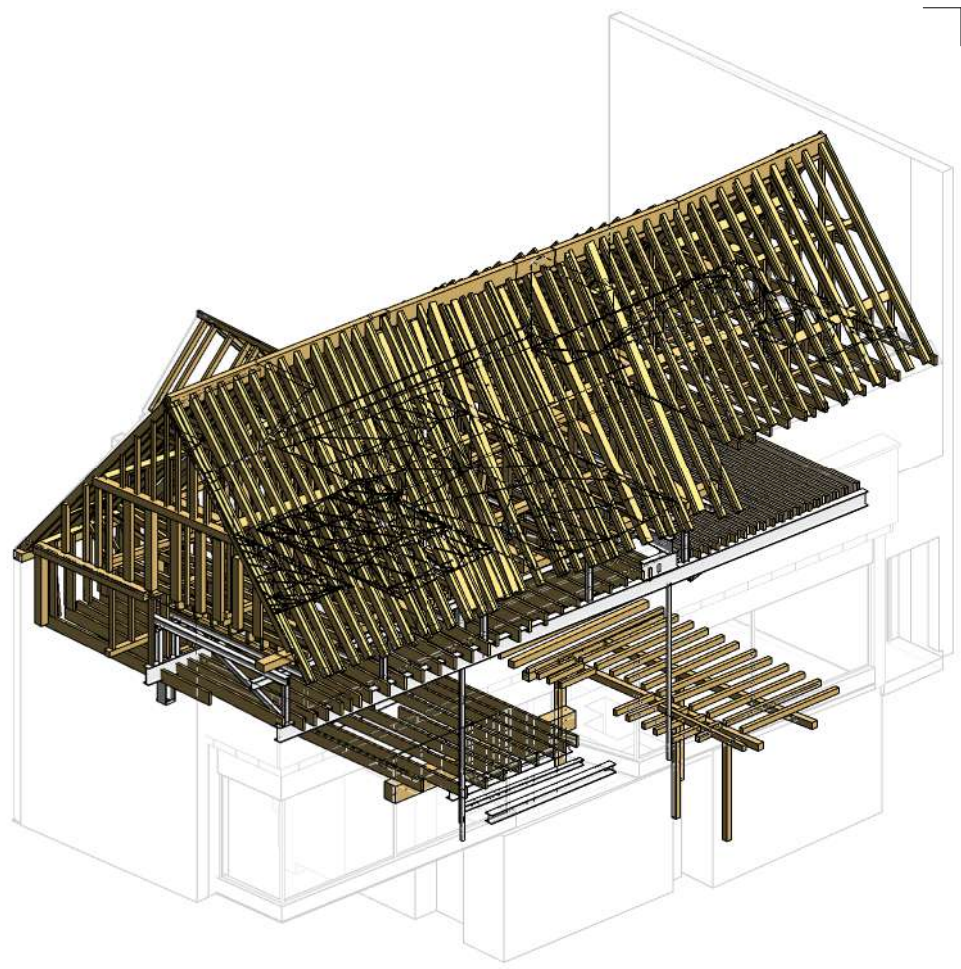
Modern structure, whilst not compliant with agreed proposal from MNP in 2020, appears to adequacy strengthen existing medieval structure

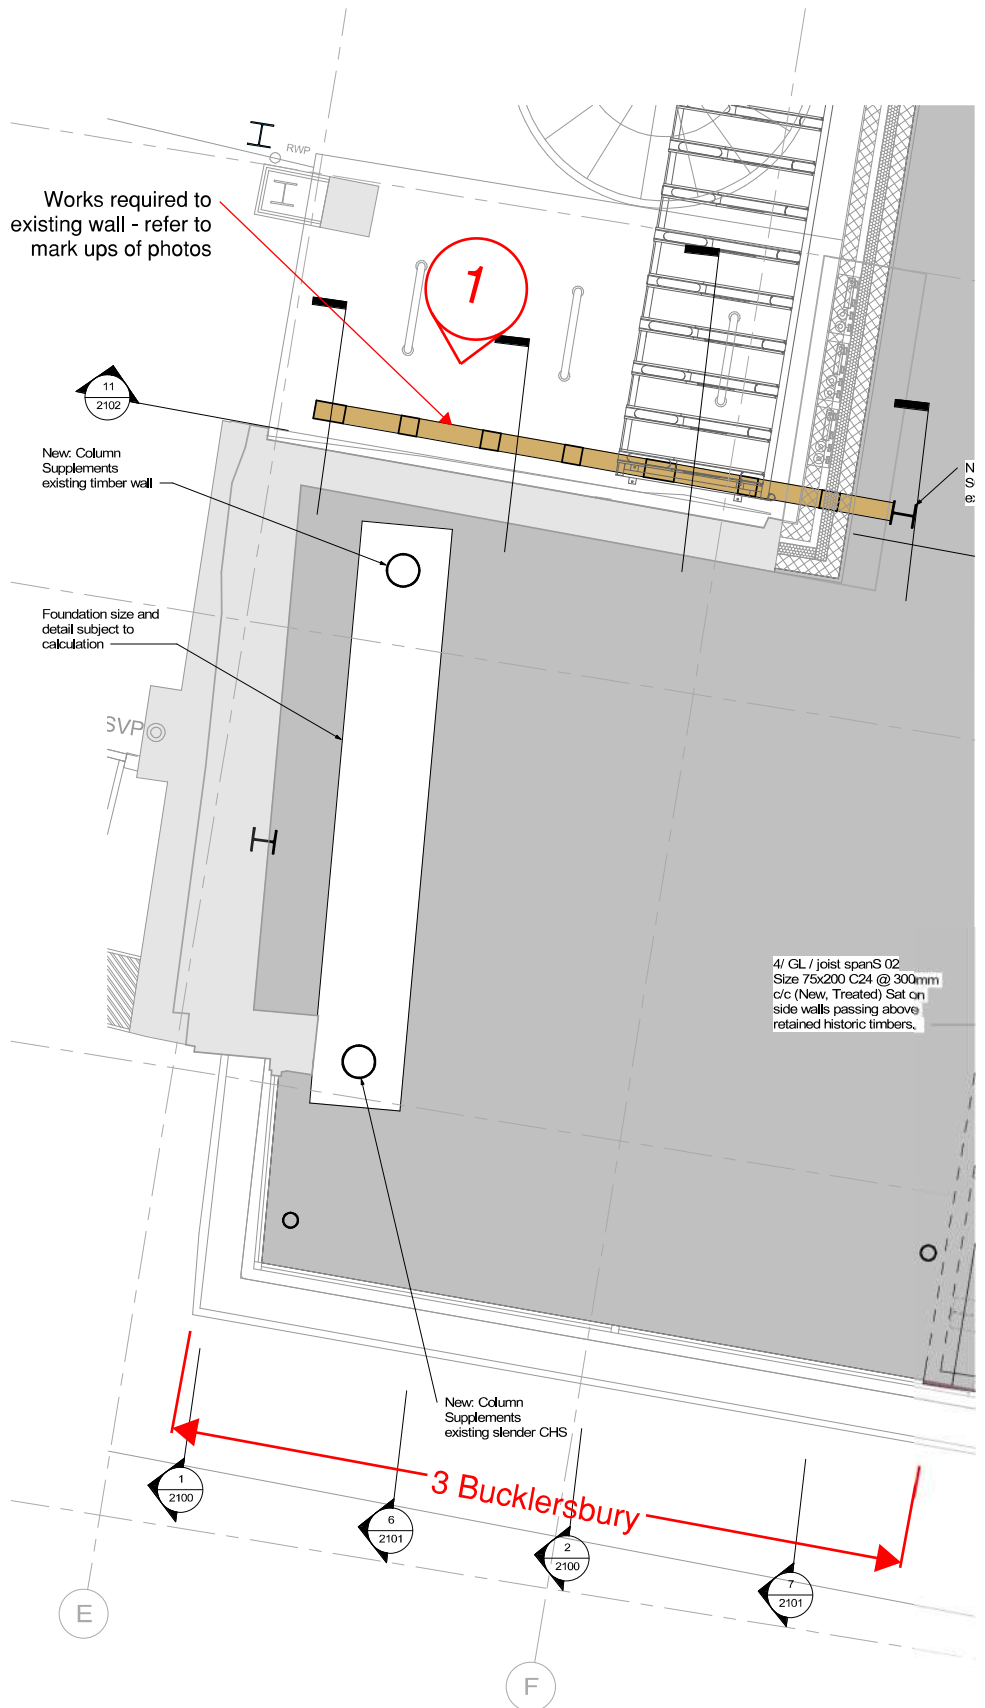
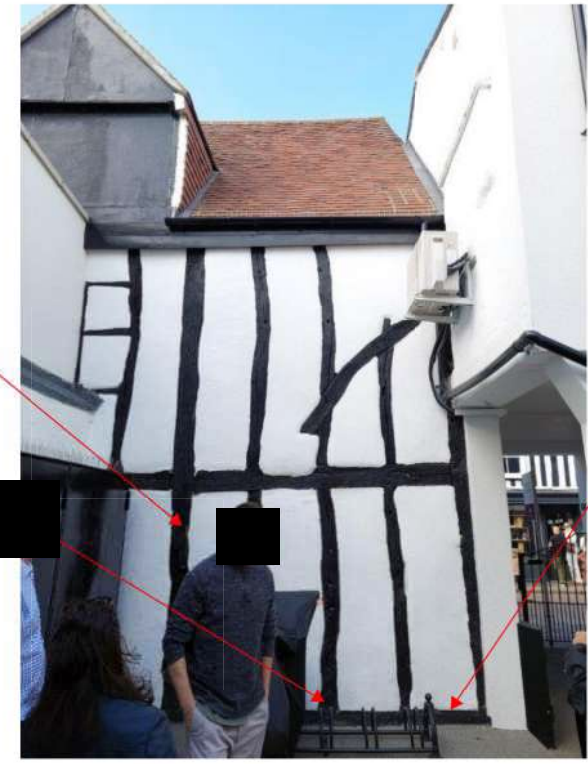
**Elevation 1**

Further investigation and making good of the rear wall are required, refer to Appendix D. Any missing or rotten sections of timber should be made good with new sections of timber, to match existing. The wall in question is also noted on the ground floor plan, in Appendix C.

Further investigation and remedial works are required to make good the wall where the timber studs have been lost previously. It is preferable to keep the sections that remain, apart from any rotten section, and scarf in new timbers to extend the studs back to the original sole plate. The sole plate should also be checked for rot and if there is any sections that have been affected, an allowance should be made to remove these sections and provide a new section of sole plate, scarfed into the existing.

Further investigation into the condition of the timbers are required. Any rotten sections of the sole plate and studs should be carefully removed and replaced with new oak, scarfed into the existing studs/sole plate. The section of missing post should also be reinstated with a new section of oak.

Check all bearings of studs into sole plate and condition of existing sole plate. Replace any rotten sections with new timber, to match existing, providing slip tenons, if needed, to fix into sole plate. Replace any rotten sections of sole plate using scarf or screwed and glued half lap joints, with the lap three times the section depth
