LEVEL 2

# Your survey report

5 Pryors Court, Baldock, Herts, SG7 6QU

30<sup>th</sup> June 2025

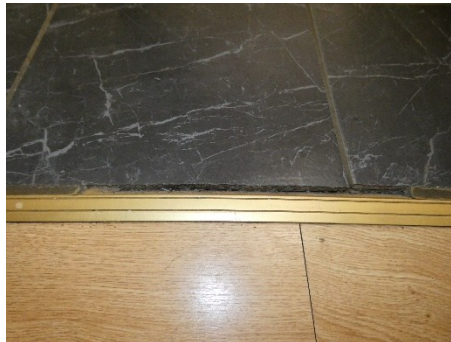
It was noted that there are some areas of deterioration to the laminate flooring in the living room area. Additionally, some change in colour was visible to areas of the flooring adjacent to the passageway wall.

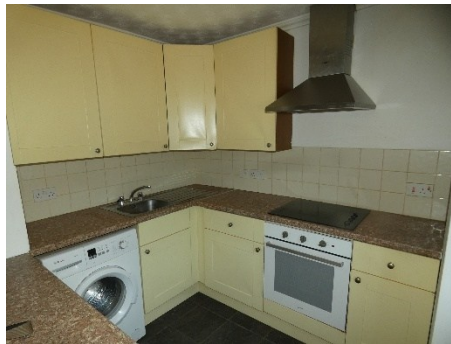
However, it was noted that many of the vinyl coverings to the doors have separated from the substrate. Additionally, damage was noted adjacent to the cooker where the units have been placed too closely to the appliance.

We would note that units have not been inspected in detail and it is recommended upon occupation you check handles, hinges and other mechanisms undertaking remedial work where required.

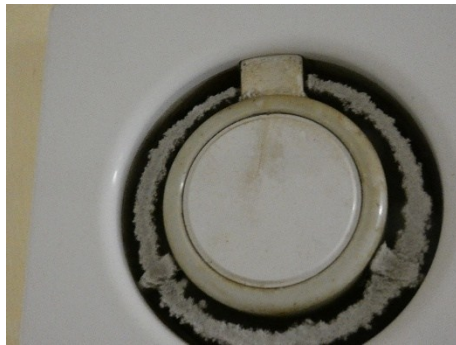
An extract fan is present and was functioning at the time of inspection. However, this is clogged with a dust accumulation and should be cleaned. The extractor ducting is boxed internally but is of some length and this will reduce the effectiveness of the fan. You may wish to consider installing an improved model.

Waterproof seals should be regularly inspected to maintain the waterproof seals and renewed as necessary.

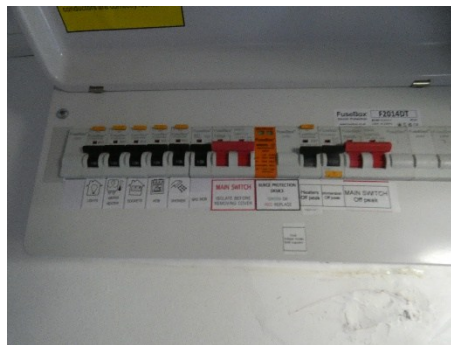
It is believed that alterations have been made to the installation since its original installation and all appropriate works should be certified. This has including updating of the consumer unit which appears to conform to current Regulations. All appropriate certification for this work should be obtained.

The property appears to have a dual rate supply and details should be confirmed in this respect.

We are not qualified to judge the safety, efficiency, or compliance of the electrical installation with Electricity Company's standards and at least some updating of the installation may prove necessary. Whilst we saw no indications of issues to the installation, you may wish to instruct a suitably qualified registered electrician to carry out a test and report on the electrical installation and provide you with estimates for any necessary remedial works.

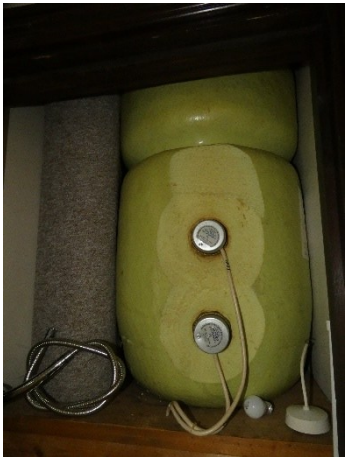
| <p>Hot water is provided by the immersion heater to the hot water storage cylinder located to the airing cupboard.</p> <div data-bbox="647 956 992 1411"></div> <p>This is a 'primatic' cylinder with the water supply tank forming the top part of the cylinder.</p> <p>The cylinder is likely to be original to the construction of the property. As the property is located in a hard water area, it is likely that some degree of limescale build-up will have occurred to the cylinder over this period which will affect its efficiency.</p> <p>However, we noted no evidence of significant issue or leakage at the time of inspection.</p> <p>Condition Rating : 1</p> | 1 |

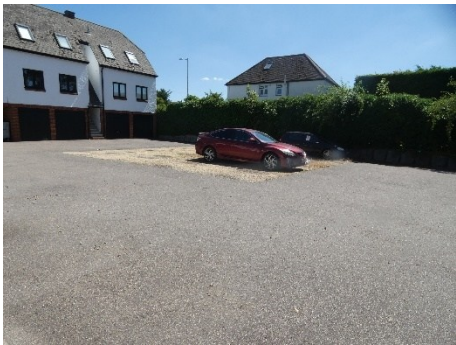
There is an allocated parking space to the property, believed to be located in the parking area to the rear of the development. This should be confirmed by your legal adviser.

The courtyard to the property has a number of allocated parking spaces although a number are for visitors use. You should ensure all appropriate rights of access are in place.
