**HERITAGE ASSESMENT, SCHEDULE OF WORKS, PHOTOGRAPHIC  
SCHEDULE AND ROOM IDENTIFICATION PLANS**

February 2025 **(REV A)**

FOR ASSOCIATED REMEDIAL AND REPAIR WORKS  
AT  
OLD SEXTONS, RUSHDEN ROAD  
SANDON, NR. BUNTINGFORD  
HERTFORDSHIRE SG9 0QY

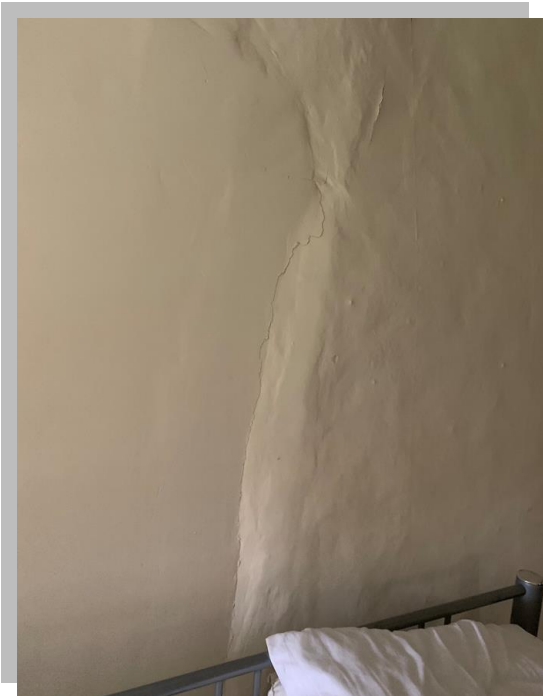
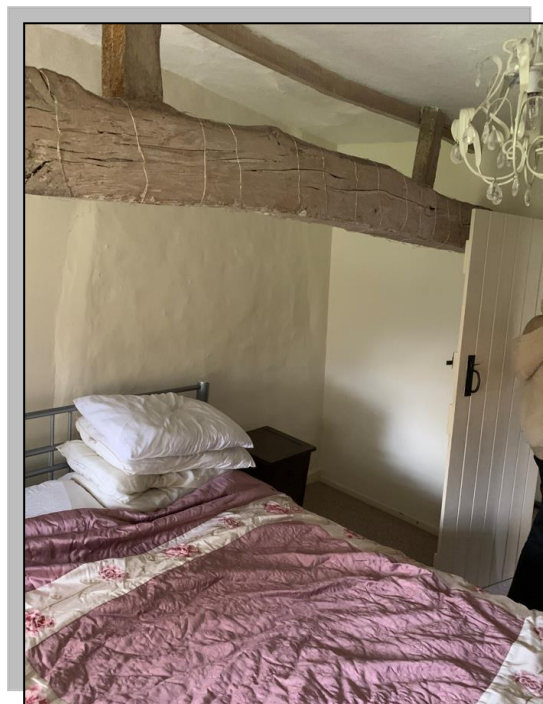
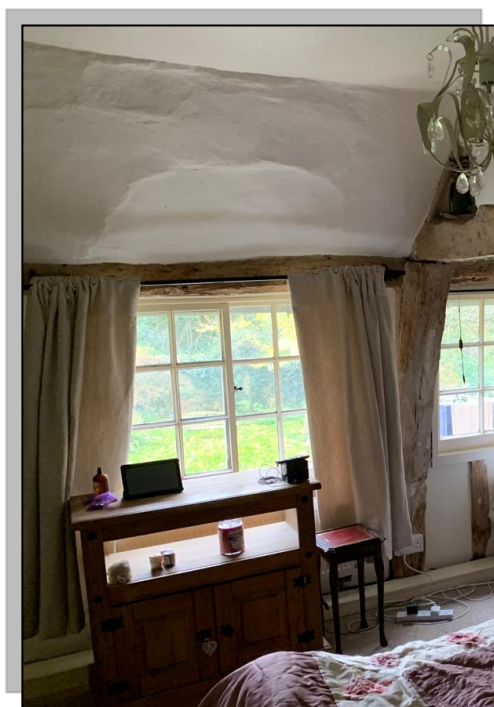
Patch repairs to the ceiling and walls to remedy where it is either loose or unstable. Window to be replaced due to its poor condition and inability to easily open, which is contributing to the lack of ventilation.

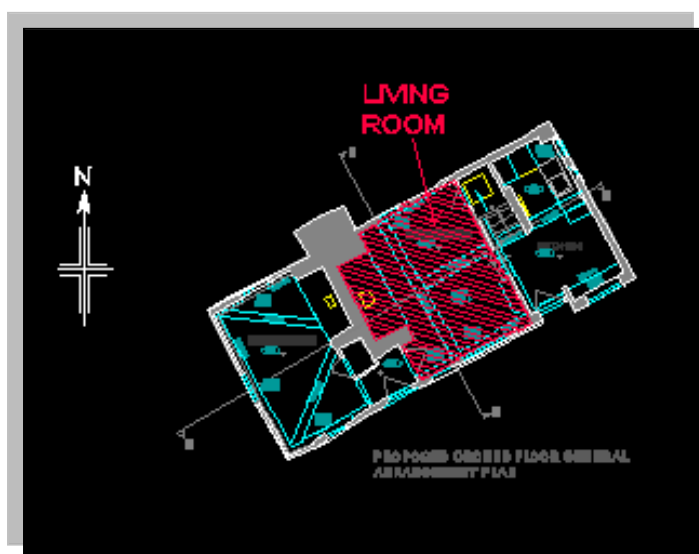
### **LIVING ROOM (GROUND FLOOR)**

The living room walls and ceilings appear to be in good order and do not require any major repairs other than general decoration. Windows W2 and W7 (later top opening casements) are to be replaced with a timber alternative to match the current appearance. Windows W3 and W8 are to be retained and repaired as agreed by separate permission.

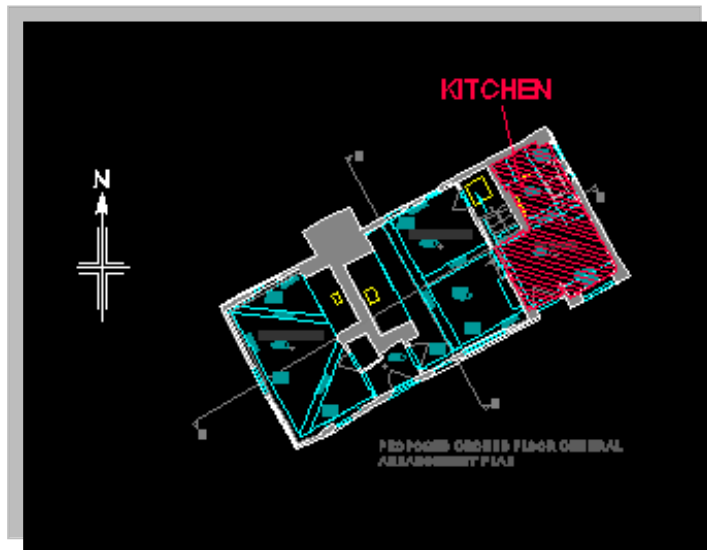
### **KITCHEN (GROUND FLOOR)**

The kitchen appears to be in good order and does not require any repairs to the walls, floor or ceiling. All units and fittings are in a serviceable condition and do not need replacing.

Slimline timber double glazed windows (W4, W5 & W6) have previously been fitted into the kitchen, although these would be replaced to ensure a suitable window cill depth over the insulated panel and render.

A carbon monoxide detector is to be installed on both floors and within any room that contains a fixed combustion appliance.

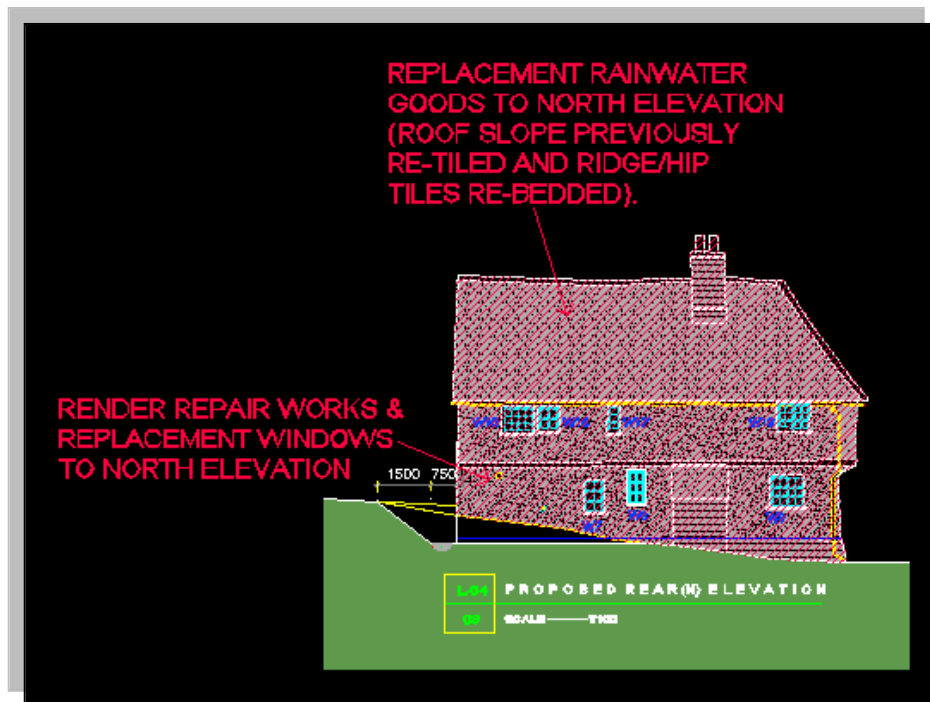
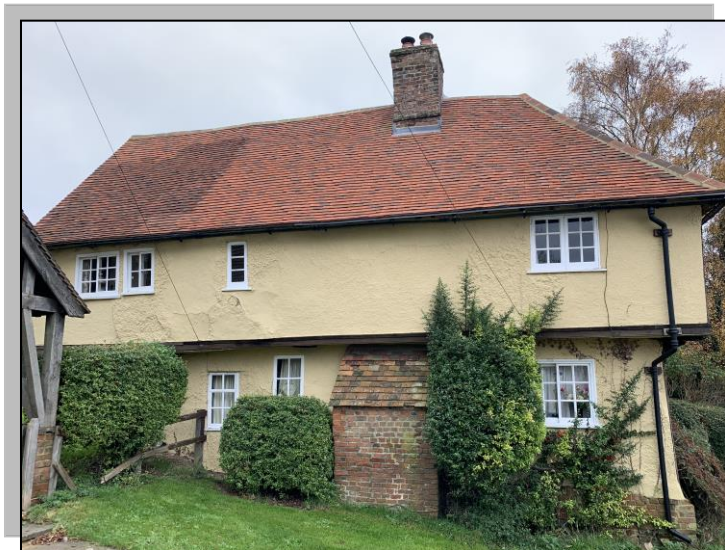
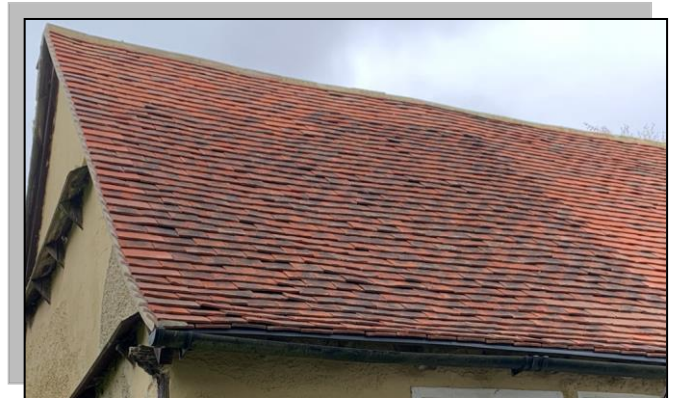
## **REAR (NORTH) ELEVATION**

- Replace all gutters as these are not fitted correctly due to large gaps between the underside of the bottom row of tiles and the gutter itself, allowing rainwater to pass through.

All proposed replacement rainwater goods are to be Brett Martin plastic heritage iron effect roundstyle, with a 112mm dia. gutter, fixed back to each rafter end with matching gutter clips and galvanised steel top rafter brackets, and 68mm dia. downpipes. All fittings to be in black from the same range. Include for all running outlets, junctions, stop ends, corners, swan necks etc. This specification has recently been approved at the nearby Dovecote (Listed Building Ref: 18/00585/LBC) and other barn nearby refurbishments.

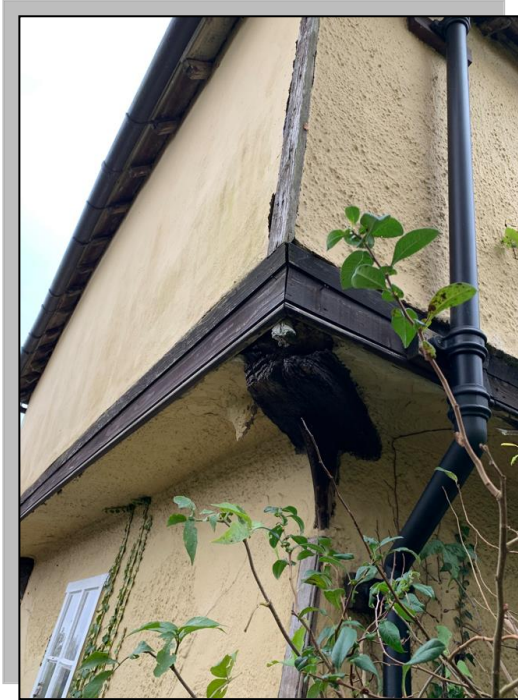
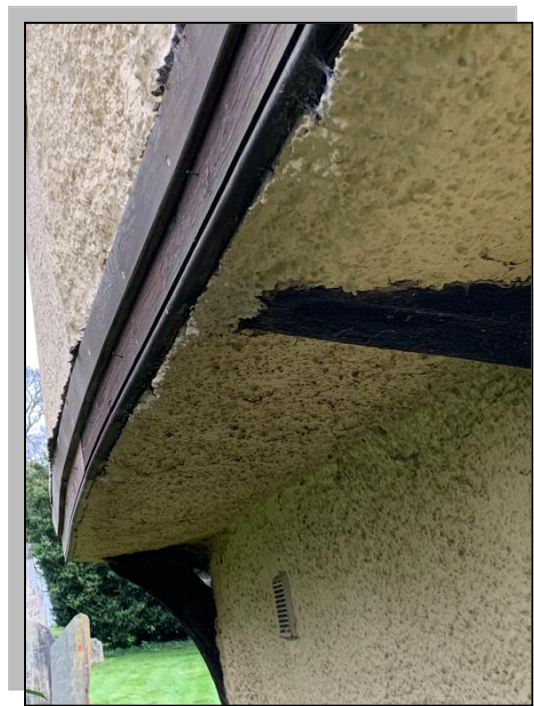
- Timber to the perimeter of the overhanging jetty is to be replaced with a simple profiled board more in keeping with the historic appearance of the building. The underside is to be insulated and re-rendered as described elsewhere.

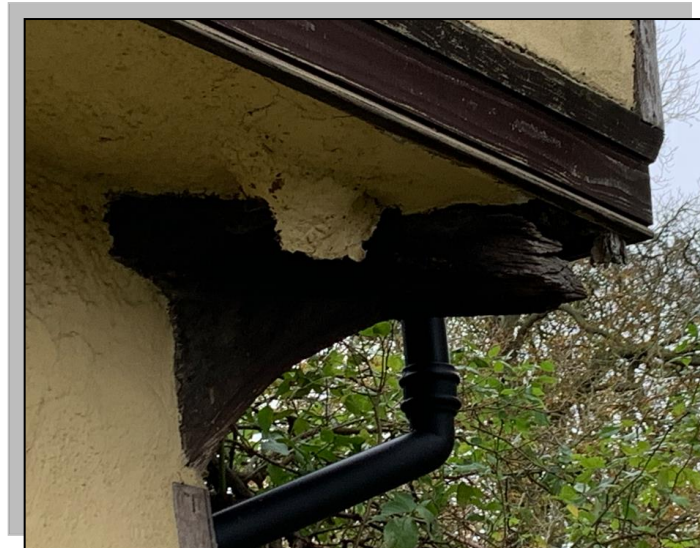
- Like-for-like repairs to the exposed timber framework. There will be no full replacement of any timber members without prior consent.

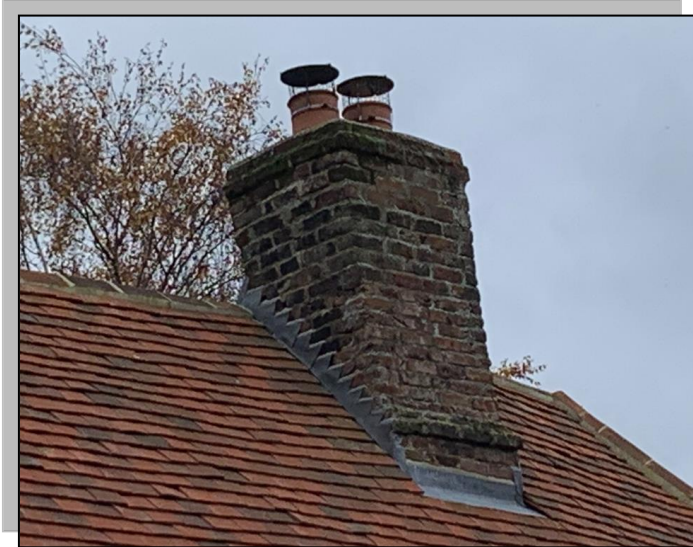
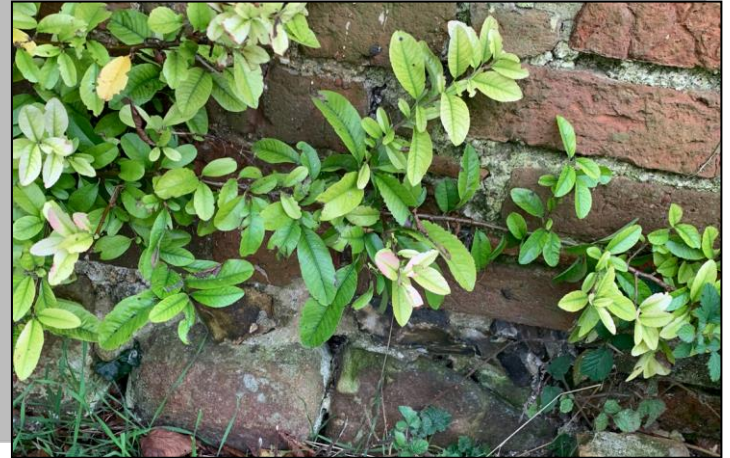
- For small areas of brickwork repair including chimney stack – Allow to rake out existing joints and re-point in a lime-based mortar to match existing as closely as possible in colour, texture and consistency.

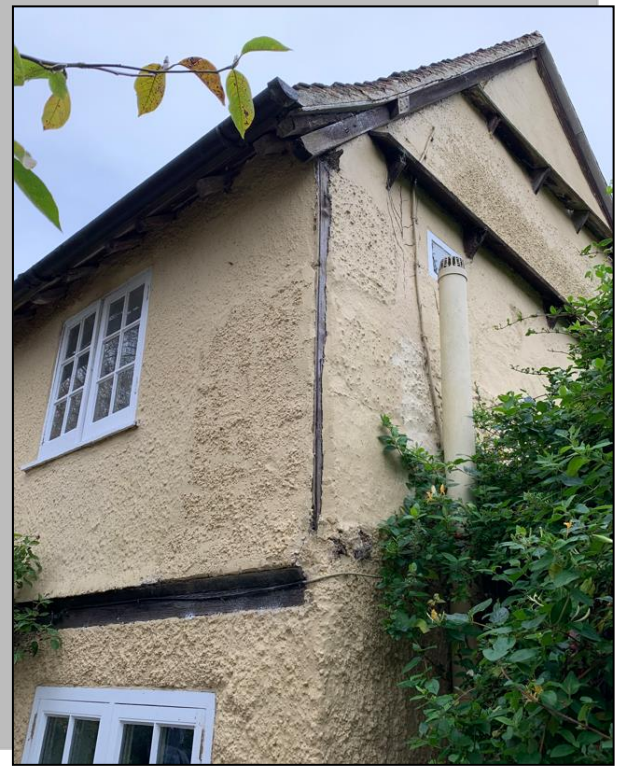
*Example of current loose and unstable cementitious render to North, East and West elevations*

- Windows W7, W15 and W17 are to be replaced (W15 replaced as a Yorkshire Slider to match the existing). Windows W8, W9, W16 and W18 are to be retained as previously described.
- Carefully remove all existing render to the ground and first floor as previously described as the existing is loose and mostly live (refer to photographs below and elsewhere within this document). Immediate attention is required to prevent damp to the timber frame which should be carefully checked upon exposure and repaired/treated as necessary. In addition, the existing render does not allow the building to breathe as it includes cementitious products for previous repairs to all elevations.
