**HERITAGE ASSESMENT, SCHEDULE OF WORKS, PHOTOGRAPHIC  
SCHEDULE AND ROOM IDENTIFICATION PLANS**

February 2025

FOR ASSOCIATED REMEDIAL AND REPAIR WORKS  
AT  
OLD SEXTONS, RUSHDEN ROAD  
SANDON, NR. BUNTINGFORD  
HERTFORDSHIRE SG9 0QY

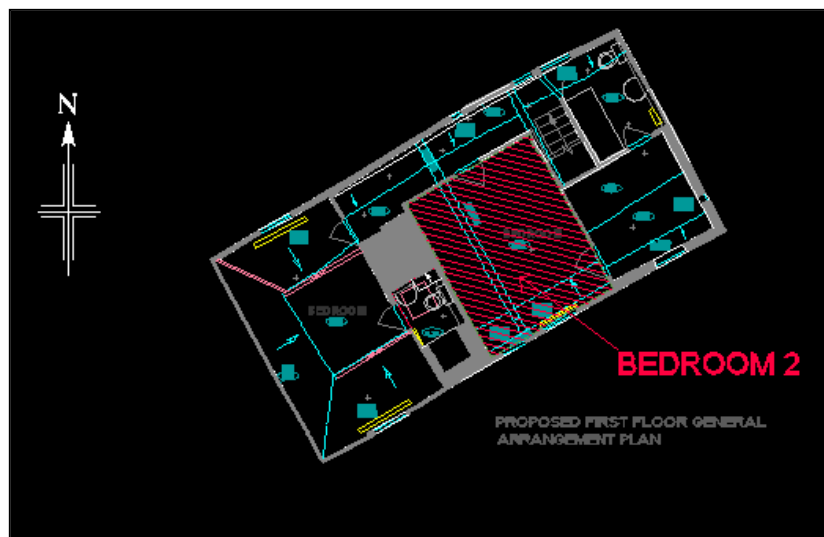
### **BEDROOM 2 (FIRST FLOOR)**

Patch repairs to the ceiling and walls to remedy where it is either loose or unstable. Window to be replaced due to its poor condition and inability to easily open, which is contributing to the lack of ventilation.

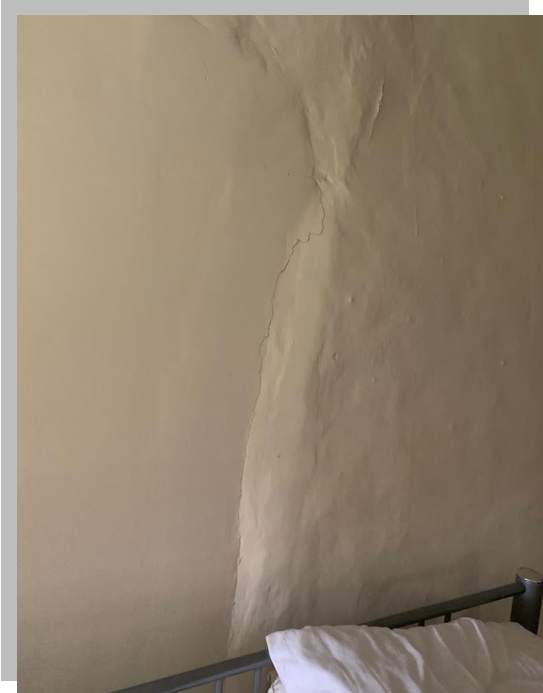
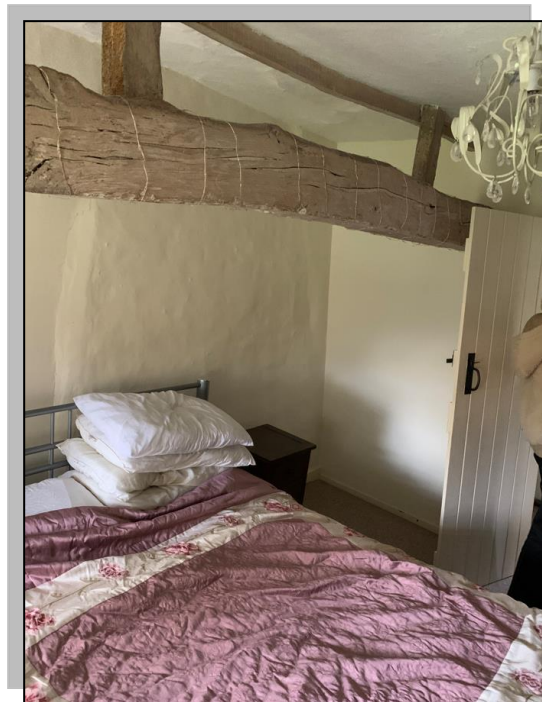
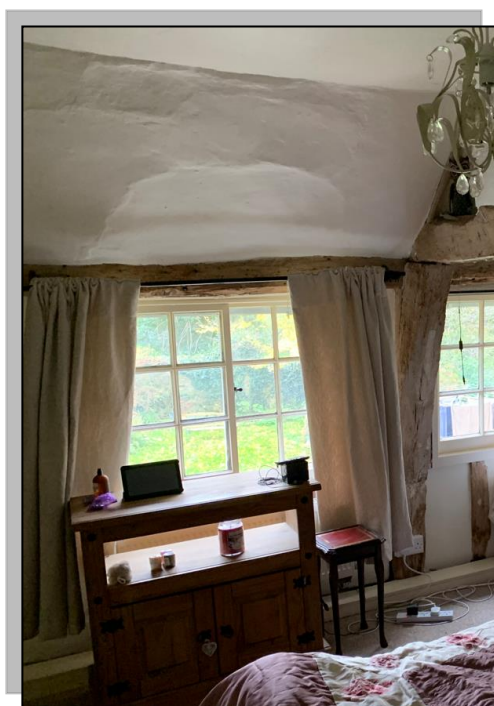
Patch repairs to the ceiling and walls to remedy where it is either loose or unstable. Window to be replaced due to its poor condition and inability to easily open, which is contributing to the lack of ventilation.

water. The skim coat will utilise a pre-mixed lime topcoat superfine plaster such as 'Ty-Mawr' with water mixed on site. A breathable emulsion finish suitable for lime based plaster is to be used.

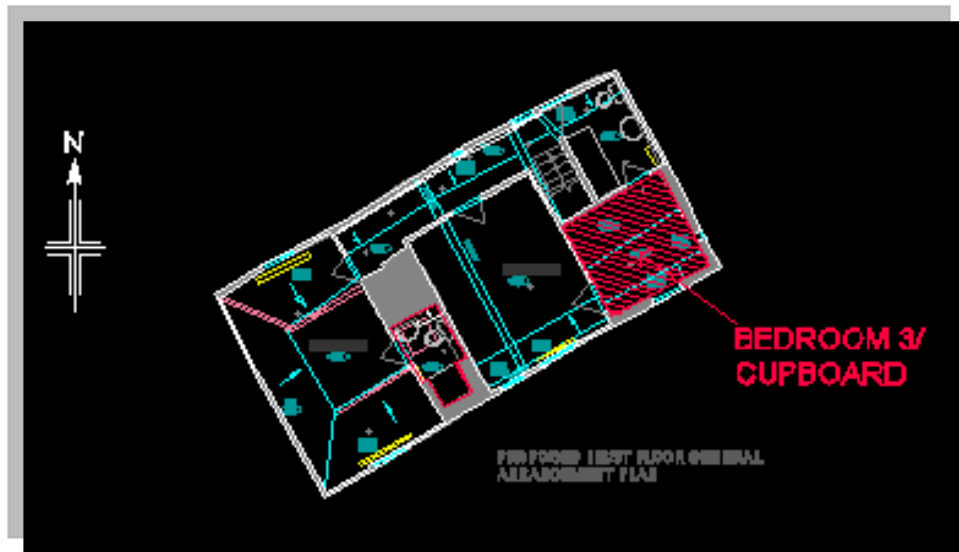
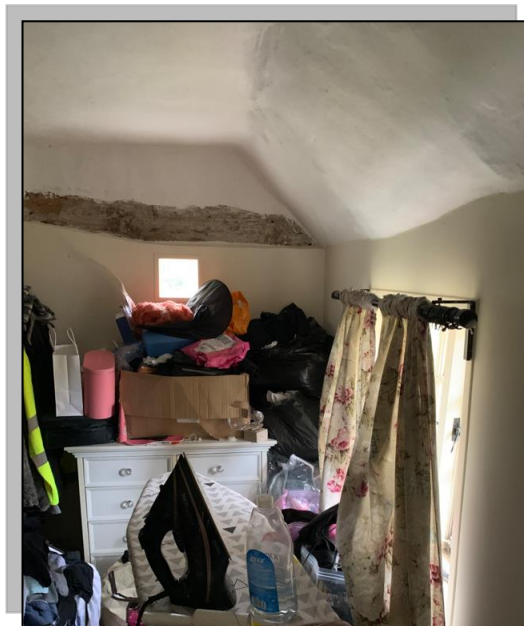
### **BEDROOM 3/CUPBOARD (FIRST FLOOR)**

Patch repairs to the ceiling and walls as previously described, and replacement window.

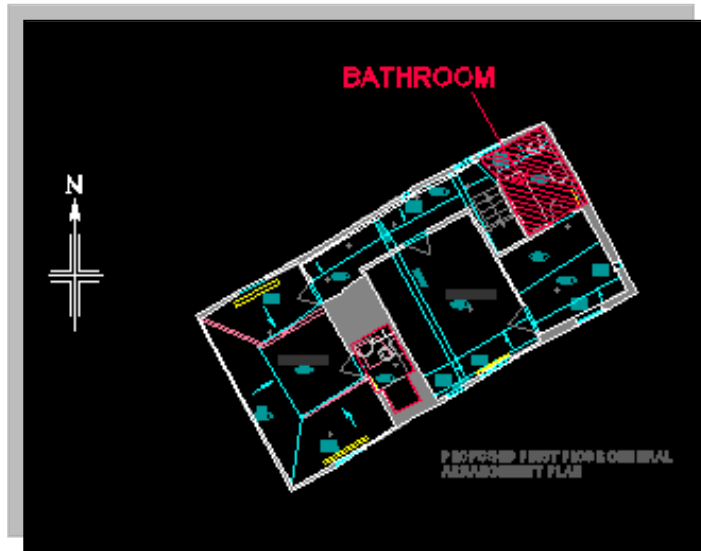
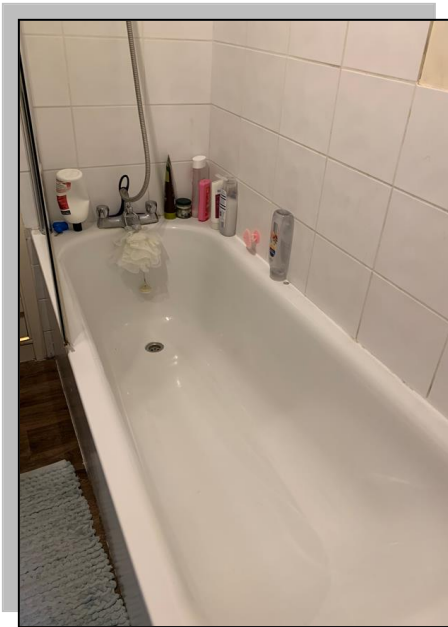
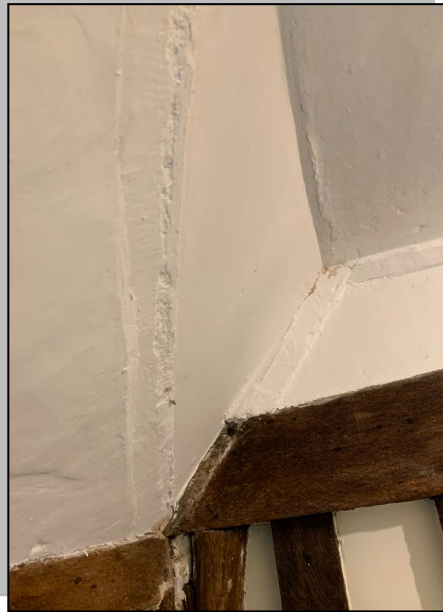
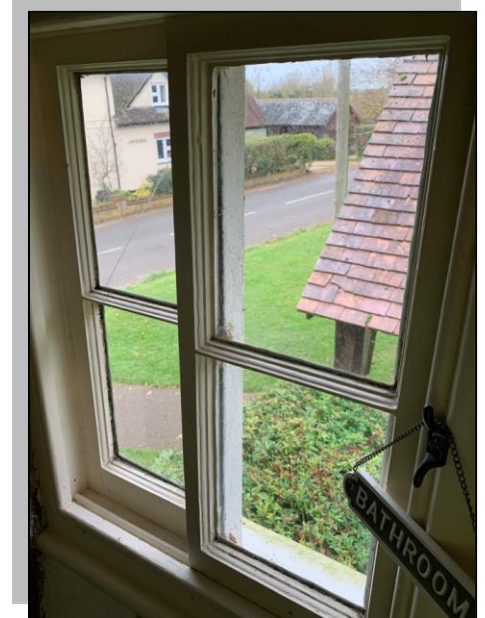
## **BATHROOM (FIRST FLOOR)**

Patch repairs to the ceiling and walls as previously described, and replacement window. Replacement sanitaryware and wall tiling on a like-for-like basis. All fittings to be installed in current locations and connected to existing waste pipes.

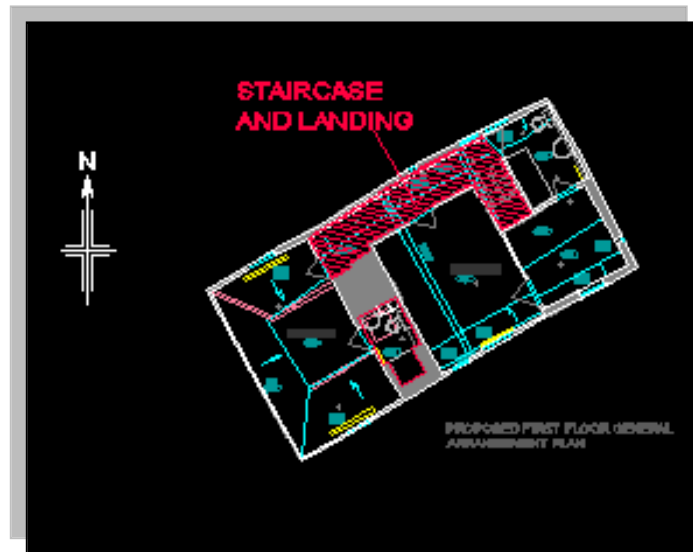
## **STAIRS AND LANDING**

Patch repairs to the ceiling and walls as previously described, and replacement window.  
Damage to the timber wall plate over the landing area to be locally repaired as can be seen in the photograph below.

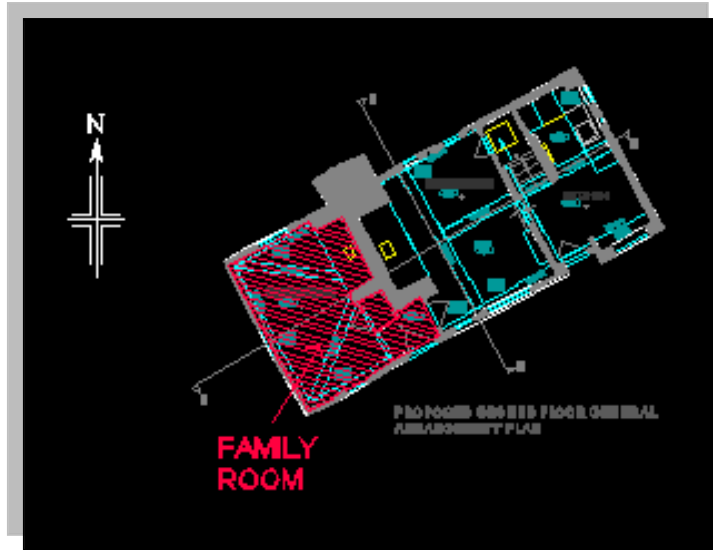
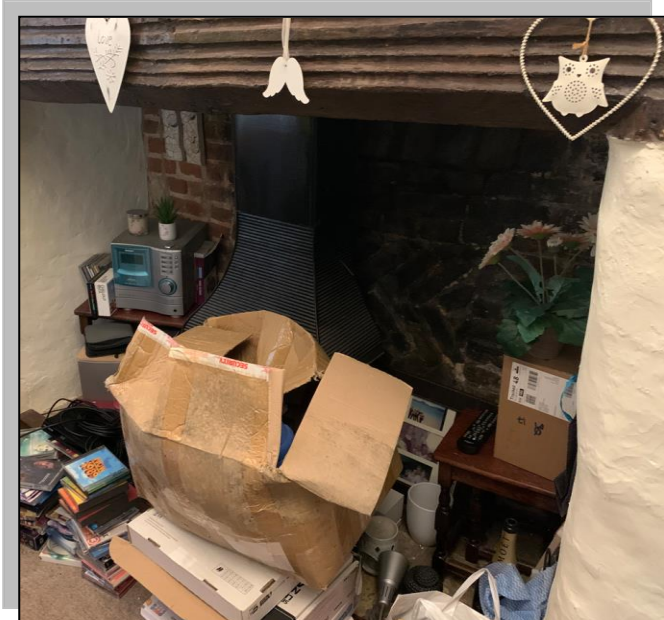
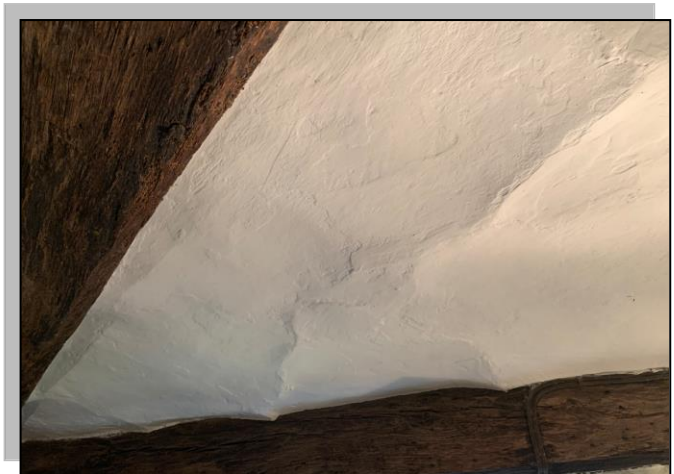
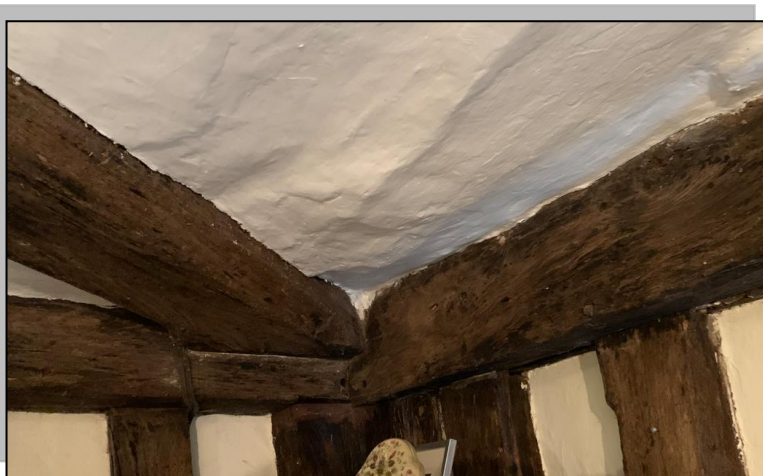
## **FAMILY ROOM (GROUND FLOOR)**

Patch repairs to the ceiling and walls as previously described, and replacement windows.

Replacement log burner to be installed. Existing flue to be checked for adequacy by specialist installer prior to installation.

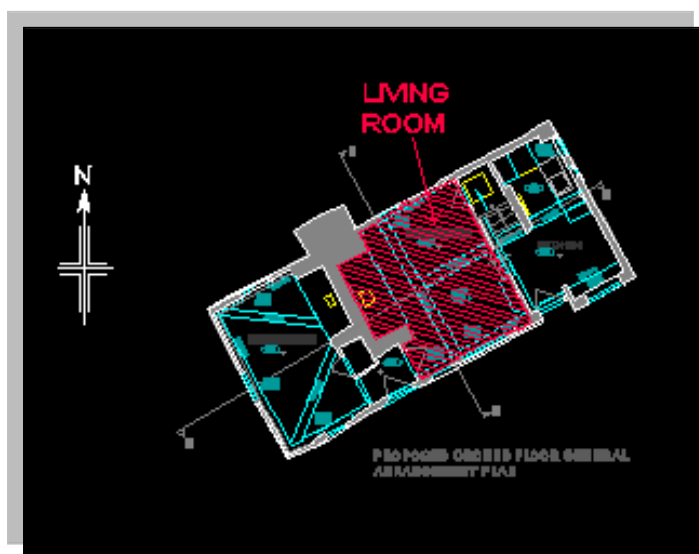
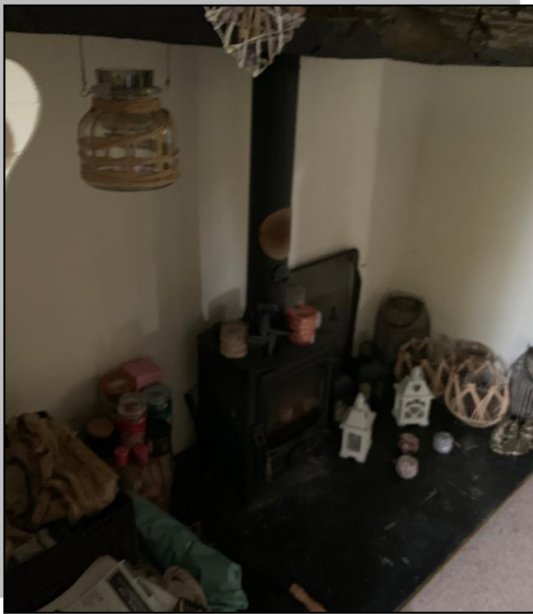
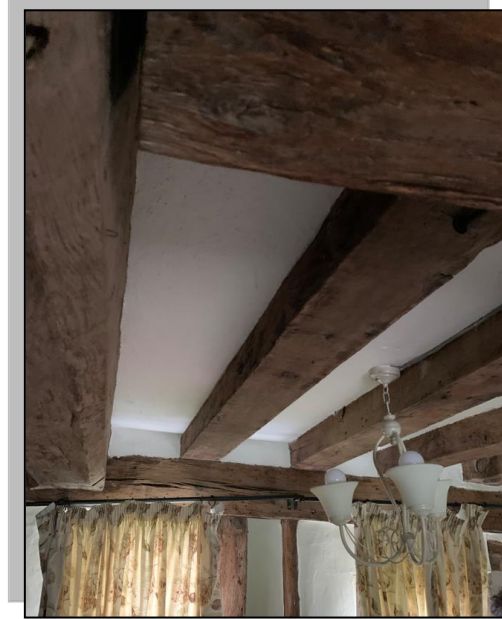
### **LIVING ROOM (GROUND FLOOR)**

The living room walls and ceilings appear to be in good order and do not require any major repairs other than general decoration. The windows are to be replaced as previously described.

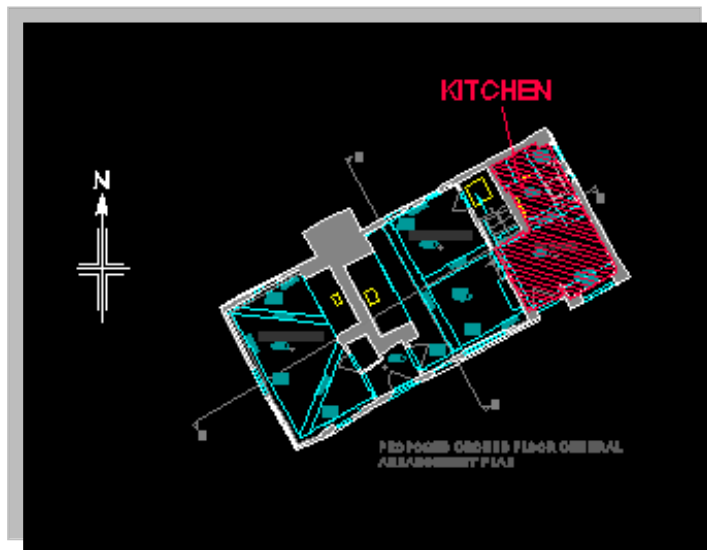
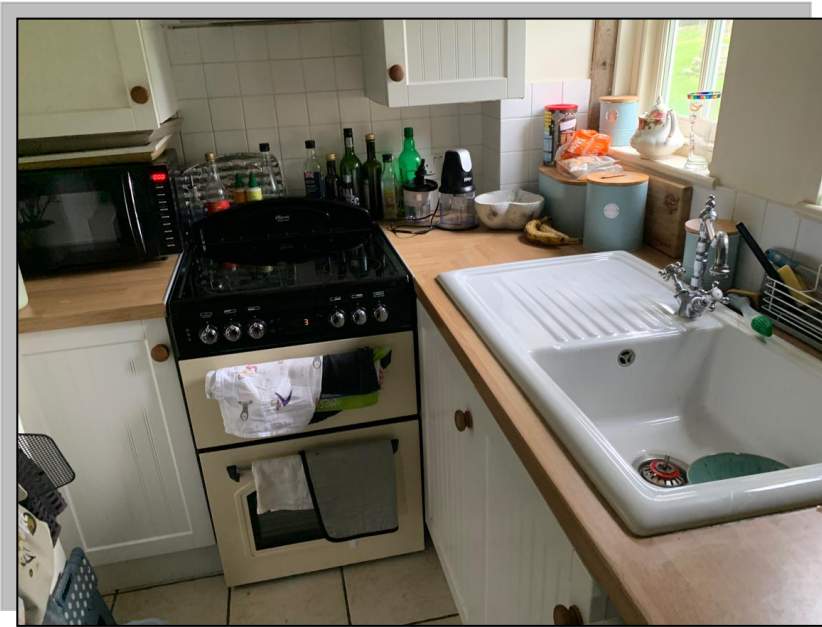
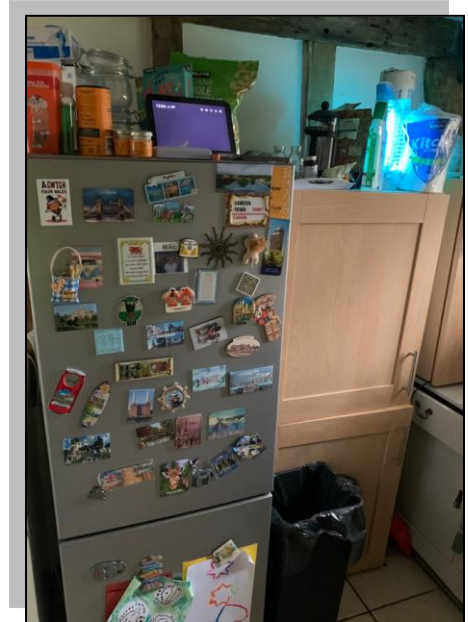
### **KITCHEN (GROUND FLOOR)**

The kitchen appears to be in good order and does not require any repairs to the walls, floor or ceiling. All units and fittings are in a serviceable condition and do not need replacing.

Slimline timber double glazed windows have previously been fitted into the kitchen, although these would be replaced to ensure a suitable window cill depth over insulated panel and render.

A carbon monoxide detector is to be installed on both floors and within any room that contains a fixed combustion appliance.

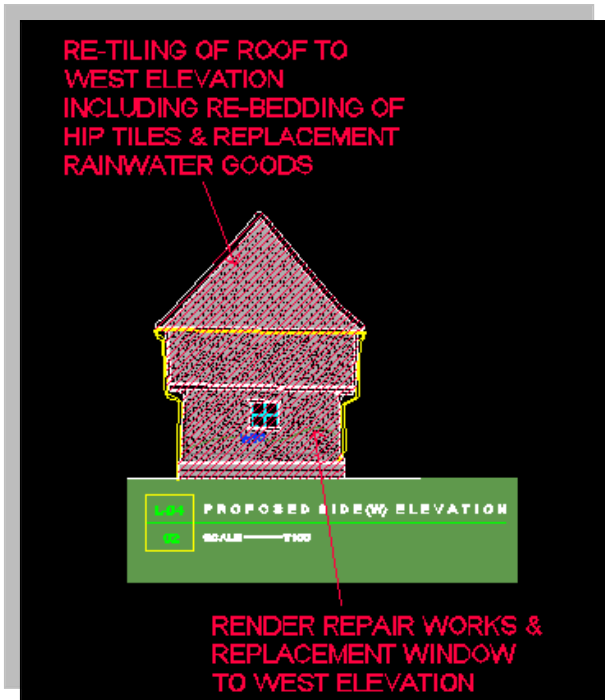
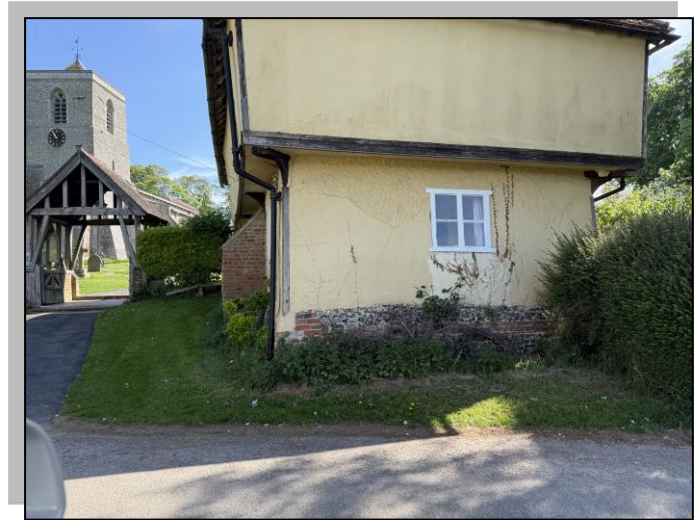
## **SIDE (WEST) ELEVATION**

- Re-roofing of west elevation and insulation to roof space all as described previously to south elevation.
- Replace existing gutter with a Brett Martin plastic heritage iron effect roundstyle equivalent as described previously to south elevation.
- Re-rendering as described to south elevation and as described in detail on drawing No. L-04 (Proposed plans & elevations), including the repainting of the walls with a suitable breathable paint for lime render.
- Existing bushes and shrubbery are to be trimmed and cut back away from the building.

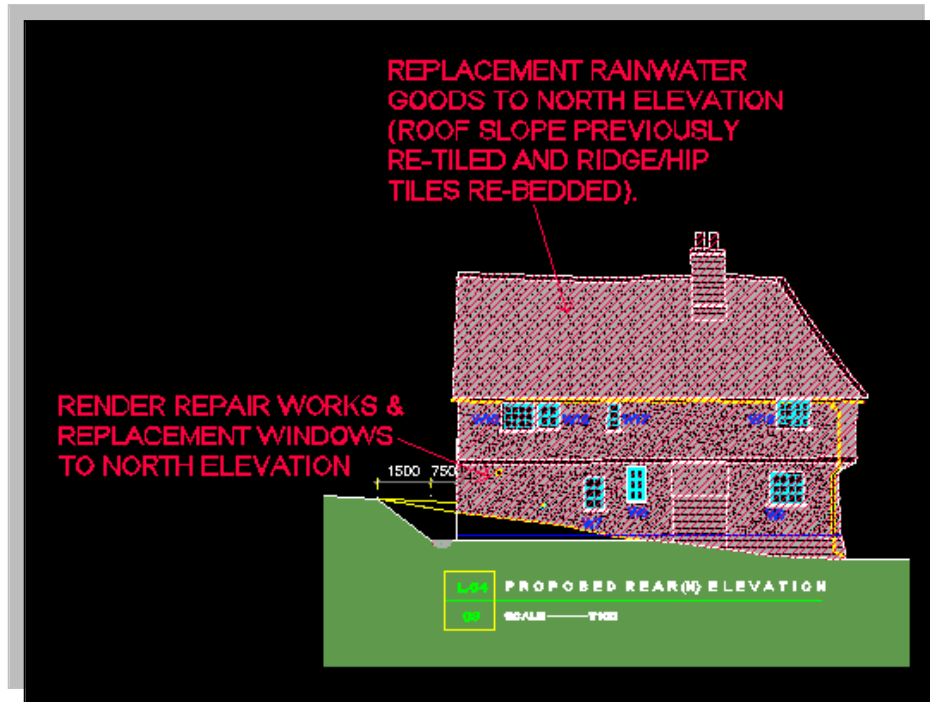
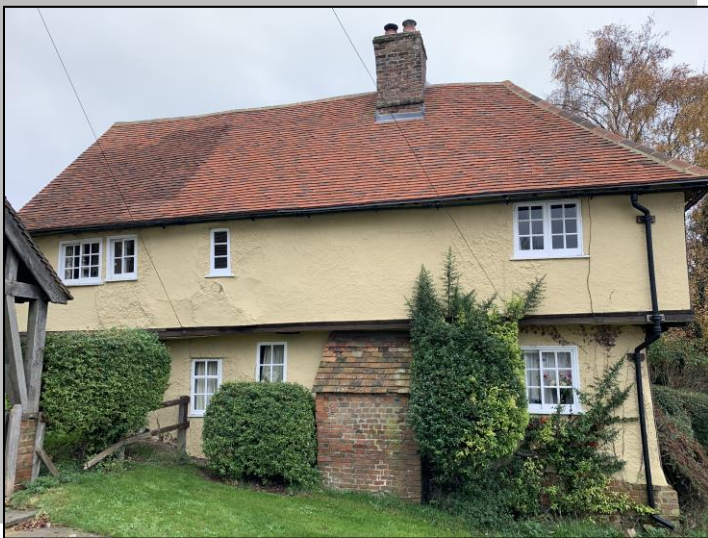
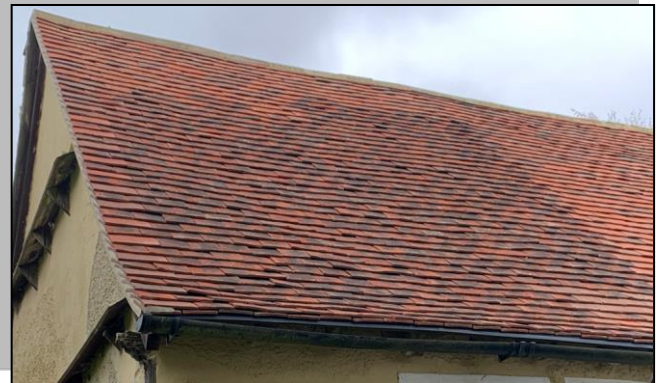
## **REAR (NORTH) ELEVATION**

- Replace all gutters as these are not fitted correctly due to large gaps between the underside of the bottom row of tiles and the gutter itself, allowing rainwater to pass through.

- Timber to the perimeter of the overhanging jetty is to be replaced with a simple profiled board more in keeping with the historic appearance of the building. The underside is to be insulated and re-rendered as described elsewhere.

- Replace all timber windows as previous described and illustrated on the enlarged details and joinery details submitted.
- Carefully remove all existing render to the ground and first floor as previously described as the existing is loose and mostly live (refer to photographs below and elsewhere within this document). Immediate attention is required to prevent damp to the timber frame which should be carefully checked upon exposure and repaired/treated as necessary. In addition, the existing render does not allow the building to breathe as it includes cementitious products for previous repairs to all elevations.

All proposed replacement rainwater goods are to be Brett Martin plastic heritage iron effect roundstyle, with a 112mm dia. gutter, fixed back to each rafter end with matching gutter clips and galvanised steel top rafter brackets, and 68mm dia. downpipes. All fittings to be in black from the same range. Include for all running outlets, junctions, stop ends, corners, swan necks

- Like-for-like repairs to the exposed timber framework. There will be no full replacement of any timber members without prior consent.

- For small areas of brickwork repair including chimney stack – Allow to rake out existing joints and re-point in a lime-based mortar to match existing as closely as possible in colour, texture and consistency.

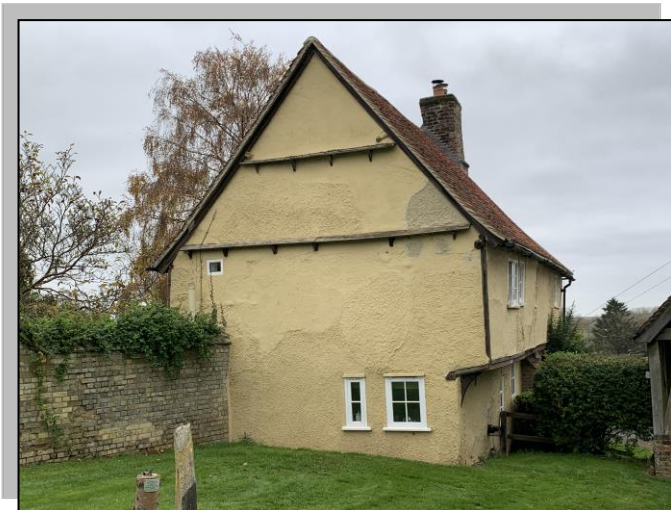
## **SIDE (EAST) ELEVATION**

- Carefully remove all existing render to the ground and first floor as previously described as the existing is loose and mostly live (refer to photograph below and elsewhere within this document). Immediate attention is required to prevent damp to the timber frame which should be carefully checked upon exposure and repaired/treated as necessary. In addition, the existing

render does not allow the building to breathe as it includes cementitious products for previous repairs to all elevations.

- Ground to be cut back and graded away from the house after all agreements have been secured with the land owners. New perforated pipe to be installed around the perimeter at this side of the building including connection of both new downpipes as indicated on the submitted drawings.
- Replacement windows as previously described.
- Repairs to roof verges after the south elevation has been re-tiled and all wall insulation installed.

- It is proposed to install Warmshell External Woodfibre boards (100mm thick) to all elevations after the careful removal of the existing loose and unstable render. This will be installed in full accordance with the manufacturer's recommendations. See literature below.

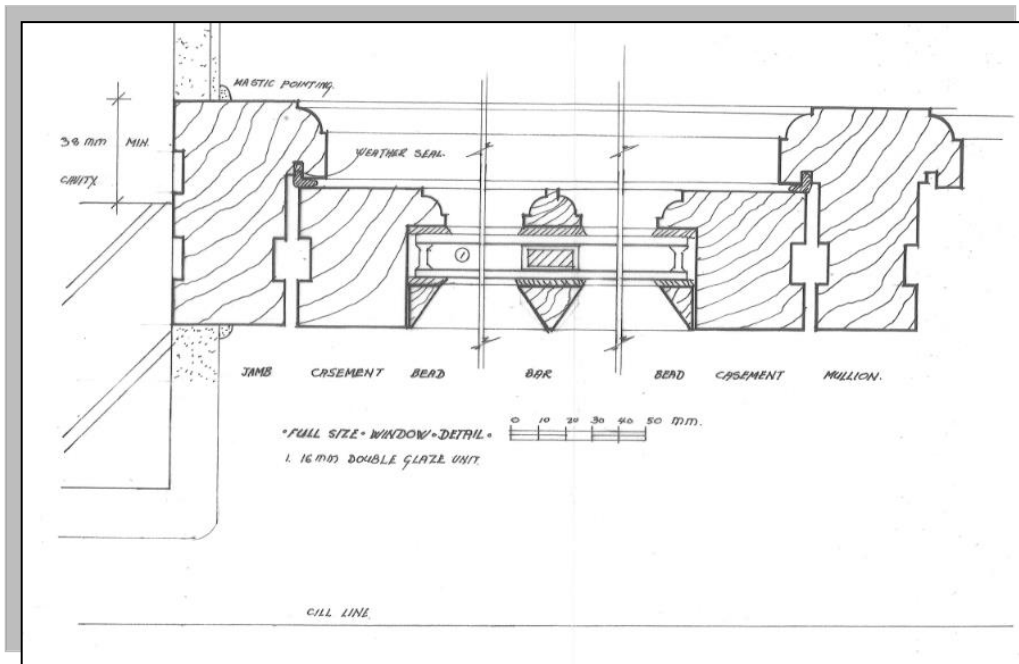
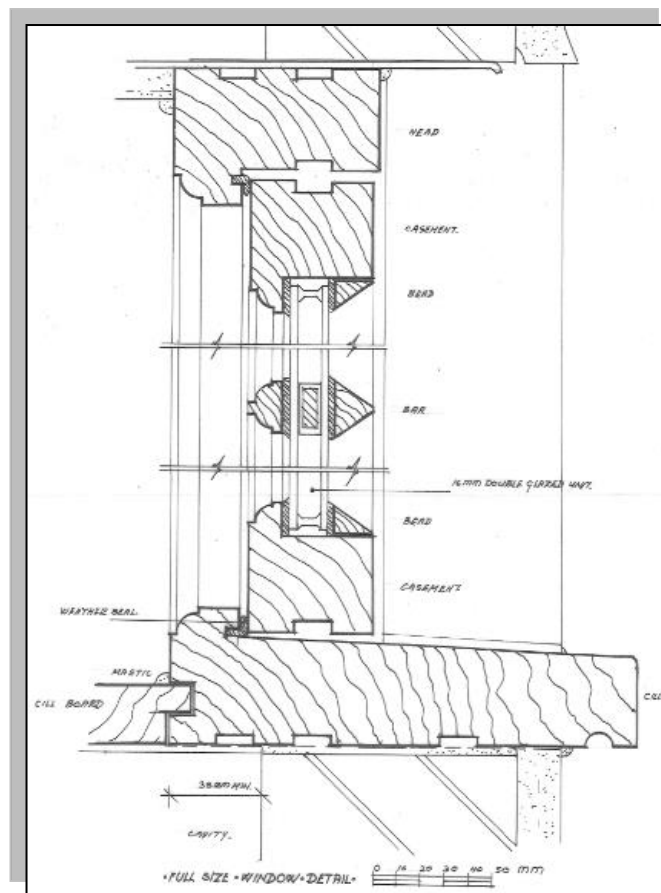
Typical enlarged replacement window details (plan & section)  
as previously approved at the Dovecote (Listed Building Ref: 18/00585/LBC)
