SS25299

## Structural Inspection Report

Historic Boundary wall

Ickleford Mill, Arlesey Road

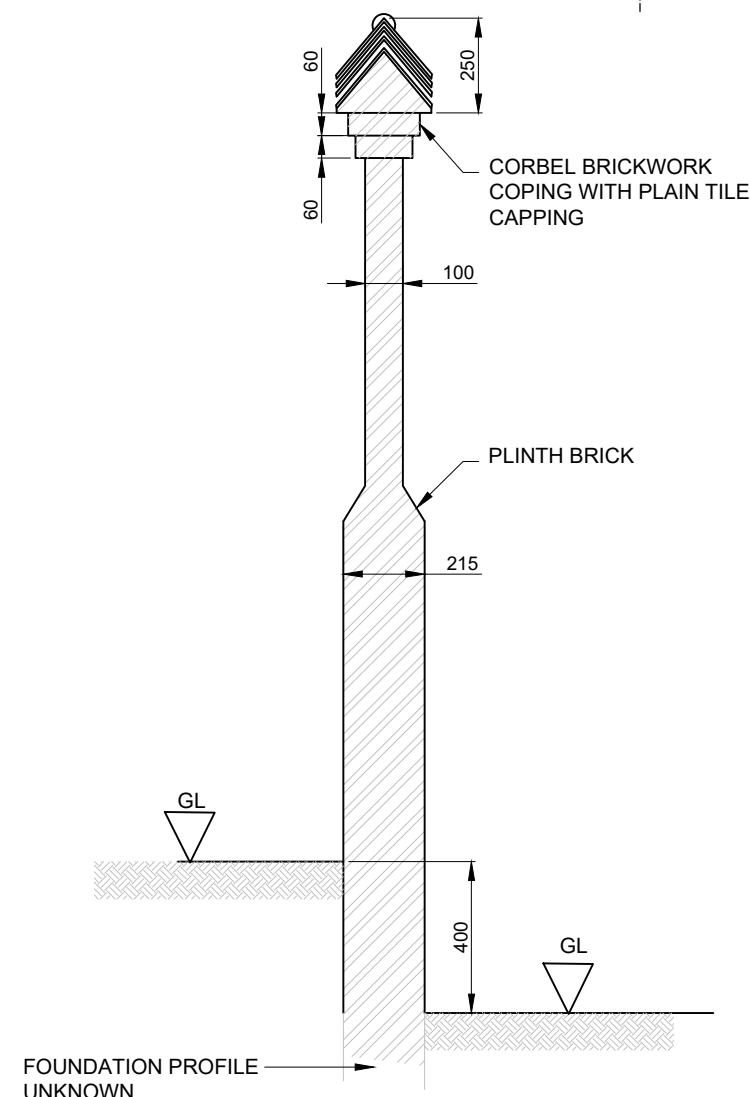
**G.A. PLAN**  
**SCALE: 1:100**

REPAIR SCHEDULE  
BOUNDARY WALL

1. CAREFULLY REMOVE ALL IVY GROWTH FROM THE WALL INCLUDING ANY DEAD VINES
2. RE-INSPECT WALL TO CHECK FOR ANY DAMAGE PREVIOUSLY CONCEALED BY VEGETATION
3. RAKE OUT BED JOINTS AROUND CRACKS AS INDICATED ON PLAN TO 40mm IN DEPTH AND RE-POINT IN LIME MORTAR(1:3).
4. REPLACE ANY MISSING COPING PLAIN TILES AND BED ON NEW LIME MORTAR
5. INSTALL PROTECTION MEASURES DURING DEMOLITION WORKS - REFER TO SEPARATE PLAN
6. RE-INSPECT WALL TO CHECK FOR ANY DAMAGE PREVIOUSLY CONCEALED BY THE MILL BUILDING
