# BS 5837 Arboricultural Report

& Impact Assessment

at  
**Land adjacent to Flint House  
North End  
SG8 9SD**

**Dated  
22<sup>nd</sup> March 2024**

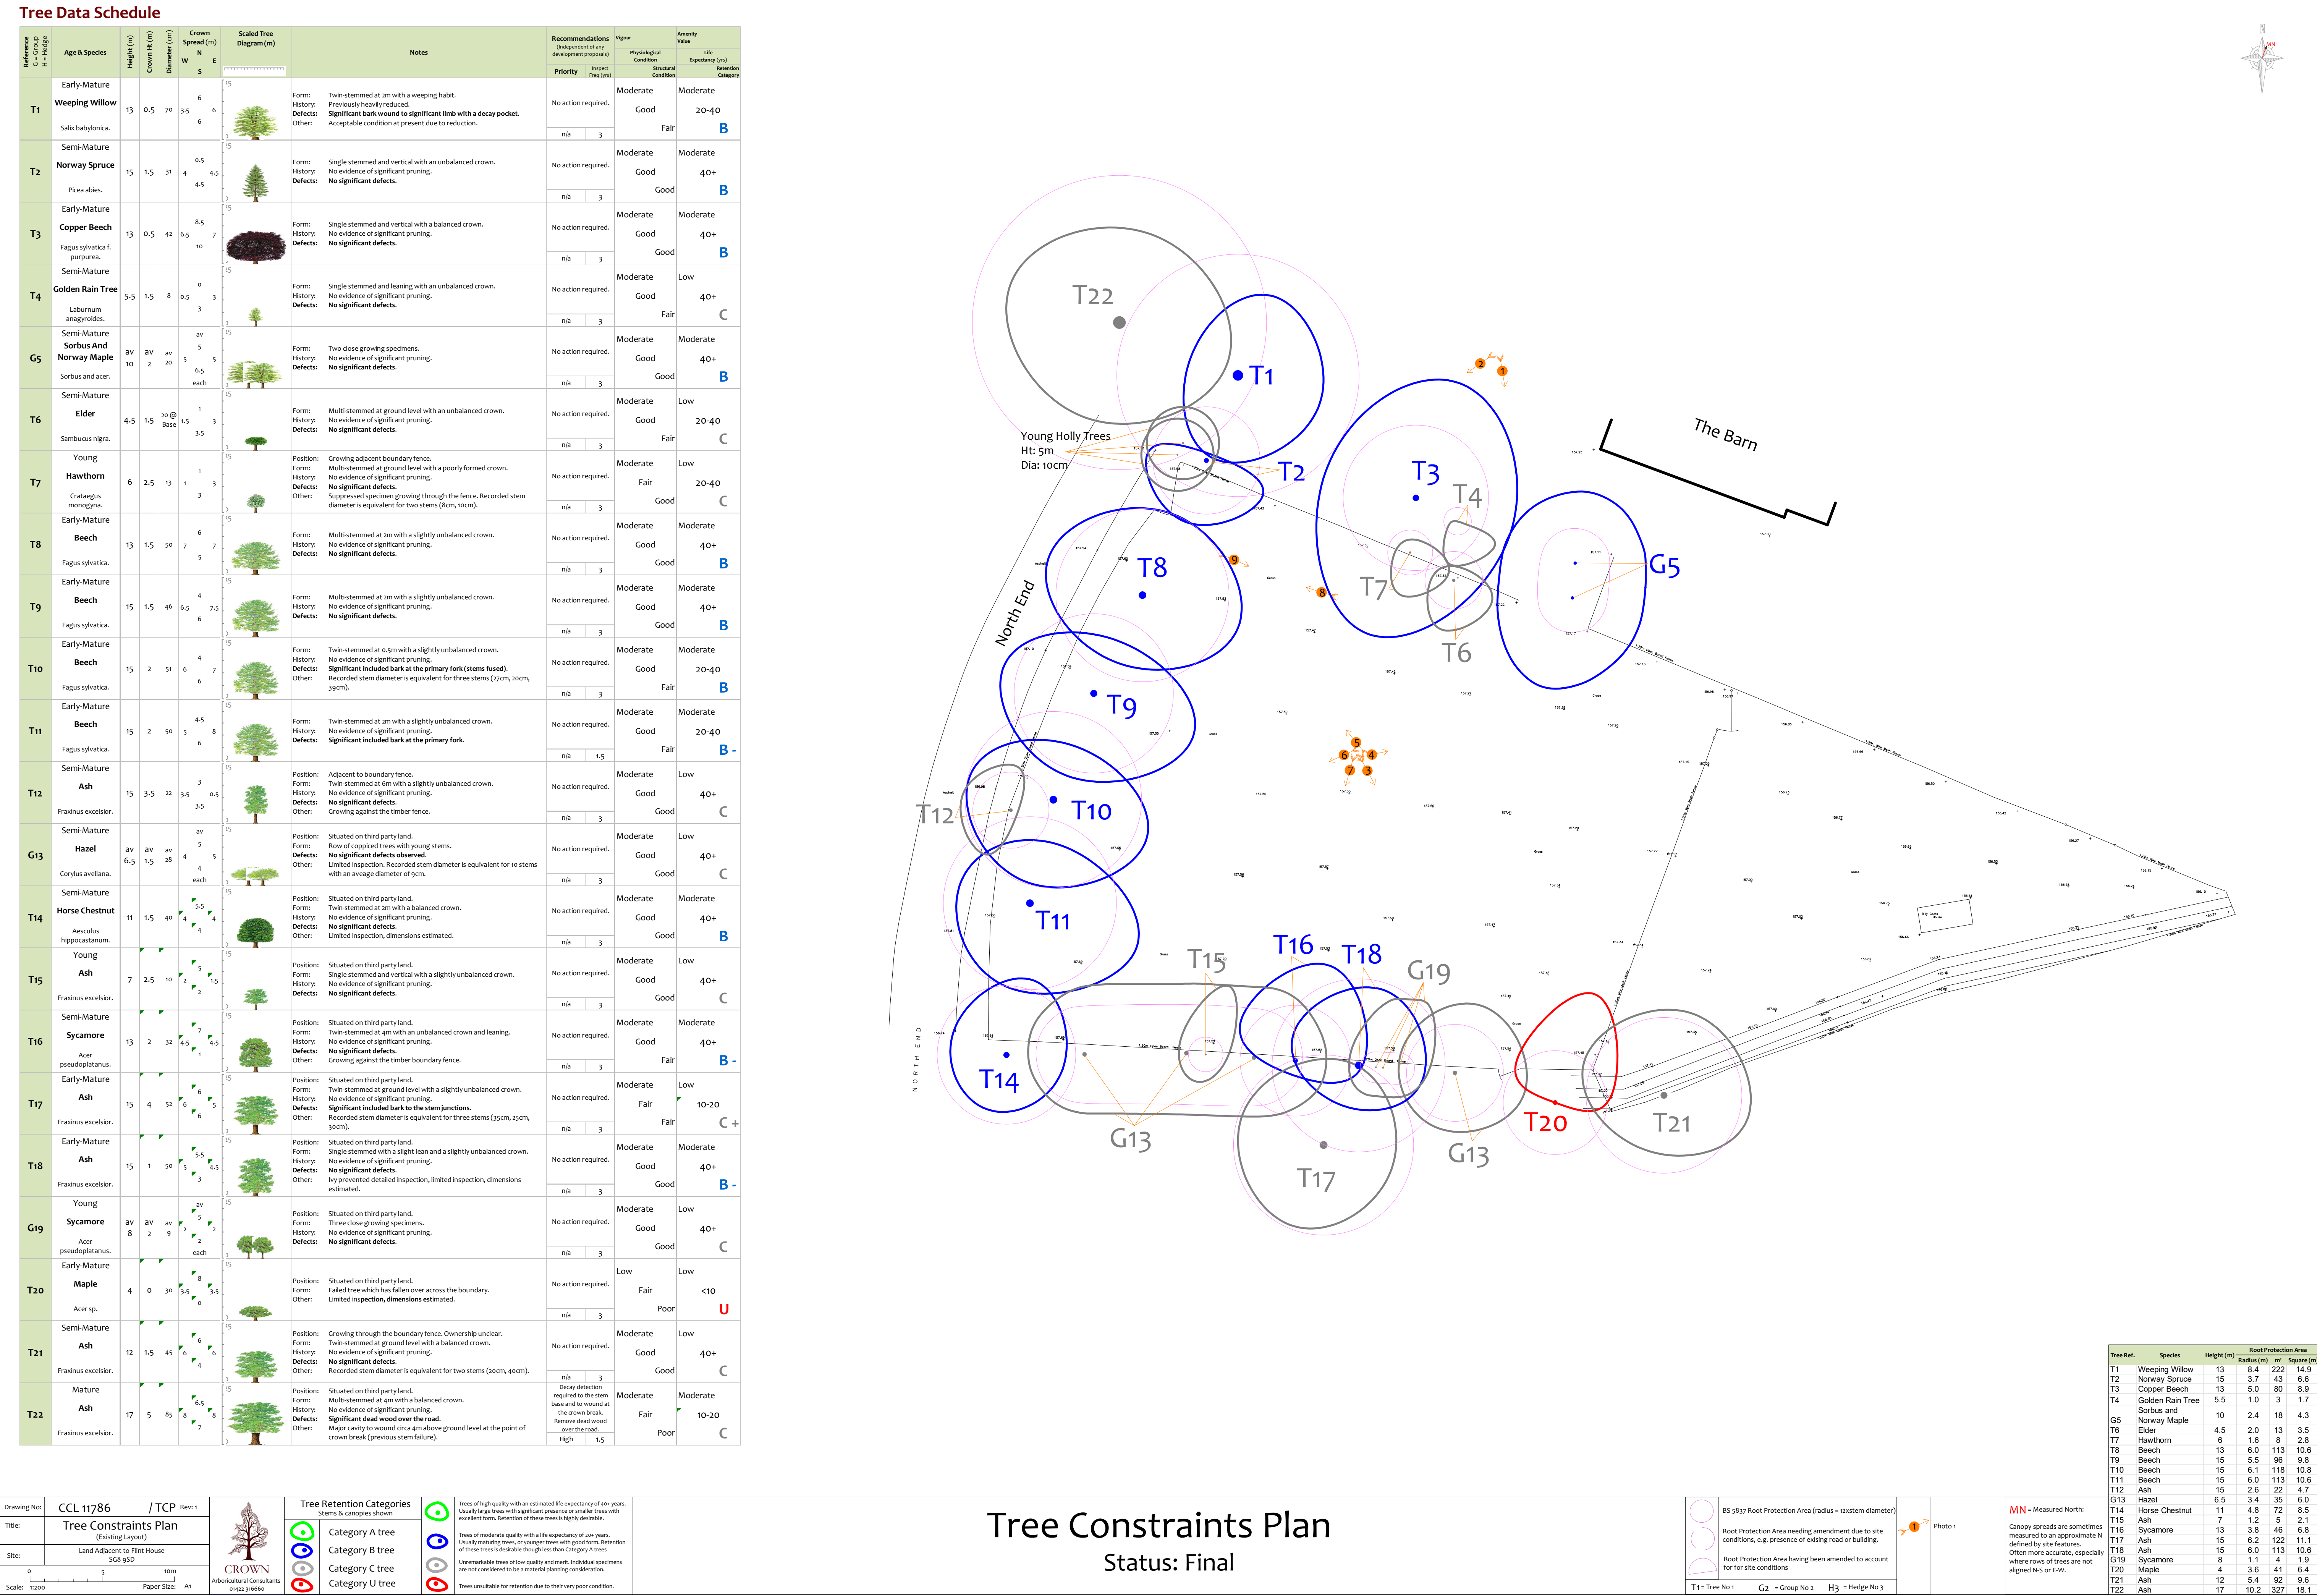
Clearance of 5m beneath the canopies of T2 and T8 will be required for construction vehicle access. Canopies should be neatly pruned to provide the required clearance to avoid any accidental damage to branches. Such pruning shall not have a significant impact on tree health.

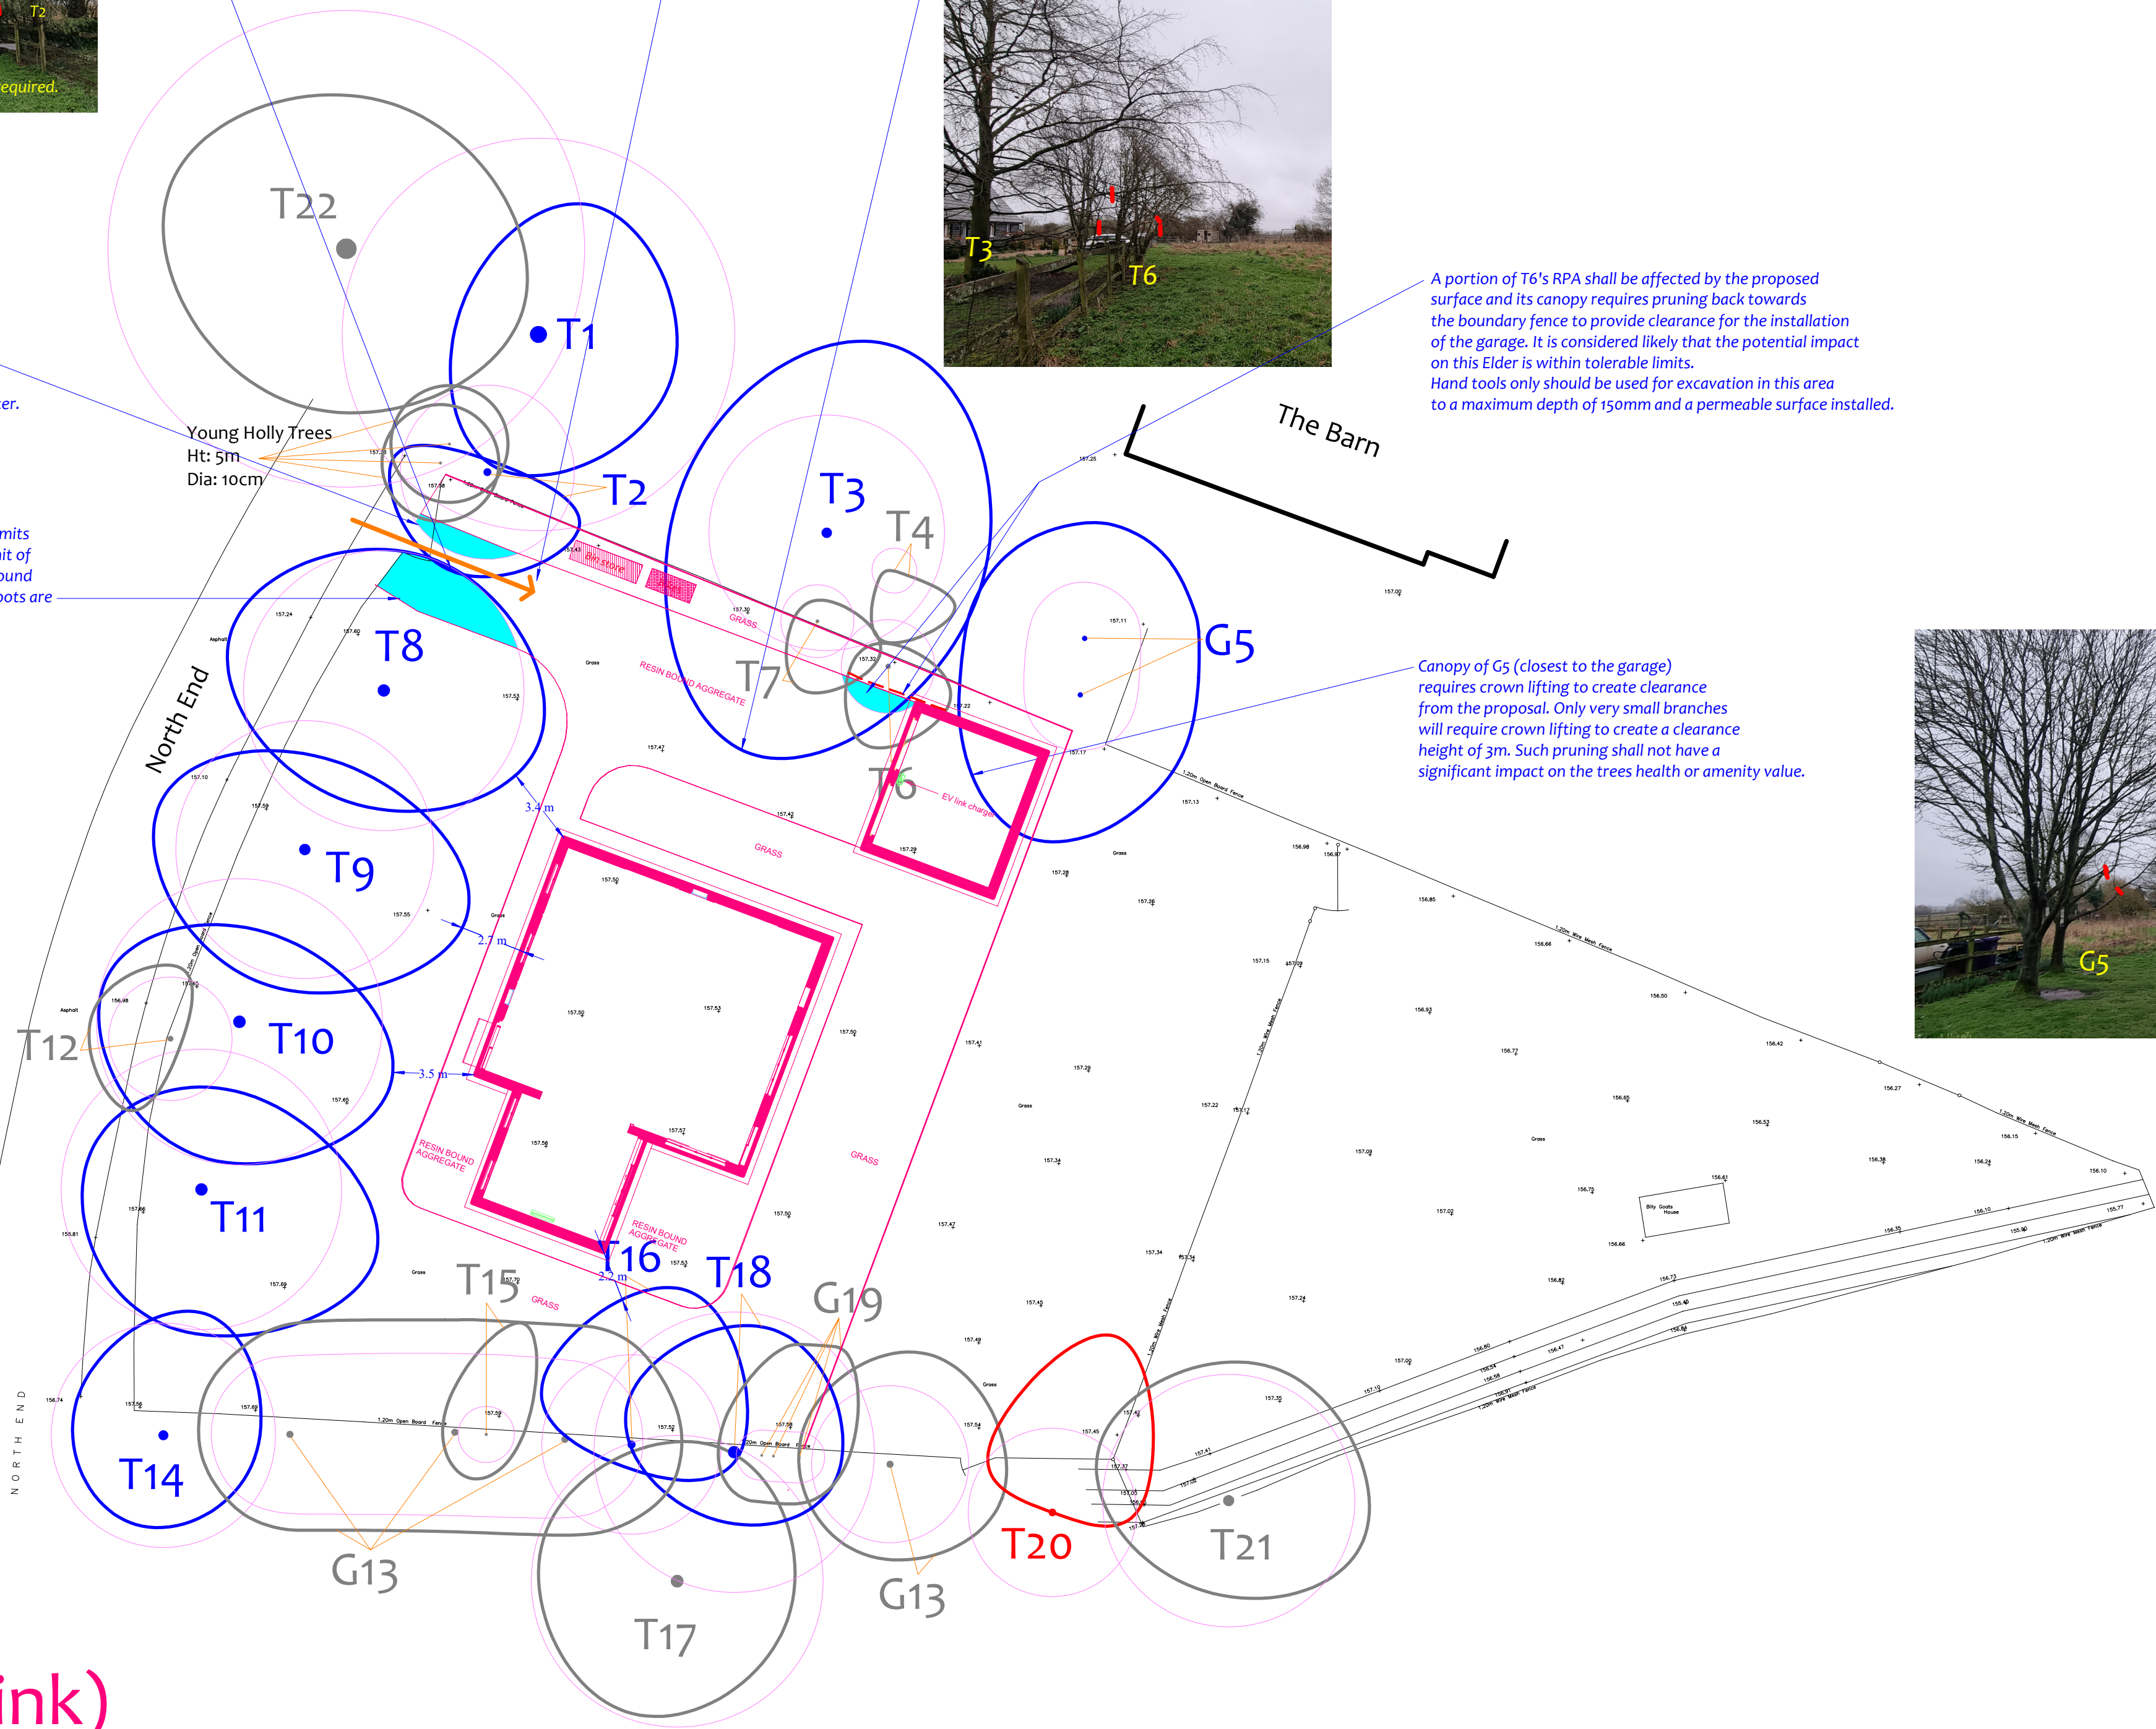
Canopy of G5 (closest to the garage) requires crown lifting to create clearance from the proposal. Only very small branches will require crown lifting to create a clearance height of 3m. Such pruning shall not have a significant impact on the trees health or amenity value.
