## **ARBORICULTURAL REPORT:**

**ARBORICULTURAL  
IMPACT ASSESSMENT**

**ARBORICULTURAL METHOD  
STATEMENT**

**The Node Court, Drivers End Lane,  
Codicote, Hertfordshire, SG4 8TR.**

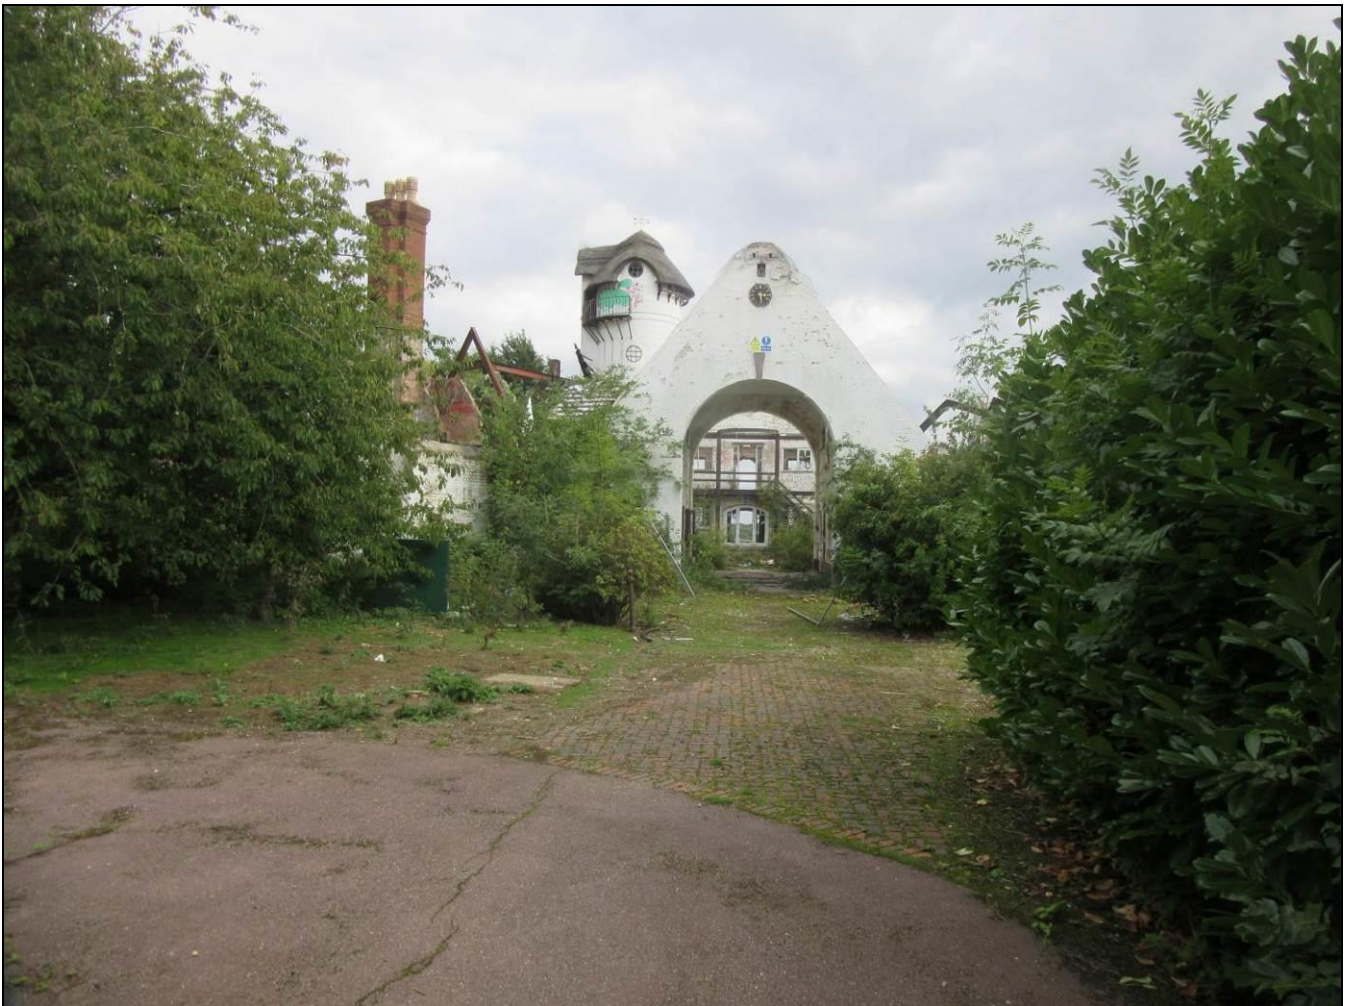
- 4.1 The site was a former model dairy set within a large plot. It was constructed in 1928 and is accessed by a long driveway from Drivers End Lane. The main building and a building to the rear boundary are now derelict and in a poor condition (see Photograph A). There have been fires on the site which have destroyed part of the buildings and have burnt some of the vegetation. It is a circular rendered brick building mainly of 1 storey and attic arranged around a courtyard and covered with a continuous roof of thatch. To the South-East of the main building a walkway – formerly thatched – leads to an office building to the rear of the site. This building is accessed by the driveway which continues along the eastern boundary to the rear of the site. There are areas of parking within the site. The site is relatively level.

Photograph A – Looking south towards the main building.

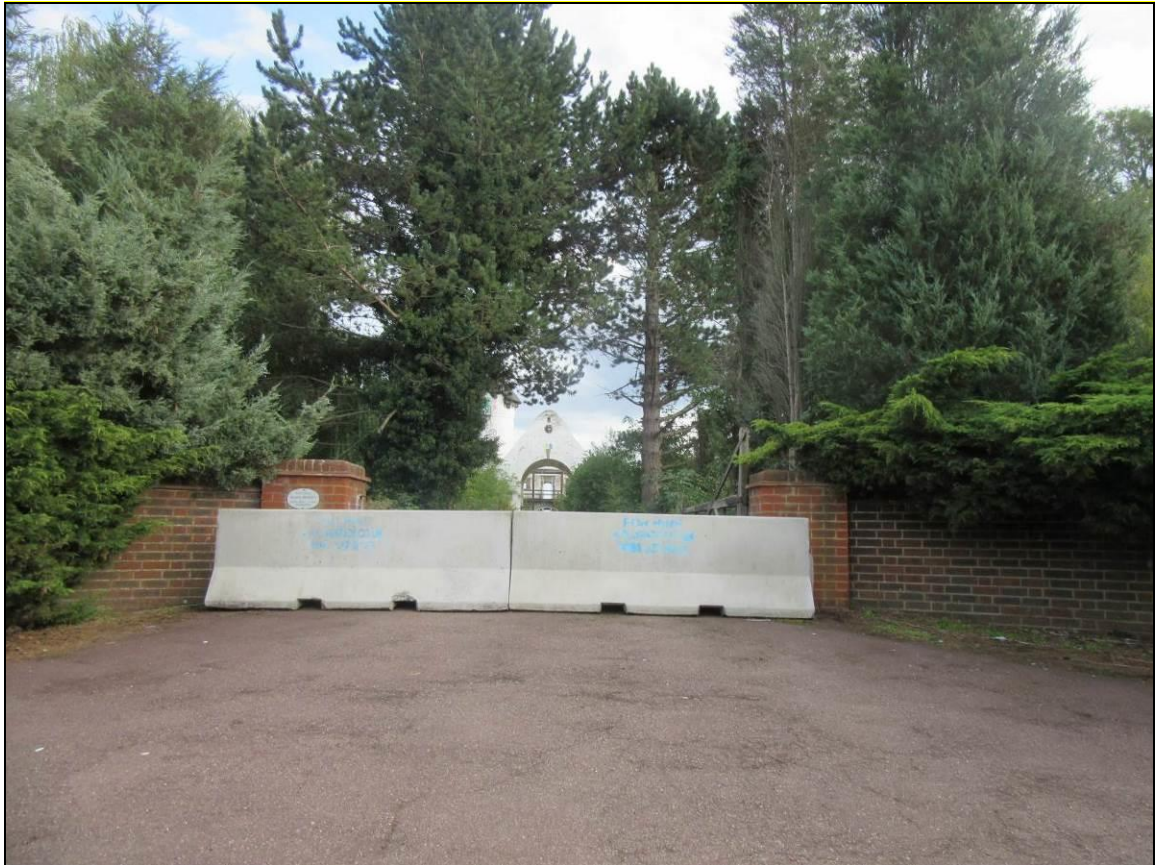
Photograph C – Showing the existing site access.

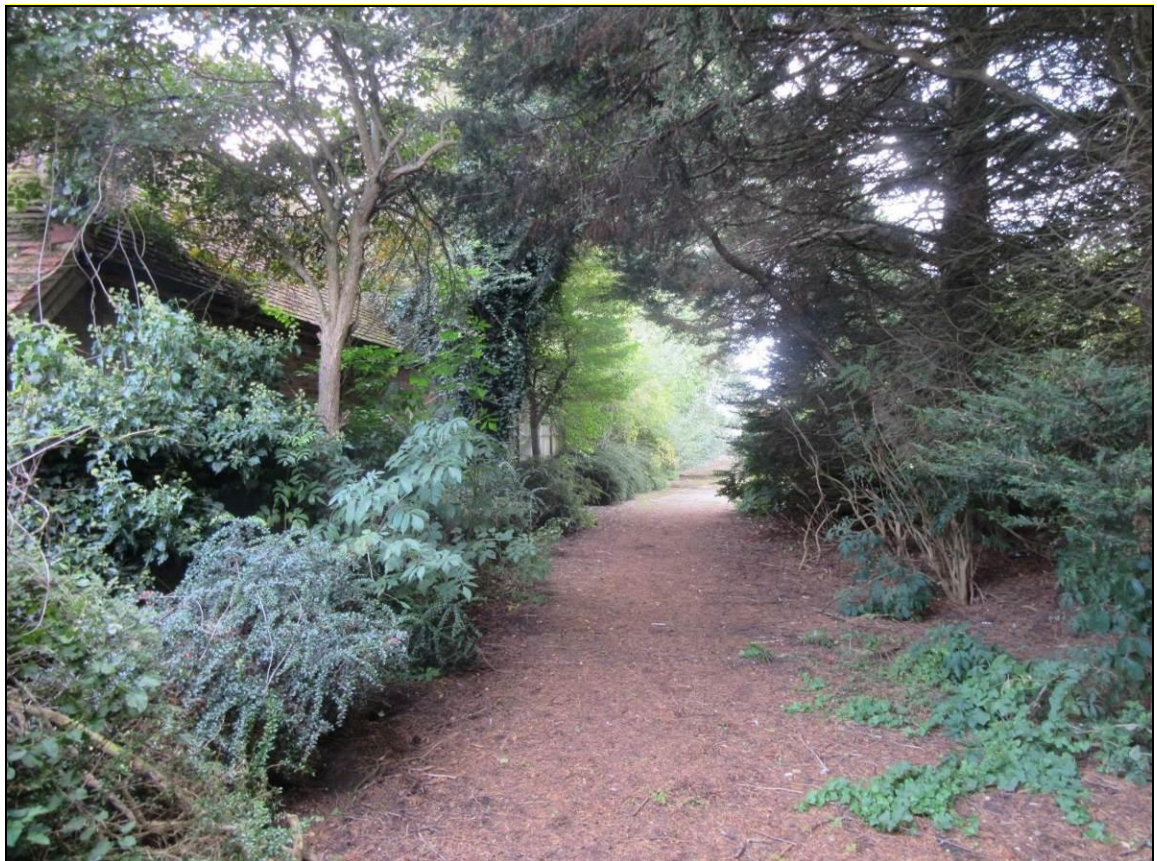
Photograph D – Showing the trees and vegetation along the access to the eastern boundary.

- 6.19 With regard to the trees within this report there are potential constraints within their RPAs. These include existing offsite buildings and areas of hardstanding (see Photograph D). The capping of the soils by the building(s) will reduce the availability of resources (such as water) to potential root activity and reduce gaseous exchange between the soils and the atmosphere. Factors such as soil compaction during the construction of the building and the physical presence of foundations would significantly reduce or prevent rooting activity in these areas. There will be a similar position for the hardstanding and it is likely that the majority of roots will be found within 'soft' landscaped areas where conditions for root growth are more favourable. However, the exact construction of the buildings and the hardstanding is not known and therefore there may be some potential for water percolation and gaseous exchange to occur beneath these areas which would encourage some root activity here. This would only be confirmed by undertaking further site investigations such as trial trenches. These are proposed within this report in relation to the foundation design for the enabling development.

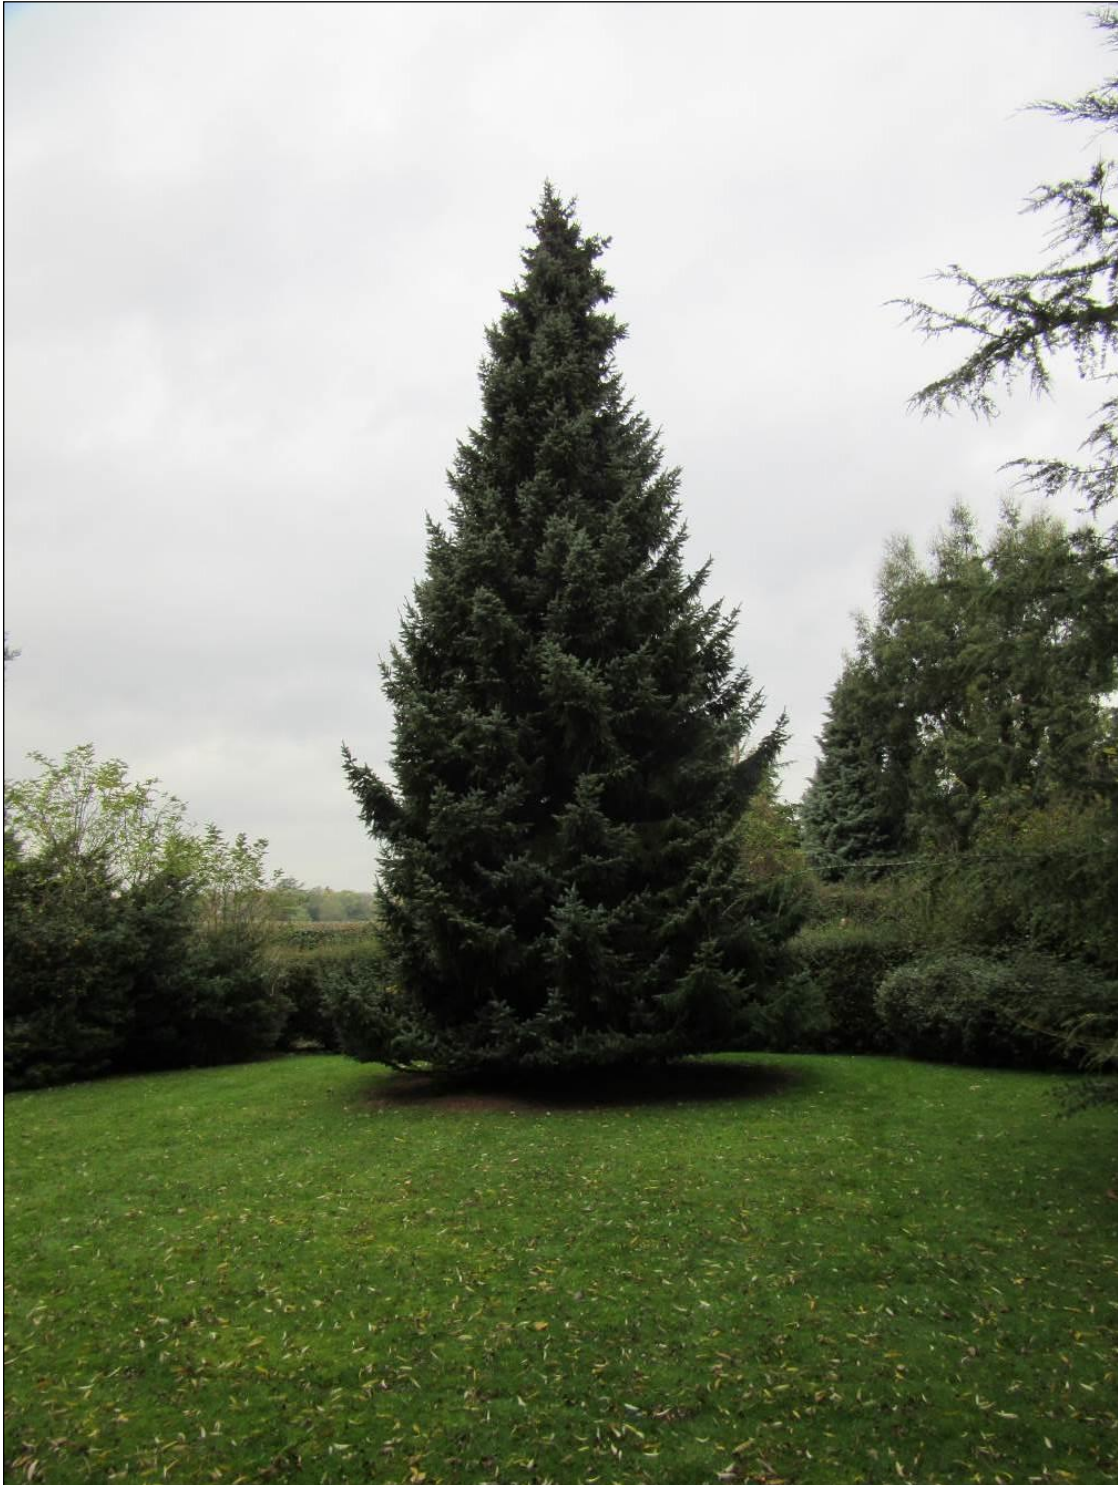
Photograph L – Showing Spruce (T2) to the site frontage (2018).
