# Site Investigation Report

194196.1.USI

Auger were commissioned by Quadra to undertake a site investigation and CCTV inspection of the underground drainage within the area of concern (AOC) at the property.

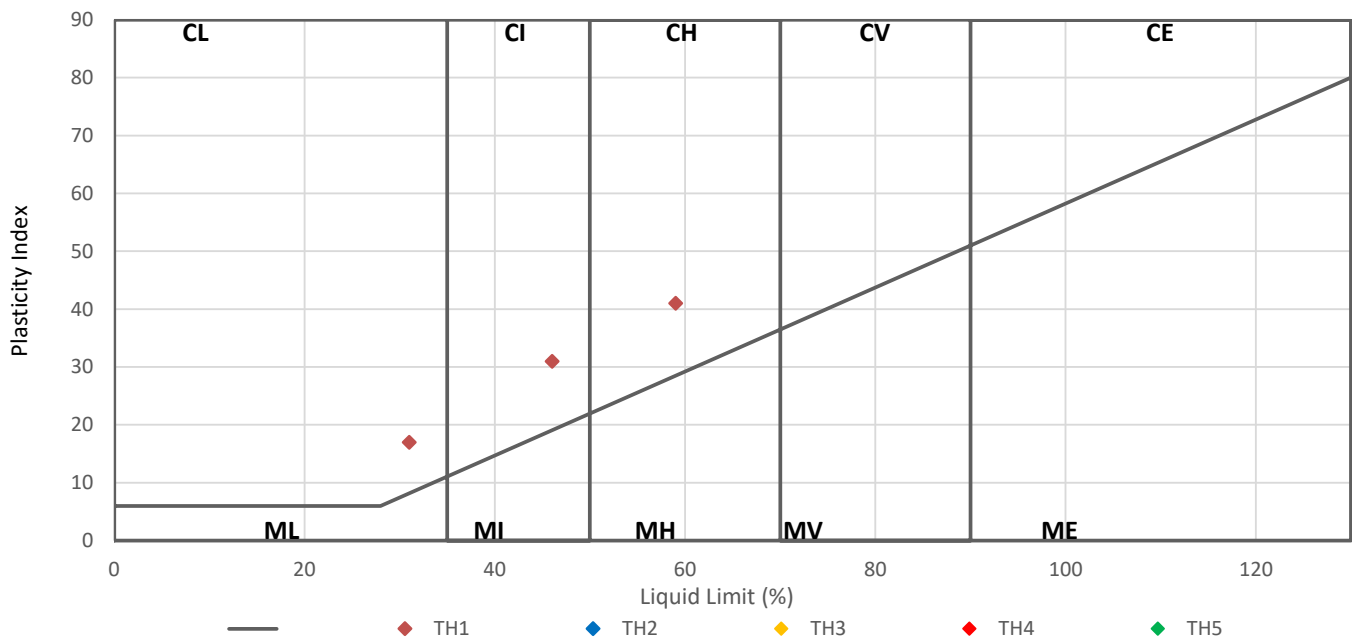
Modified Plasticity Index (PI) <10 : Non Classified  
 Modified PI = 10 to <20 : Low volume change potential (LOW VCP)  
 Modified PI = 20 to <40 : Medium volume change potential (Med VCP)  
 Modified PI = 40 or greater : High volume change potential (HIGH VCP)
